Section 19 Flood and Water Management Act 2010

Earl Soham Flood Investigation

Storm Babet 2023

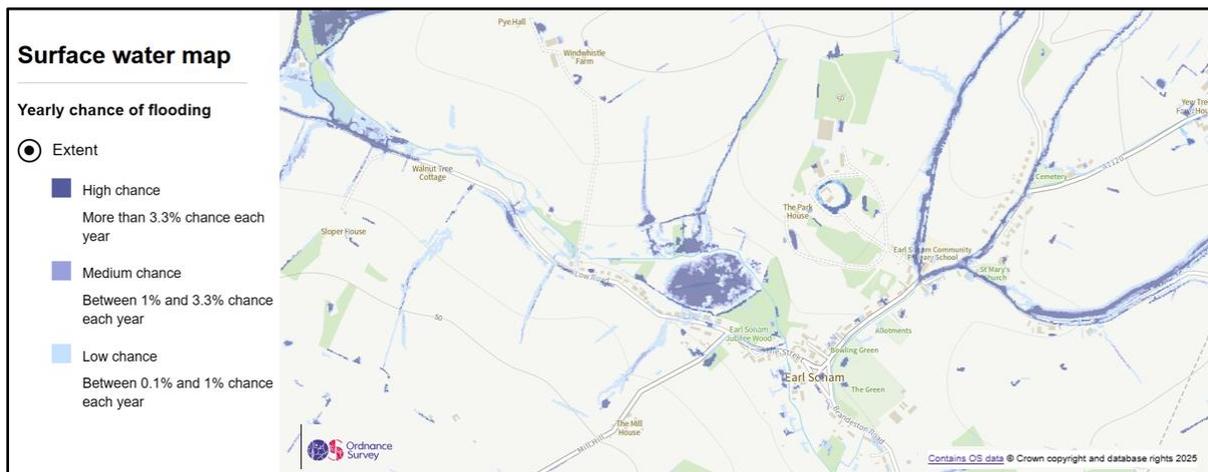
Fig. 5 Predicted flood risk from surface water

The parish of Earl Soham is at significant risk of pluvial (surface water) flooding (Fig. 5). Surface water flood risk ranging from low to high chance of flooding is projected for all the affected property in the northeast of the village, where three watercourses converge east of The Street, in the vicinity of the school. Further southwest on The Street, in the vicinity of the A1120 bridge over Earl Soham watercourse, impacted property was not projected to be at surface water flood risk. Affected property to the west of Earl Soham on Low Road (zone 2) is projected to be at low risk of surface water flooding. It should be noted that low chance of flooding indicates a flood risk during extreme events, such as Storm Babet.
