## Section 19 Flood and Water Management Act 2010

### Report Title: Goulds Close, Palgrave

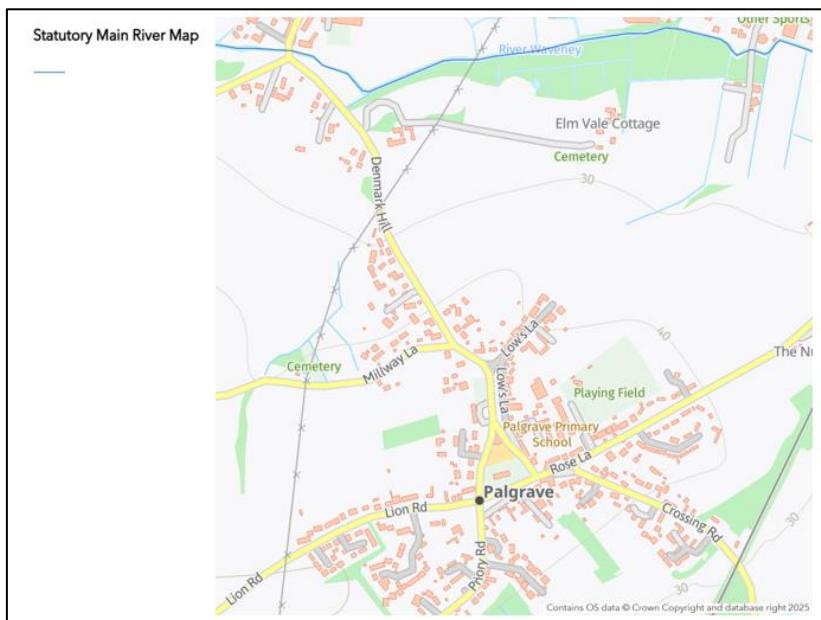
Figure 2- Location of statutory main river and ordinary watercourses.

Figure 2 below, shows the most significant watercourses in and around Palgrave.

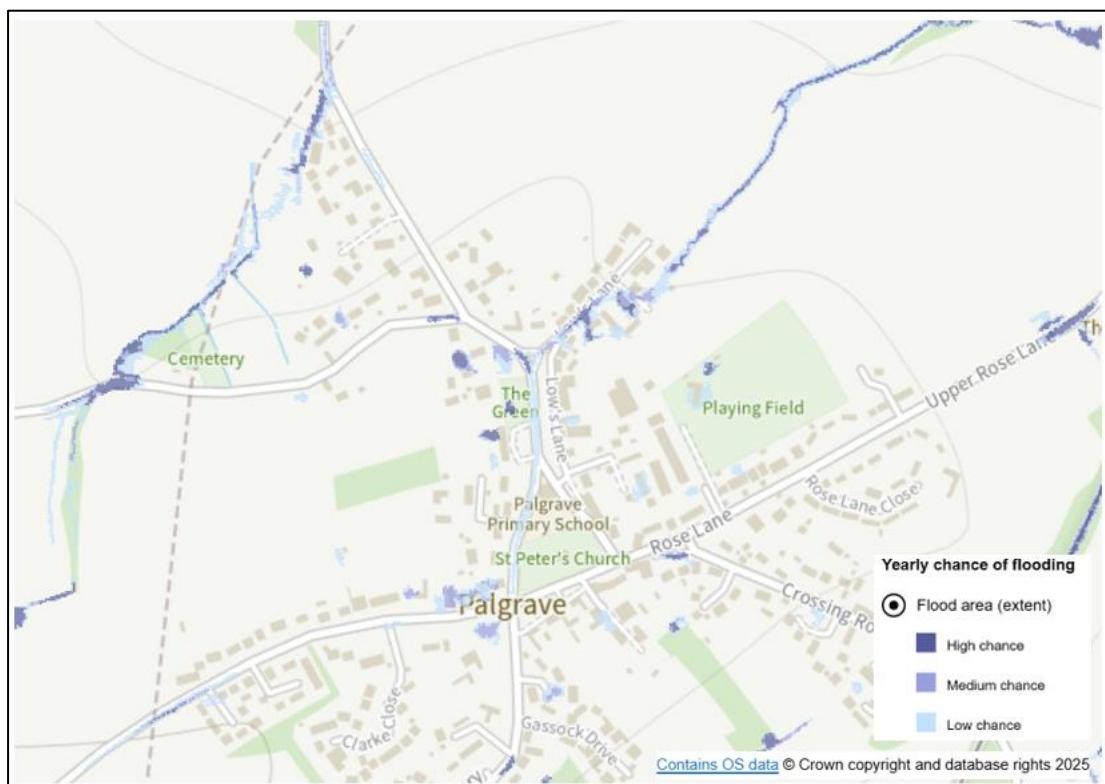
Figure 3- Surface water flood risk.

The surface water flow path in this area varies in risk level from low risk along Priory Road, increasing to medium and high risk along Lows Lane and Goulds Close. Goulds Close has been affected by flooding on several occasions.

Figure 3 highlights the predicted pluvial surface water run-off from surrounding land and highways flood risk in Palgrave, with one main flow path travelling Northeast through the village and into the River Waveney.

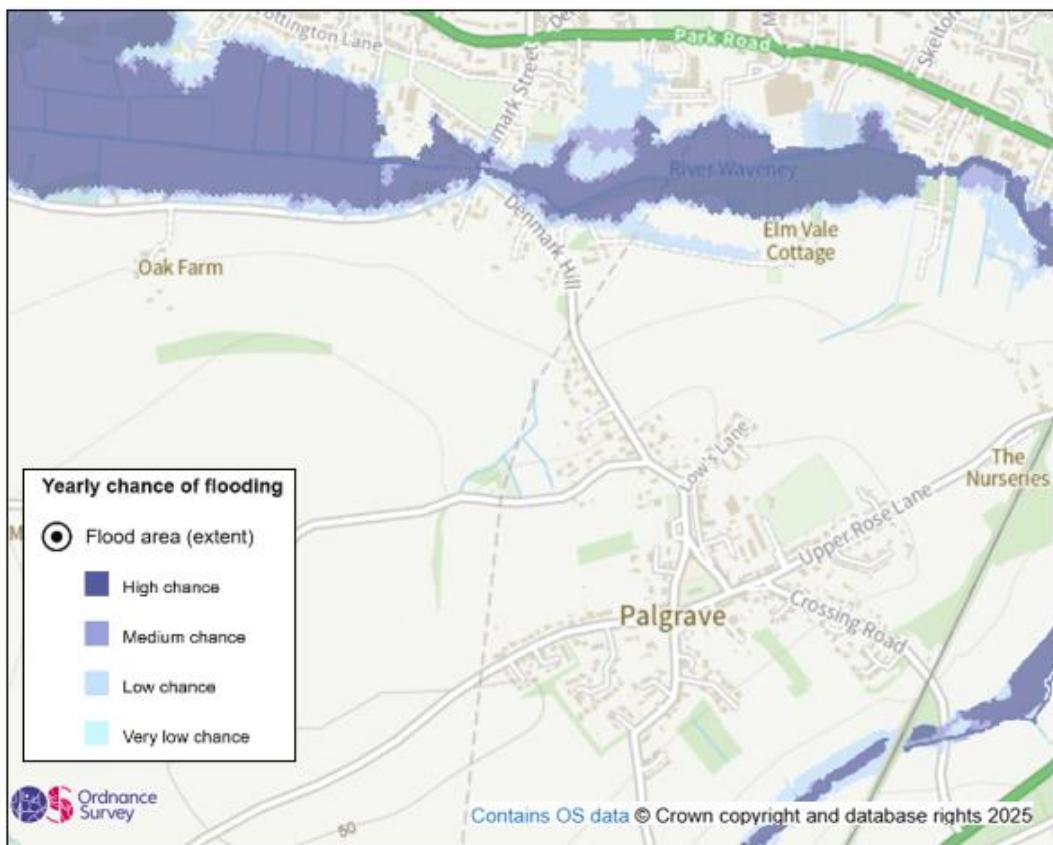
Figure 4- Flood risk from rivers and sea.

Figure 4 shows the predicted fluvial (from designated main river and ordinary watercourses) flood risk in Palgrave. The fluvial flood risk in the Palgrave area is predominantly associated with the River Waveney to the North of the village and a watercourse feeding into the Waveney from the South.

There is no current risk of fluvial flooding in Palgrave.

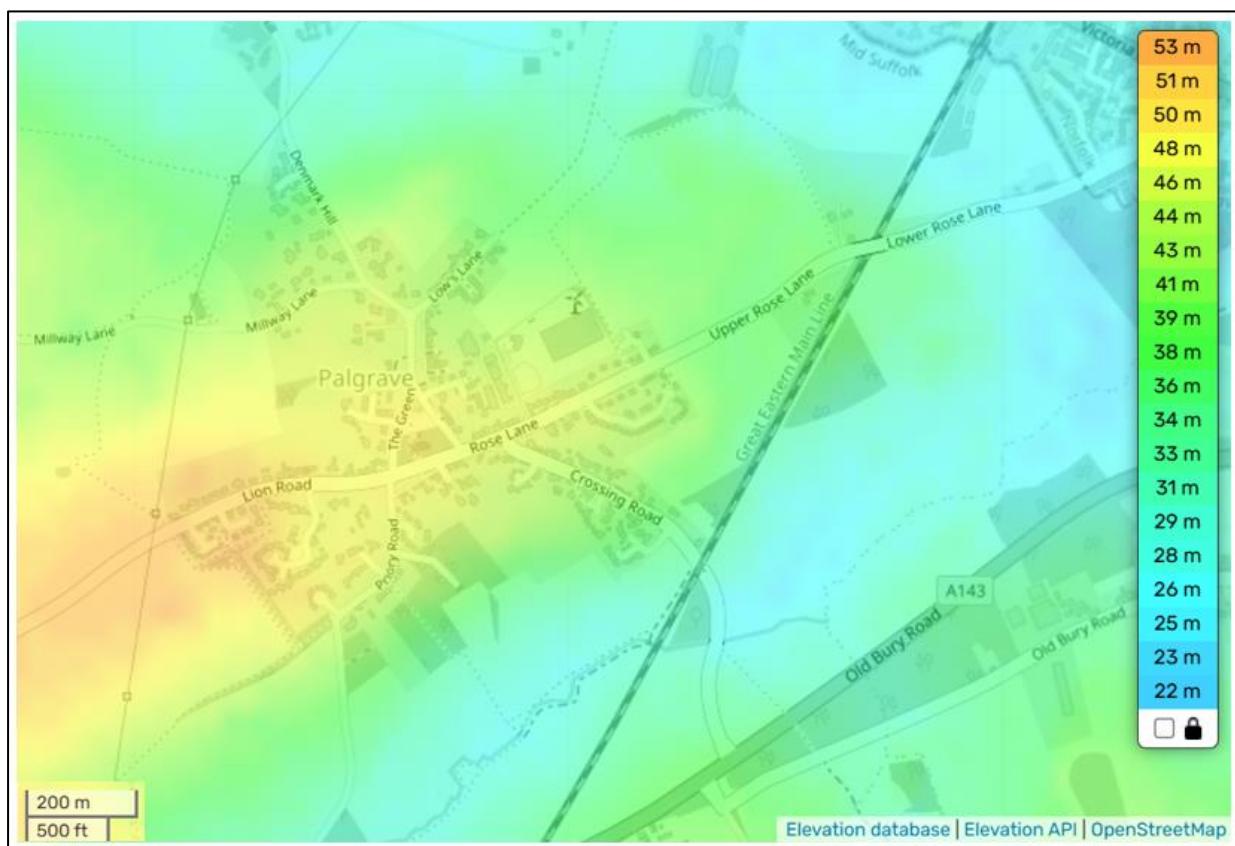
Figure 5- Palgrave and surrounding area topography (TessaDEM as cited in topographic-map.com).

The village of Palgrave varies in topography ground levels with the West sitting higher than the East. Figure 3 shows the topography surrounding Palgrave with gradient changes across the wider area. Goulds Close is situated in a lower lying area where higher grounds surround it from the West while it continues to fall towards the East where the River Waveney flows.

The low-lying nature of Goulds Close means that during high rain fall events floodwater can become close in proximity to properties. Overwhelmed drainage infrastructure is frequently observed during these rainfall events.

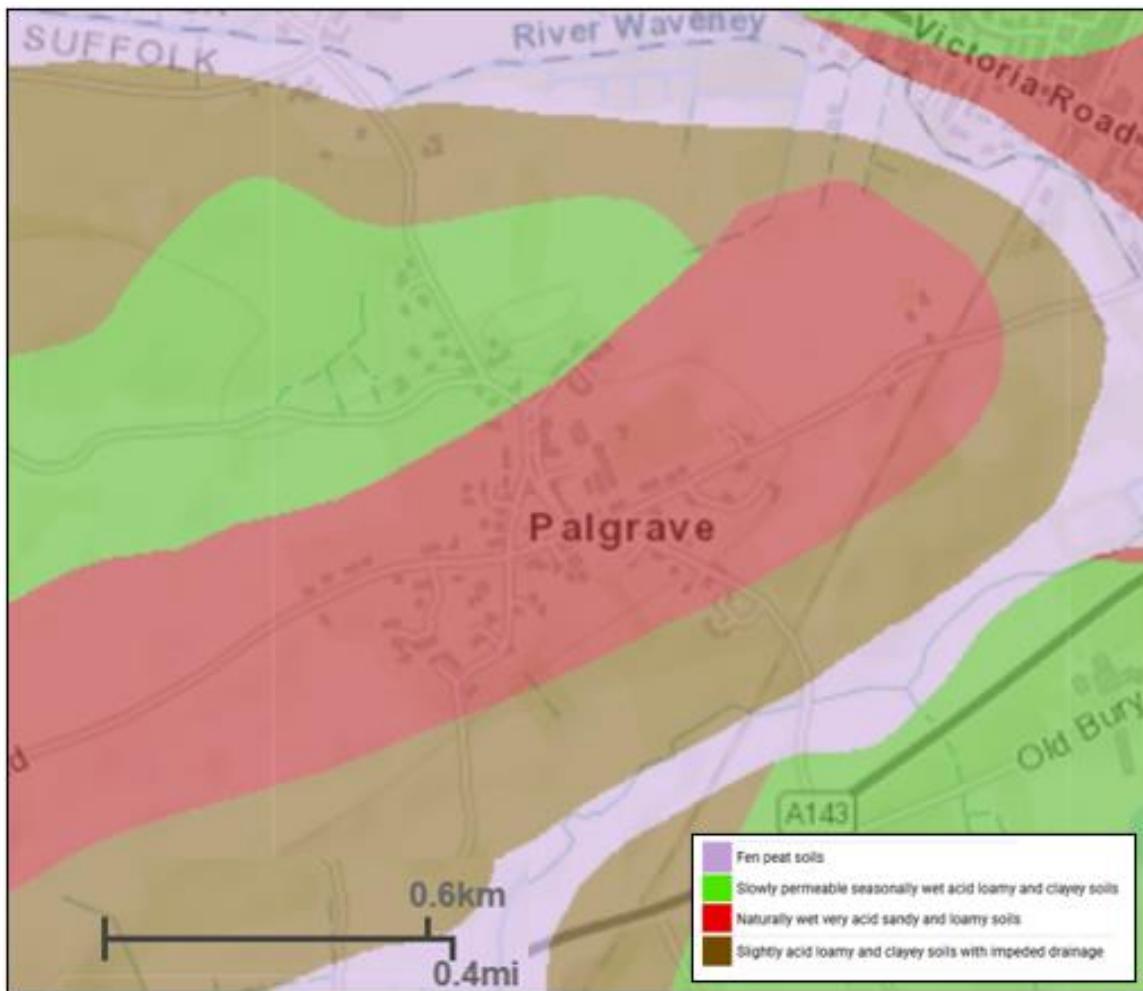
Figure 6- Soil Map (LandIS Soilscapes).

The soils surrounding Palgrave area are sandy (red) which is relatively free draining and covers most of the village. However, there is less free draining loam and clay (green) present along Lows Lane and Goulds Close through which water drains more slowly into the ground and excess surface water runoff is greater. Clayey soils (brown) surround the village which cause reduced drainage along with fen peat soils (purple) follow the River Waveney and similarly can cause naturally wet areas.

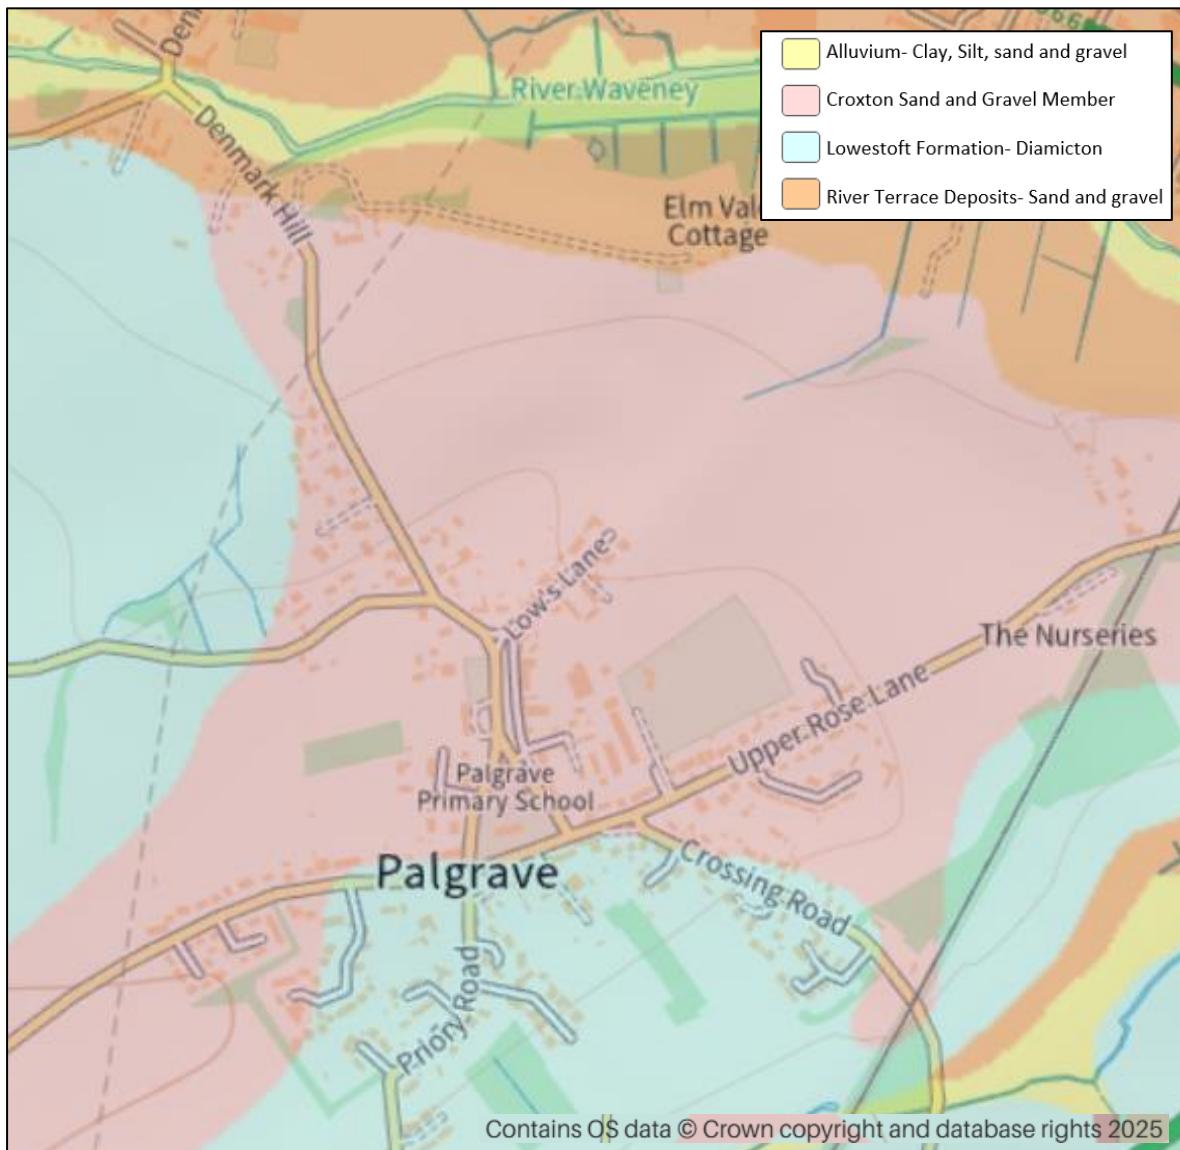
Figure 7- Superficial Geology (BGS Viewer).

Lowestoft Formation 'Diamicton' is present locally and underlies half the village (described by the British Geological Survey as a diverse mixture of clay, sand, gravel, and boulders varying widely in size and shape). This generally has a low permeability, meaning water will tend to flow off it before it can be infiltrated into the ground.

Croxton Sand and Gravel Member underlies the other half of the village which is described by the British Geological Survey as sand and gravel. This generally has a higher permeability, meaning water will tend to infiltrate instead of running off resulting in reduced flood risk typically.

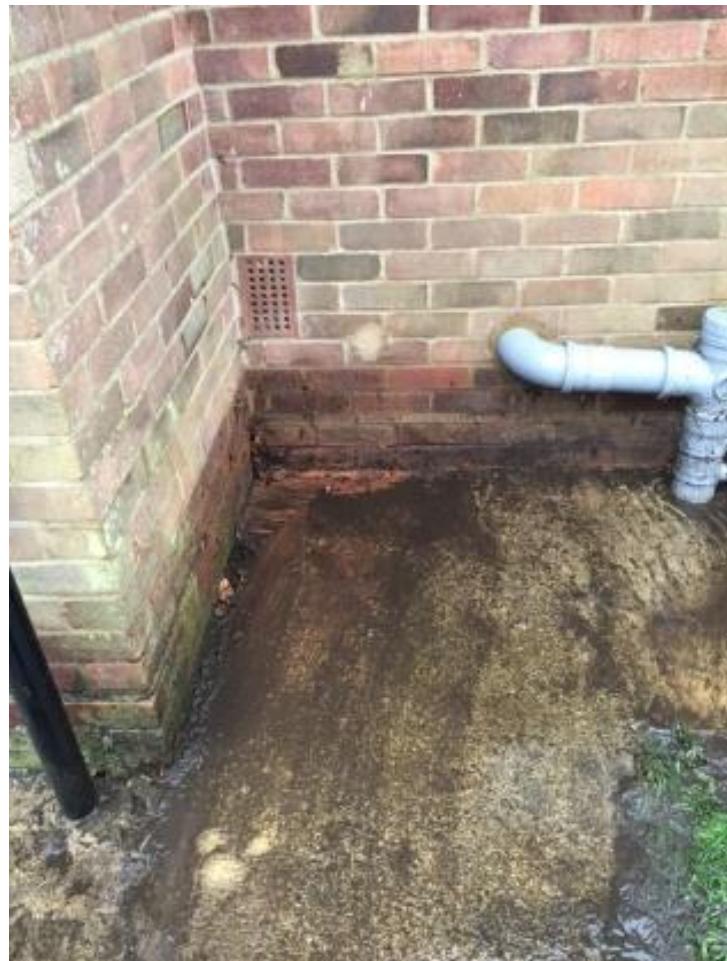
*Image 1- Aftermath of flooding, height line and muddy debris.*

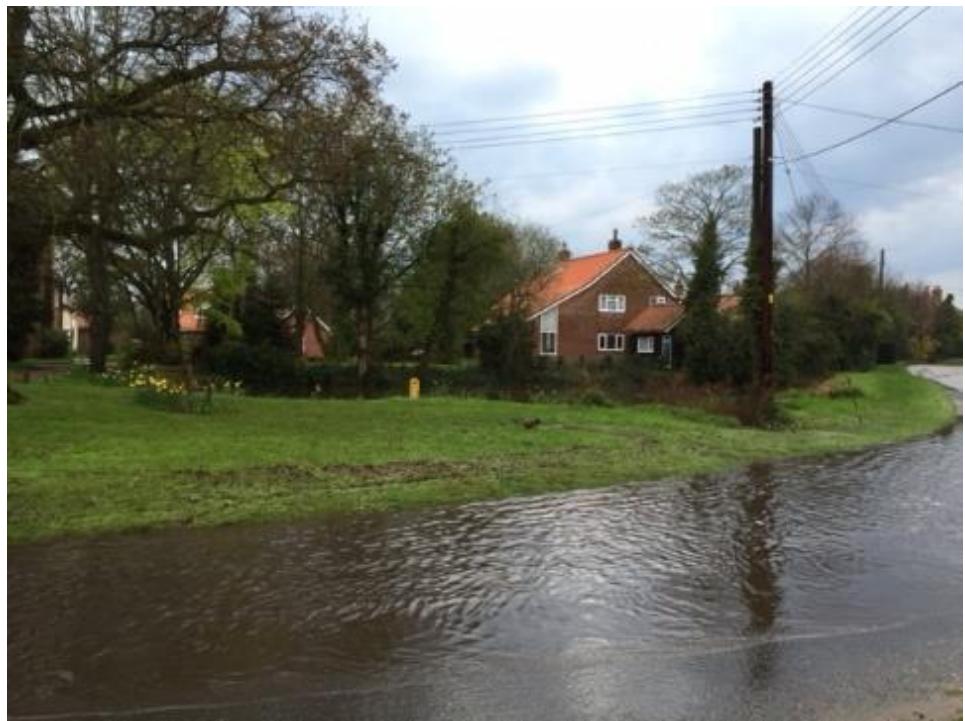
Several previous internal flooding events have been recorded at more than one property. Reports dating back to 2016 described recurring flooding issues originating from the pond located at the top of Millway Lane. During periods of heavy rainfall, the capacity of the pond is overwhelmed and therefore the pond overflows, causing water to flow down towards Goulds Close. Shallow kerbs and low property thresholds resulted in flood water entering properties.

*Image 2- Flooding by the pond on Priory Road (Lows Lane junction).*

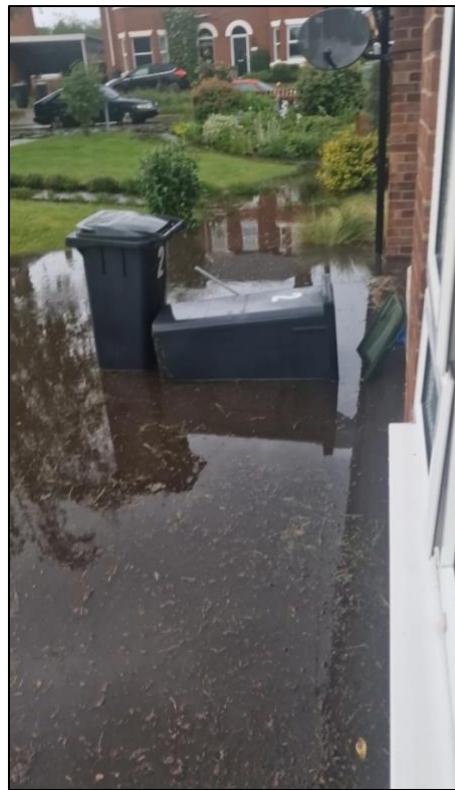
*Image 3- Flooding at Goulds Close.*

- Residents to install Property Flood Resilience (PFR) measures.
- Suffolk Highways to ensure the completion of highway drainage asset cyclic maintenance on Lows Lane.
- Residents/Parish Council to consider joining the Community Self Help scheme to enable small scale clearance of drainage assets.
- Suffolk Highways to investigate the drainage issues and consider increasing the frequency of gully clearance in this location.
- Suffolk Highways to review levels in highway and assess whether pierced chamber covers, additional gullies or realignment of kerb line would reduce flood flows towards properties.
- Landowners / General public to report any observed blockages along Priory Road, Lows Lane and Goulds Close on the Suffolk Highways Online Reporting Tool.
- MSDC to investigate the drainage issues in Goulds Close and repair/improve as required.

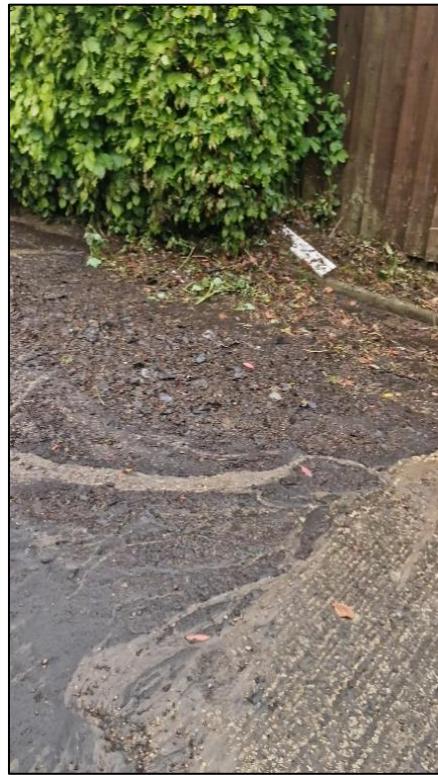
*Image 4- Flooding and debris accumulation at Goulds Close, private road behind.*

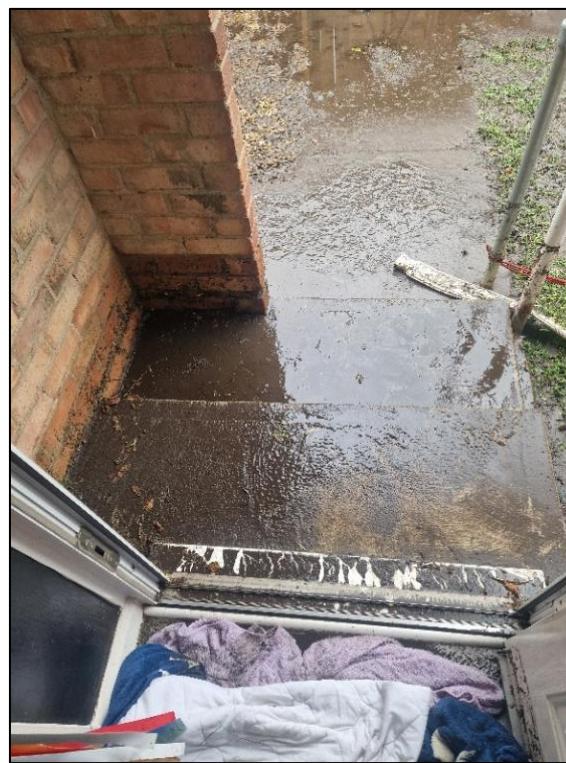
*Image 5- Aftermath of Flooding, height line and muddy debris left.*

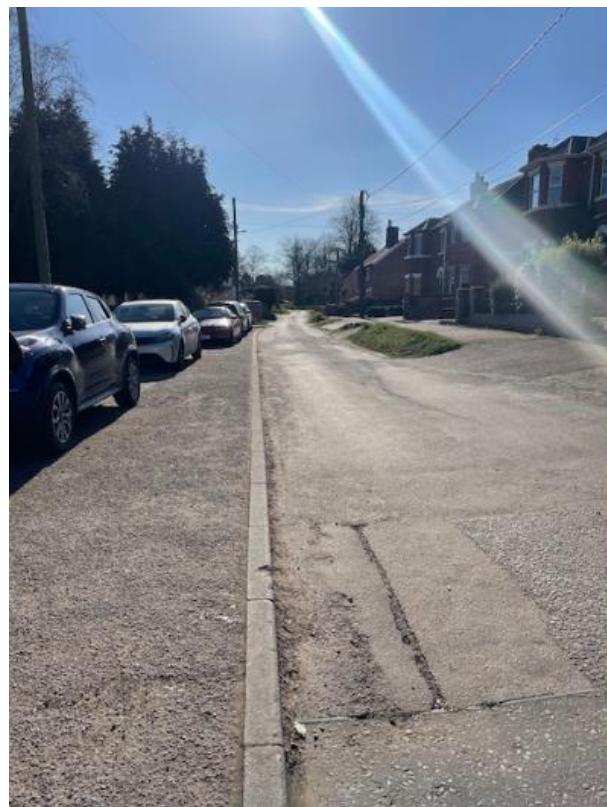
*Image 6- Looking up Lows Lane, shallow kerb for parking.*

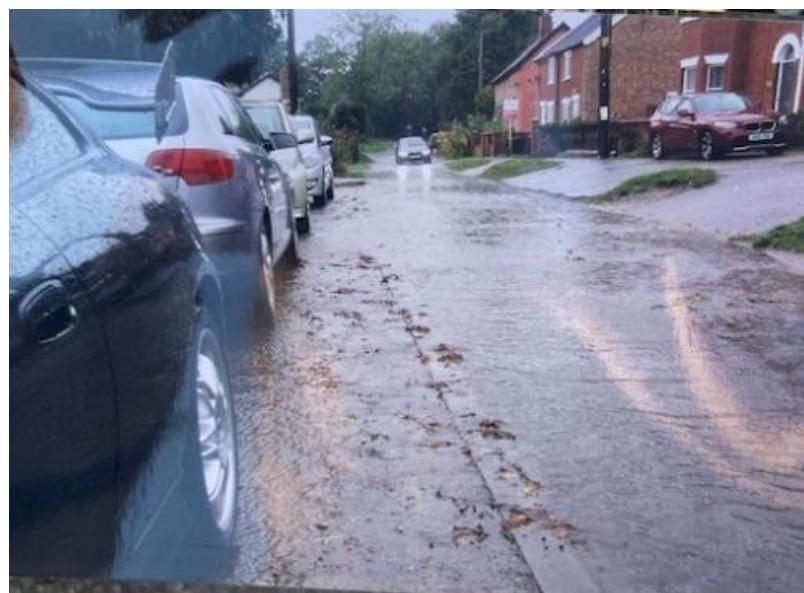
*Image 7- Residents Photo of the same location as Image 6 when flooded.*

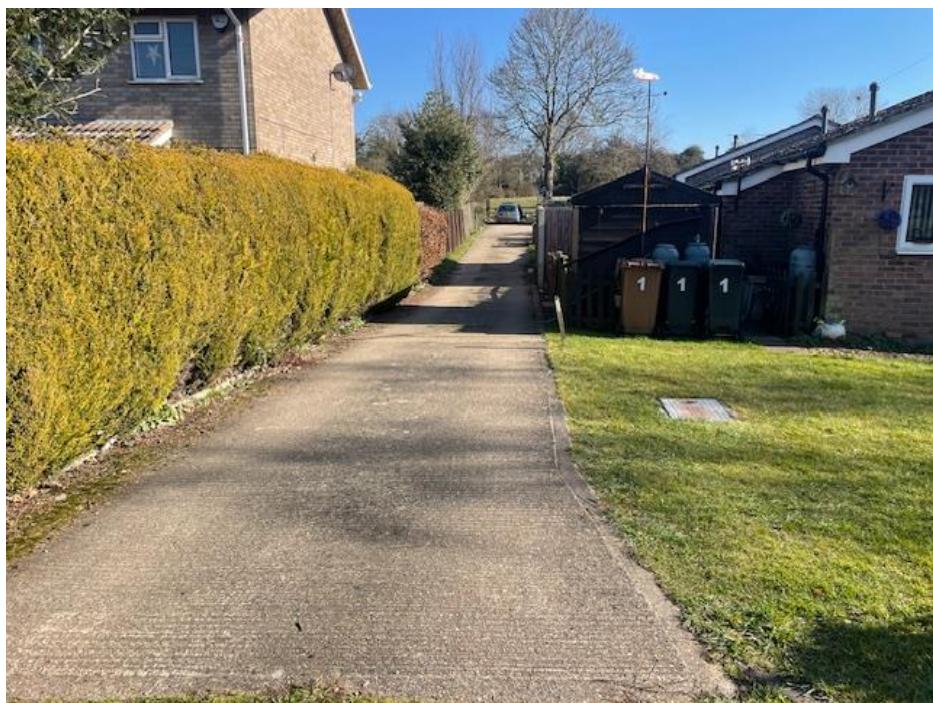
*Image 8- Back road at Goulds Close, leads to parking for residents.*

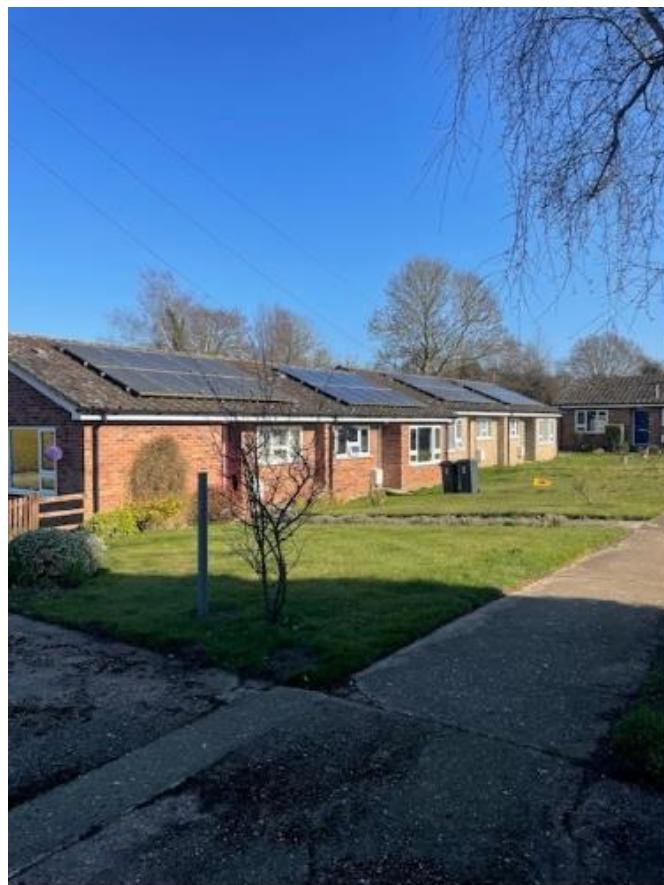
*Image 9- Front gardens of Goulds Close.*

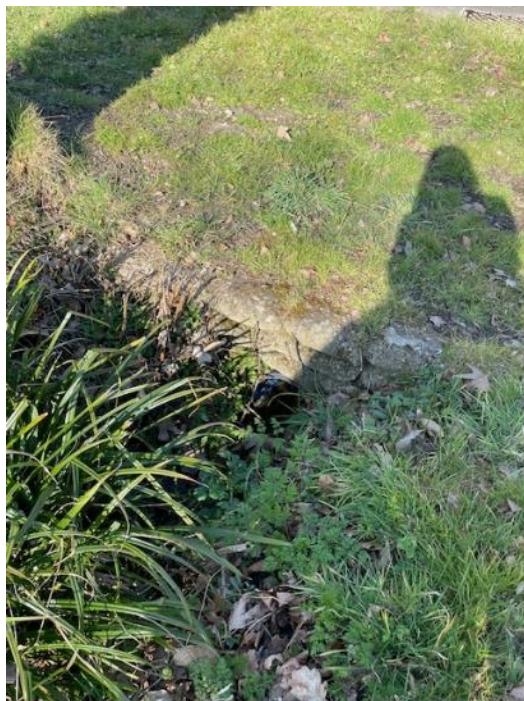
Due to this being a reoccurring incident, SCC Highways undertook an investigation and consequently implemented a new drainage scheme designed to help alleviate the issues. The scheme included construction of a new headwall and pipe network with new chambers and gullies connecting into the existing drainage. These works were completed in January 2017. Some reports, made by the residents, were submitted during the period between the works ordered and the completion of the scheme. As a result, further investigations by SCCs Floods Team were deferred until

*Image 10- Inlet from pond to pipe system from highways scheme in 2017.*

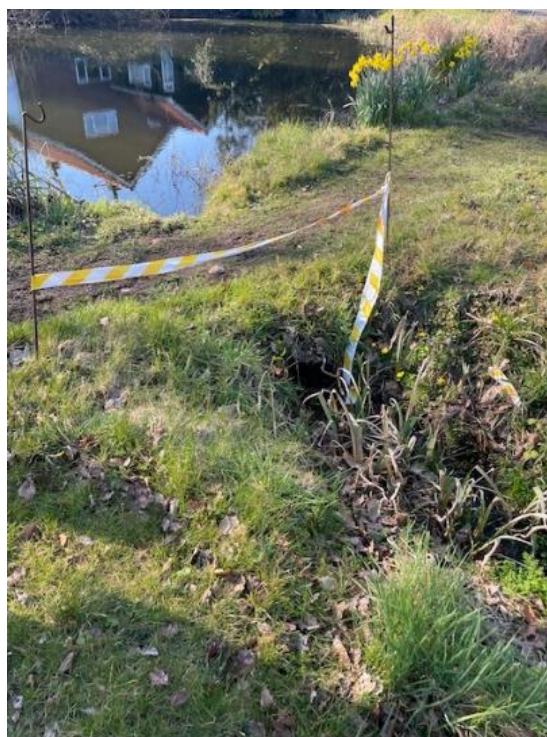
*Image 11- Inlet from pond and ditch before entering pipe system from highways scheme in 2017.*

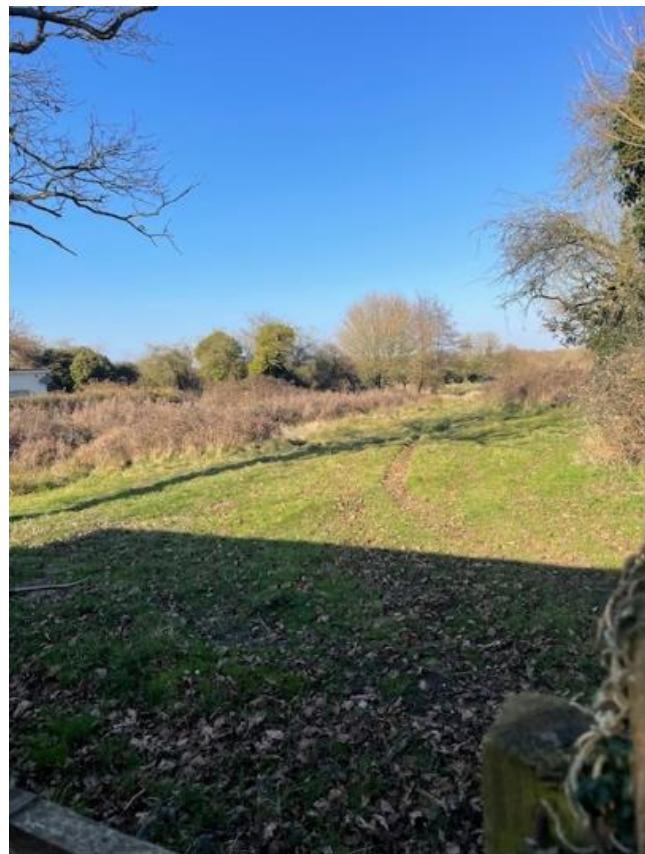
*Image 12- Field at the end of Goulds Close. 2017 highways scheme ends here with a headwall within the bushes.*
