## Section 19 Flood and Water Management Act 2010

### Great Bealings Flood Investigation –

### Storm Babet 2023

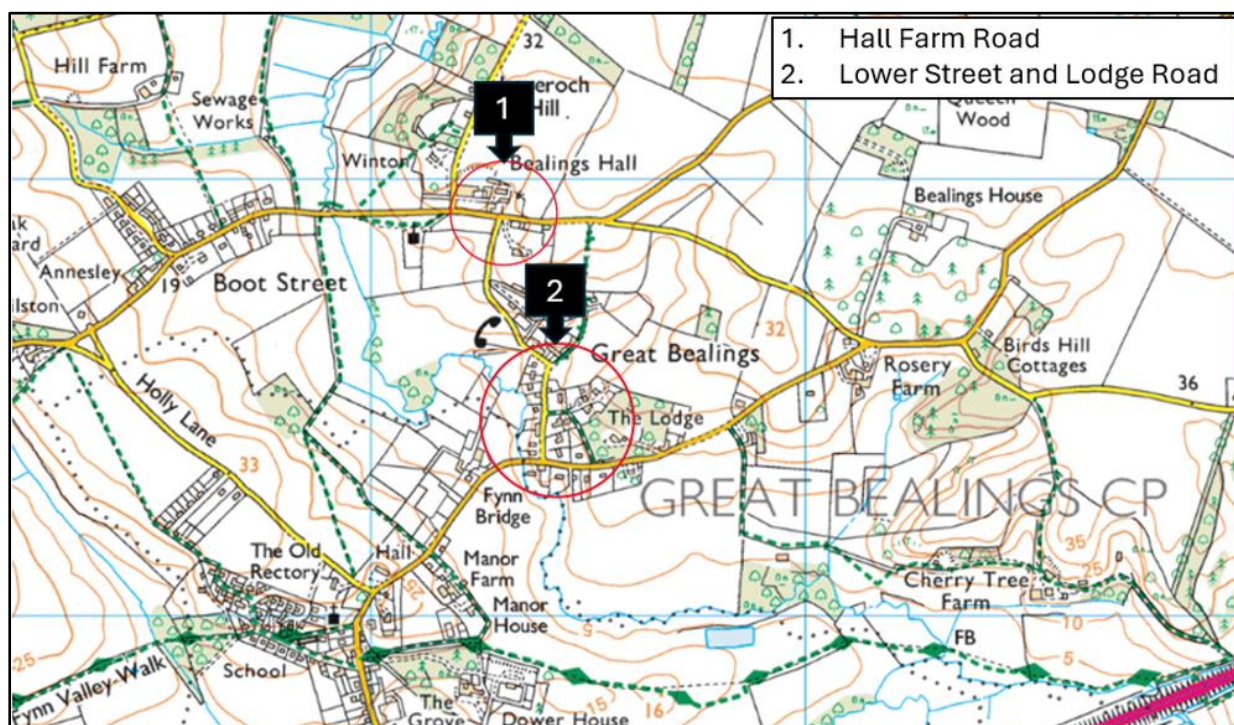
For the purposes of this investigation the various areas affected by flooding have been separated into two distinct locations (see Figure 4). The locations are as follows:

1. Hall Farm Road
2. Lower Street and Lodge Road

Figure 4. Great Bealings investigation area map with locations

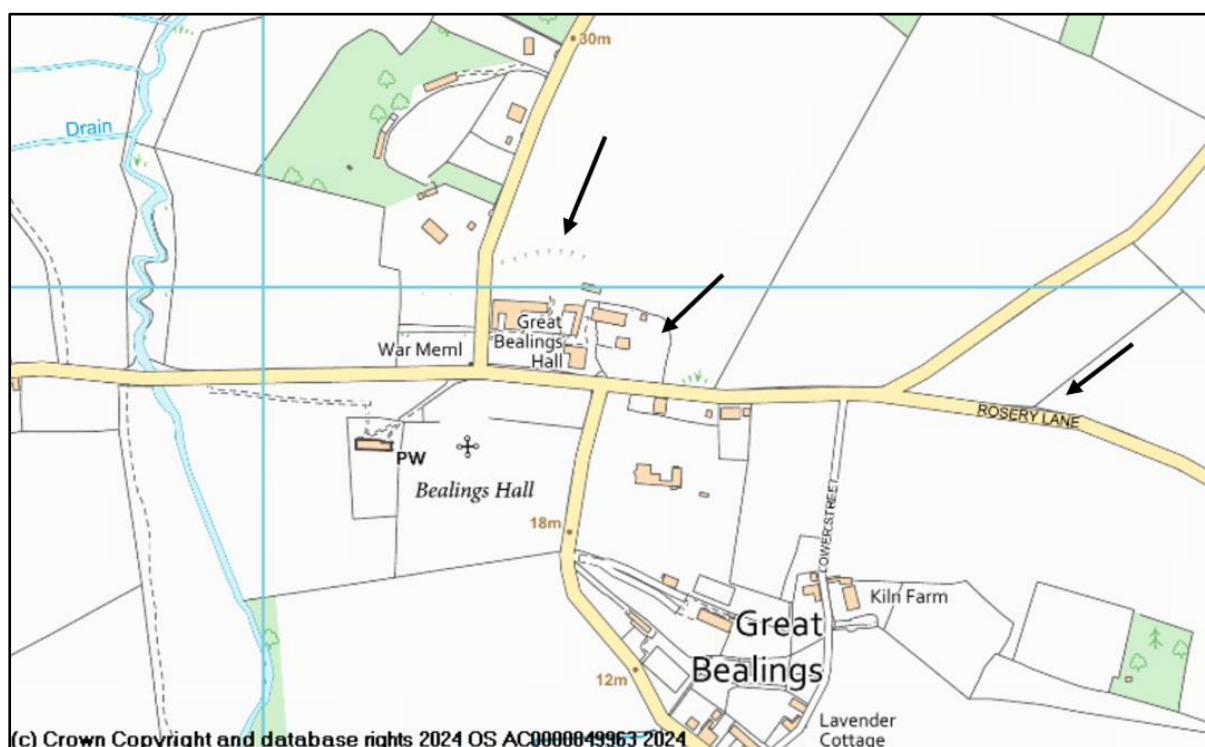
The primary cause of flooding on Hall Farm Road was pluvial flooding. Following heavy rainfall on the morning of 20 October, surface water flows from adjacent farmland, flowed overland and overwhelmed existing ditches.

Floodwater from the arable field to the north flowed towards lower lying property from the rear (see Figure 9). Residents described the impact as 'flash flooding' and cited a

lack of maintenance of the field ditch as a possible contributing factor. Positive discussions between homeowners and the landowner regarding future ditch maintenance have begun post Storm Babet.

*Figure 9. Approximate flood water flow routes affecting Hall Farm Road*

- Intense rainfall caused large amounts of surface water to flow from the field to the north towards properties on Hall Farm Road.
- The sheer amount of field runoff overwhelmed the existing ditches.
- A lack of ditch maintenance likely contributed to the flooding.

- Residents to install Property Flood Resilience (PFR) via grant funded scheme.
- Landowners to carry out appropriate ditch and watercourse maintenance to reduce flood risk as necessary as per their riparian responsibilities.

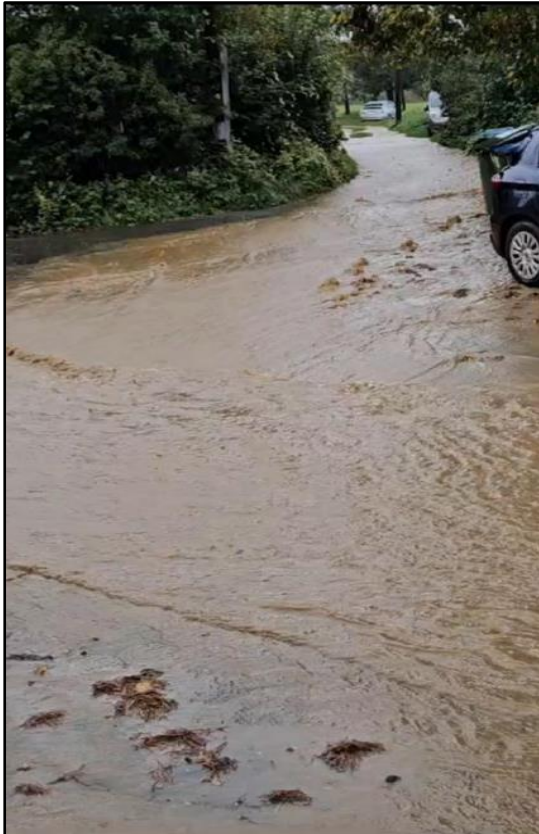
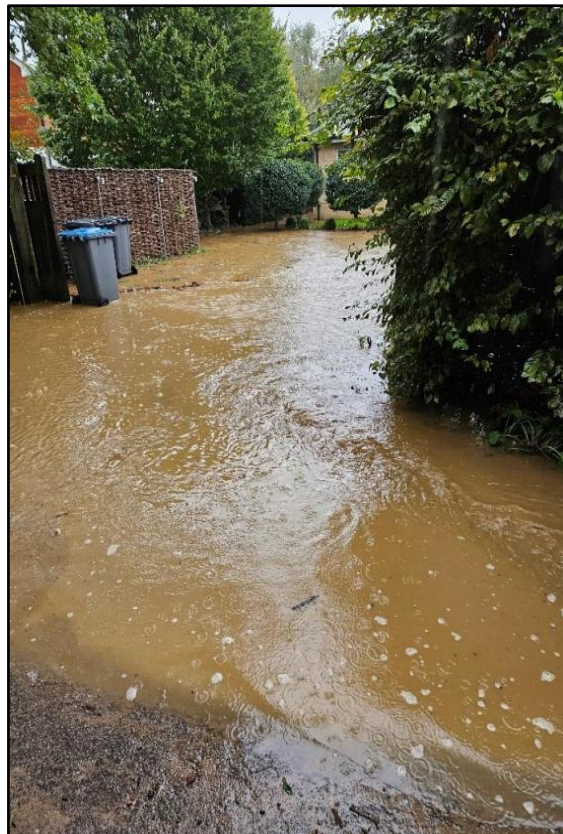
In addition to floodwater from the river, the flooding experienced on Lower Street and south onto Lodge Road was exacerbated by surface water flows originating from farmland to the northeast flowing onto Kiln Lane (see Images 1a & 1b). The surface water flows overwhelmed the small roadside ditch and flowed along the highway on Lower Street from early morning. The amount of floodwater far exceeded the capacity of the drainage assets on Lower Street. Surface water runoff from Orchard Lane also merged with the floodwater on Lower Street adding to its extent.

Residents reported that on the morning Oct 20 the highway drainage gullies in this area were blocked with silt and sediment and that by lunchtime the road had become a 'running river'. These additional floodwater flows added to the fluvial flooding from the river Lark effectively surrounding some of the houses on Lower Street and Lodge Road. Some traffic was diverted along Lodge Road as there were issues on the nearby A12. Motorists driving through the flood water further exacerbated the situation as bow waves were pushed towards the properties.

*Images 1a & 1b, Kiln Lane runoff & Surface water flooding on Lower Street*

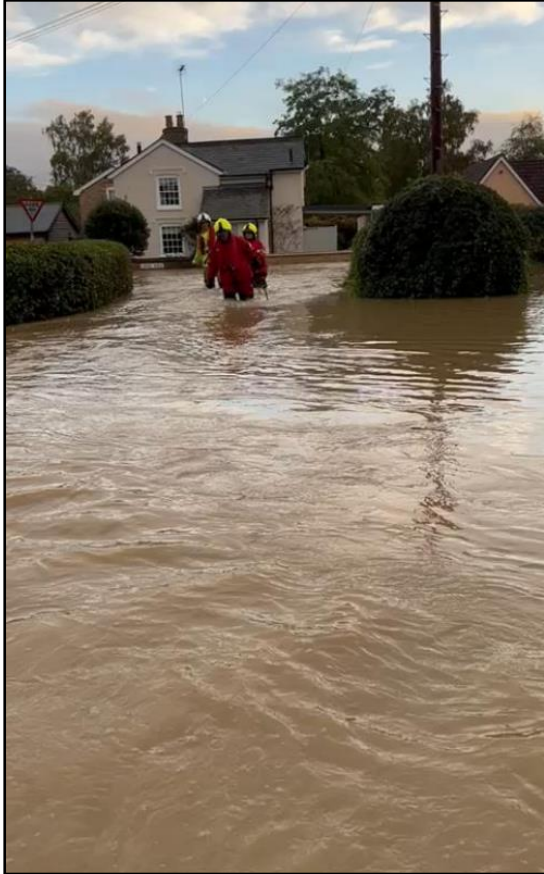
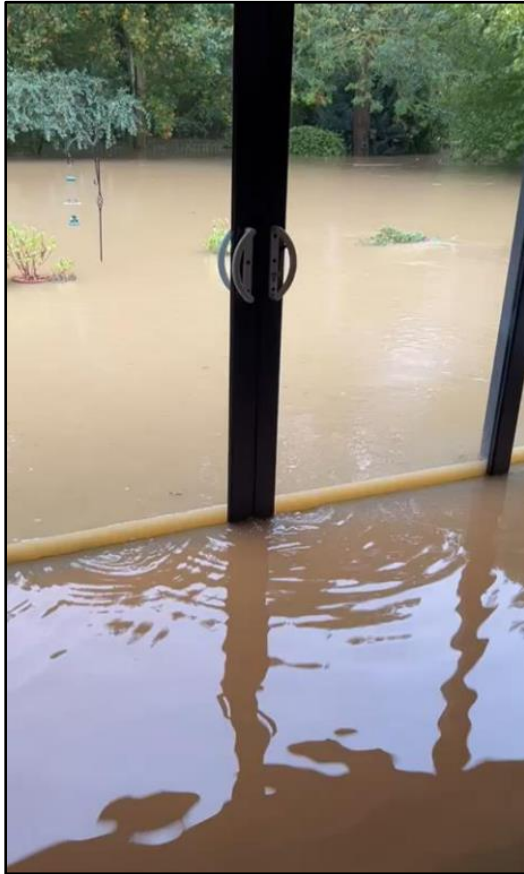
*Images 2a & 2b, Lower Street junction with Lodge Road & Flooding on Lower Street*

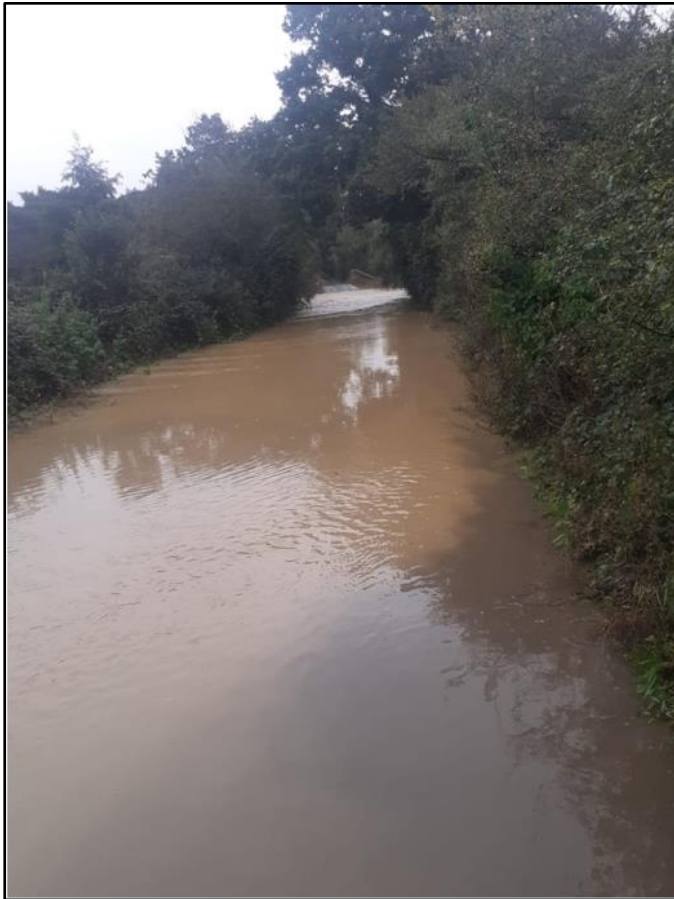
*Image 3 Flooding at Boot Street road bridge*

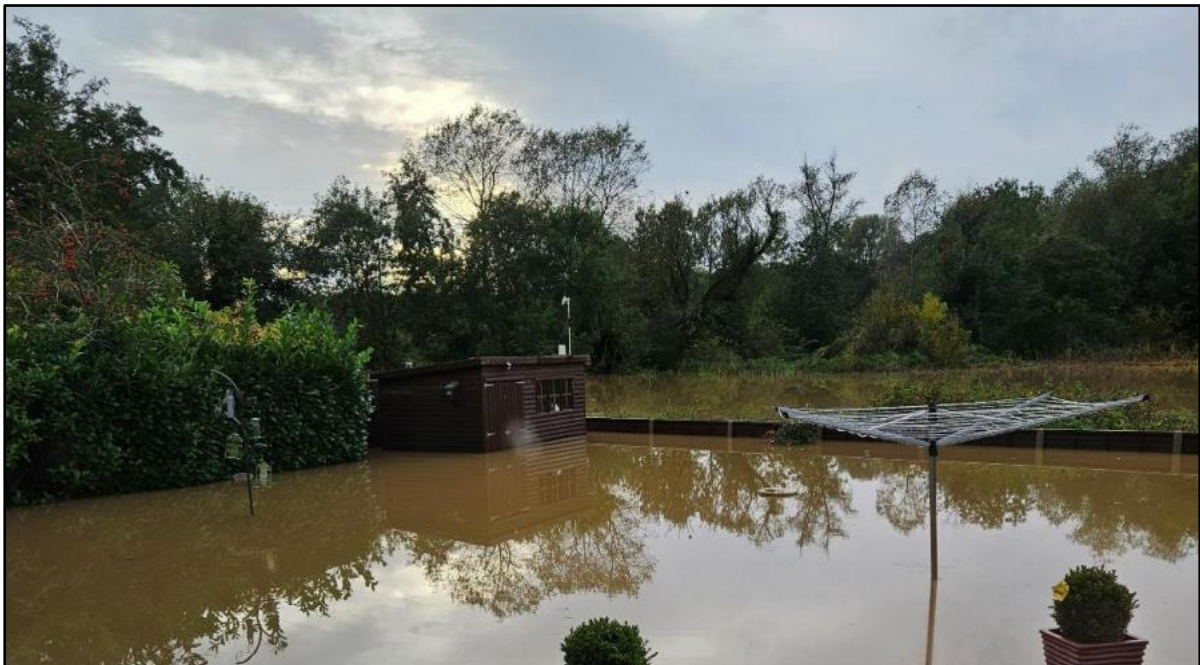
On the morning of 20 October, intense rainfall caused huge amounts of floodwater to flow down from the upper catchments into the river Lark and towards Great Bealings. The majority of the internal flooding on Lower Street and Lodge Road was caused by the river Lark overtopping and flowing directly into and across gardens (see Image 4),

*Image 4 Garden flooded from river Lark overtopping*
