Section 19 Flood and Water Management Act 2010

Great Glemham Flood Investigation

Storm Babet 2023

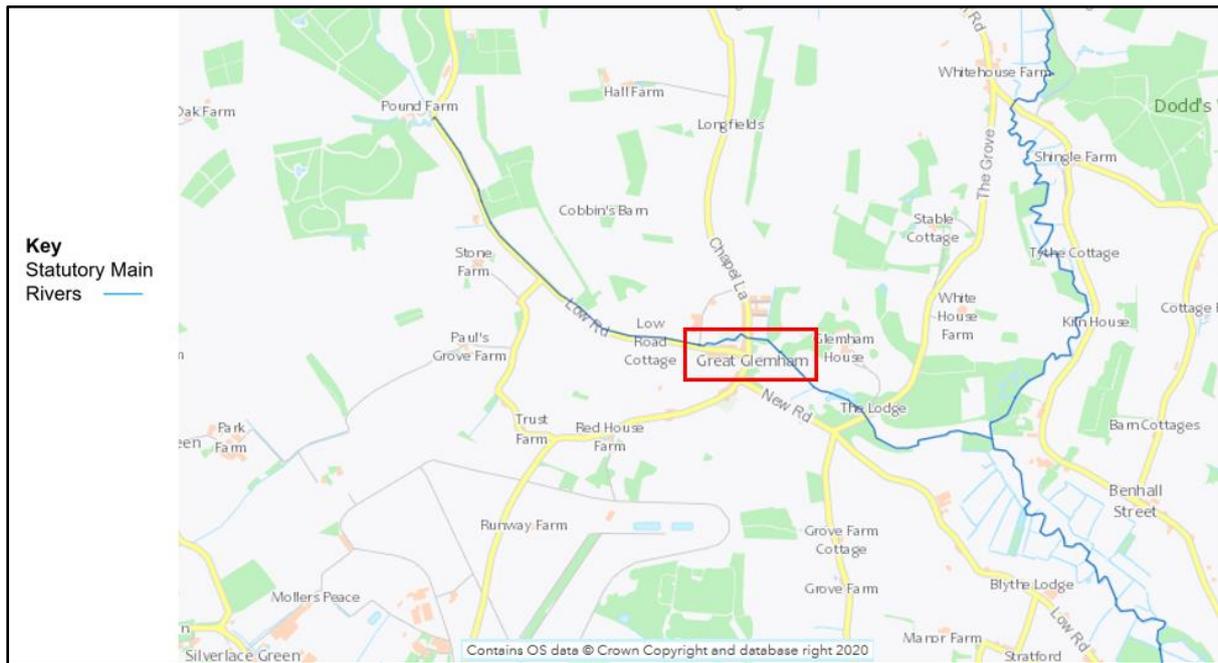
Fig. 3 shows the most significant watercourses in and around Great Glemham. It includes a statutory main river and a tributary of the River Alde which converge downstream, approximately three quarters of a mile east of the village of Great Glemham.

Fig. 3. Location of statutory main rivers and significant ordinary watercourses (Environment Agency)

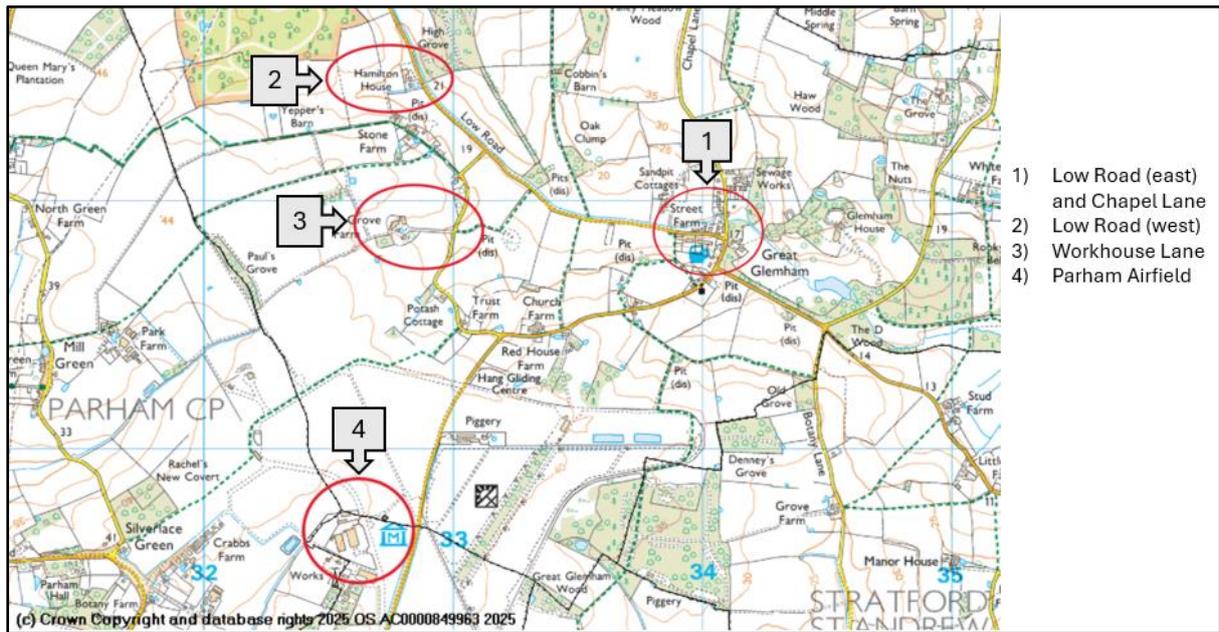
For the purposes of this investigation the various areas affected by flooding have been separated into four distinct zones:

1. Low Road (east) and Chapel Lane
2. Low Road (west)
3. Workhouse Lane
4. Parham Airfield

Fig. 4. Distinct flood zones

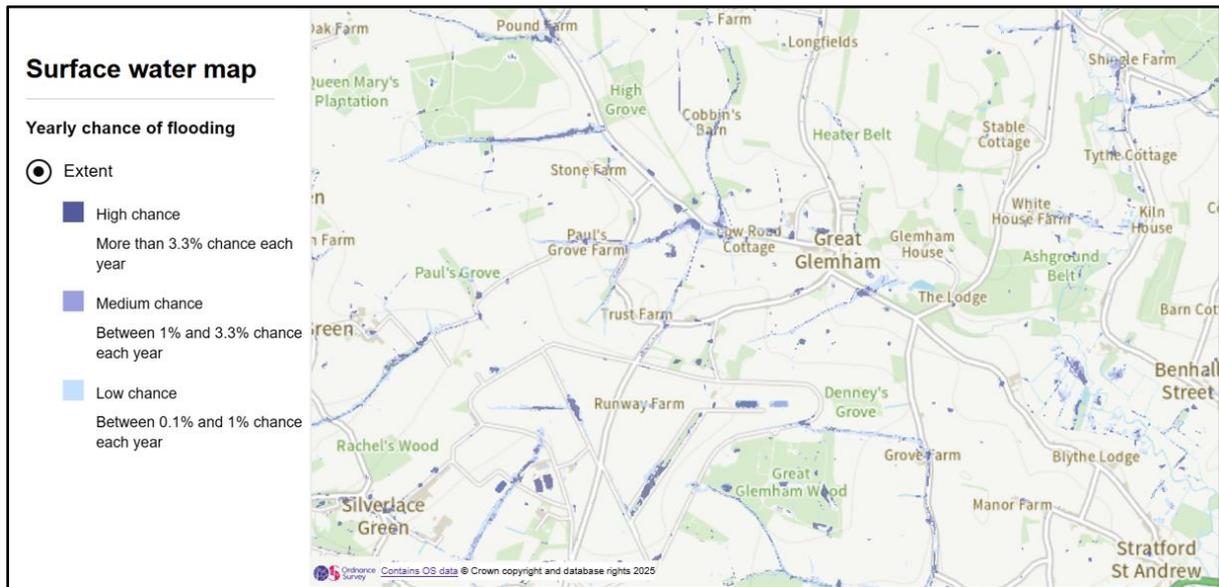
Affected property on Low Road (east) and Chapel Lane in Great Glemham village is projected to be at no risk of surface water flooding with the exception of one property on Chapel Lane which is projected to be at low risk. It should be noted that low risk of flooding indicates a flood risk during extreme events, such as Storm Babet. Affected property in the three outlying zones is projected to be at high risk of surface water flooding.

Fig. 5. Predicted flood risk from surface water

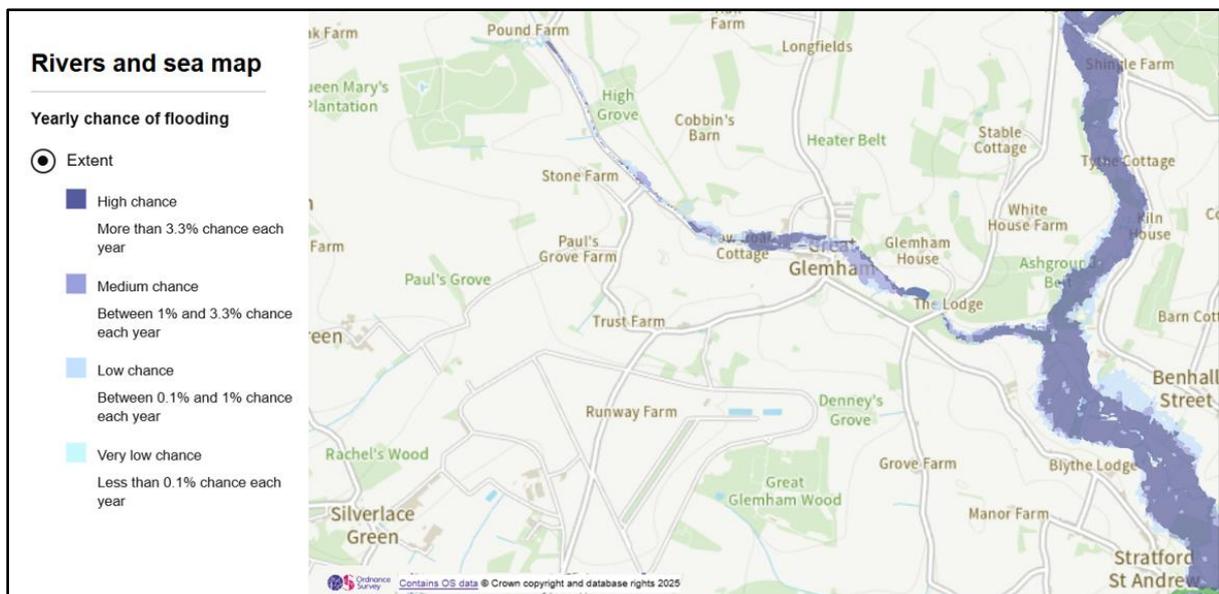
Fluvial flood risk on Low Road (east) and Chapel Lane in Great Glemham village is associated with the tributary to the River Alde. Affected property in this area was mostly at low and medium risk, although one was at high risk. Affected property in the outlying zones was not projected to be at fluvial flood risk.

Fig. 6. Predicted flood risk from rivers

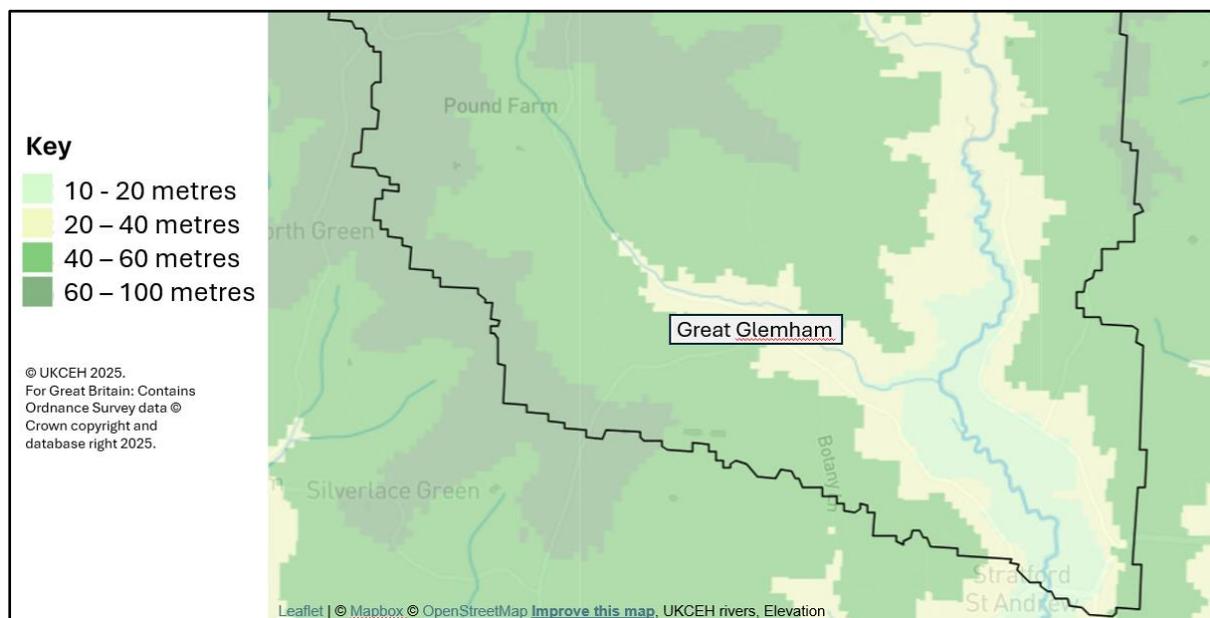
The low-lying nature of the village means that during high rainfall events considerable flows of water converge towards Great Glemham (see Fig. 7). Overwhelmed infrastructure and watercourses may be observed during these intense rainfall events.

Fig. 7. Elevation map of catchment area showing 35003 Alde at Farnham gauging station catchment boundary (National River Flow Archive)

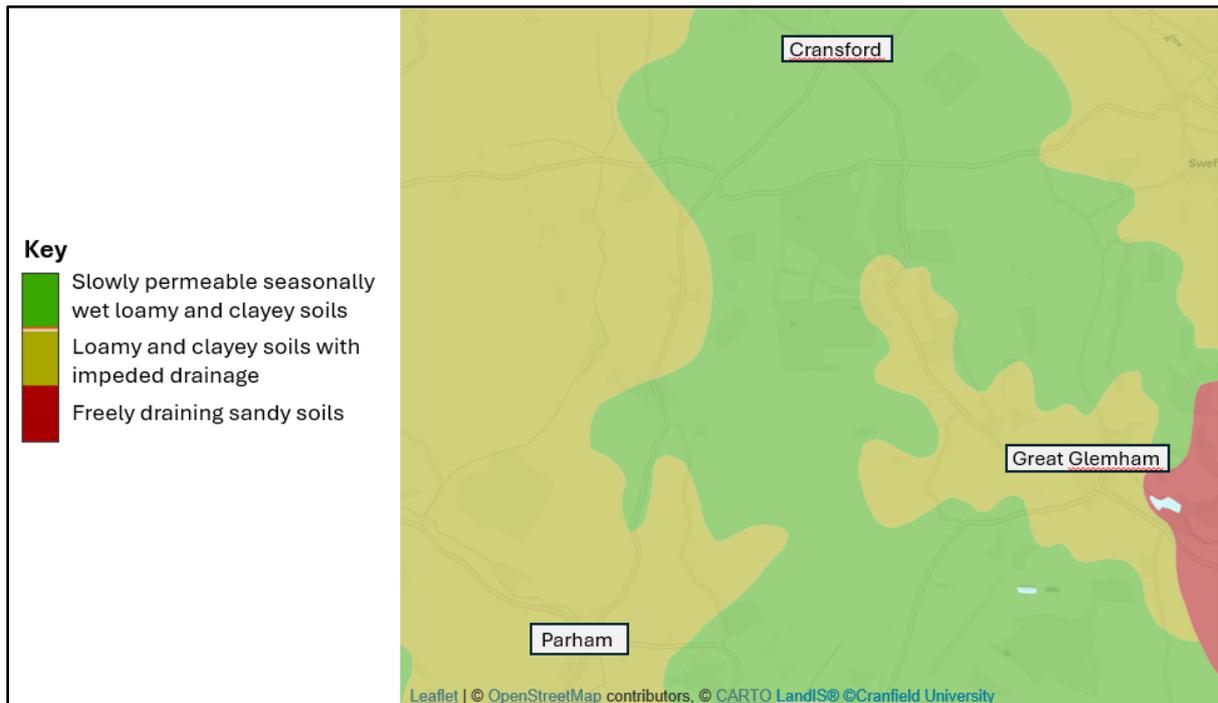
The soils in the wider catchment surrounding Great Glemham and the catchment around Parham Airfield are loamy and clayey with impeded drainage, meaning that water permeates more slowly and surface water runoff is greater, particularly during intense rainfall (Fig. 8). However, the saturated nature of the soils leading up to the event would also have prevented some infiltration.

Fig. 8. Soil map of catchment area (LandIS Soils)

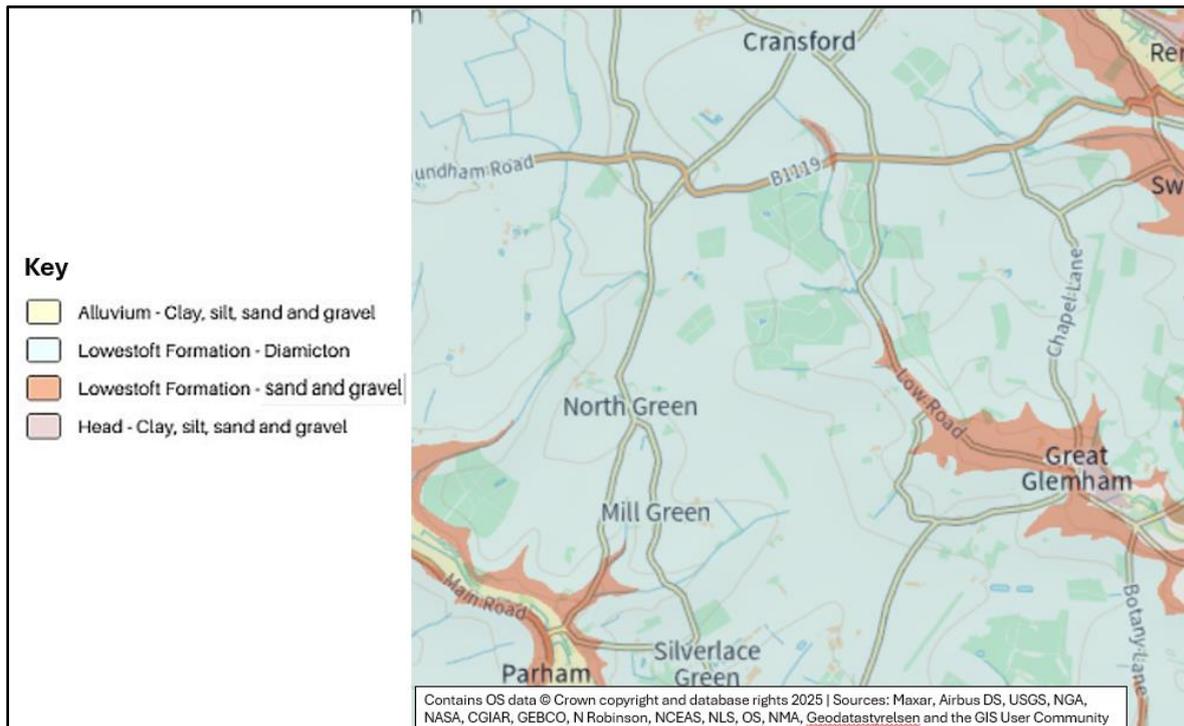
Fig. 9 shows that much of the superficial geology in the wider catchment of Great Glemham and around Parham Airfield is made up of 'Lowestoft Formation – Diamicton' which is described by the British Geological Survey as a diverse mixture of clay, sand, gravel, and boulders varying widely in size and shape. This is sometimes known as boulder clay. This generally has a low permeability meaning water will tend to flow off it before it can infiltrate, which also reflects the reports collected during Storm Babet.

Fig. 9. Superficial geology in catchment area (British Geological Society)

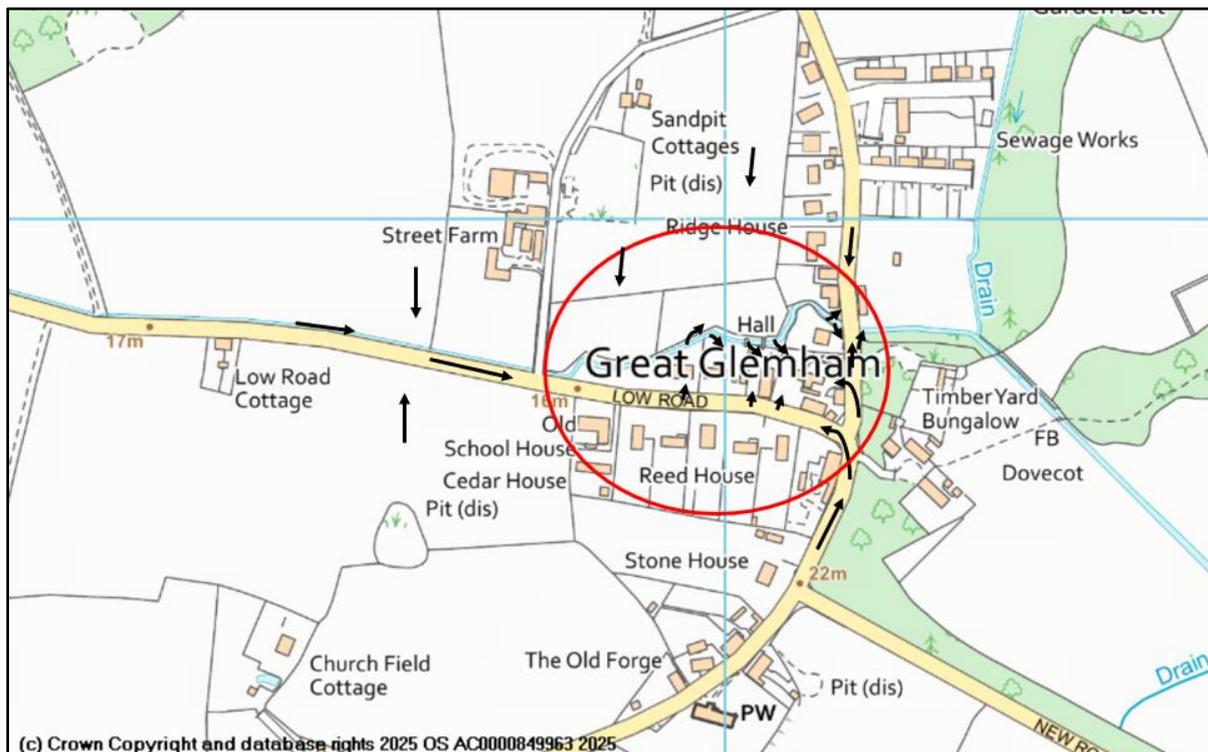
The easternmost area where property was affected by internal flooding was in Great Glemham village, on Low Road and Chapel Lane. At least five properties are known to have flooded internally in this area. Affected property here was projected to be at no risk of surface water flooding with the exception of one property on Chapel Lane which is projected to be at low risk. Fluvial flood risk for impacted property was projected to be mostly at low and medium risk, although one affected property on Low Road was at high risk.

Fig. 10. Approximate floodwater flow paths, Low Road (east) and Chapel Lane

On the west side of Great Glemham village, significant rainfall caused large quantities of surface water to flow across fields towards Low Road and the adjacent watercourse (tributary to the Rive Alde) from both sides. Flood water was also reported to have flowed east down Low Road and collected at a low point on the highway, close to the junction with Chapel Lane. Surface water was also reported to have flowed down Chapel Lane from the south which then flowed into Low Road at the junction, as well as continuing to flow north on Chapel Lane towards the bridge over the tributary. On the north side of the bridge, surface water also flowed south down Chapel Lane towards the bridge. Floodwater flowed down driveways which were at a lower level than the highways in Low Road and Chapel Lane. Highway drainage was reported to be blocked in Low Road in the vicinity of affected property. Flooding of the highway and pavement is reported to occur repeatedly here. (SCC Highways has increased the frequency of the maintenance cycle from biennial to annual since Storm Babet). However, in the extreme rainfall conditions, the capacity of the wider drainage system, even if fully functioning, would have been limited.

The watercourse overflowed at the rear of property on Low Road and Chapel Lane, contributing significantly to floodwater in the vicinity. The road bridge over the watercourse on Chapel Lane acted as an additional pinch point. Some silt deposits were subsequently observed under the bridge, which has a solid base (invert). However, in high flow events, small accumulations of silt are likely to be washed away, particularly where there is a hard invert and no vegetation growth. The bridge was inspected in December 2023 – silt accumulation was observed to be very minor at that time and no silt clearance was considered necessary. (The next inspection is

- Intense and prolonged rainfall exceeded the capacity of field drains west of Great Glemham village and surface water flowed across fields on the north and south sides of Low Road towards Low Road and the adjacent watercourse.
- Surface water flowed west along Low Road from the junction with Chapel Lane and east along Low Road from the west side of the village. This collected at a low point in the centre of the village.
- Floodwater flowed down lower level driveways relative to the highways.
- Surface water flowed down Chapel Lane from the north and south sides towards the bridge.
- The watercourse overtopped in the village, contributing to flooding on Low Road and Chapel Lane.
- Highway drainage was reported to be blocked in Low Road.
- The road bridge over the watercourse in Chapel Lane was an additional constriction to flow.

- Residents to install Property Flood Resilience (PFR) measures.
- Suffolk Highways to investigate highway drainage assets in Low Road in the vicinity of reported blockages.
- Suffolk Highways to continue to monitor silt deposits below the road bridge on Chapel Lane over the watercourse during biennial bridge inspections.
- Explore potential natural flood management measures (eg. leaky dams and attenuation ponds) to “slow the flow” and attenuate water in the upper catchment of Great Glemham village on the surface water flow paths and ditches.

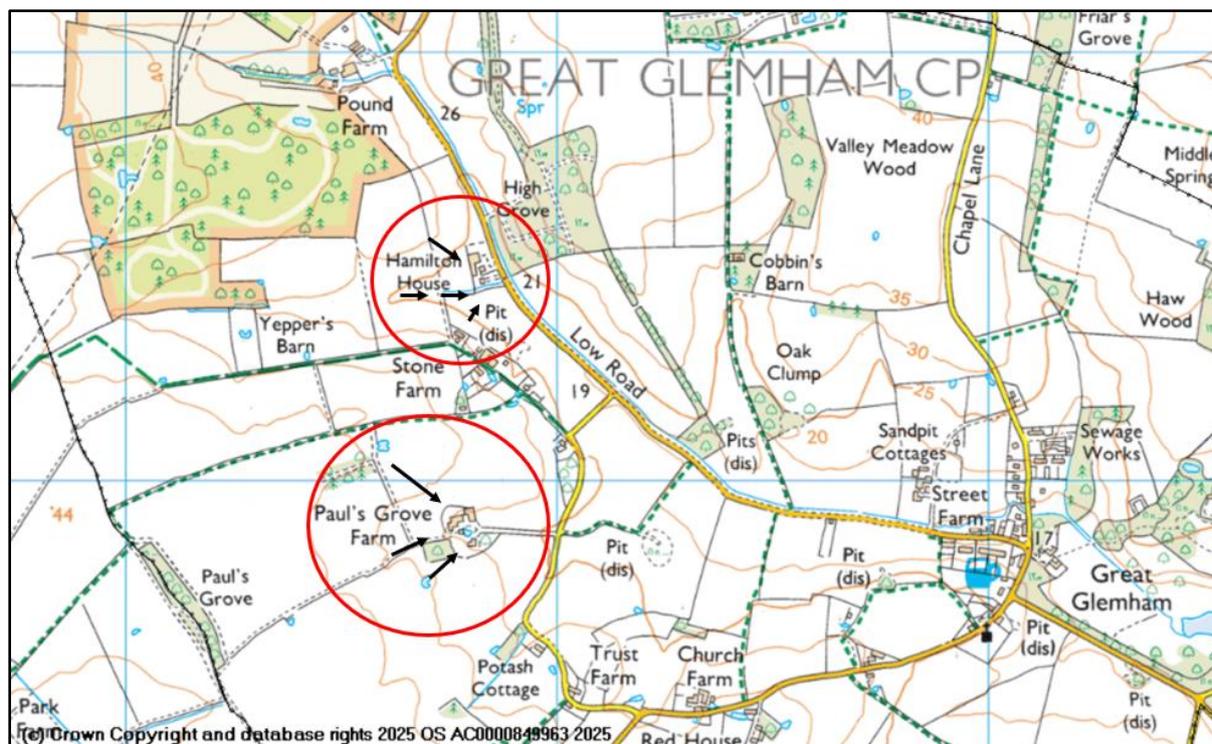
One property on Low Road (west), was reported to have flooded internally, attributed to surface water runoff from fields.

One property on Workhouse Lane was also reported to have flooded internally to a depth of approximately 10cm, attributed to surface water runoff from fields and ditches overtopping.

Fig. 11. Approximate floodwater flow paths in Low Road (west) and Workhouse Lane

- Intense and prolonged rainfall exceeded field drainage systems and surface water flowed across fields, flooding property.

- Residents to install Property Flood Resilience (PFR) measures.
- Landowners to carry out watercourse maintenance to reduce flood risk as necessary in accordance with their riparian responsibilities.

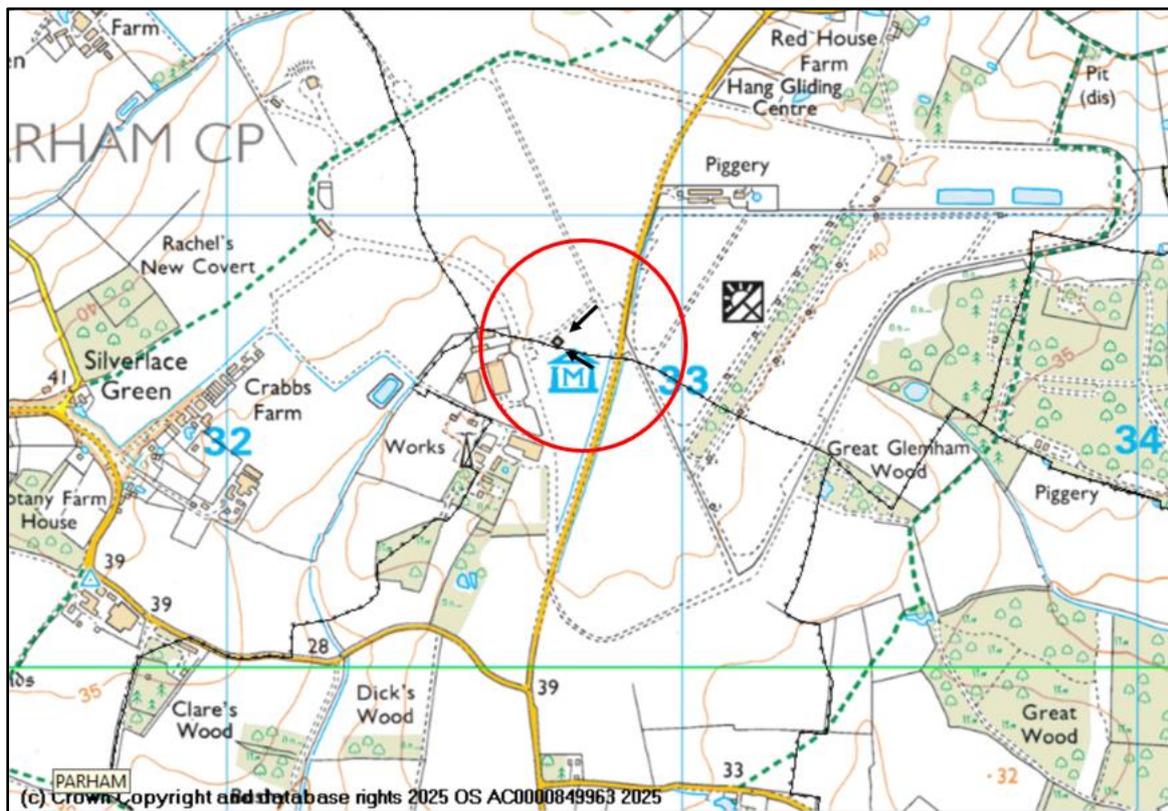
One property at Parham Airfield was reported to have flooded internally to an approximate depth of 5cm, attributed to surface water runoff from fields. It was projected to be at high surface water flood risk and no fluvial flood risk.

Fig. 12 Approximate floodwater flowpaths, Parham Airfield

- Intense and prolonged rainfall caused surface water to flow across fields and flood lower-lying property.

- Residents to install Property Flood Resilience (PFR) measures.

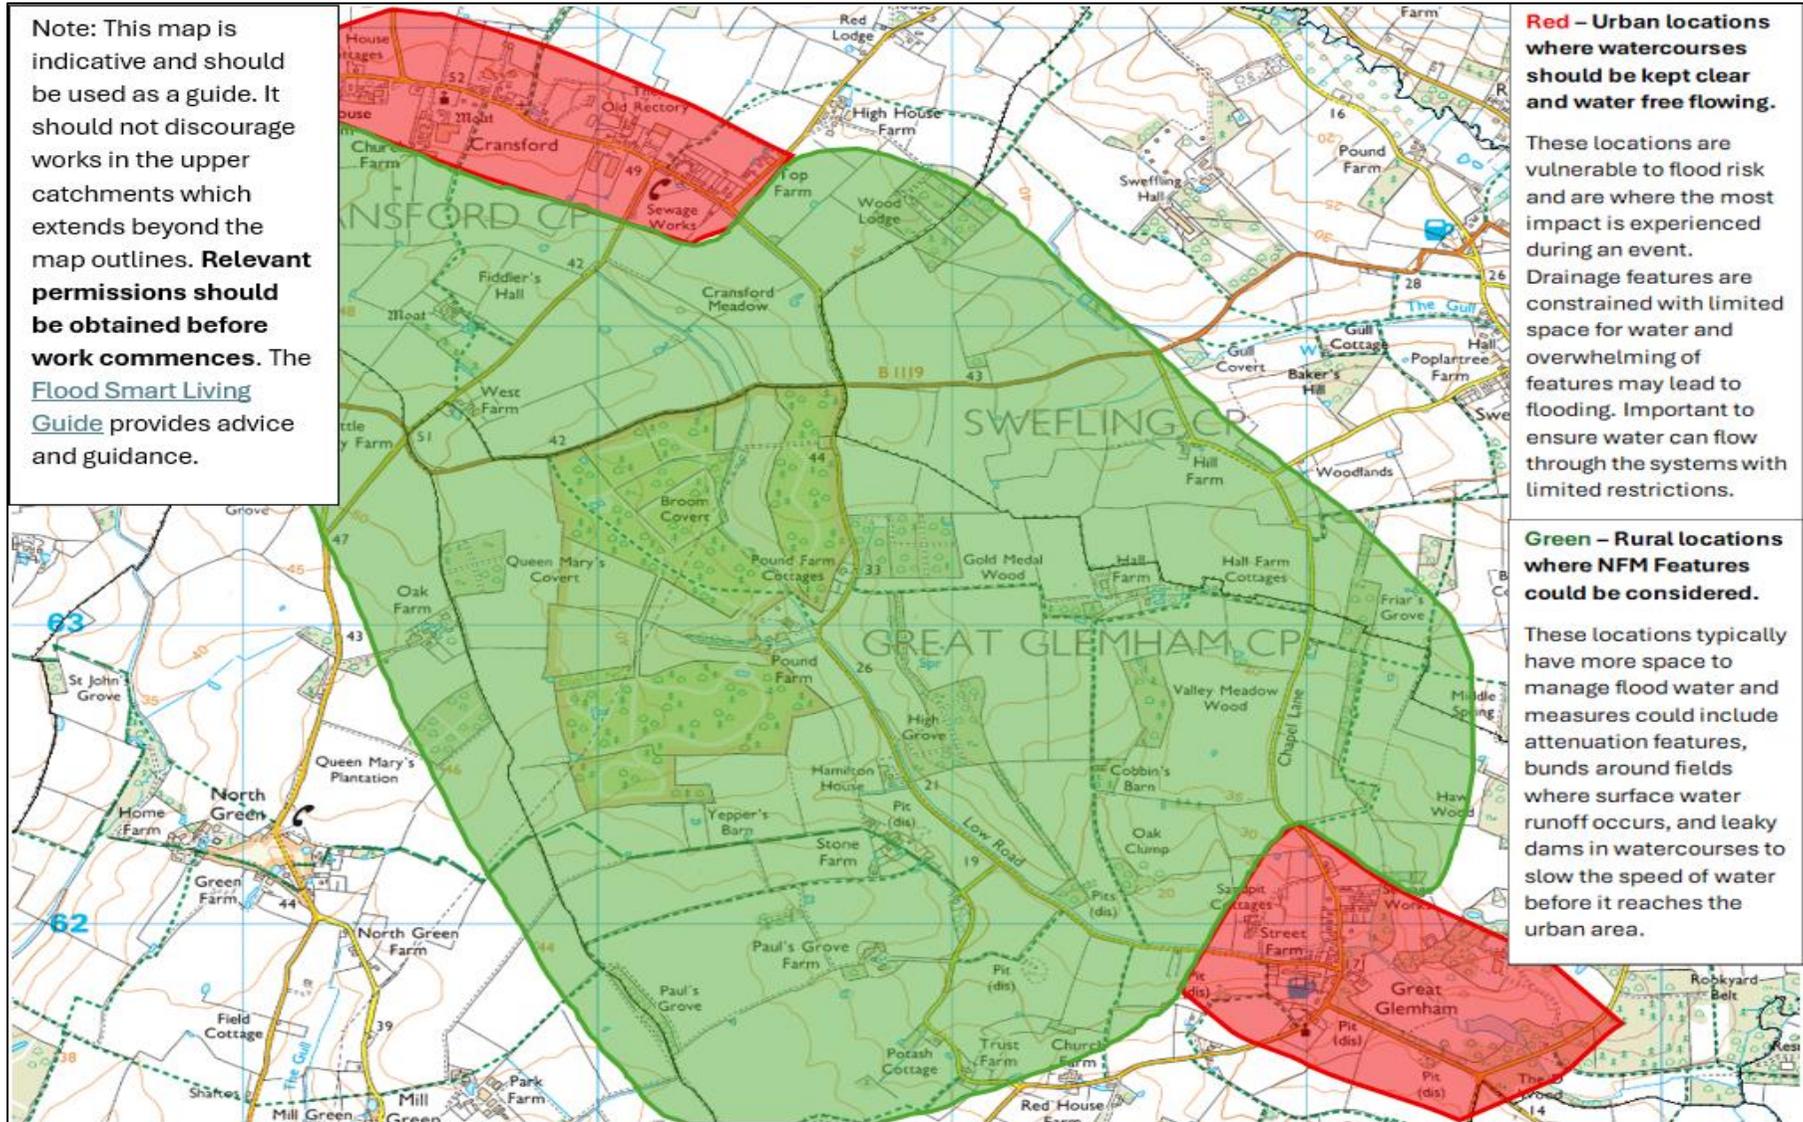
APPENDIX A - Indicative locations for NFM and watercourse maintenance

Riparian landowners to carry out appropriate watercourse maintenance to reduce flood risk as necessary as per their riparian responsibilities. See Appendix A.	Riparian landowners	N/A – to be completed as required	Further information on Riparian Ownership can be found within SCC published “ Flood Smart Living ” handbook.
Utilise the Community Self Help scheme to undertake minor maintenance activities.	Great Glemham Parish Council / Suffolk Highways	6-12 months	Further information can be found at the following https://www.suffolk.gov.uk/roads-and-transport/highway-maintenance/community-self-help-scheme
Investigate highway drainage assets in Low Road in the vicinity of reported blockages	SCC Highways Authority	6 months	Ongoing - Update from Suffolk Highways: Inspections identified defects at Gully 60062845 (root ingress) and Offlets 60062850 and 60062852, where exposed or buried pipework and poor ditch levels restrict discharge. Further excavation, ditch regrading, and reinstatement are planned to restore reliable operation.
