Section 19 Flood and Water Management Act 2010

Grundisburgh Flood Investigation

Storm Babet 2023

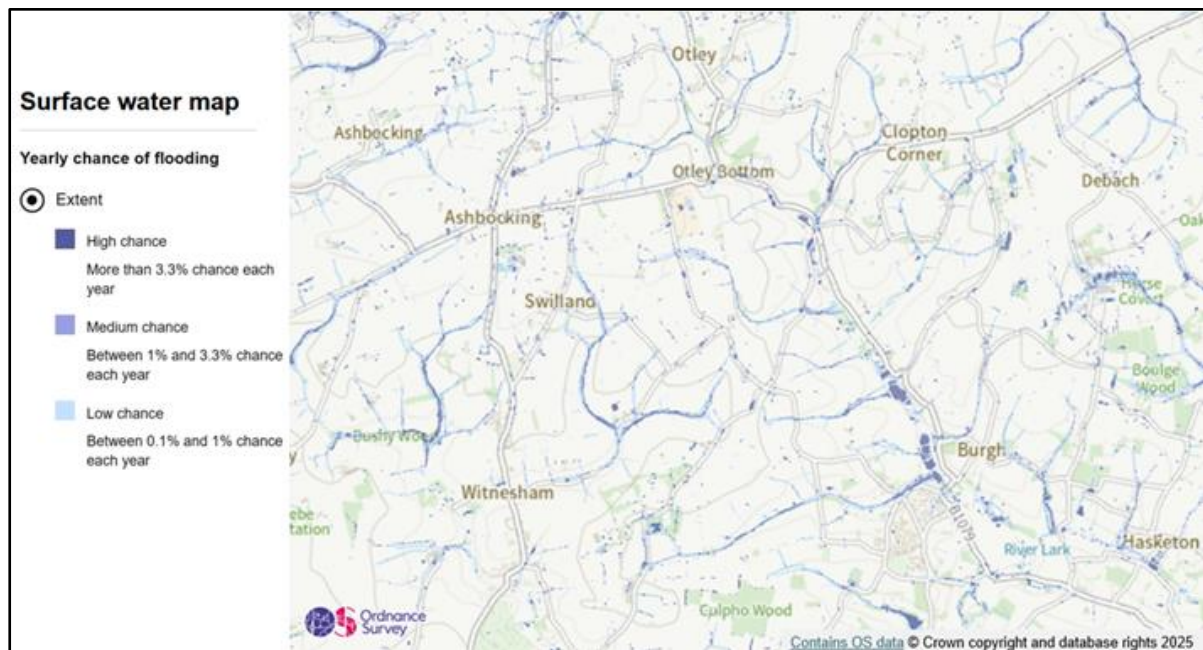
Fig. 6. Predicted pluvial flood risk (surface water) (Environment Agency)

The parish of Grundisburgh is at significant risk of pluvial (surface water) flooding (Fig. 6). All affected property is projected to be at high surface water flood risk except for two properties on the B1079 in the vicinity of the junction with Woodbridge Road (Zone 2). One of these is projected to be at medium surface water flood risk and the other is projected to be at no surface water flood risk.

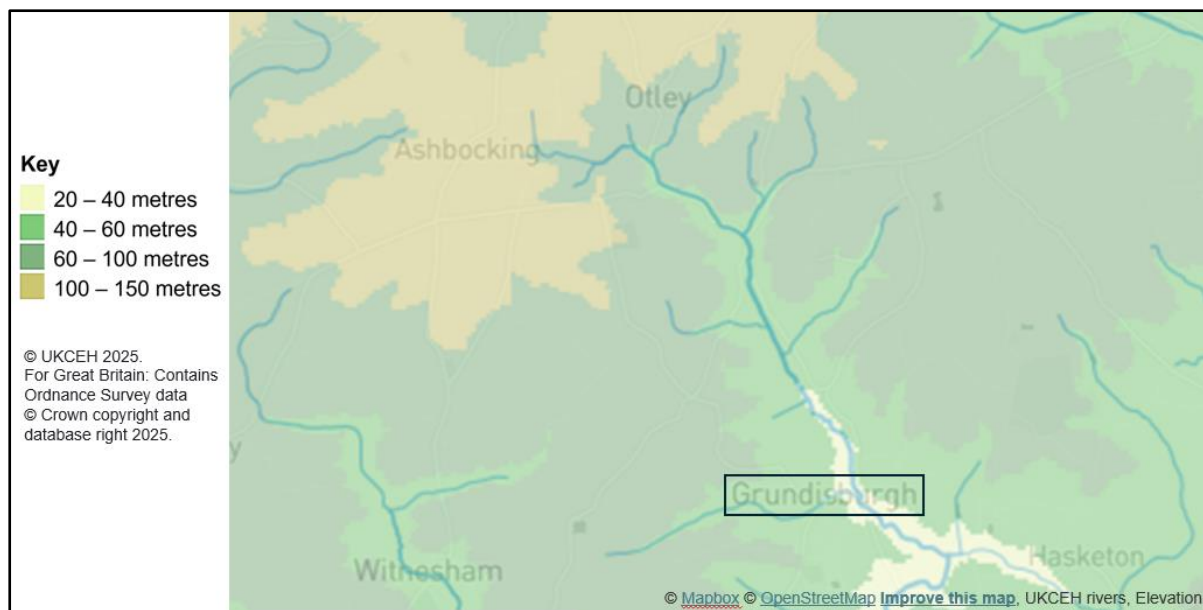
Fig. 8. Elevation (National River Flow Archive)

The parish is situated in a rural area with farmland used predominantly for arable agriculture, with some grassland and pasture. Significant areas of the parish are relatively flat and low lying, meaning that surface water accumulates in these areas and is not rapidly dispersed. Overwhelmed infrastructure and watercourses may be observed during intense rainfall events.
