Section 19 Flood and Water Management Act 2010

Hoxne Flood Investigation – Storm Babet 2023

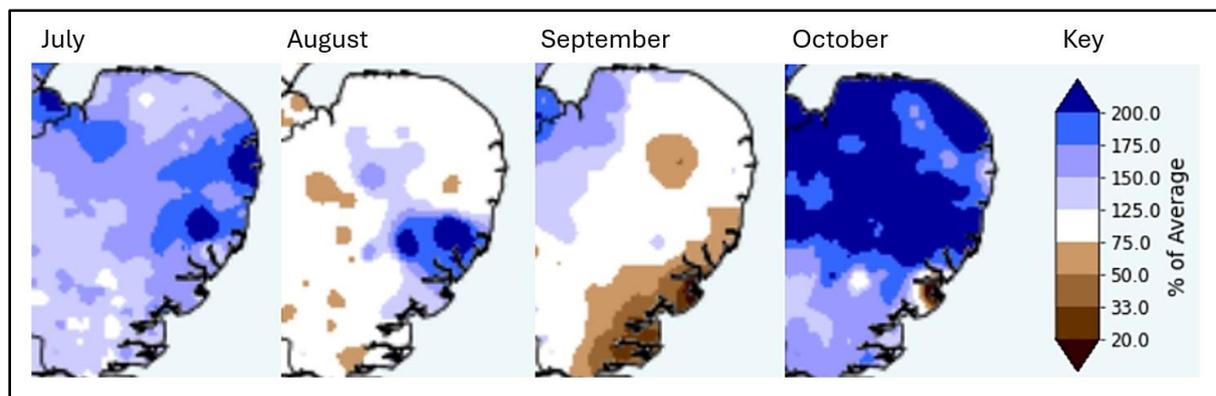
The following maps illustrate the extent to which the rainfall in the months preceding Storm Babet exceeded the average monthly rainfall for July to October in recent years in Suffolk.

Figure 1. Average rainfall in East Anglia between July and October 2023 as a percentage of the historical average monthly rainfall

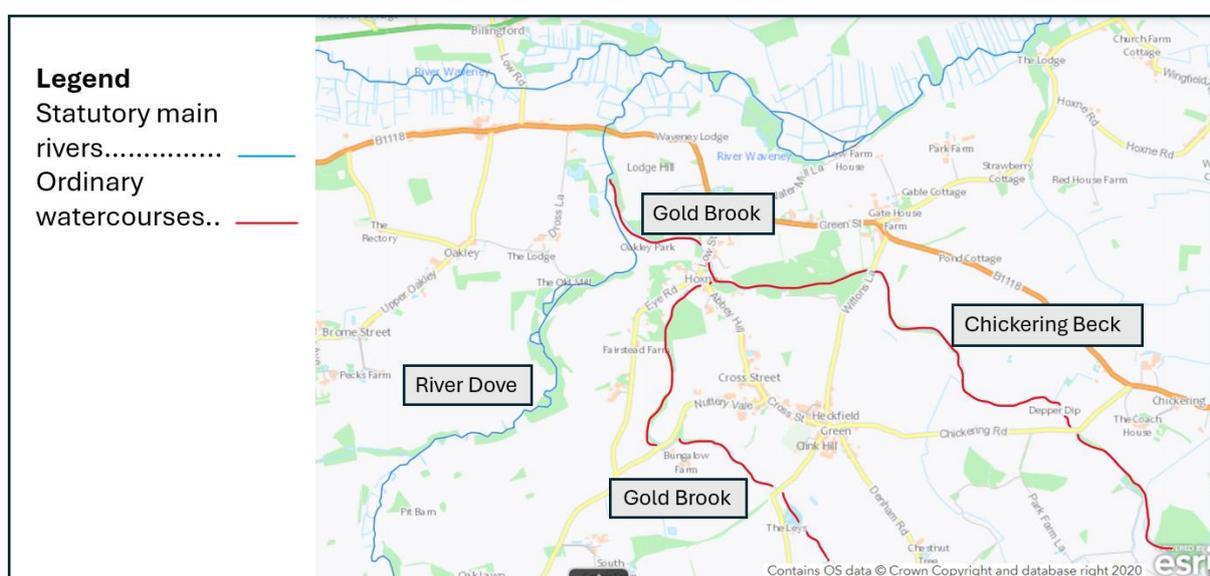
Figure 3 shows the most significant watercourses in the area surrounding Hoxne. The Environment Agency has permissive powers to carry out maintenance, improvement or construction work on main rivers to manage flood risk. The Internal Drainage Boards (IDBs) have similar permissive powers but instead relate to ordinary watercourses within their board area.

Figure 3. Location of statutory main rivers and significant ordinary watercourses

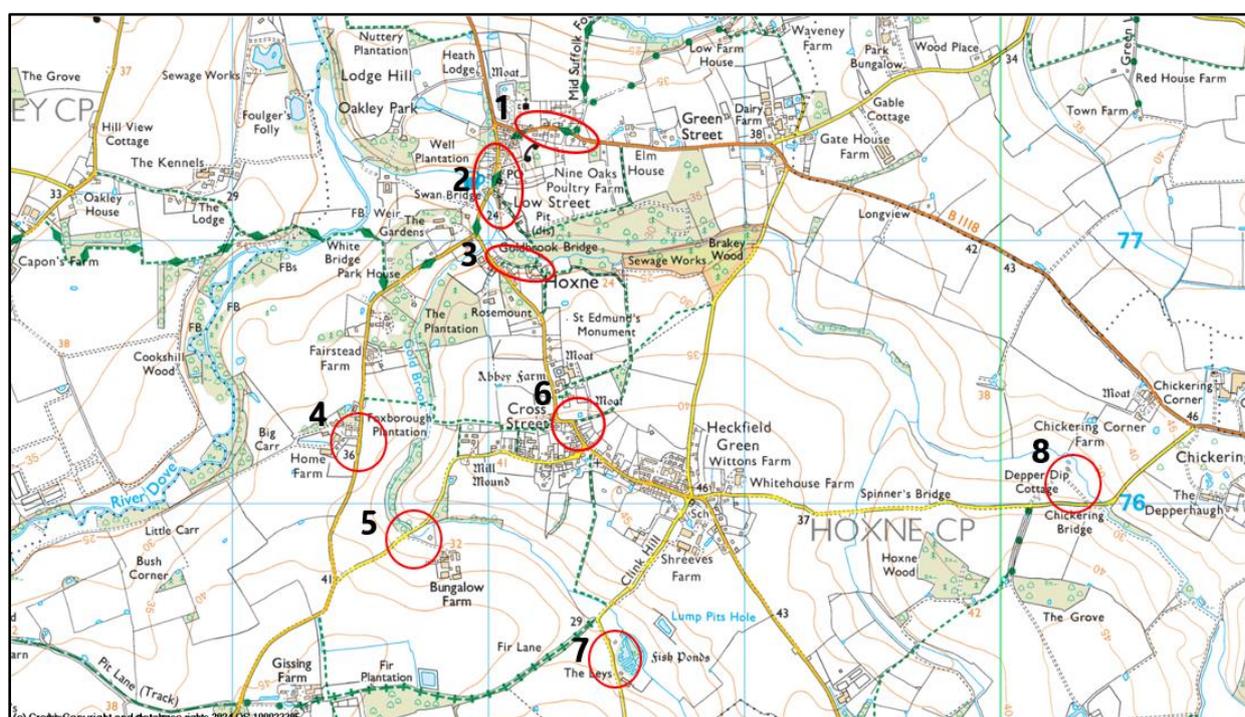
For the purposes of this investigation the various areas affected by flooding have been separated into eight distinct locations (see Figure 4). The locations are as follows:

1. Green Street
2. Low Street
3. Abbey Hill
4. Eye Road
5. Nuttery Vale
6. Cross Street
7. Denham Low Road
8. Chickering Road

Figure 4. Investigation area map with locations

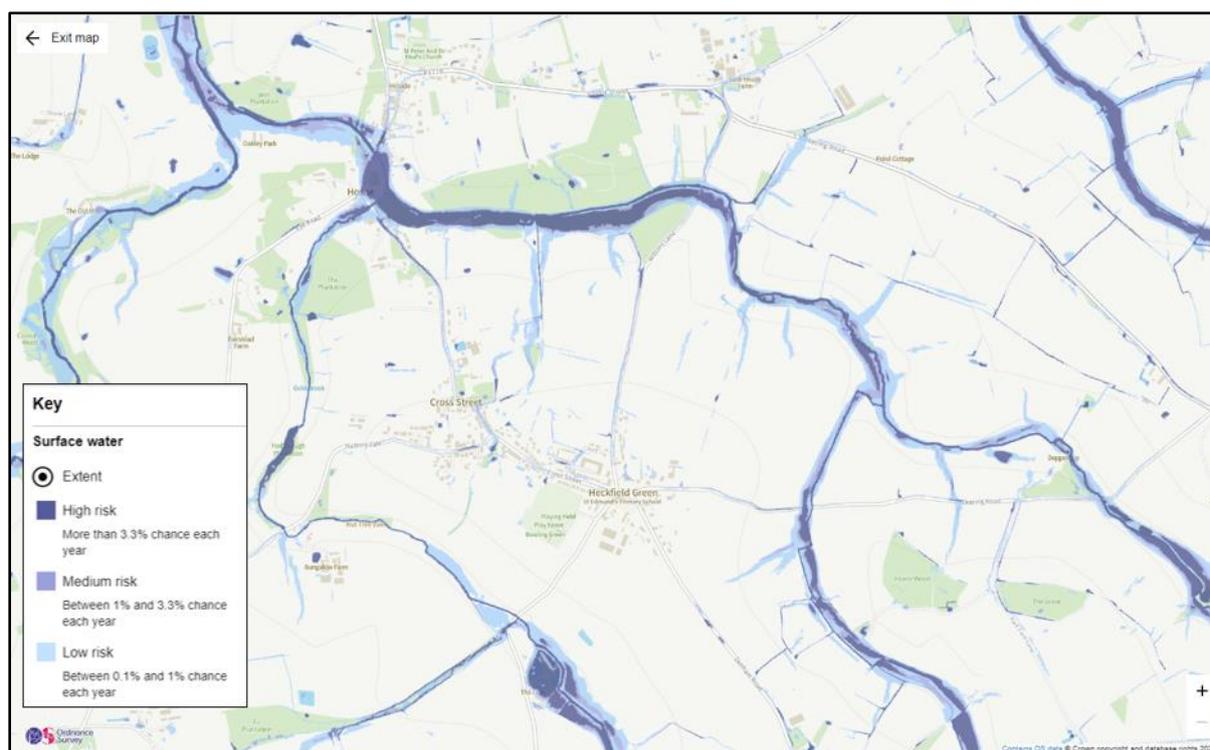
Figure 5. Predicted surface water flood risk

Figure 5 highlights the predicted pluvial (surface water run-off from surrounding land and ditches) flood risk in and around Hoxne, with four main flow paths coming into the village from the southwest, south, southeast and east, closely aligned with Gold Brook and Chickering Beck. Flatter areas at high risk of surface water flooding include south central Hoxne, the flood plain surrounding Chickering Beck to the east of Hoxne and the Denham Low Road to the south of Hoxne.

There is significant risk of surface water flooding on Green Street and Cross Street. These areas were affected by flooding during Storm Babet.

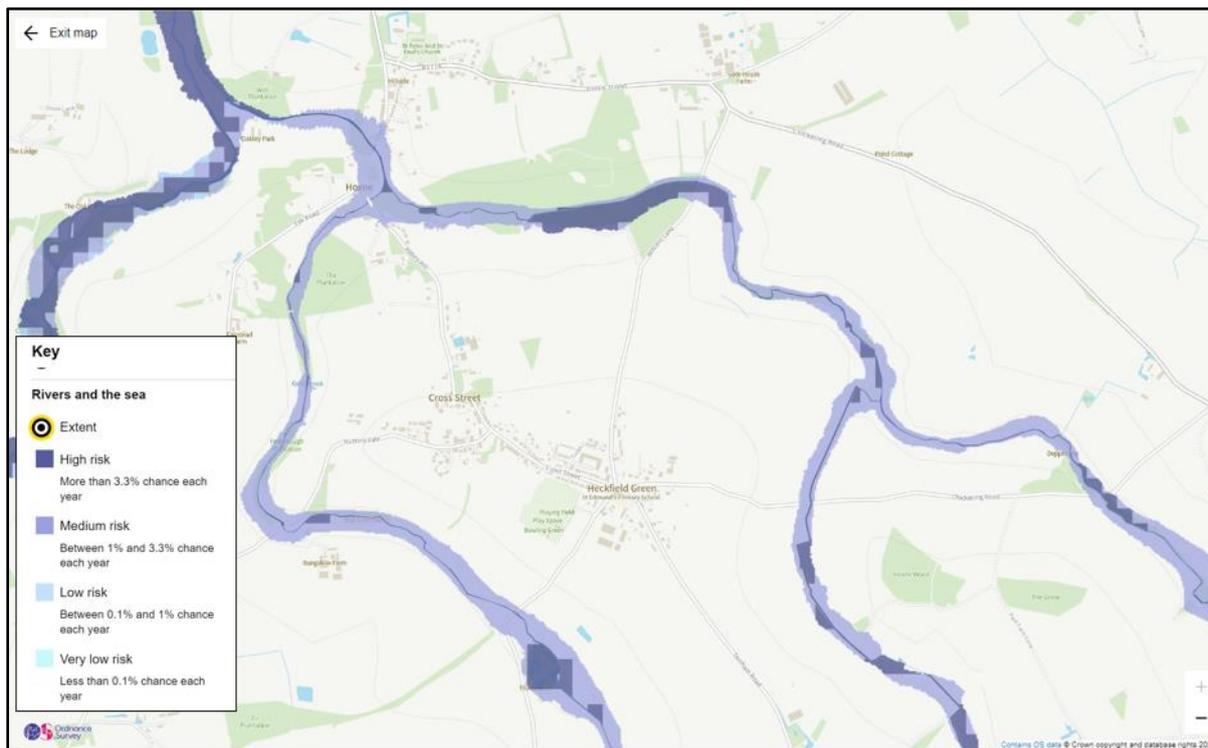
Figure 6. Predicted flood risk from rivers and sea

Figure 6 highlights the predicted fluvial (from designated main river and ordinary watercourses) flood risk in and around Hoxne. Fluvial flood risk around Hoxne is associated with the Chickering Beck and Gold Brook watercourses. Areas at high risk of fluvial flooding include the Denham Low Road, Low Street, Abbey Hill and parts of Chickering Road. These areas were affected by flooding during Storm Babet.

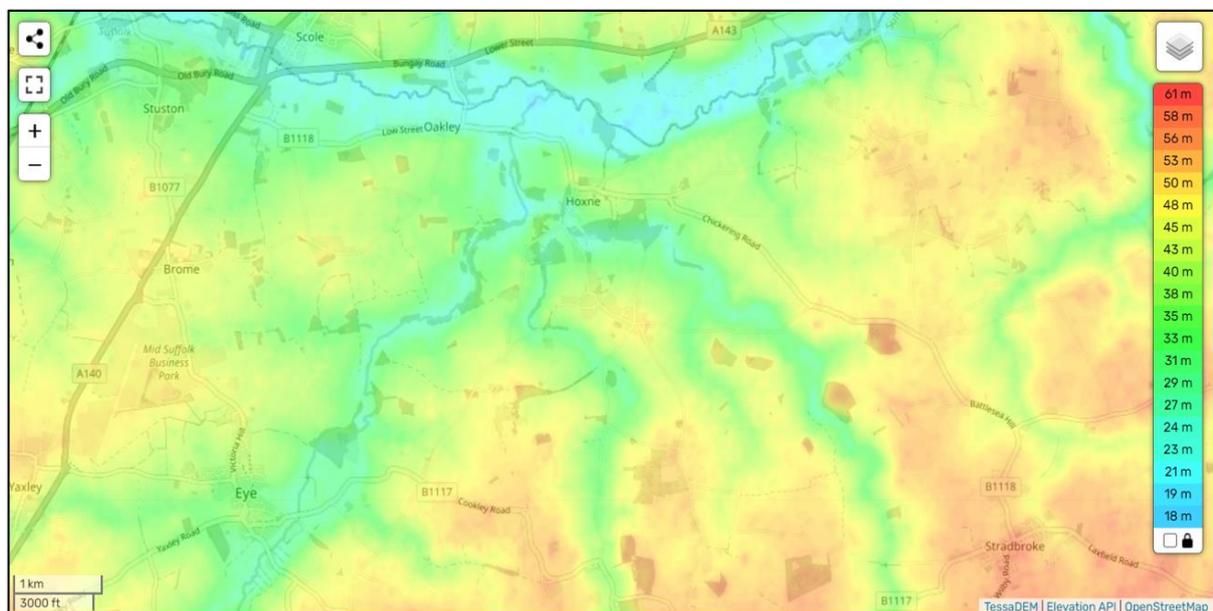
Figure 7 shows the topography surrounding Hoxne and the gradient changes across the village. Low Road, Abbey Hill and Nuttery Vale are among the lowest lying locations in Hoxne. These were identified as being some of the worst affected areas following Storm Babet.

Figure 7. Hoxne and surrounding topography (National River Flow Archive)

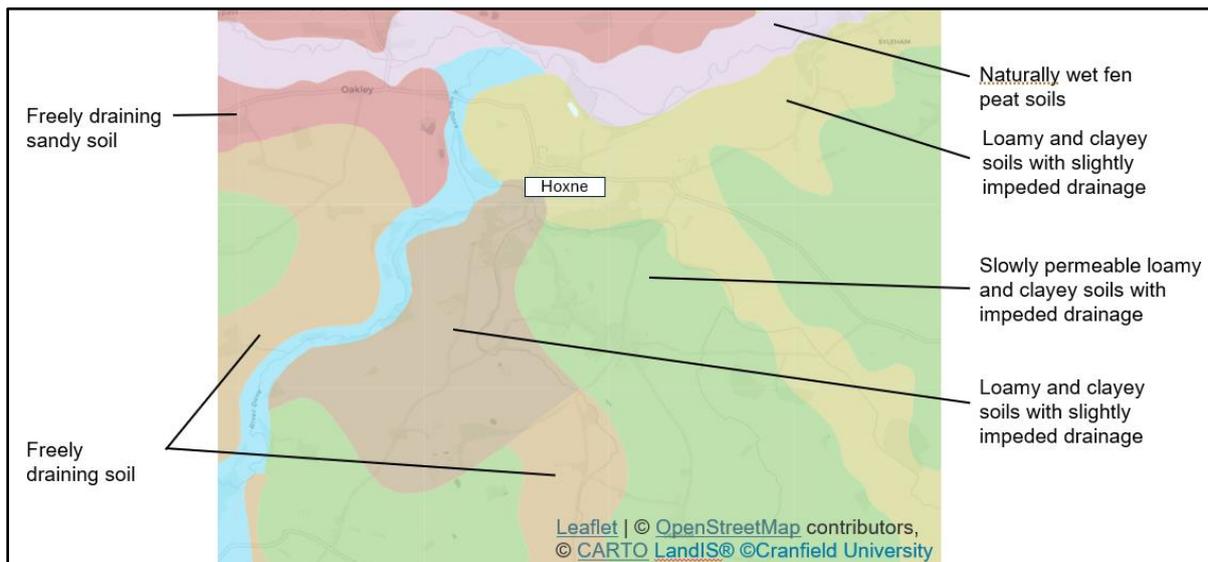
Figure 8. Hoxne and surrounding soils (LandIS Soilsapes)

With regards to soils, Hoxne is situated mostly on sand and gravels with a mixture of clay and silts. To the east and immediately south of the village they are described as loamy and clayey, with impeded drainage. To the west and further due south of Hoxne village, soils are more freely draining, allowing water to permeate more rapidly and therefore reducing the amount of surface water run-off. The floodplain soils surrounding the Gold Brook and Chickering Beck watercourses usually have naturally high groundwater and tend to be wetter.

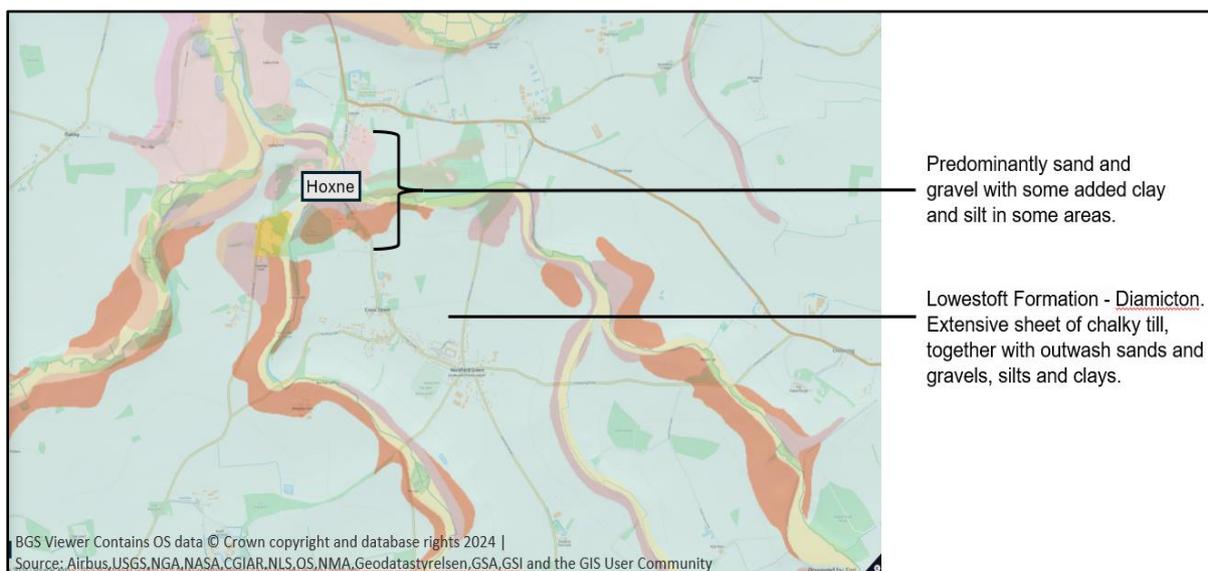
Figure 9. Superficial geology (BGS Geology Viewer)

Lowestoft Formation 'Diamicton' surrounds the village more generally which is described by the British geological survey as a diverse mixture of clay, sand, gravel, and boulders varying widely in size and shape. This generally has a low permeability meaning water will tend to flow off it before it can be infiltrated, which reflects some of the reports from the Storm Babet event.

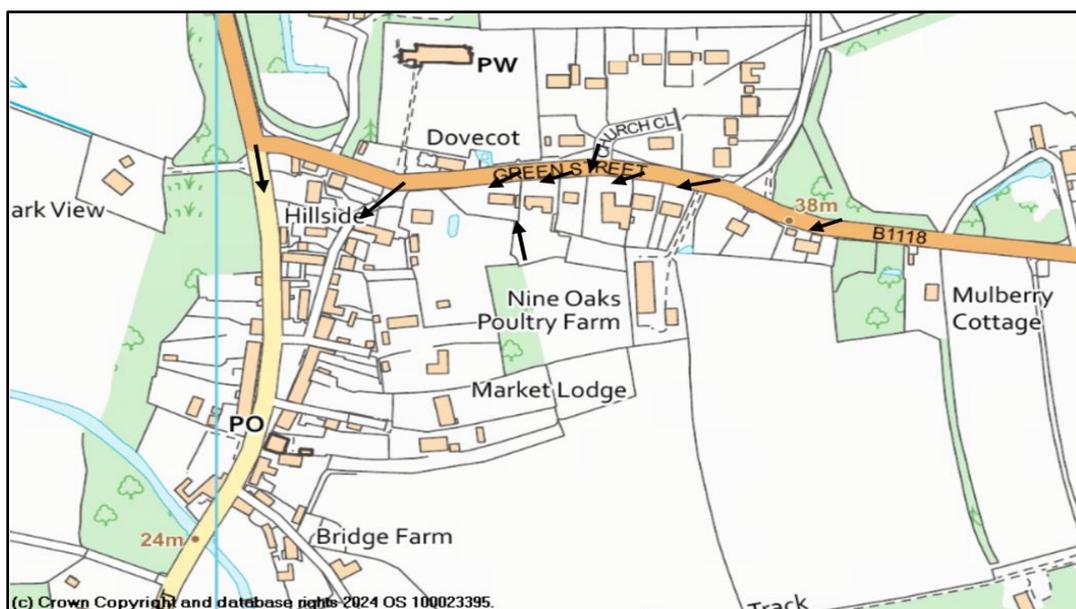
Following prolonged heavy rainfall on the morning of 20 October large amounts of surface water began pooling on the highway along Green Street near to the entrance to Church Close. Houses were flooded internally, primarily from the front due to the sheer amount of floodwater flowing off the highway towards properties over the low kerbs and across driveways (see Figure 10). Some of the properties also experienced additional flooding from the rear as surface water flowed from higher gardens south of Green Street. The large volume of floodwater on the road likely meant that the existing highway drainage assets were overwhelmed.

Figure 10. Approximate floodwater flow routes on Green Street

Suffolk Highways are aware of historic flooding on the carriageway and footway on Green Street. Previous flooding has been known to take several days to clear. Initial investigations have indicated a possible break between a drainage gully and manhole. Further work to improve the situation at this location is in Suffolk Highways future programme.

- Residents to install Property Flood Resilience (PFR) via grant funded scheme.
- Suffolk Highways future works programme to locate and repair / replace damaged drainage assets on Green Street to be carried out.
- Investigate highway drainage infrastructure on Green Street generally to ensure capacity and condition are sufficient.

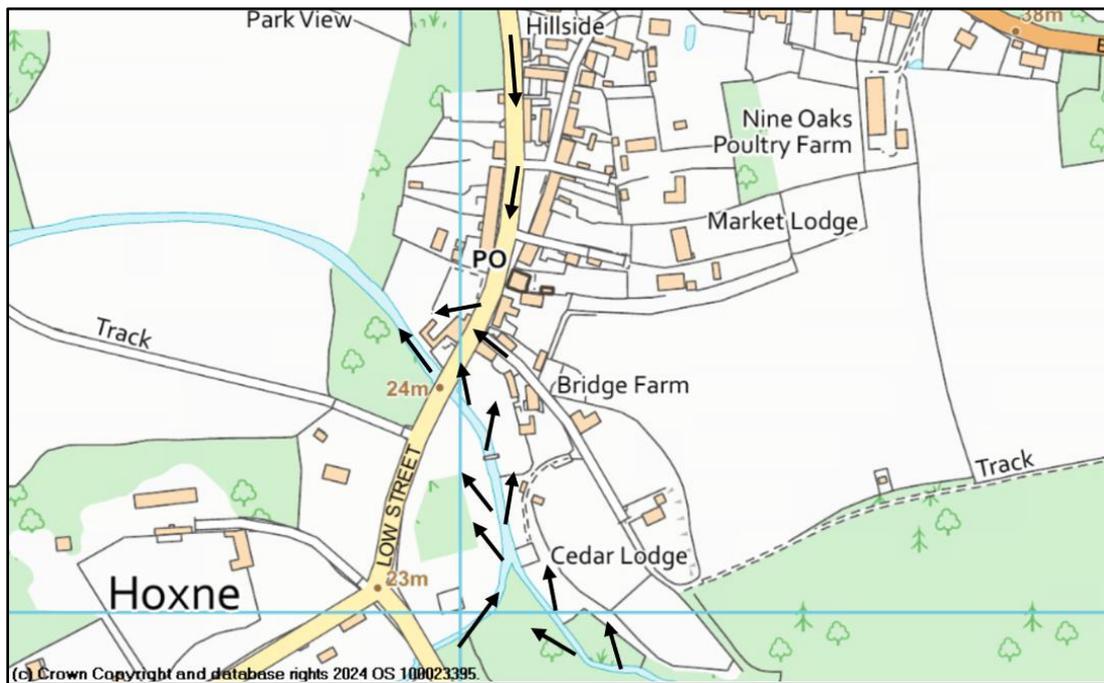
Excess surface water from the rainfall flowed down the gradient from the north end of Low Street towards the Swan bridge area. The highway gullies on the west side of Low Street were seen to be clogged with fallen leaves inhibiting drainage. On 20 October from 9:30am water was surcharging from the manhole in front of the Swan pub indicating the surface water drainage system was already reaching capacity and/or may have become blocked with the floodwater debris. This surcharging water was merging with the surface water flowing down Low Street, pooling across the highway to the pub, swan bridge and along Sandpit Lane (see Image 3).

The Gold Brook watercourse overtopped its banks with the fields and areas either side of the watercourse upstream of the bridge extensively flooded (see Figure 11). Swan bridge acted as a constriction to the large volume of water flowing down the catchment from the Gold Brook and Chickering Beck watercourses. The floodwater flowed across gardens with multiple properties suffering internal flooding ranging from 10 to 45cm deep. As the floodwater continued to back up at Swan bridge, a torrent of water flowed from Sandpit Lane across Low Street and into the Swan pub carpark (see Image 4). By 4:00pm the entire area was submerged as the floodwater extended and merged with the surface water from the highway. The highway drainage assets and infrastructure in this location were overwhelmed and could not discharge into the already overfull watercourse. Residents have reported that the flood water level on Low Street peaked around 8:30pm and at 9:15pm the electricity on Low Street went off.

Figure 11. Approximate floodwater flow routes on Low Street

- Residents to install Property Flood Resilience (PFR) via grant funded scheme.
- Investigate the capacity and condition of highway drainage infrastructure and Anglian Water assets on Low Street, particularly the area in the vicinity of the Swan pub.
- Report any observed blockages below Swan bridge on the Suffolk Highways Online Reporting Tool.
- Landowners to carry out watercourse maintenance to reduce flood risk as necessary as per their riparian responsibilities.

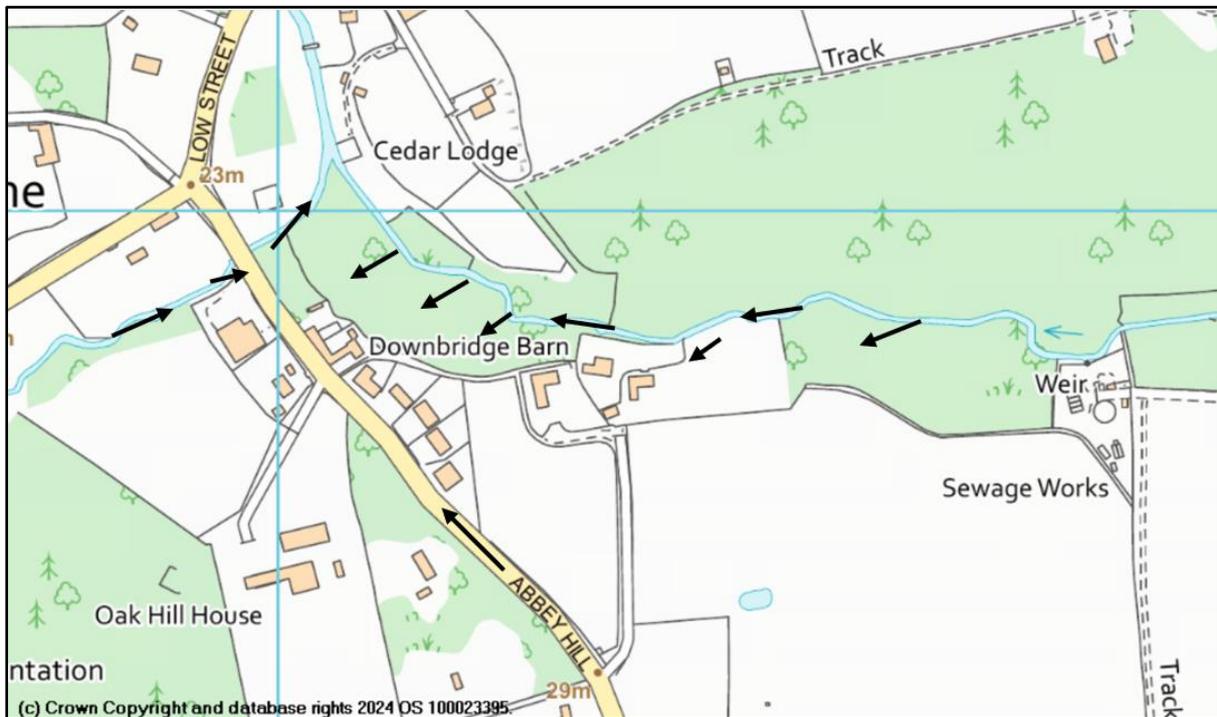
Abbey Hill was predominantly impacted by fluvial flooding from the Chickering Beck and Gold Brook watercourses, the confluence of both is just north of Abbey Hill. Chickering Beck on the morning of 20 October was swollen by heavy rainfall and overtopped towards the properties to the south. Floodwater flowed across gardens from approximately 11:30am and started to enter houses from the early afternoon onwards (see Image 2). The Gold Brook also overtopped across the surrounding fields and flowed onto Abbey Hill, effectively surrounding properties in floodwater and additionally flooding some houses internally from the front. Surface water on the highway running down the hill also contributed to the flooding. National flood risk mapping indicates parts of Abbey Hill to be at medium risk (between 1% and 3.3% chance each year) from fluvial flooding and at high risk (more than 3.3% chance each year) from surface water flooding.

Figure 12. Approximate floodwater flow routes on Abbey Hill

The increasing volumes of floodwater on the road meant that the highway drainage assets were overwhelmed and could not drain the water away. Residents have reported that the gullies were ineffective due to silt build-up and blockages.

Suffolk Highways are aware of pre-existing problems on the carriageway along Abbey Hill with gullies frequently blocking and root ingress being a known problem. Investigations carried out by Suffolk Highways post Storm Babet found multiple silted gullies that required clearing.

- Residents to install Property Flood Resilience (PFR) via grant funded scheme.
- Investigate potential NFM projects to 'slow the flow' and attenuate water on overland flow paths (leaky dams, restoration of watercourses, etc.) east of Abbey Hill.
- Report any observed blockages below Gold Brook bridge on the Suffolk Highways Online Reporting Tool.
- Landowners to carry out watercourse maintenance to reduce flood risk as necessary as per their riparian responsibilities.

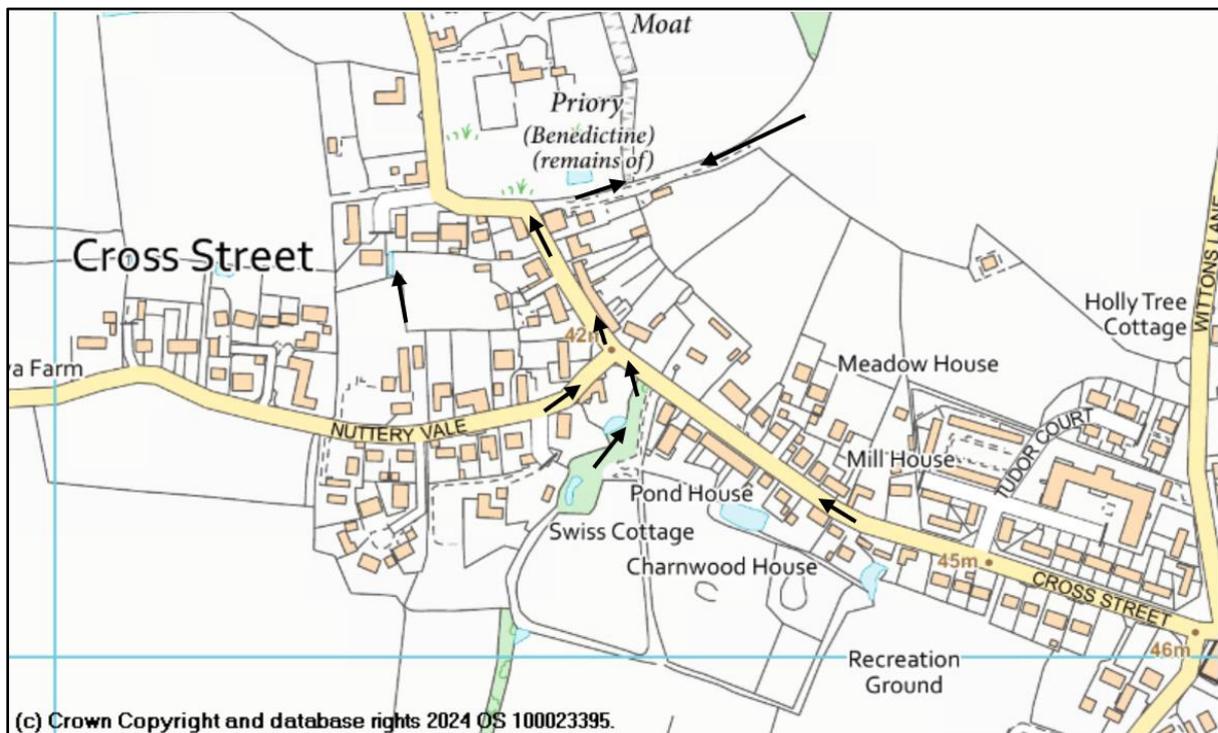
On Cross Street multiple properties were impacted by surface water flooding. During the morning of 20 October heavy rainfall resulted in large volumes of floodwater pooling on the road in different locations as the highway drainage gullies and sewer infrastructure reached capacity.

Figure 13. Approximate floodwater flow routes on Cross Street

Residents reported a number of manholes on Cross Street were surcharging and bubbling up with a mixture of foul water and rainwater in the middle of the street. Several reports indicated that almost all the roadside gullies were blocked and/or overwhelmed and failed to drain the increasing amounts of surface water from the highway.

- Residents to install Property Flood Resilience (PFR) via grant funded scheme.
- Investigate potential NFM projects to ‘slow the flow’ and attenuate water on overland flow paths (leaky dams, restoration of watercourses, etc.) north of Cross Street.
- Ensure the completion of highway drainage asset cyclic maintenance on Cross Street.
- Landowners to carry out watercourse/ditch maintenance to reduce flood risk as necessary as per their riparian responsibilities.
- Investigate highway drainage and sewer infrastructure on Cross Street generally to ensure capacity and condition are sufficient.

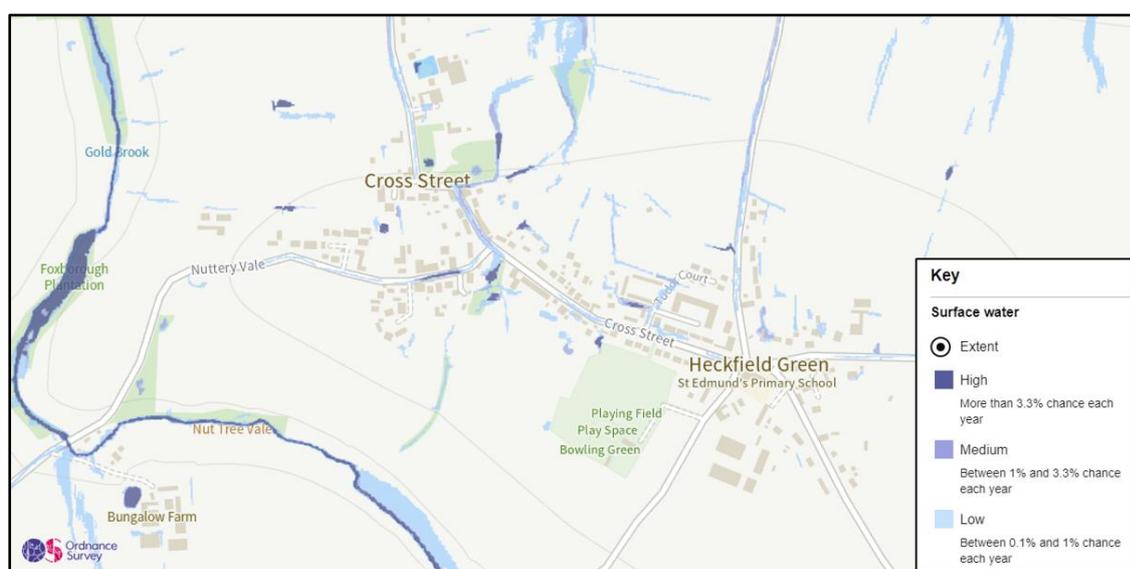
Additional surface water flows originating from the fields to the northeast flowed into the ditch behind the properties to the north of Cross Street. This surface water run off filling the ditch reduced the effectiveness of the highway drainage assets and added to the flooding. The national flood risk mapping shows large sections of Cross Street and the adjoining Nuttery Vale to be at medium to high risk of surface water flooding (see figure 14).

Figure 14. Surface Water flood risk on Cross Street and Nuttery Vale

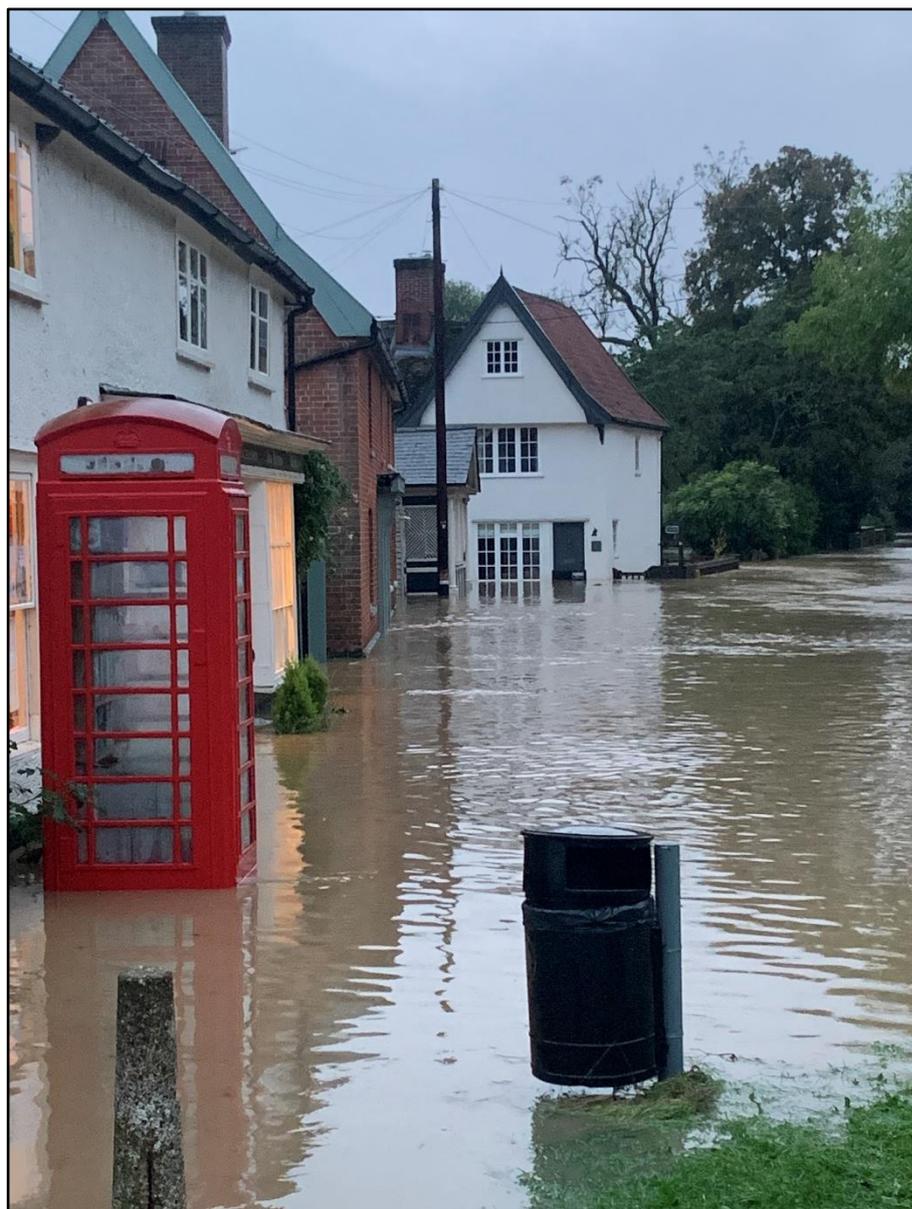
Image 1. Flooding outside the Post Office on Low Street

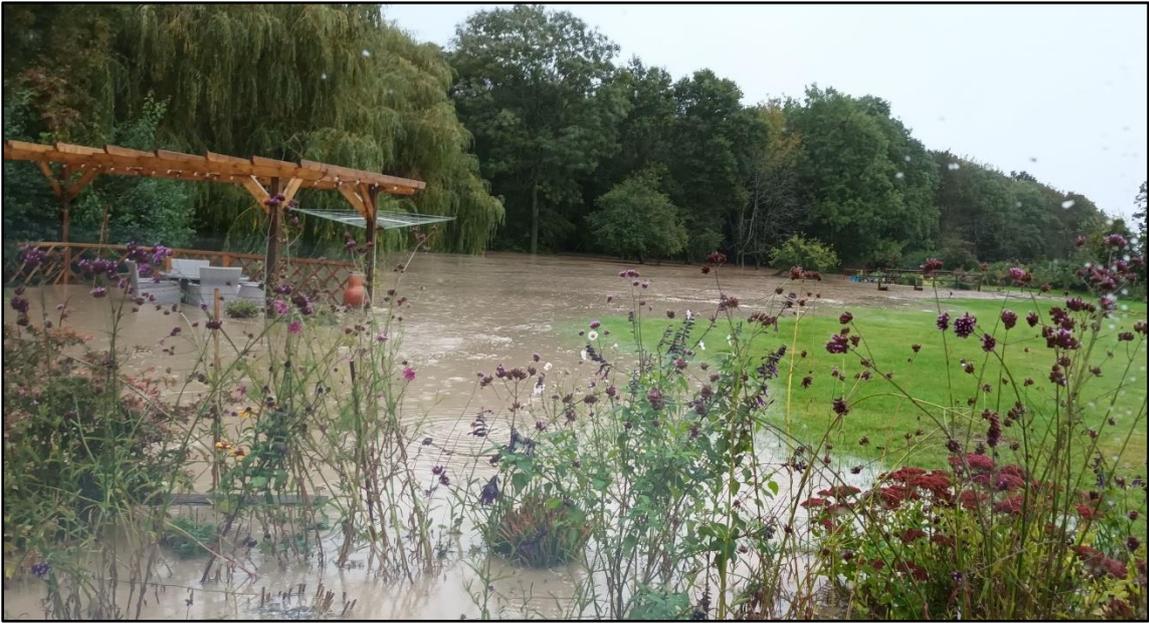
Image 2. Flooding from Chickering Beck watercourse

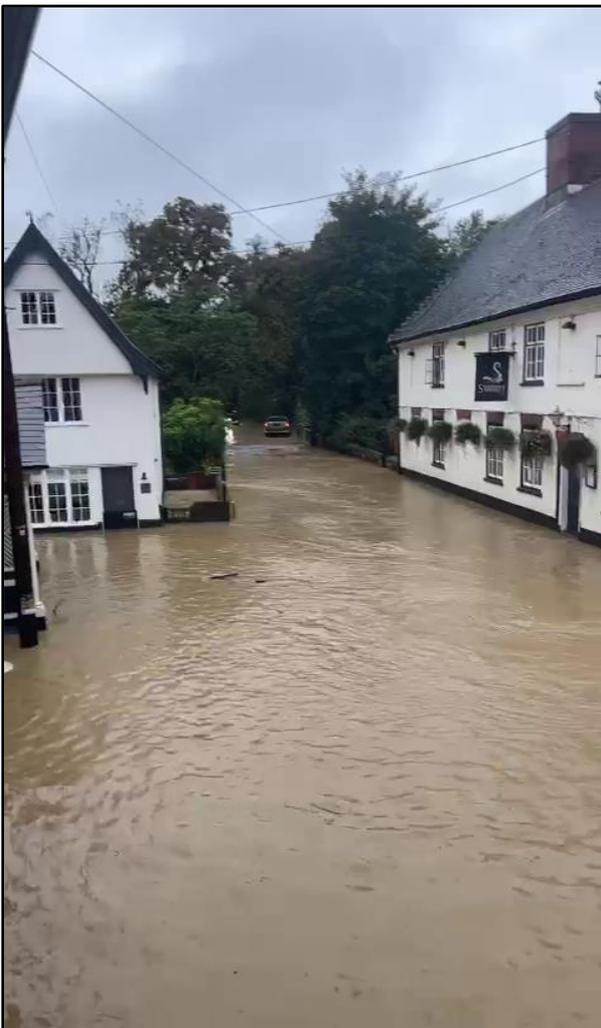
Image 3. Looking towards Swan bridge

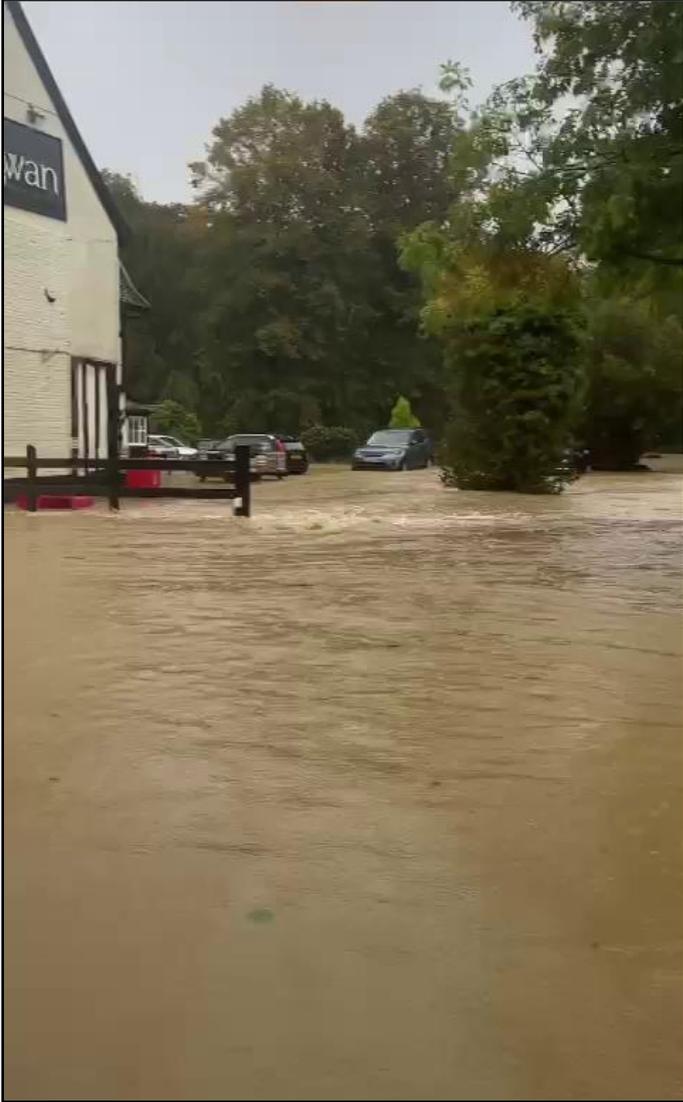
Image 4. Looking towards the Swan pub carpark
