Section 19 Flood and Water Management Act 2010

Letheringham Flood Investigation –

Storm Babet 2023

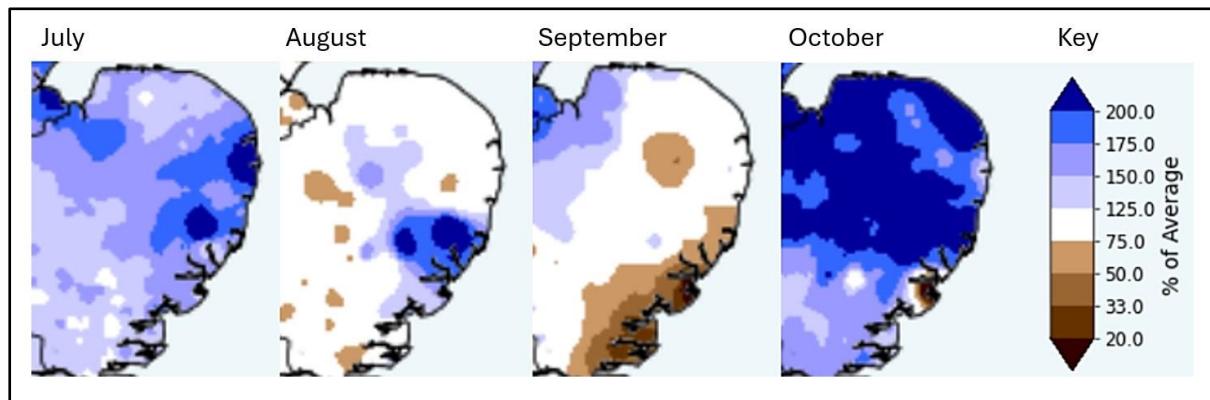
The following maps illustrate the extent to which the rainfall in the months preceding Storm Babet exceeded the average monthly rainfall for July to October in recent years in Suffolk.

Figure 1. Average rainfall in East Anglia between July and October 2023 as a percentage of the historical average monthly rainfall

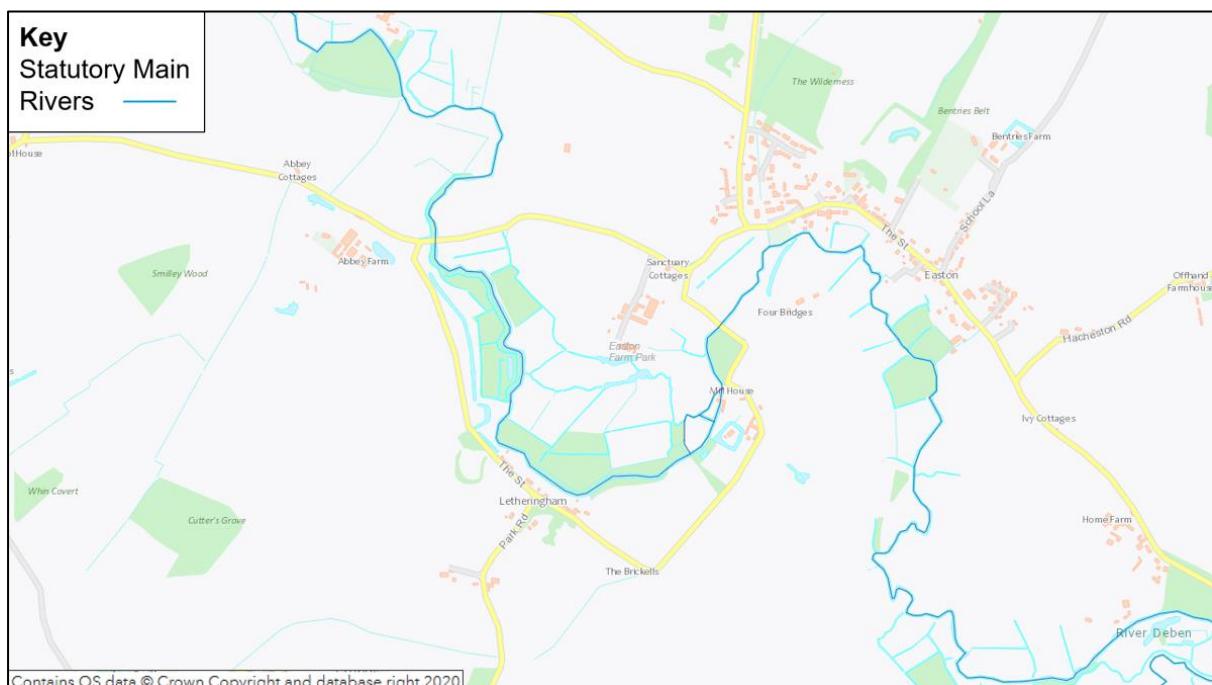
Figure 4. Location of statutory main river and ordinary watercourses

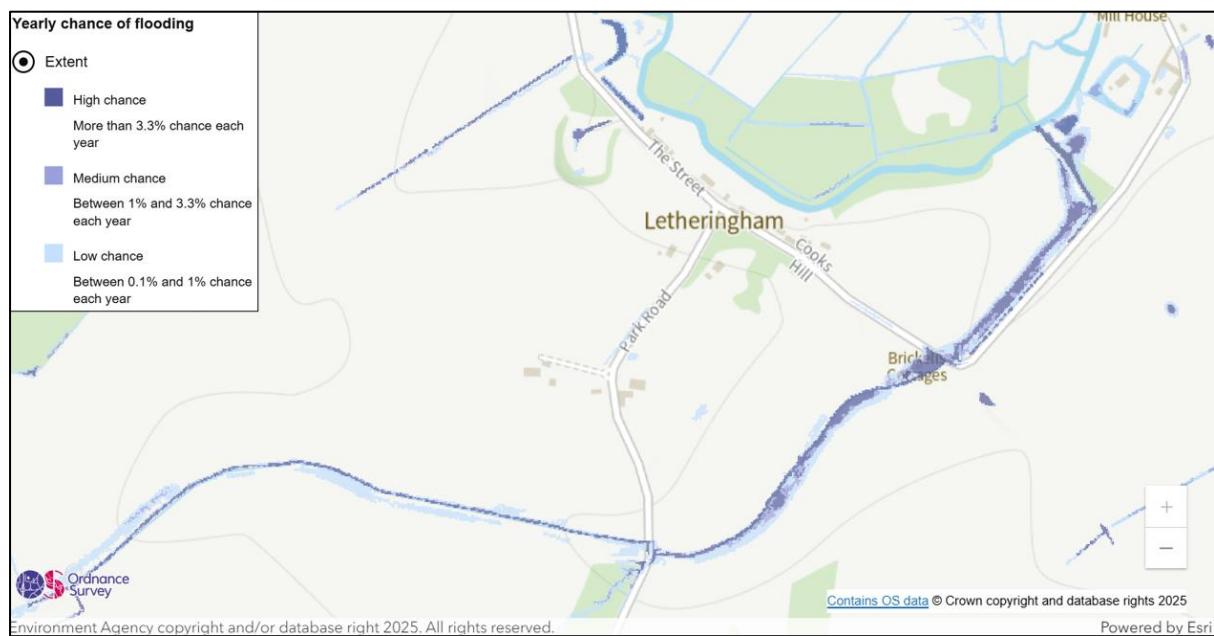
The floodwater flowpaths observed on The Street and Cooks Hill during Storm Babet broadly align with the national surface water flood risk mapping (see Figure 13). In some locations the flooding experienced was more extensive than the current mapped risk.

Figure 13. Surface water flood risk on The Street and Cooks Hill

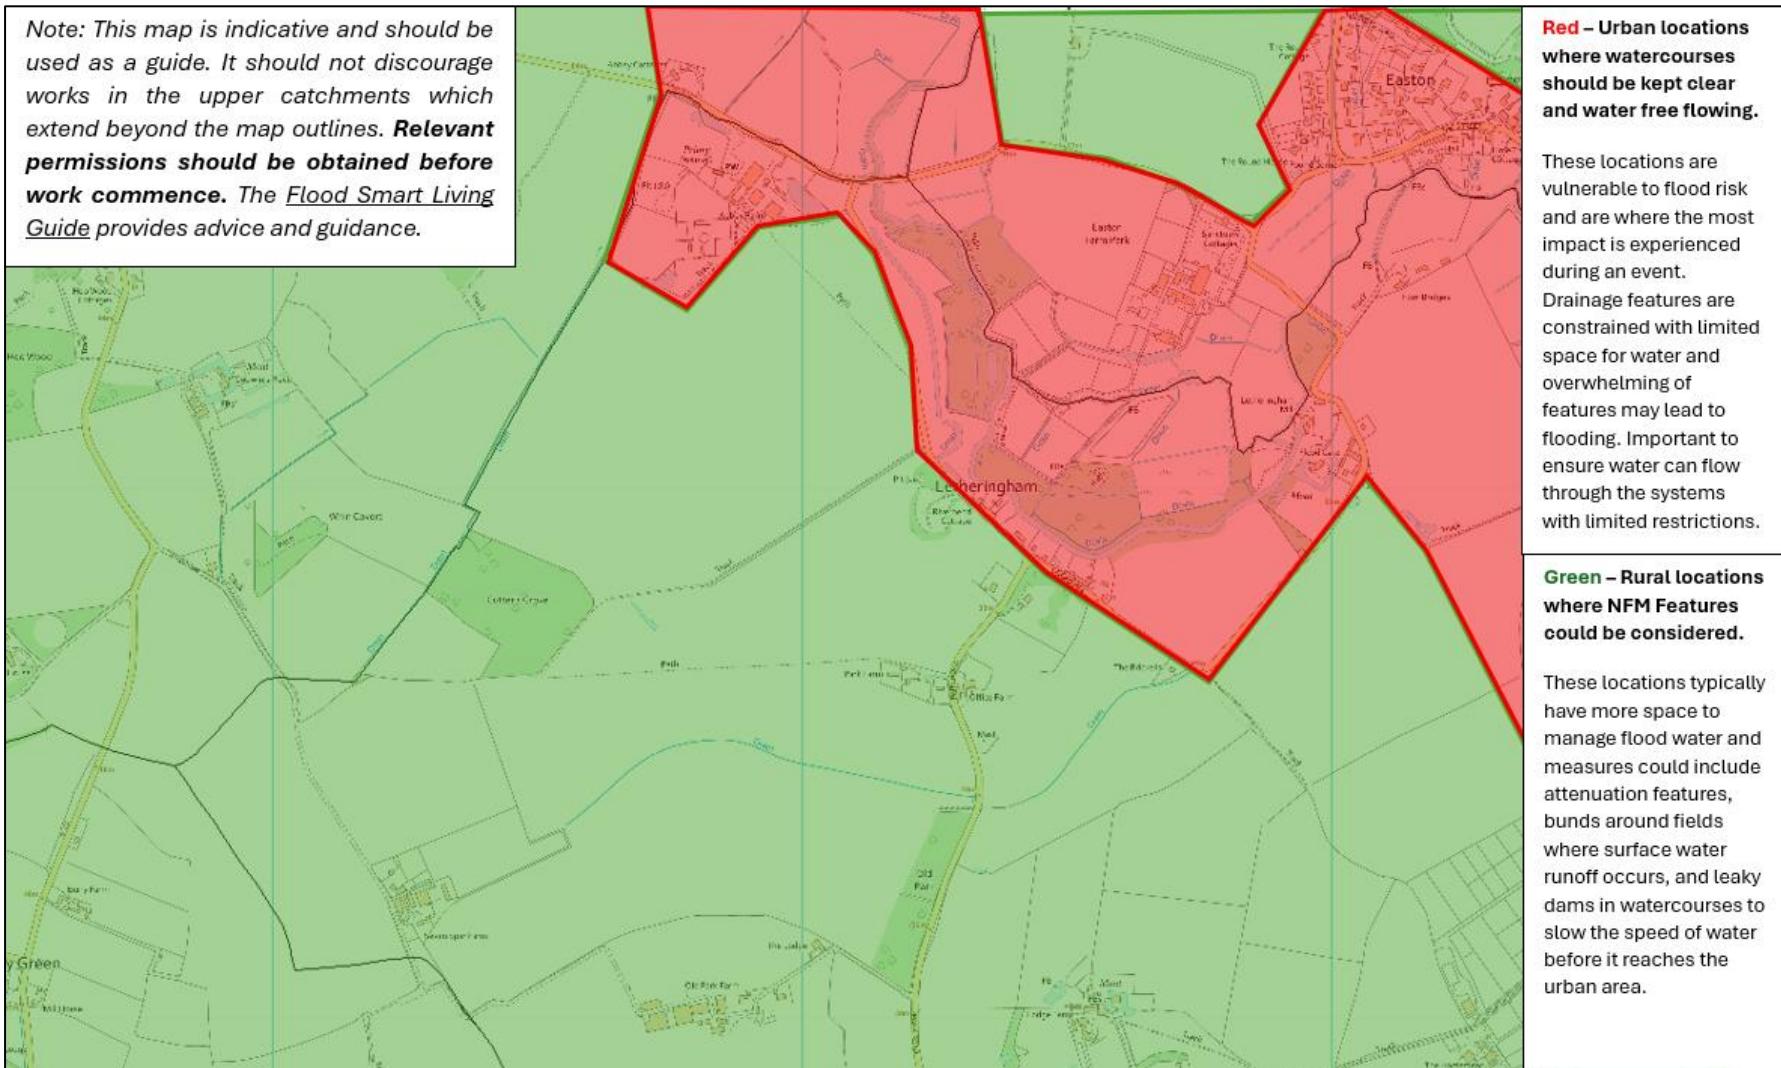
Appendix A – Indicative locations for NFM and watercourse maintenance

*Note: This map is indicative and should be used as a guide. It should not discourage works in the upper catchments which extend beyond the map outlines. **Relevant permissions should be obtained before work commence.** The Flood Smart Living Guide provides advice and guidance.*
