Section 19 Flood and Water Management Act 2010

Martlesham Flood Investigation –

Storm Babet 2023

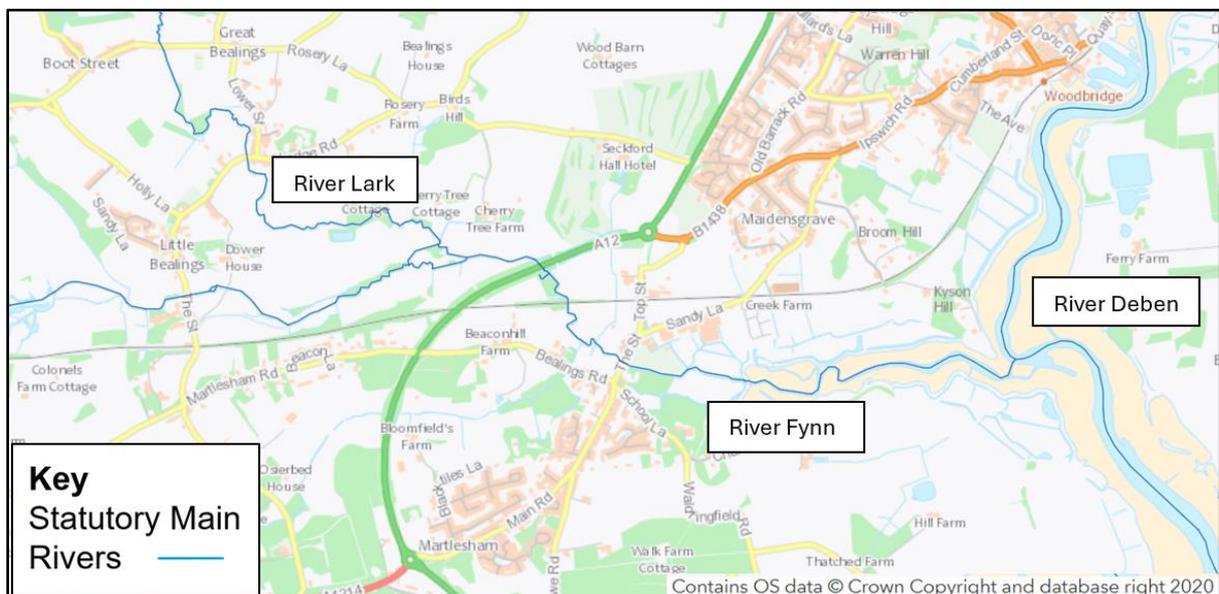
Figure 3. Location of statutory main rivers and significant ordinary watercourses near Martlesham

Figure 3 shows the most significant watercourses in the area surrounding Martlesham. These include the river Fynn, the Lark and the Deben, all statutory main rivers.

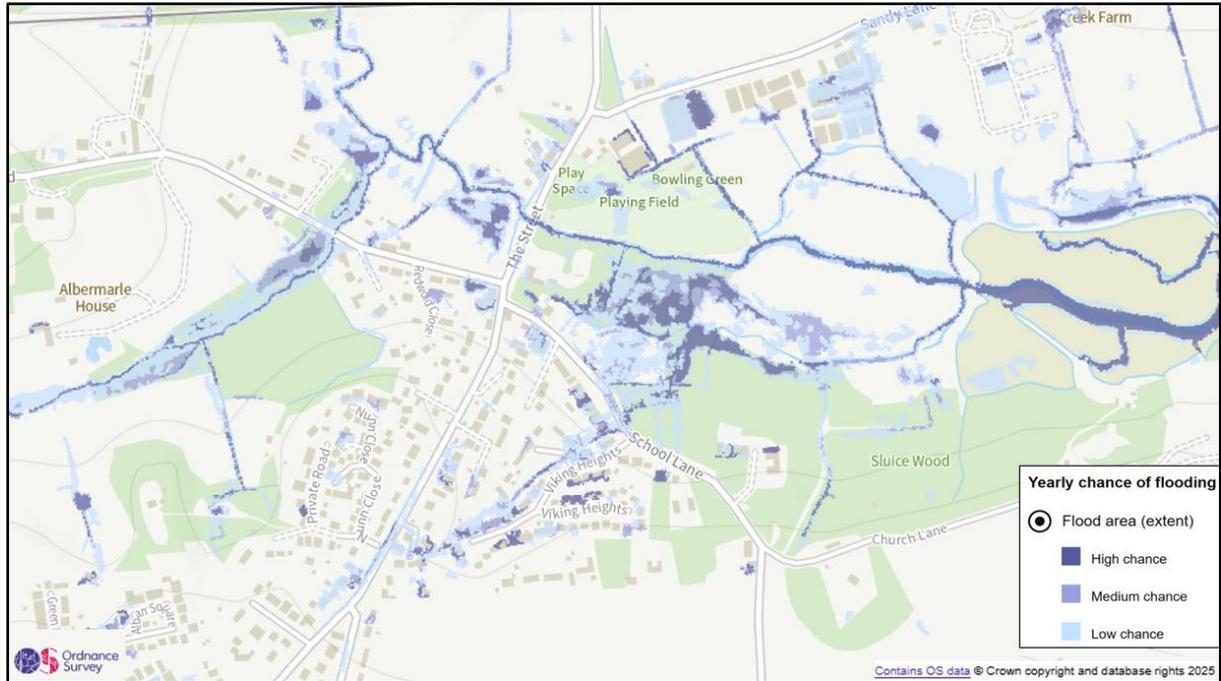
Figure 4. Surface water flood risk

Figure 5 highlights the pluvial (surface water run-off from surrounding land and highways) flood risk in Martlesham. Several surface water flow paths traverse across Martlesham and into the river Fynn, upstream and downstream of the road bridge on The Street. Sections of The Street and Post Office Lane are characterised as having a low chance of surface water flooding. With one isolated area shown at being high chance. These two areas were affected by flooding during Storm Babet.

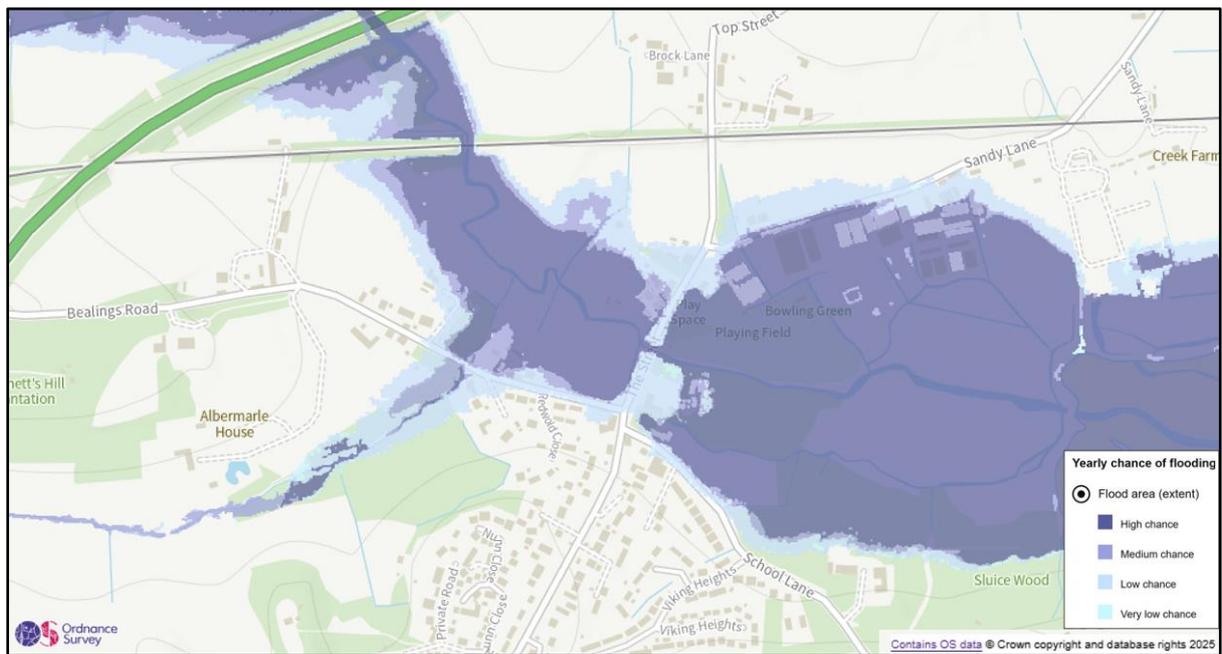
Figure 5. Flood risk from rivers and sea

Figure 6 shows the fluvial (from designated main river and ordinary watercourses) flood risk in Martlesham. Fluvial flood risk is associated with the river Fynn which flows just north of the centre of Martlesham. Parts of The Street and Post Office Lane have a yearly chance of fluvial flooding ranging from low to high. Properties on The Street and Post Office Lane were affected by flooding during Storm Babet.

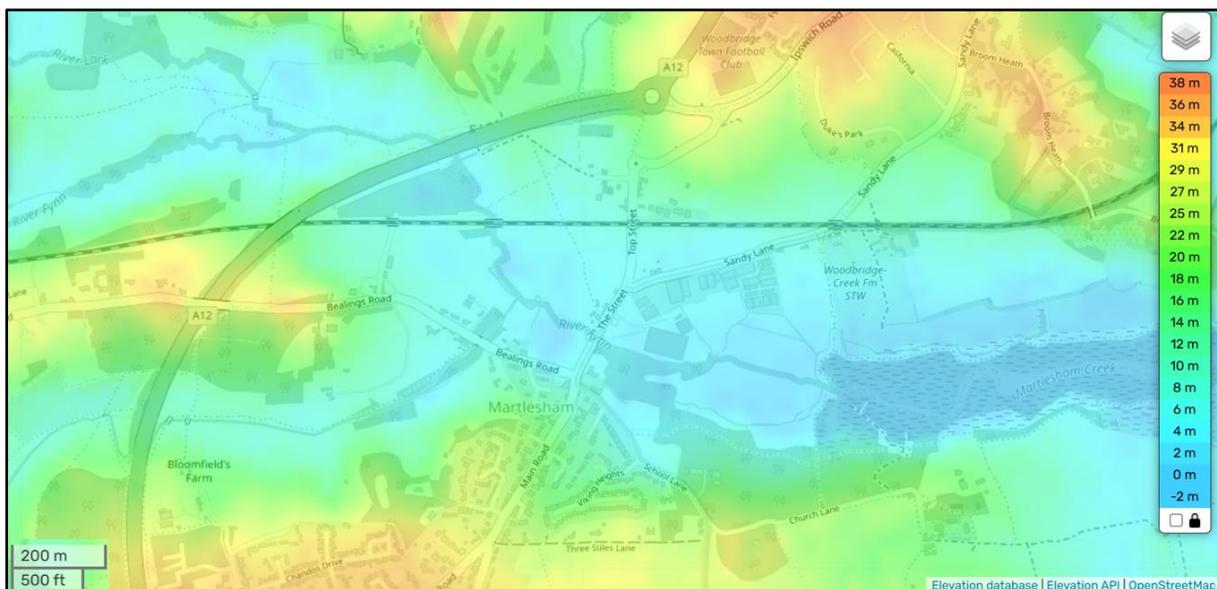
Figure 7 shows the topography and gradient changes surrounding Martlesham. The north of the village is situated in the valley of the river Fynn before it flows into Martlesham Creek. Its elevation is lower than the surrounding land to the north and south. One of the lowest points is along The Street at the river crossing. This location was affected by flooding during Storm Babet.

Figure 6. Martlesham and surrounding topography (TessaDEM as cited in topographic-map.com)

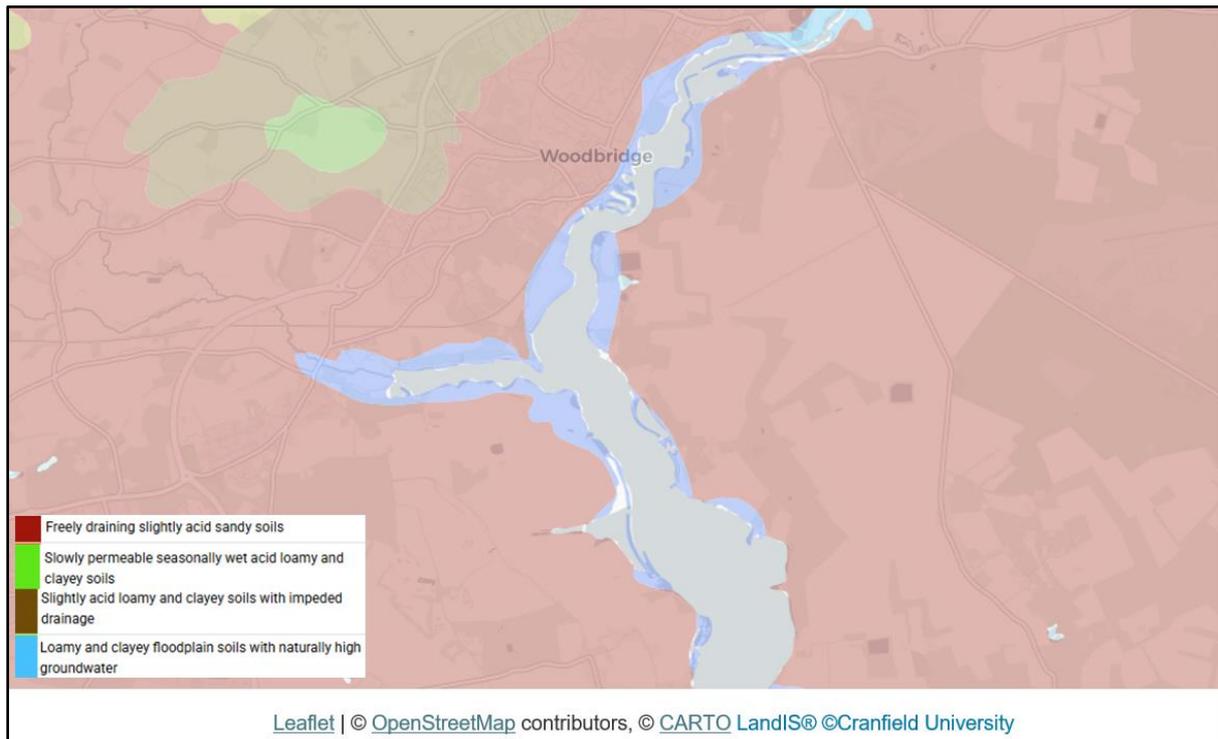
Figure 7. Soil map (LandIS Soils)

The soils more generally surrounding Martlesham are freely draining, slightly acid sandy soils. The village itself is situated on a mixture freely draining soils and floodplain soils surrounding the river Fynn which usually have naturally high groundwater and tend to be wetter.

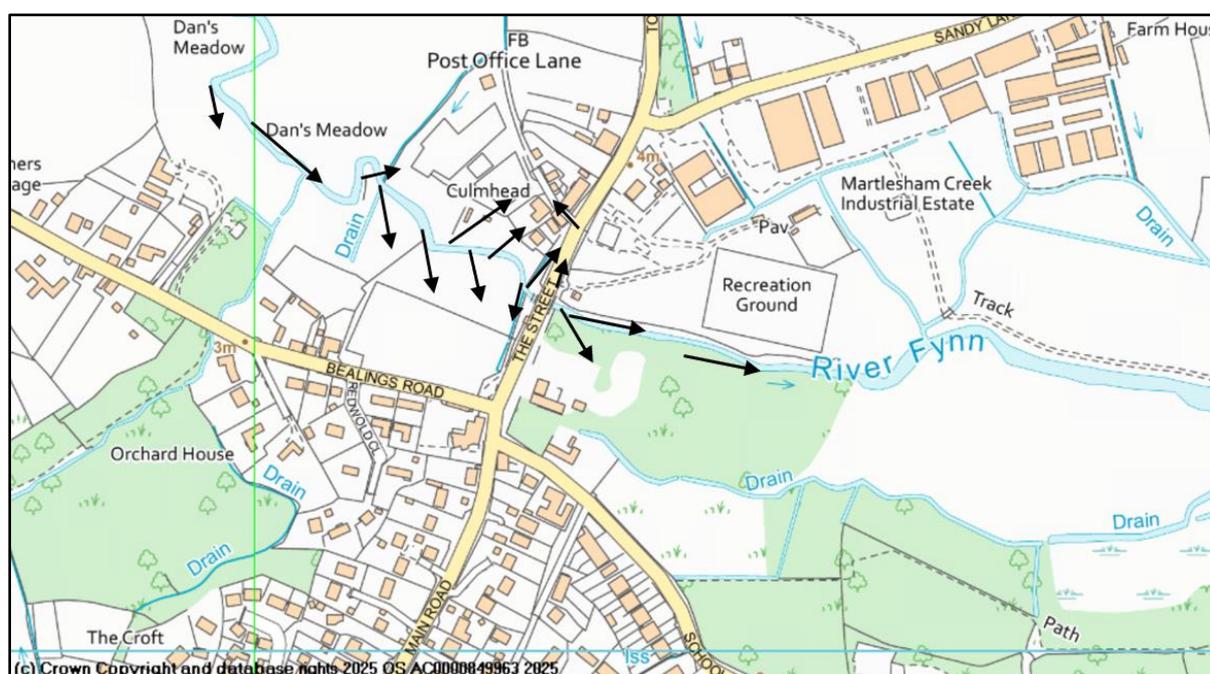
The primary cause of flooding on The Street and Post Office Lane was fluvial flooding. On 20 October 2023, intense rainfall caused huge amounts of floodwater to flow down from the upper catchments of the river Lark and the river Fynn towards Martlesham. The internal flooding on The Street and Post Office Lane was caused by the river Fynn overtopping and flowing directly across gardens, roads and into properties.

Residents reported the speed of the flooding was very fast. From 5:30pm the river began overflowing onto the land to the north and by 8:30pm, floodwater was entering properties and flowing further onto Post Office Lane (see Figure 9). The layby in front of Post Office Lane was entirely submerged. Residents also reported the properties in the area suffered a complete power cut around this time, making the situation even more difficult and dangerous. Floodwater levels continued to rise until midnight.

Figure 8. Approximate flood water flow routes affecting The Street and Post Office Lane

- Residents to install Property Flood Resilience (PFR).
- Investigate potential NFM projects to 'slow the flow' and attenuate water on overland flowpaths in the fields southwest of the river Fynn and Bealings Road (leaky dams, restoration of watercourses, storage ponds etc.).
- Suffolk Highways to ensure the completion of highway drainage asset cyclic maintenance on The Street and Post Office Lane.
- Report any observed blockages below the road bridge on The Street on the Suffolk Highways Online Reporting Tool.
- Riparian landowners to carry out appropriate watercourse maintenance through Martlesham to reduce flood risk as necessary as per their riparian responsibilities.

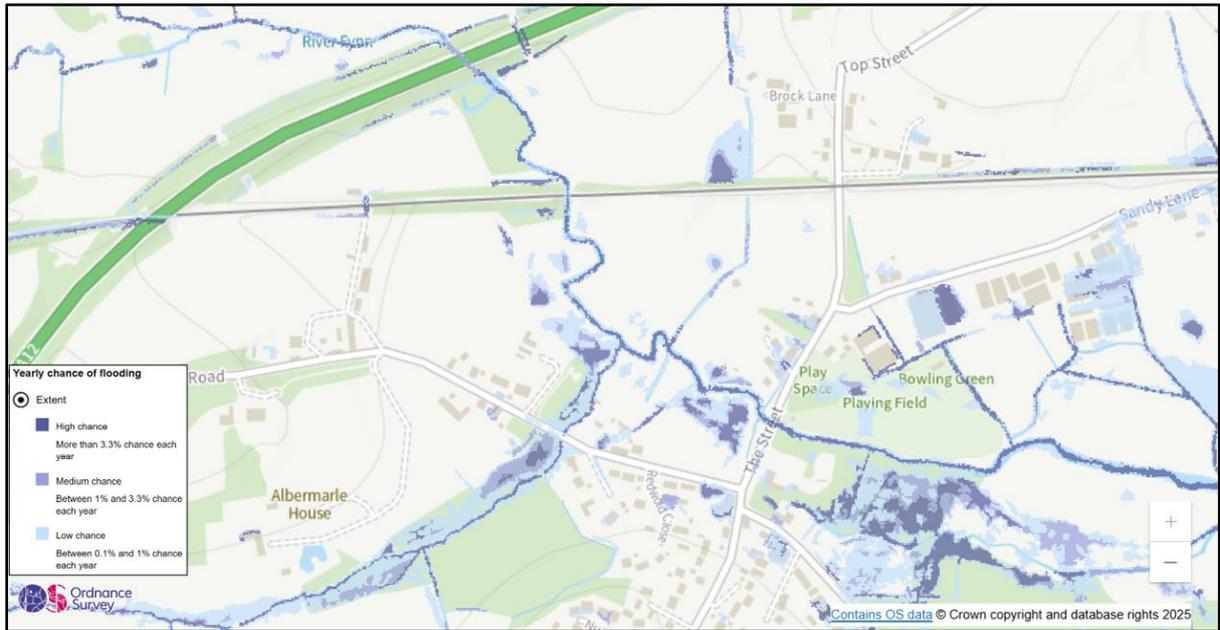
Figure 9. Surface water flood risk on The Street and Post Office Lane

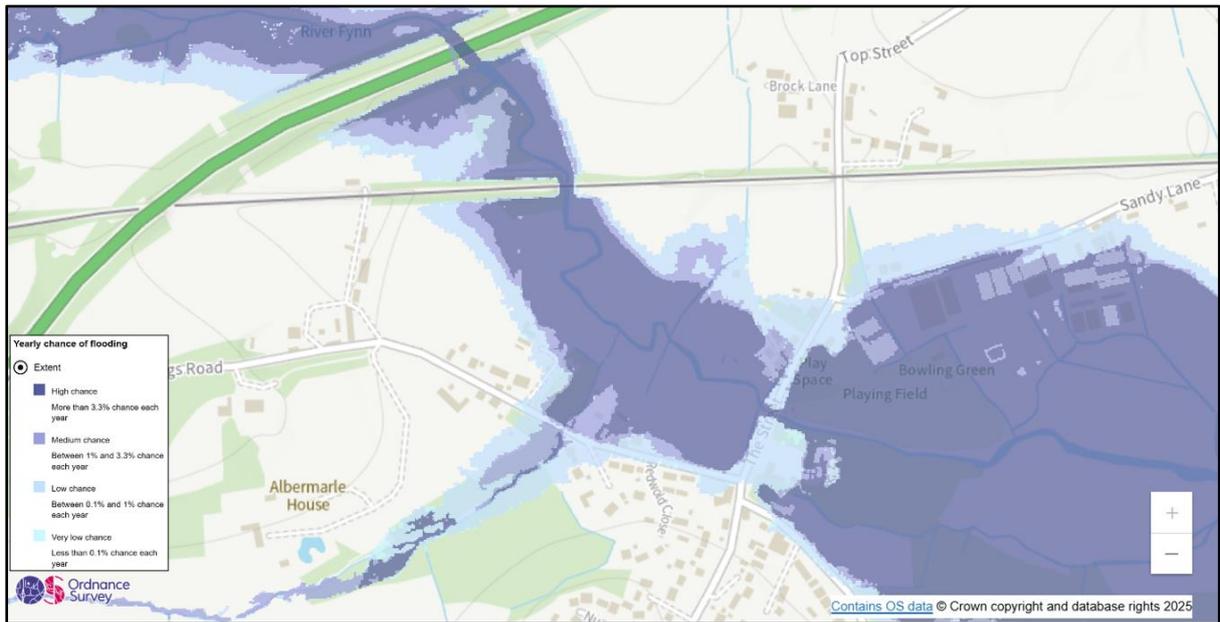
The fluvial flood risk to properties in this area ranges from a medium to high chance of flooding from the river each year (see Figure 11). The flood extents shown on the national flood mapping aligns with the observed floodwater limits seen during Storm Babet.

Figure 10. Flood risk from rivers and sea on The Street and Post Office Lane

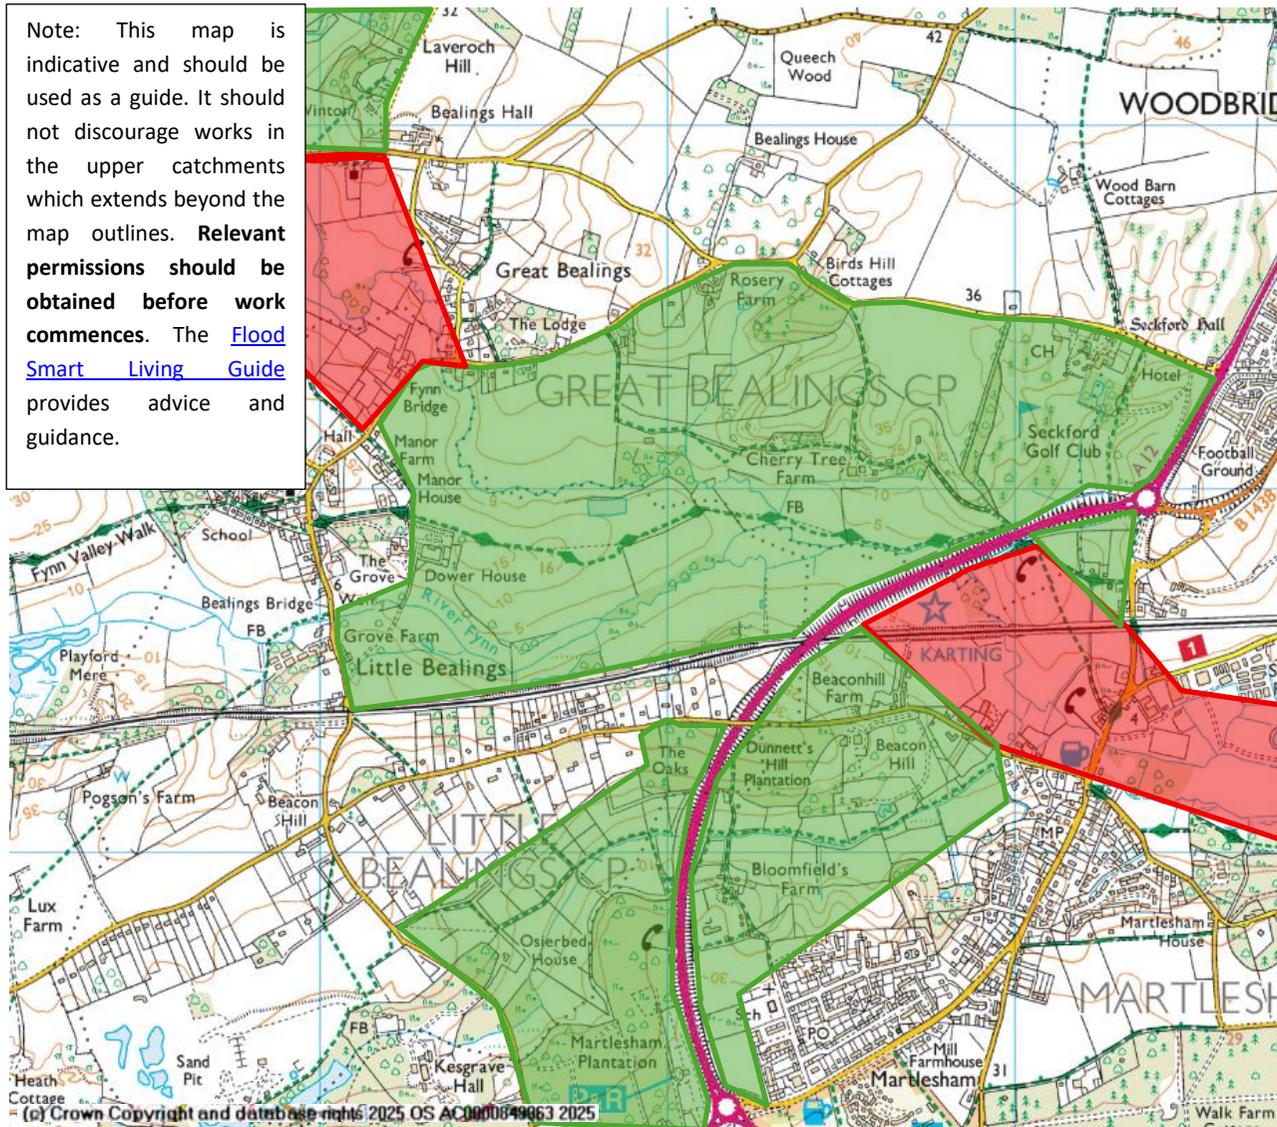
Appendix A - Indicative locations for NFM and watercourse maintenance

Red – Urban locations where watercourses should be kept clear and water free flowing.

These locations are vulnerable to flood risk and are where the most impact is experienced during an event. Drainage features are constrained with limited space for water and overwhelming of features may lead to flooding. Important to ensure water can flow through the systems with limited restrictions.

Green – Rural locations where NFM Features could be considered.

These locations typically have more space to manage flood water and measures could include attenuation features, bunds around fields where surface water runoff occurs, and leaky dams in watercourses to slow the speed of water before it reaches the urban area.
