## Section 19 Flood and Water Management Act 2010

### Mendlesham Flood Investigation –

### Storm Babet 2023

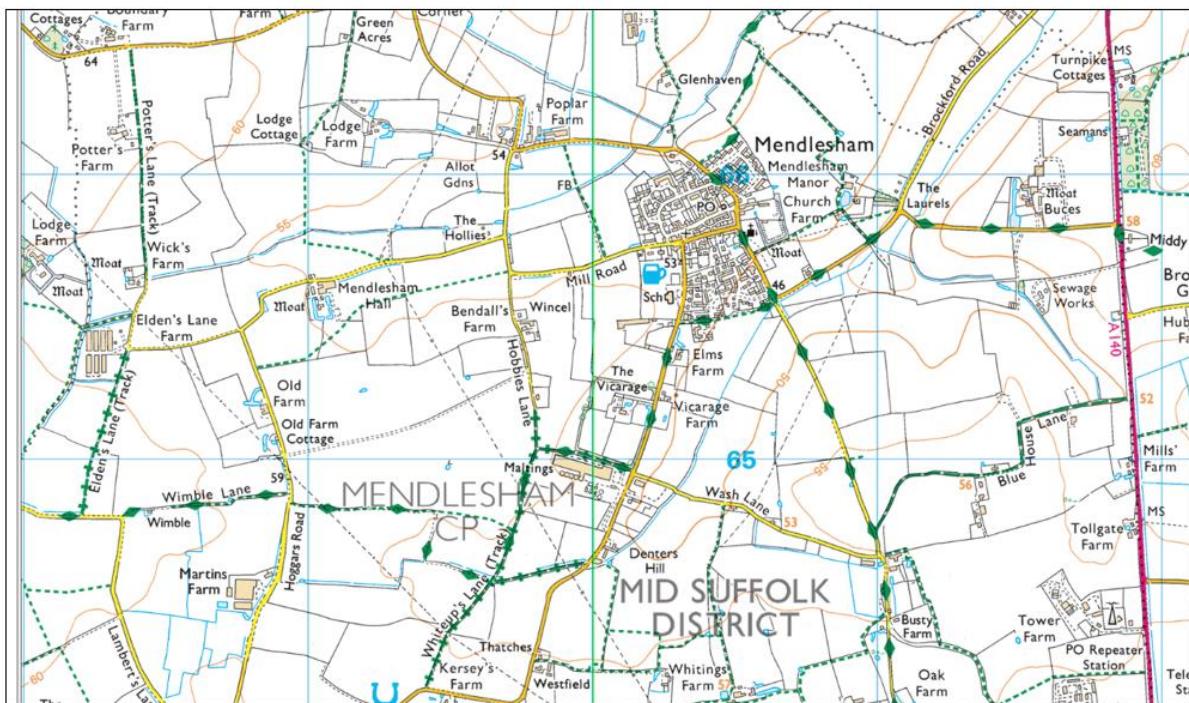
Figure 2. Investigation area map

Mendlesham is a small village situated five miles northeast of the market town of Stowmarket. It is in the local authority district of Mid Suffolk.

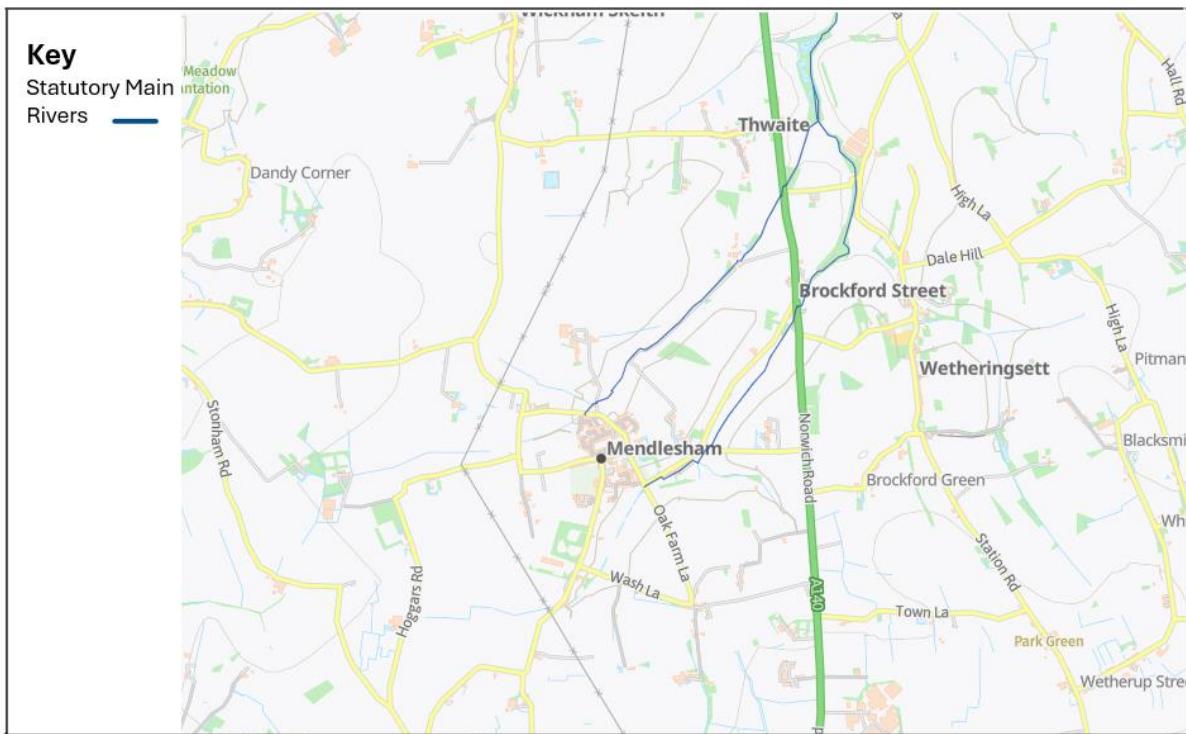
*Figure 3. Location of statutory main river and ordinary watercourses*

Figure 3 shows the most significant watercourses (designated main river) in and around Mendlesham. The River Dove originates near Mendlesham and flows northward to join the River Waveney. A separate designated watercourse runs parallel to the River Dove, also flowing north before merging with the Dove and ultimately the Waveney.

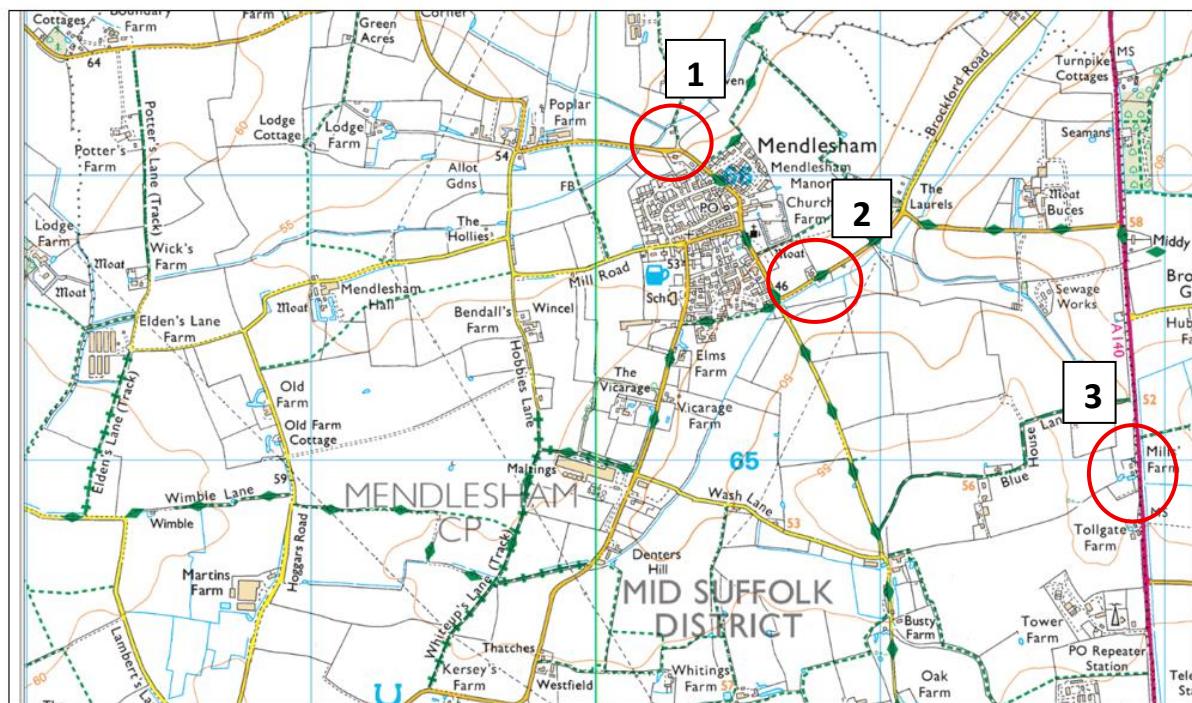
For the purposes of this investigation the areas affected by flooding have been separated into three distinct locations. The locations are as follows:

1. Chapel Road
2. Brockford Road
3. Norwich Road

Figure 4. Mendlesham investigation area map with locations

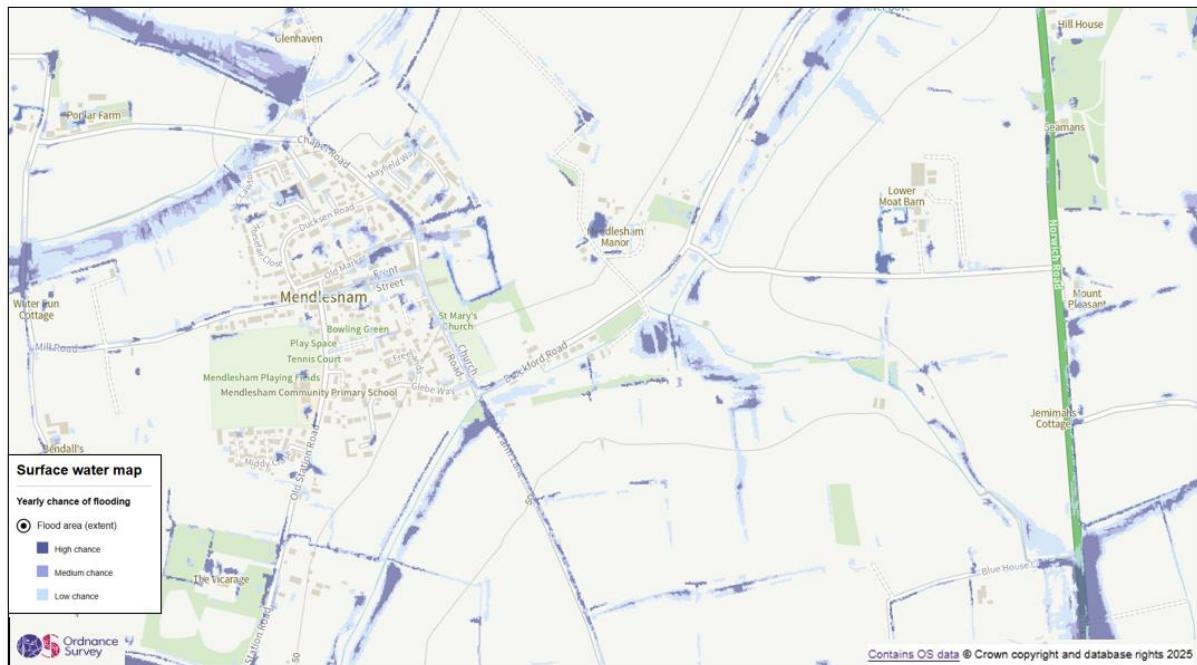
*Figure 5. Surface water flood risk*

Figure 5 highlights the predicted pluvial (surface water run-off from surrounding land and highways) flood risk in Mendlesham, with multiple areas of isolated locations predicted to be at risk.

Pluvial risk varies across this location, ranging from low to high risk. There are high risk surface water flow paths near to Chapel Road and Norwich Road.

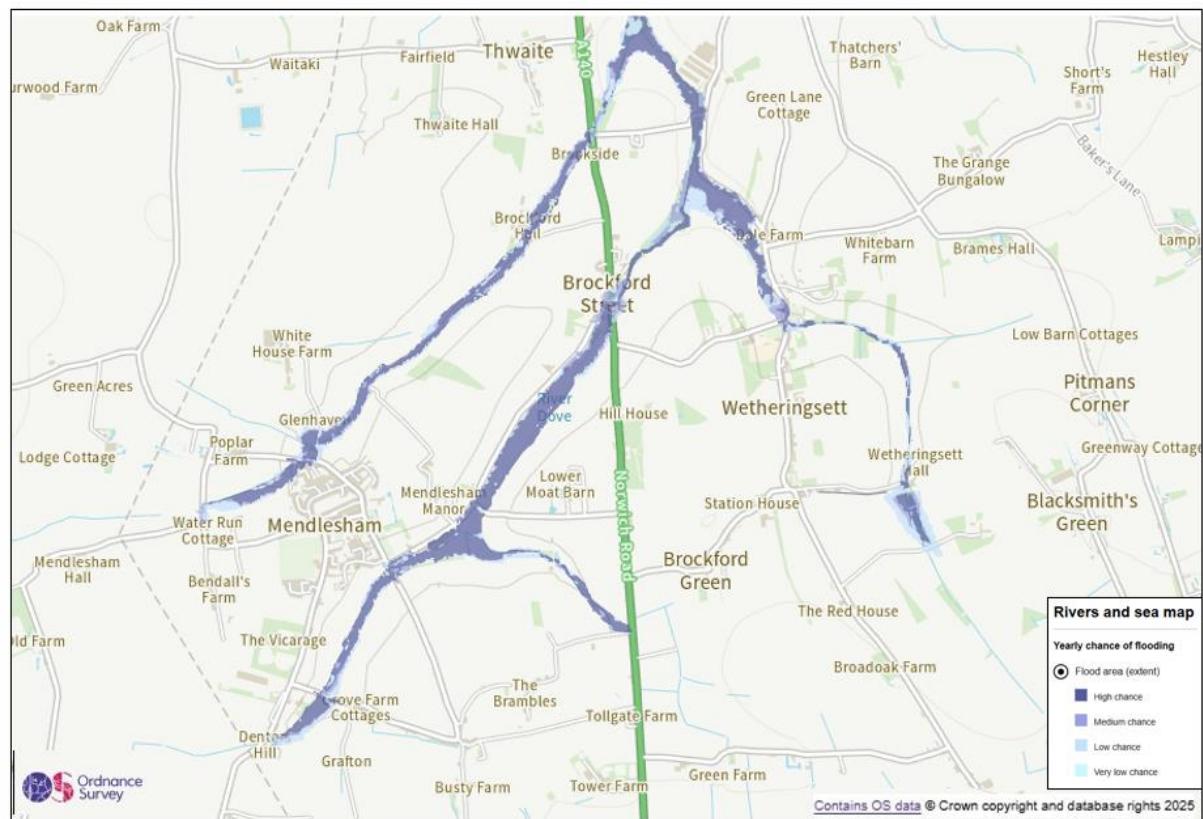
Figure 6. Flood risk from rivers and sea

Figure 6 shows the predicted fluvial (from designated main river and ordinary watercourses) flood risk in Mendlesham. The primary source of fluvial flood risk in the area is the River Dove, which flows from the south of the village toward the northeast. An additional watercourse runs roughly parallel to the River Dove, originating to the west, flowing northeast, and eventually merging with it before continuing toward the River Waveney.

There is a medium to high chance of fluvial flooding on sections of Chapel Road and Brockford Road. These areas were affected by flooding during Storm Babet.

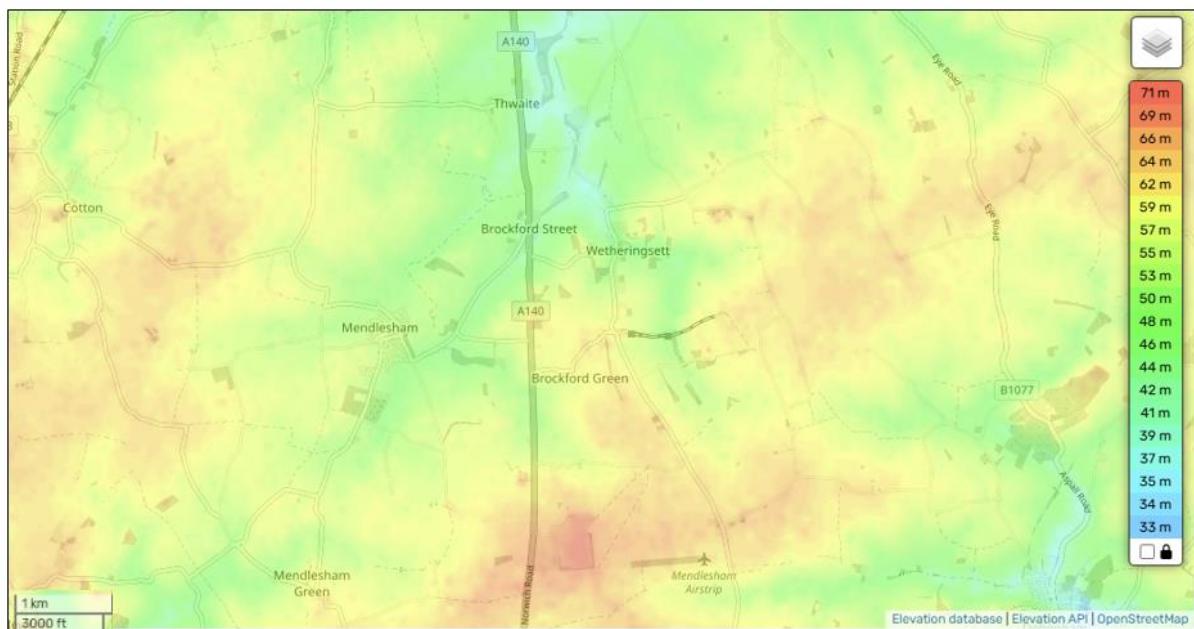
Figure 7. Mendlesham and surrounding topography (TessaDEM as cited in topographic-map.com)

Figure 7 shows the topography surrounding Mendlesham with gradient changes across the wider region. Part of Mendlesham village is situated low in the landscape and some of the lowest points in Mendlesham are along Norwich Road, Chapel Road and Brockford Road. These locations were identified as being some of the worst affected areas during Storm Babet.

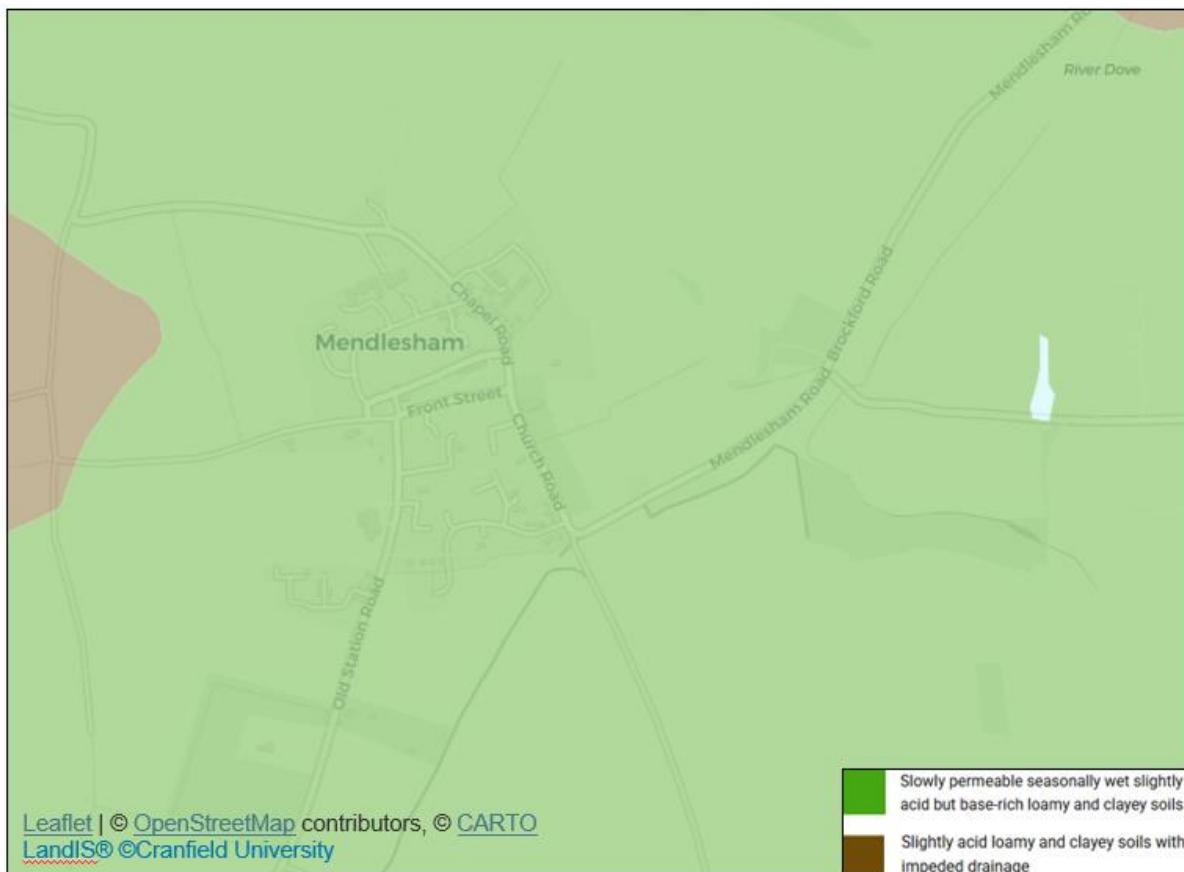
Figure 8. Soil map (LandIS SoilsScapes)

The soils surrounding Mendlesham are loamy and clayey with impeded drainage, meaning that water permeates more slowly and surface water runoff is greater.

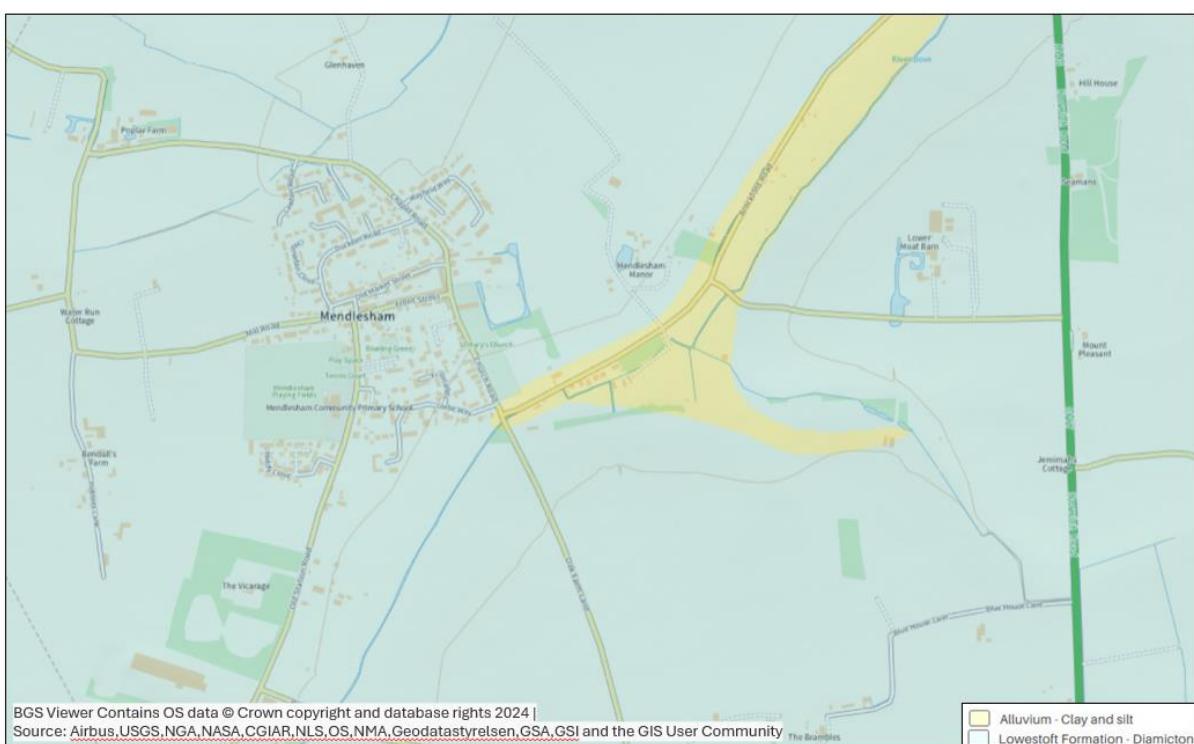
Figure 9. Superficial Geology (BGS Viewer)

Lowestoft Formation 'Diamicton' surrounds Mendlesham which is described by the British geological survey as a diverse mixture of clay, sand, gravel, and boulders varying widely in size and shape. This generally has a low permeability, meaning water will tend to flow off it before it can be infiltrated.

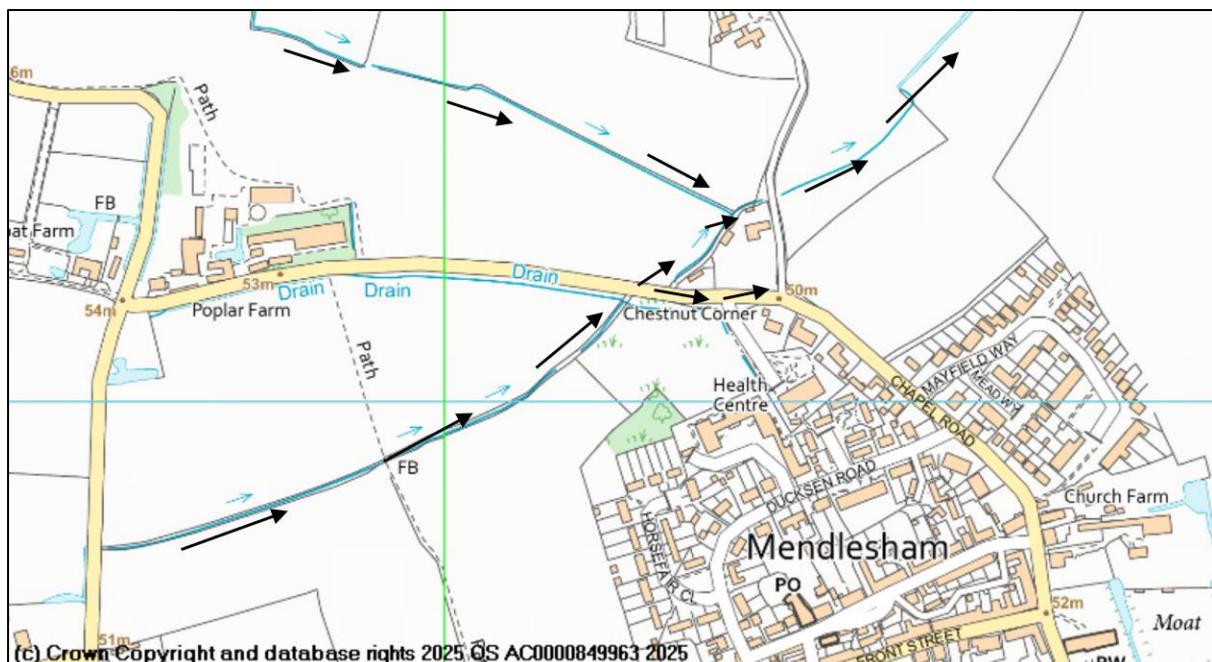
The primary cause of flooding on Chapel Road was fluvial flooding. On 20 October 2023, intense rainfall caused huge amounts of floodwater to flow down the watercourses to the northwest and southwest of Chapel Road (see Figure 10). One property was flooded initially to the rear, directly from the overwhelmed watercourse. The capacity of this small stream was clearly exceeded by the amount of floodwater flowing into it from the fields and catchments above.

Figure 10. Approximate floodwater flow routes on Chapel Road

- The primary cause of the flooding on Chapel Road was fluvial flooding.
- Large amounts of floodwater from the fields and catchments upstream flowed down the watercourses to the northwest and southwest of Chapel Road.

- The capacity of the watercourse was exceeded in several places, directly flooding one property.

- Residents to consider installing Property Flood Resilience (PFR) measures.
- Riparian landowners to carry out appropriate open and piped watercourse maintenance to reduce flood risk as necessary as per their riparian responsibilities.
- Explore potential NFM projects to 'slow the flow' and attenuate water on flow paths northwest and southwest of Chapel Road E.g. leaky dams, woody debris installation, restoration of watercourses, storage ponds, wetland areas.
- Suffolk Highways to ensure the completion of highway drainage asset cyclic maintenance on Chapel Road.
- Suffolk Highways to investigate opportunity to improve drainage infrastructure within this location.

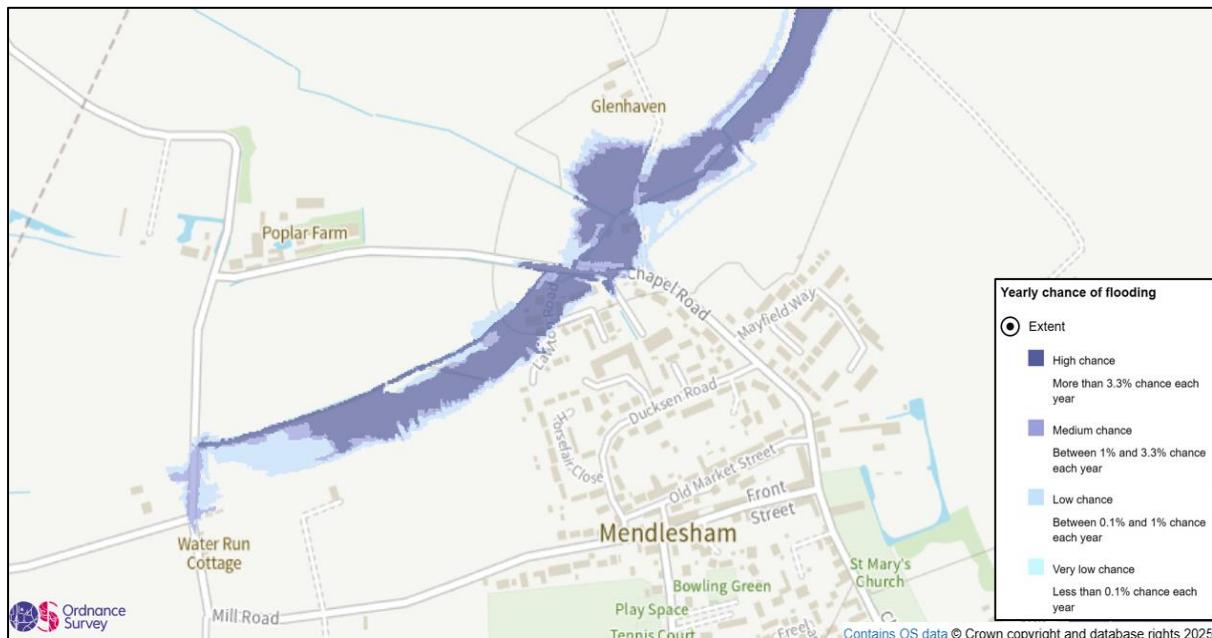
A section of Chapel Road is shown as having a high risk of fluvial flooding. This location also has a low to medium risk of surface water flooding.

*Figure 11. Fluvial flood risk on Chapel Road*

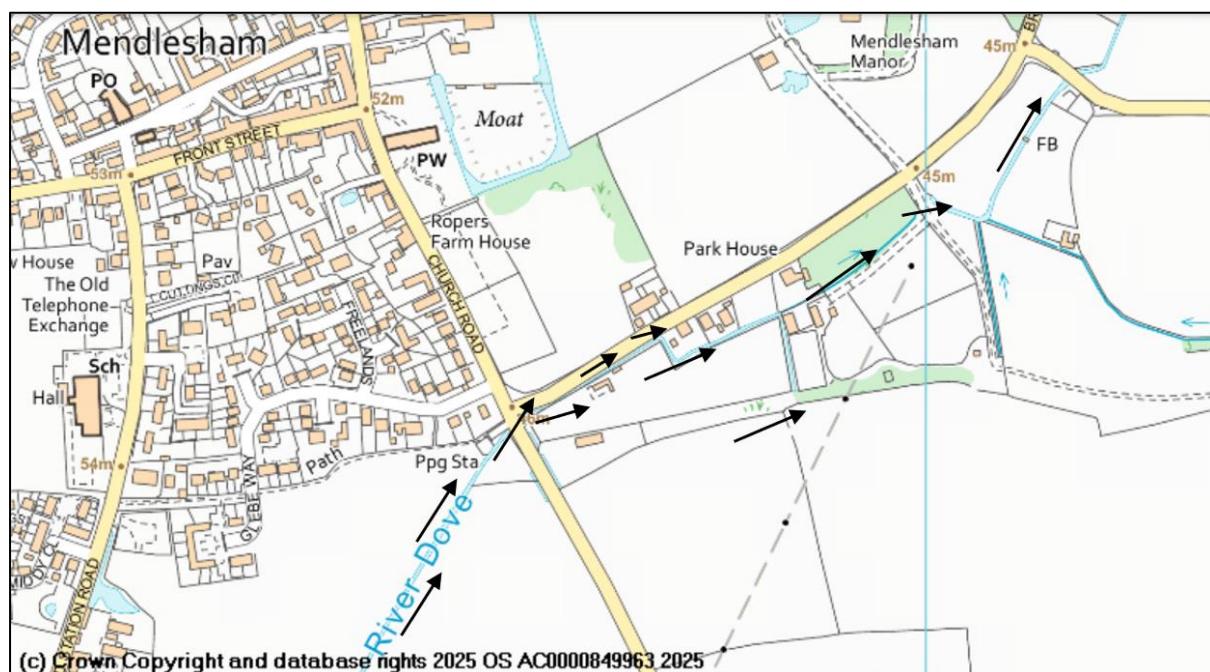
Intense rainfall caused huge amounts of floodwater to flow down the River Dove towards Brockford Street. At the junction with Church Road, the channel flows under the road, before travelling north east, to the rear of the properties. The channel's numerous sharp bends likely impeded water flow, increasing turbulence and the likelihood of water overtopping its banks during high-flow events. During Storm Babet, the volume of water experienced in this location likely overwhelmed the capacity of the channel, causing flood water to flow out of bank and onto the road.

Property was reported to be impacted by floodwater initially to the rear, directly from the overwhelmed watercourse. The capacity of this small stream was clearly exceeded by the amount of floodwater flowing into it from the fields and catchments above.

One property reported to have flooded directly from the floodwater pooling on the highway as the water flowed across the driveway toward the house. Drainage assets were recorded as being operational at the time of the event and it is therefore assumed that the intensity of the rainfall, over a relatively short timescale exceeded the design capacity of the local drainage system.

Figure 12. Approximate floodwater flow routes on Brockford Road

- Residents to consider installing Property Flood Resilience (PFR) measures.
- Riparian landowners to carry out appropriate open and piped watercourse maintenance to reduce flood risk as necessary as per their riparian responsibilities.
- Explore potential NFM projects to 'slow the flow' and attenuate water on overland flow paths southwest of Brockford Road, E.g. leaky dams, woody debris installation, restoration of watercourses, storage ponds, wetland areas.
- Suffolk Highways to ensure the completion of highway drainage asset cyclic maintenance on Brockford Road.

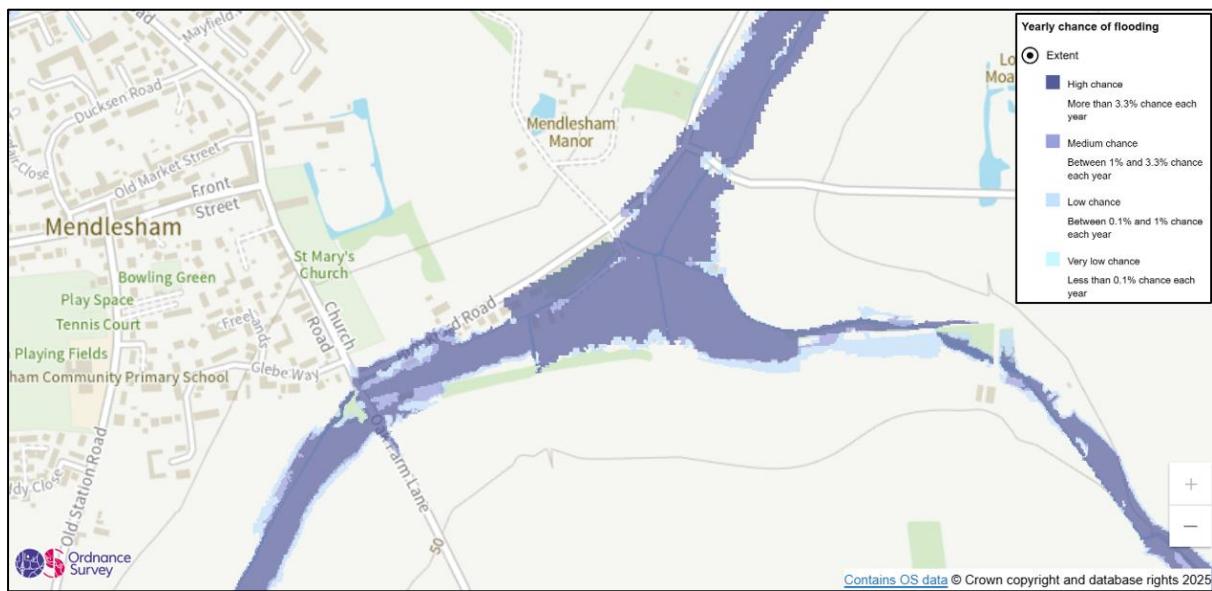
Figure 13. Fluvial flood risk on Brockford Road

The floodwater extents observed on Brockford Road during Storm Babet align closely with the national fluvial flood risk mapping (see Figure 13). Several locations in this area are characterised as having a high chance of fluvial flooding.

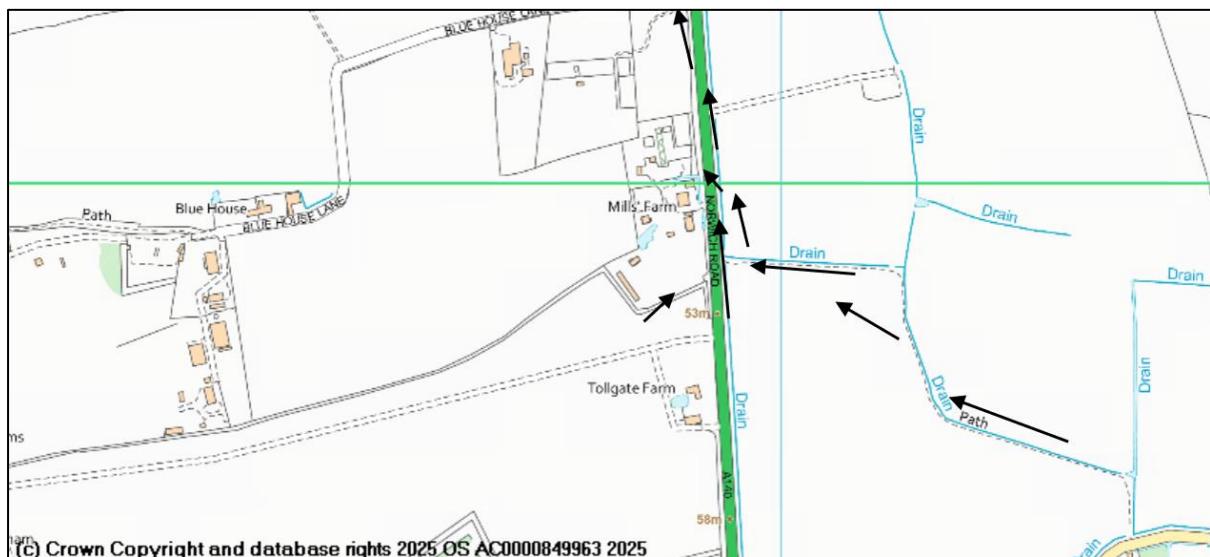
Following heavy and prolonged rainfall on the morning of the 20 October, internal flooding to property on Norwich Road was caused by large amounts of surface water flowing across fields and combining with floodwater from overwhelmed drainage ditches. Resident reports suggest the floodwater accumulated in the roadside ditch before overtopping and merging with surface water on the highway before flowing across the driveway and impacting the property and outbuildings. The existing highway drainage assets on Norwich Road were overwhelmed by the volume of water on the road. The area in which property was impacted is characterised as being at high risk of surface water flooding on the national surface water flood risk mapping (see Figure 15).

Figure 14. Approximate floodwater flow routes on Norwich Road

- The primary cause of the flooding on Norwich Road was pluvial flooding.
- Large amounts of floodwater from the fields and catchments upstream flowed down the watercourses travelling southeast to northwest towards Brockford Street.
- The capacity of the watercourse was exceeded in several places, causing flooding to property and the highway.

- Residents to consider installing Property Flood Resilience (PFR) measures.
- Riparian landowners to carry out appropriate open and piped watercourse maintenance to reduce flood risk as necessary as per their riparian responsibilities.
- Explore potential NFM projects to 'slow the flow' and attenuate water on overland flow paths east of Norwich Road, E.g. leaky dams, woody debris installation, restoration of watercourses, storage ponds, wetland areas.
- Suffolk Highways to ensure the completion of highway drainage asset cyclic gully maintenance on Norwich Road.

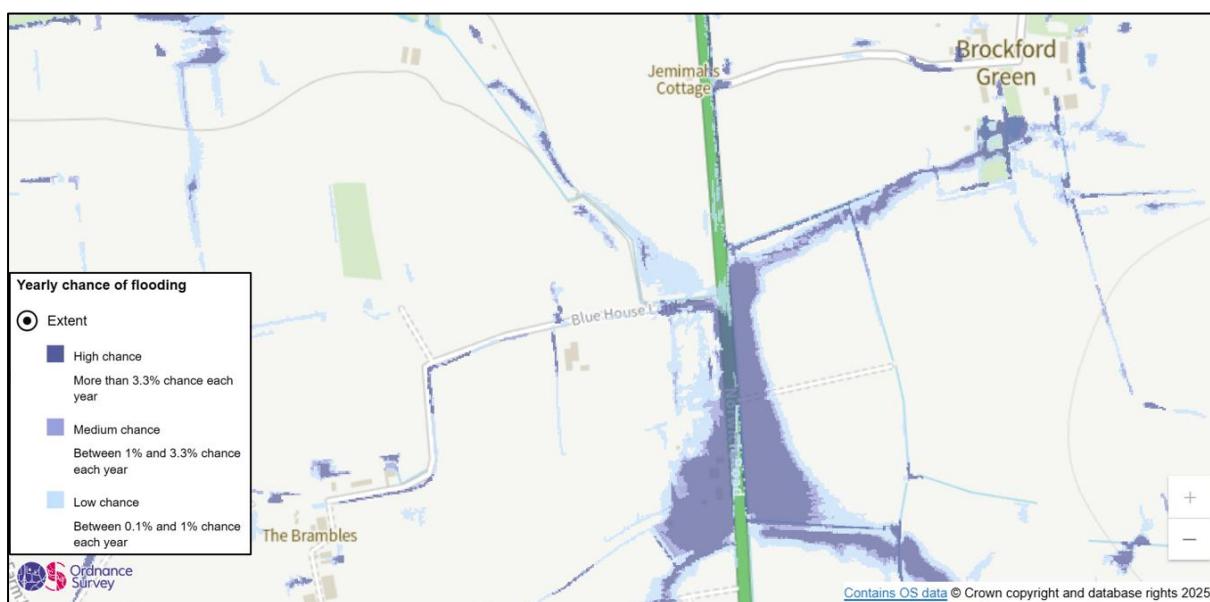
Figure 15. Surface water flood risk on Norwich Road
