Section 19 Flood and Water Management Act 2010

Parham & Hacheston Flood Investigation –

Storm Babet 2023

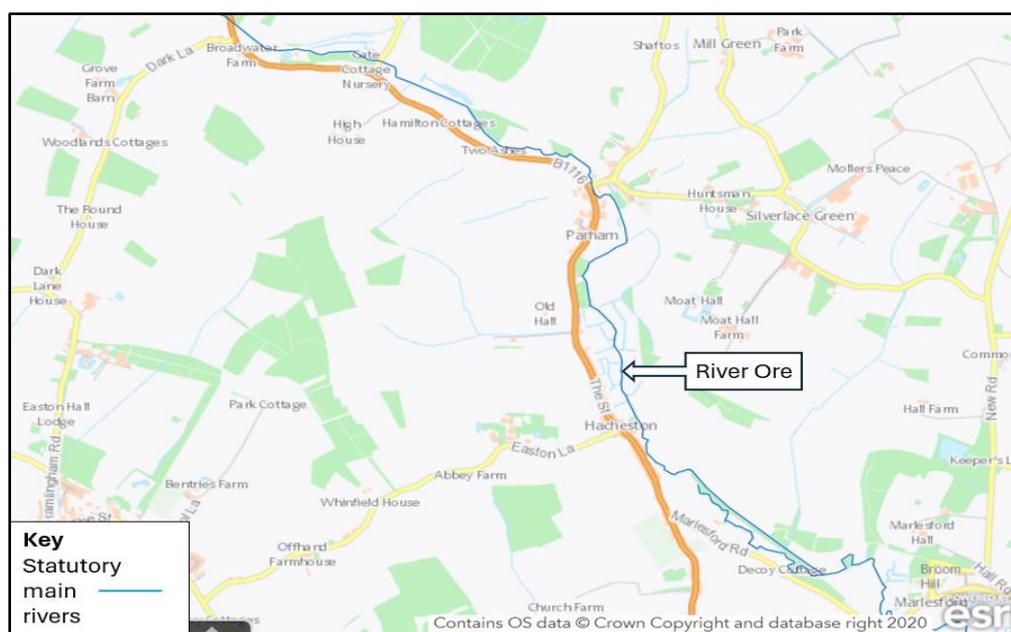
Figure 3 shows the most significant watercourses in the area surrounding Parham and Hacheston, including the River Ore, a statutory main river.

Figure 3. Location of statutory main rivers and significant ordinary watercourses

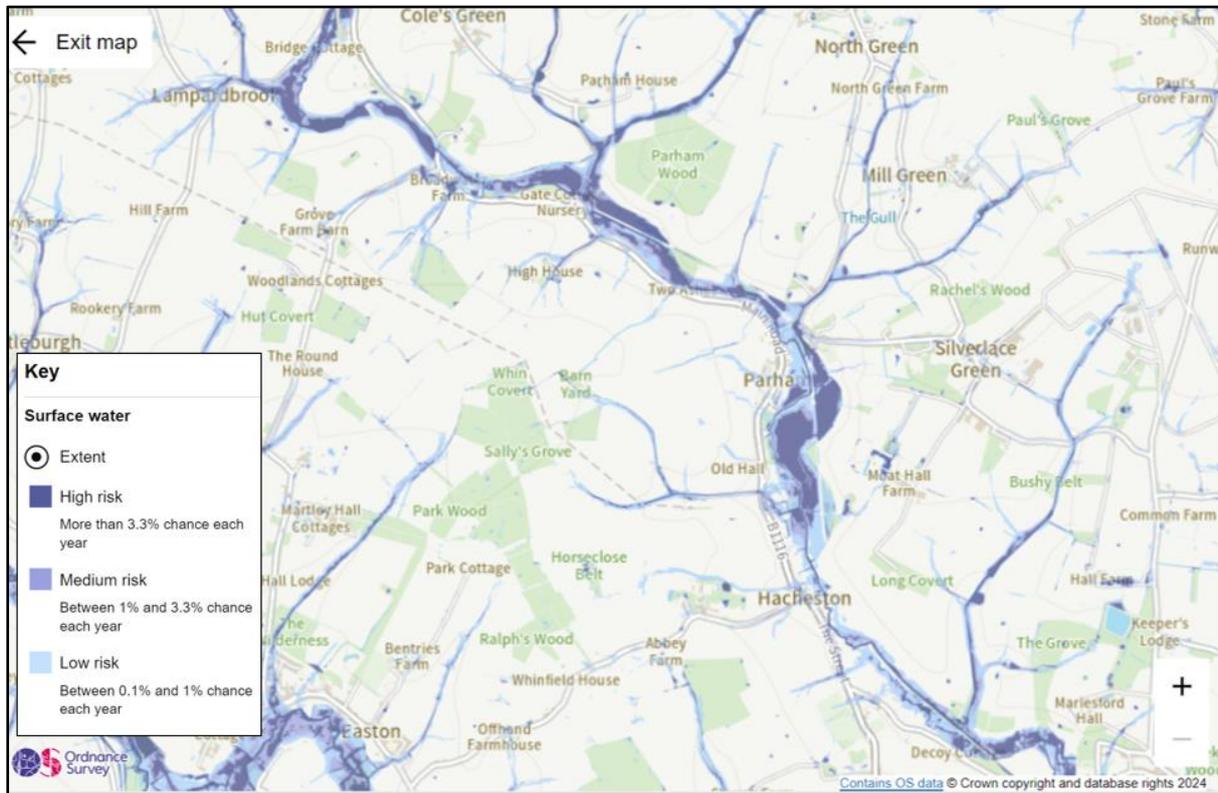
Figure 6. Predicted surface water flood risk

Figure 6 highlights the predicted pluvial (surface water run-off from surrounding land and ditches) flood risk in Parham and Hacheston, with multiple major flow paths coming into Parham from the northeast, north and west. Surface water flow paths come into Hacheston predominately from fields to the west.

There is significant predicted risk of surface water flooding on North Green Road, The Street and sections of Main Road northwest of Parham. These areas were affected by flooding during Storm Babet.

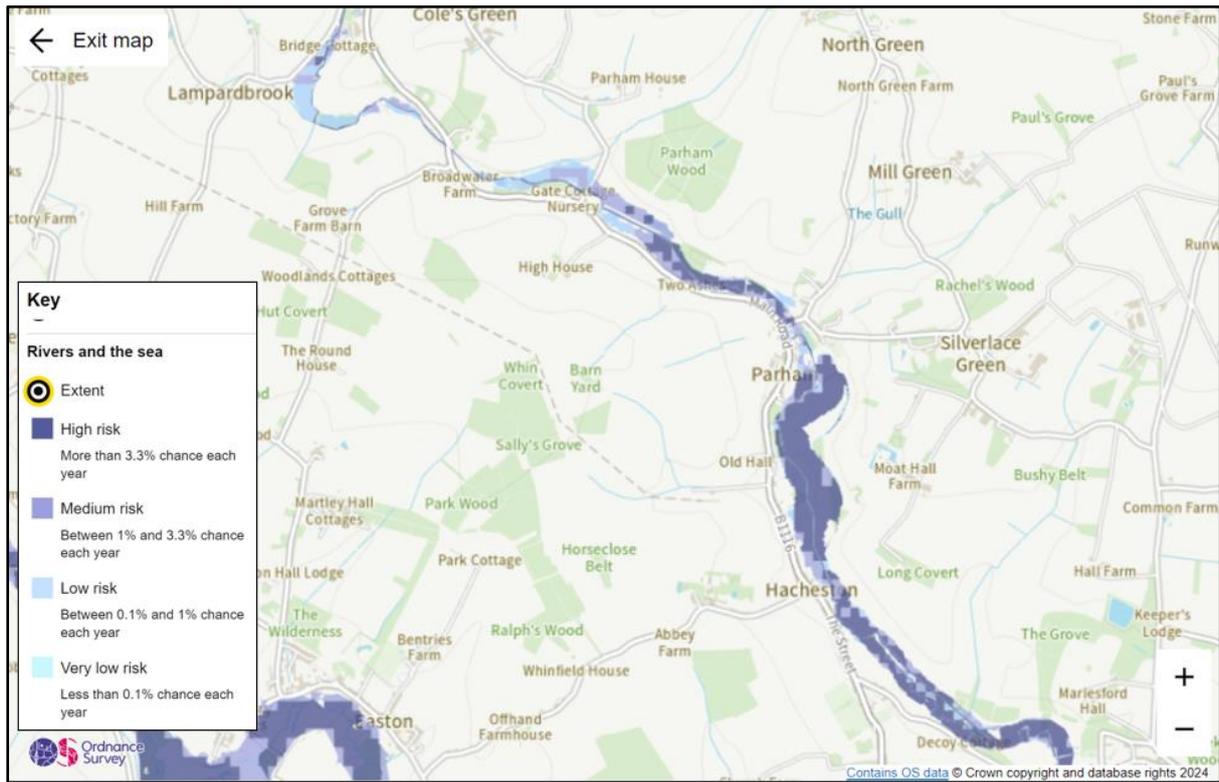
Figure 7. Predicted flood risk from rivers and sea

Figure 7 highlights the predicted fluvial (from designated main river and ordinary watercourses) flood risk in Parham and Hacheston. Fluvial flood risk in Parham and Hacheston is associated with the river Ore which passes through both villages.

In Parham, parts of Main Road and the lower end of North Green Road are predicted to be at medium to high risk of fluvial flooding. These areas were affected by flooding during Storm Babet. In Hacheston, the principal area at high risk of fluvial flooding is the fields and flood plain to the east of The Street (B1116).

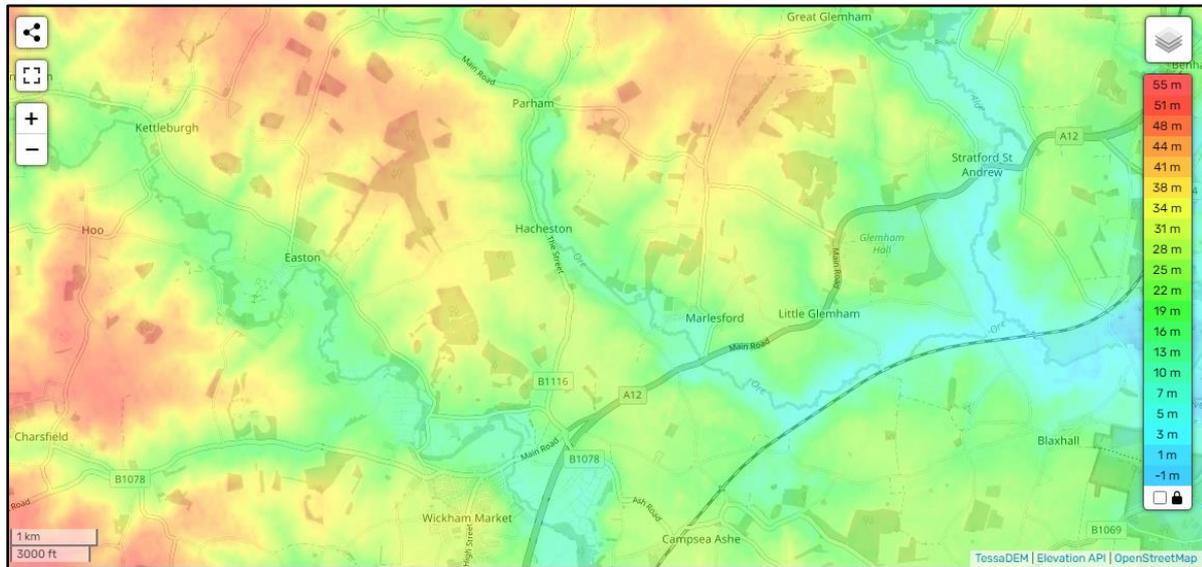
Figure 8 shows the topography surrounding Parham and Hacheston with gradient changes across both. Both villages are lower than the surrounding land. The lowest points in Parham are along The Street and Main Road which are among the areas that were affected by flooding. The Street and eastern end of Easton Lane are among the lowest lying locations in Hacheston. These were identified as being some of the worst affected areas during Storm Babet.

Figure 8. Parham, Hacheston and surrounding topography (TessaDEM as cited in topographic-map.com)

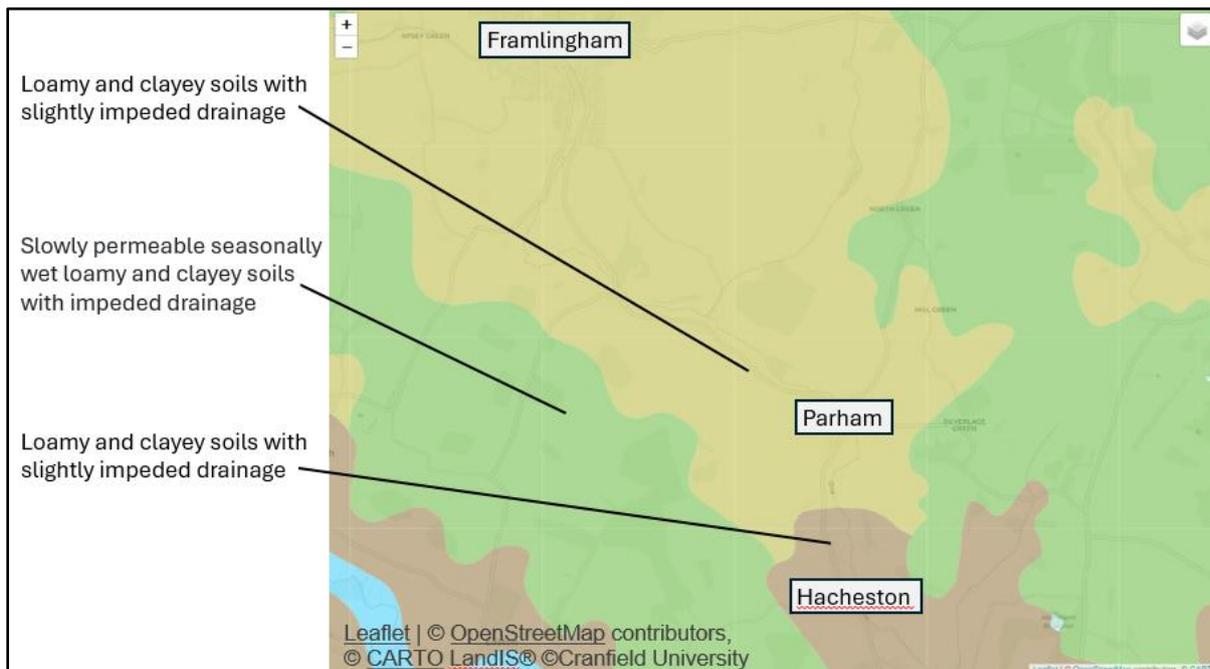
Figure 9. Soil map of catchment area (LandIS Soilscape)

The soils surrounding Parham and Hacheston are loamy and clayey with impeded or slightly impeded drainage, meaning that water permeates more slowly and surface water runoff is greater. With regards to soils, Parham and Hacheston are situated on alluvium, mostly sand and gravels with a mixture of clay and silts. The floodplain soils surrounding the river Ore usually have naturally high groundwater and tend to be wetter.

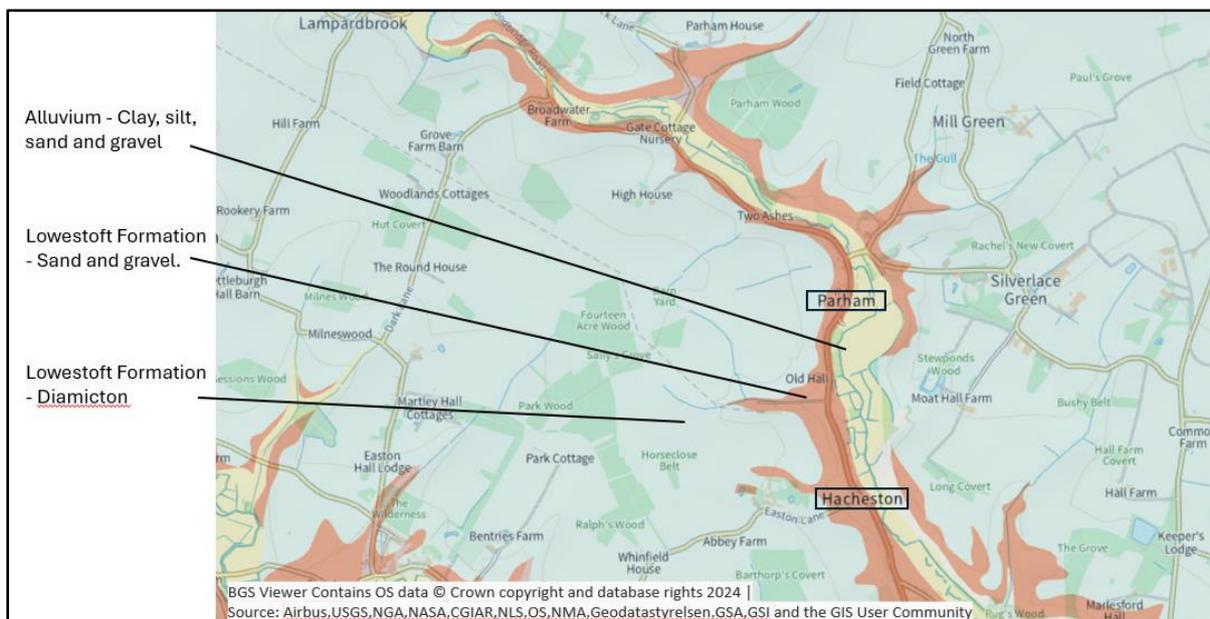
Figure 10. Superficial Geology (BGS Viewer)

Lowestoft Formation 'Diamicton' surrounds the villages of Parham and Hacheston which is described by the British geological Survey as a diverse mixture of clay, sand, gravel, and boulders varying widely in size and shape. This generally has a low permeability meaning water will tend to flow off it before it can be infiltrated, which reflects some of the reports from the Storm Babet event.

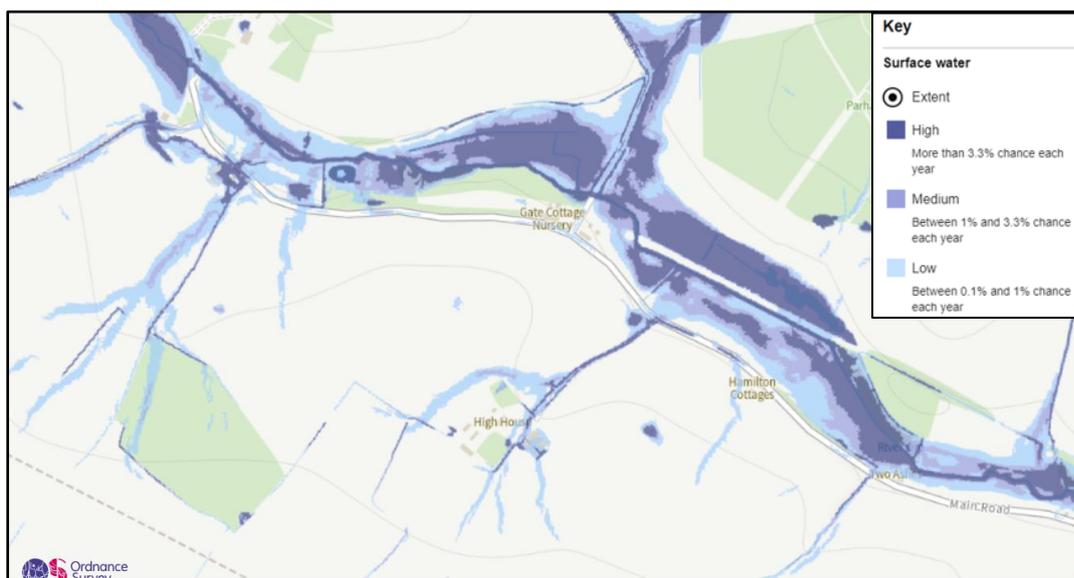
Northwest of Parham, on Main Road, following heavy rainfall on the morning of the 20 October, internal flooding to property was caused by large amounts of surface water coming across the fields combined with overwhelmed drainage ditches. Internal flooding was reported from 10am onwards. Residents stated drainage ditches were overwhelmed by the volume of water and required maintenance. North of Main Road, the river Ore overtopped its banks and added to the spread of floodwater.

Figure 11. Surface Water flood risk on Main Road northwest of Parham

- Heavy rainfall on the morning of the 20 October caused large amounts of surface water to flow across the fields and drainage ditches towards properties of Main Road.
- The flooding may have been exacerbated by a lack of ditch maintenance.
- Sections of Main Road are shown to be at Medium to High risk of surface water flooding on the national predicted flood risk mapping.

- Residents to install Property Flood Resilience (PFR) via grant funded scheme.
- Investigate potential NFM projects to 'slow the flow' and attenuate water on overland flow paths (leaky dams, restoration of watercourses, etc.) south of Main Road northwest of Parham.
- Landowners to carry out appropriate watercourse maintenance to reduce flood risk as necessary as per their riparian responsibilities.

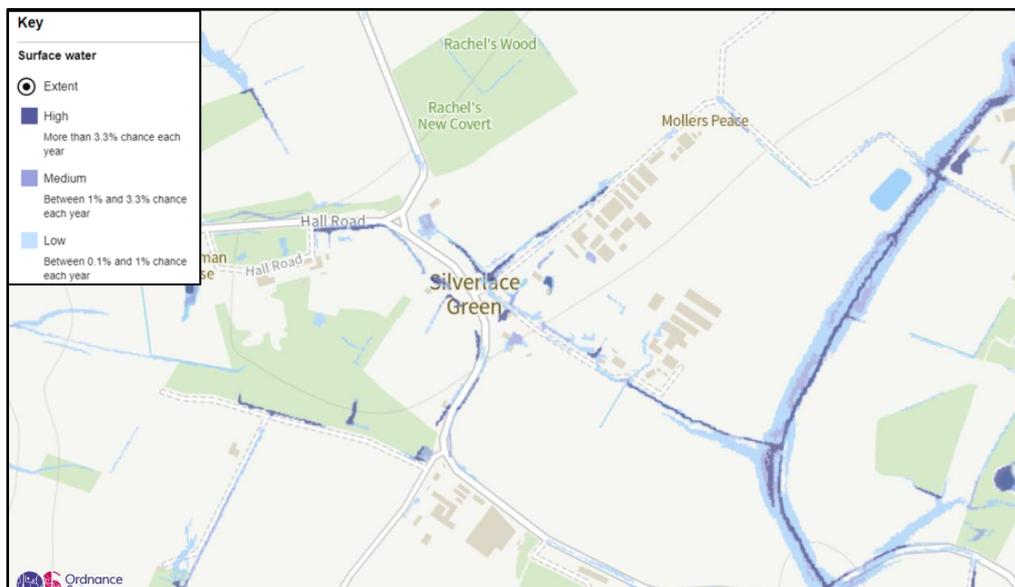
Intense rainfall caused surface water to flow across the fields and overwhelm the ditches from the north and east towards Hall Road. Internal flooding occurred from the rear as floodwaters spread into gardens and across the carriageway.

Figure 12. Surface Water flood risk on Hall Road

- Surface water from fields and ditches were overwhelmed causing water to enter property.
- Sections of Hall Road are at Medium to High risk of surface water flooding from the fields and ditches to the north and east.

- Residents to install Property Flood Resilience (PFR) via grant funded scheme.
- Landowners to carry out appropriate ditch maintenance to reduce flood risk as necessary as per their riparian responsibilities.

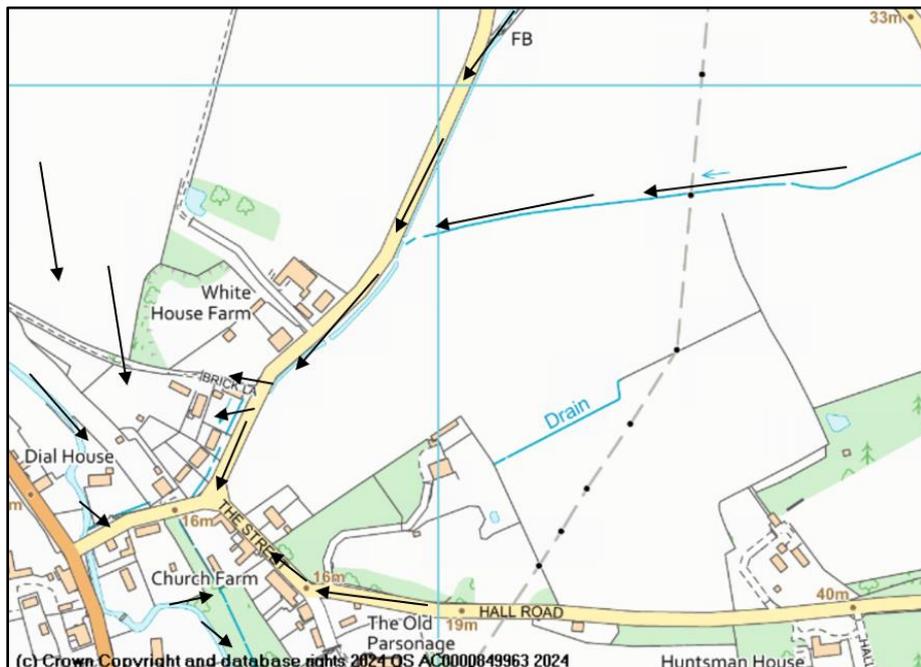
Properties on The Street were impacted by surface water flooding originating as run off from fields and ditches as well as the highways to the east and northeast along North Green Road and Hall Road. Following heavy rainfall on the morning of 20 October, the surface water was carried along these flow paths into the village (see Figure 10) exceeding the capacity of drainage features. Properties on Brick Lane were impacted as the Gull watercourse along North Green Road, overtopped and added to the floodwater already on the road (see Image 4).

Figure 13. Approximate floodwater flow routes on The Street, Brick Lane and North Green Road

The conveyance of the floodwater in the channel was restricted by the presence of culverts and a build-up of silt immediately downstream of the road bridge opposite Brick Lane causing the floodwater to backup and overflow out of the channel. There was also a significant amount of surface water that travelled along the highway.

The surface water flows from the east and northeast then merged with the fluvial flood water coming from the overtopped river Ore at the lower end of North Green Road (see Image 1). Multiple properties reported internal flooding here as the river Ore breached the channel. The lower end of North Green Road was inundated in floodwater. The highway drainage system was completely overwhelmed with frequent

- Residents to install Property Flood Resilience (PFR) via grant funded scheme.

- Investigate potential NFM projects to ‘slow the flow’ and attenuate water on overland flow paths (leaky dams, restoration of watercourses, etc.) northeast and east of Parham.
- Investigate realignment of the old watercourse behind properties on north green road to reinstate connection with the river Ore.
- Silt buildup immediately downstream of the road bridge on north green road to be removed by SCC Highways.
- Report any observed blockages below the road bridge on north green road on the Suffolk Highways Online Reporting Tool.
- Landowners to carry out any watercourse / culvert maintenance to reduce flood risk as necessary as per their riparian responsibilities.
- Ensure the completion of highway drainage asset cyclic maintenance on North Green Road and The Street.

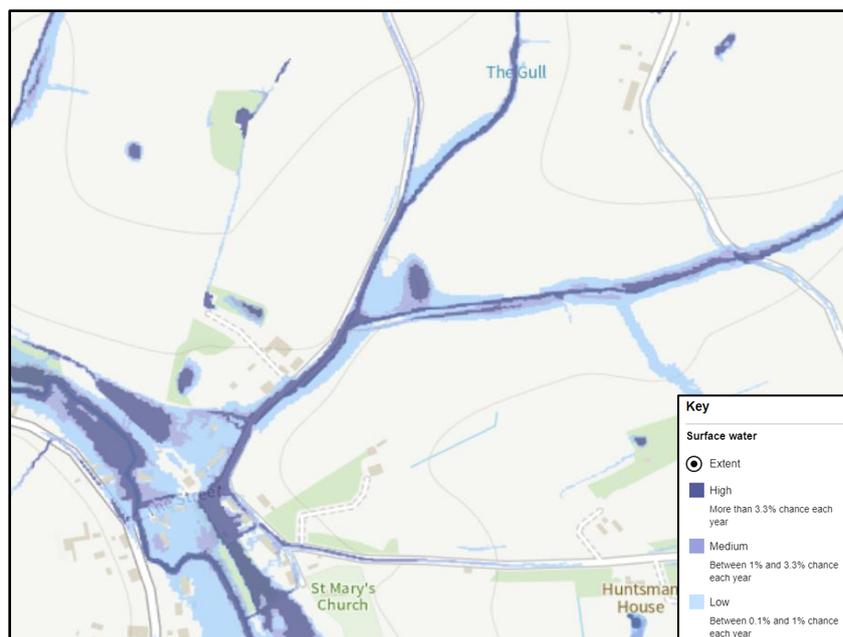
Figure 14. Surface Water flood risk on The Street, Brick Lane and North Green Road

The observed extents of the floodwater in this area correlates closely with the predicted surface water flood risk maps, with pluvial flood risk categorised as being high along sections of The Street, Brick Lane and North Green Road.

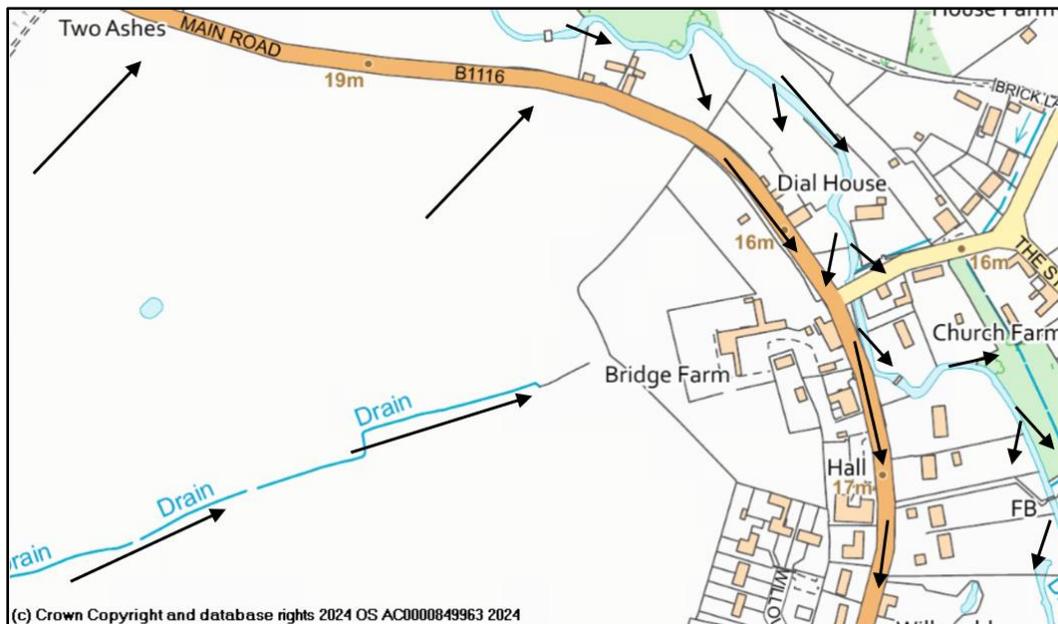
The primary source of flooding in Parham was fluvial, with the Main Road being significantly impacted when flood water overtopped the banks of the river Ore. There was also surface water runoff from the east and west, caused flooding to multiple properties from the front and rear along Main Road (see Figure 15).

The overtopping of the watercourse occurred slightly north of the village and continued to breach the riverbank as it flowed through Parham. Flood water was on the highway and effectively created a second flow path along the road towards Hacheston and extended along the lower end of North Green Road toward The Street (see Image 2).

Figure 15. Approximate floodwater flow routes on Main Road, central Parham

There were reports of unmaintained or slightly obstructed sections within the river Ore. It is unlikely this significantly contributed to the flooding on the 20 October but

- Residents to install Property Flood Resilience (PFR) via grant funded scheme.
- Investigate potential NFM projects to 'slow the flow' and attenuate water on overland flow paths (leaky dams, restoration of watercourses, etc.) northeast and east of Parham.
- Landowners to carry out any watercourse / culvert maintenance to reduce flood risk as necessary as per their riparian responsibilities.
- Ensure the completion of highway drainage asset cyclic maintenance on Main Road, Parham.

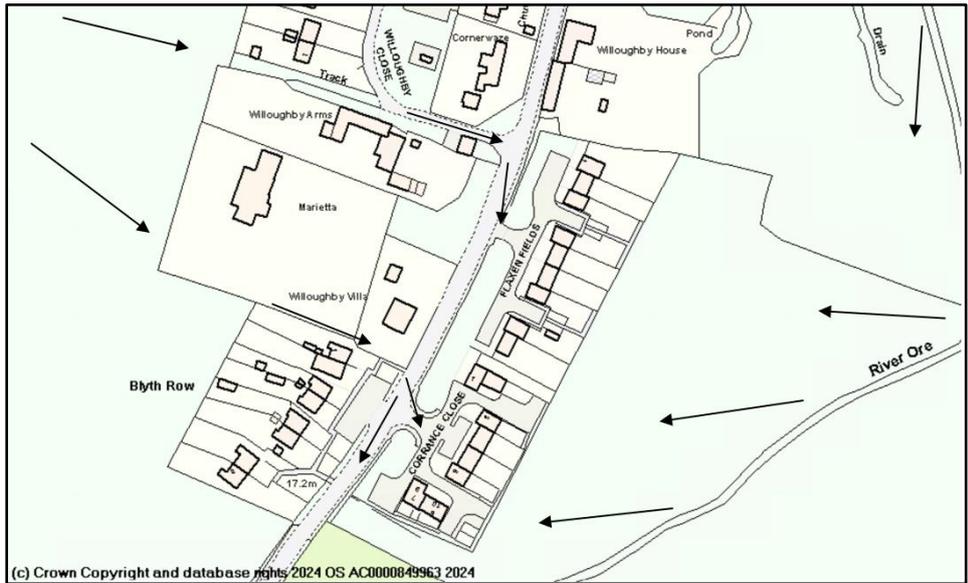
The primary source of flooding suffered on this section of Main Road and Corrance Close was pluvial flooding from the adjacent fields to the west. Surface water flows coming across the fields flowed through and around properties from the back on the western side of Main Road and spilled onto the highway impacting Corrance Close from the front. The whole of the Corrance Close estate was described as being externally flooded by residents.

Figure 16. Approximate floodwater flow routes on Main Road and Corrance Close

- Residents to install Property Flood Resilience (PFR) via grant funded scheme.
- Investigate potential NFM projects to 'slow the flow' and attenuate water on overland flow paths (leaky dams, restoration of watercourses, etc.) west of Parham.
- LLFA & East Suffolk Local Planning Authority to investigate the flooding on Corrance Close to fully understand the source and or if any possible flooding issues weren't accounted for in the development. Landowners to carry out any watercourse maintenance to reduce flood risk as necessary as per their riparian responsibilities.
- Ensure the completion of highway drainage asset cyclic maintenance on Main Road, Parham.

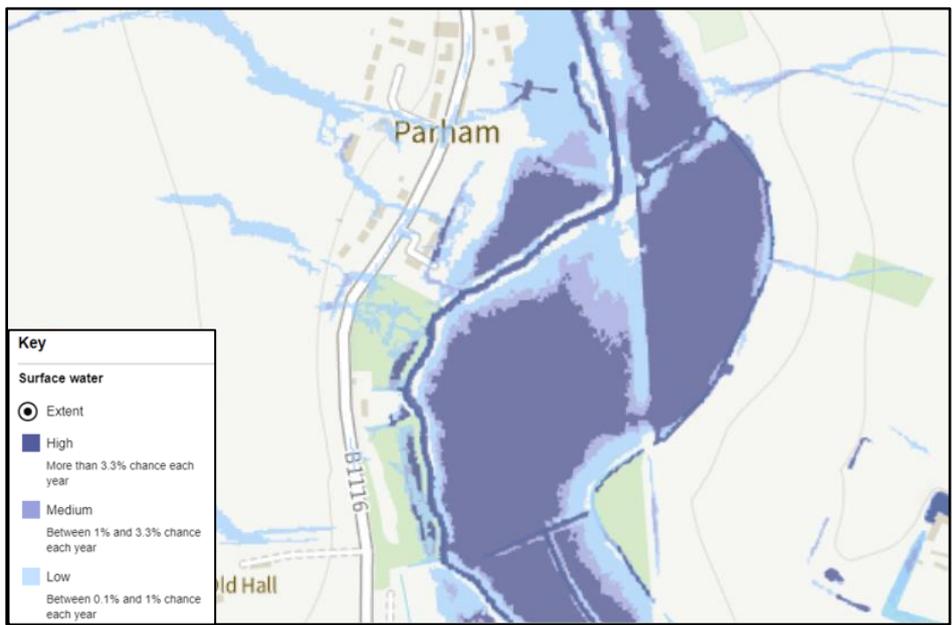
Figure 17. Surface Water flood risk on Main Road and Corrance Close

The observed floodwater flow paths and flood extents closely match the national predicted surface water flood risk mapping. Later in the day there was also fluvial flooding from the River Ore which impacted properties externally from the rear as the river levels continued to rise.

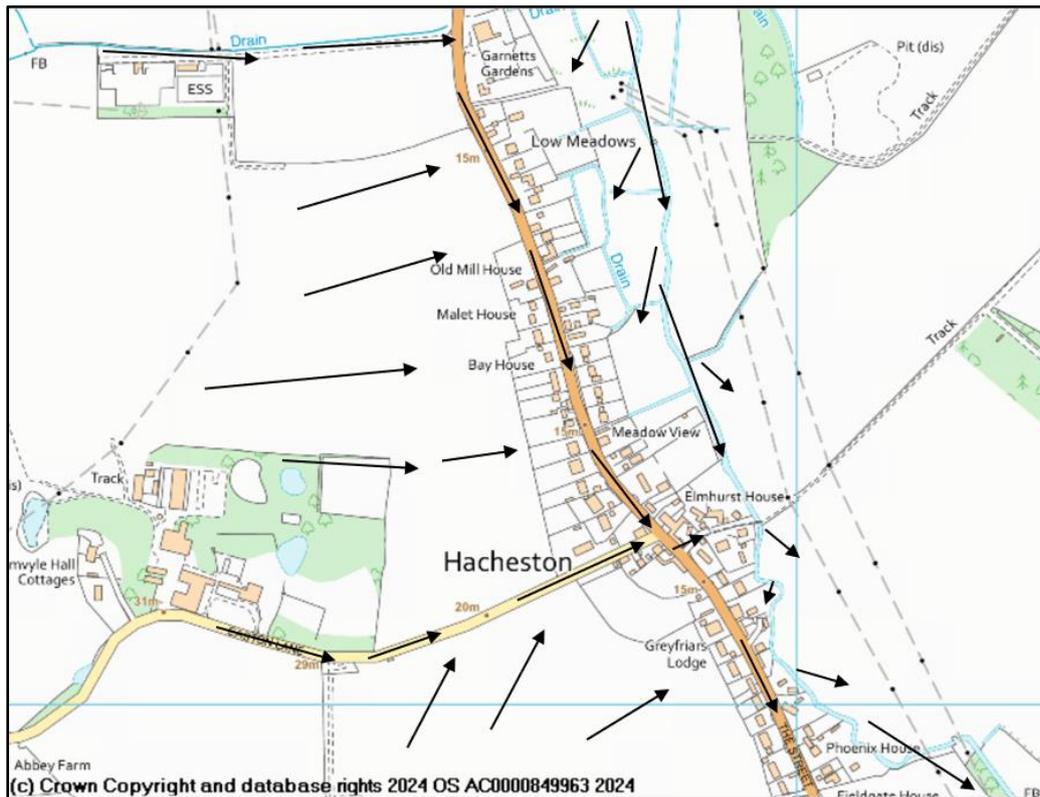
Following prolonged heavy rainfall on the morning of 20 October, by midday, the majority of the floodwater impacting Hacheston was from field run off to the west of the village (see Images 5 and 6). The surface water flowed along multiple flowpaths down the gradient from the higher fields west of Hacheston, towards properties on The Street.

Floodwater flowed across fields to the west before emerging onto the carriageway, pouring through hedges and roadside verges. One of the issues reported by residents was the lack of ditches present along the lower boundaries of the fields to intercept and direct water away from housing and connect with the river behind. Many properties were flooded from the front as floodwater on the highway flowed onto driveways situated at a lower elevation and across dropped kerbs.

Figure 18. Approximate floodwater flow routes in Hacheston

Large extents of the carriageway on The Street were submerged by floodwater as the existing drainage assets were overwhelmed by the volumes of water flowing from the fields and roads to the west. Flooding to property was exacerbated by vehicles driving through flood water, creating a bow wave that flowed into properties.

- Residents to install Property Flood Resilience (PFR) via grant funded scheme.
- Investigate potential NFM projects to 'slow the flow' and attenuate water on overland flow paths (leaky dams, restoration of watercourses, etc.) west of Hacheston.

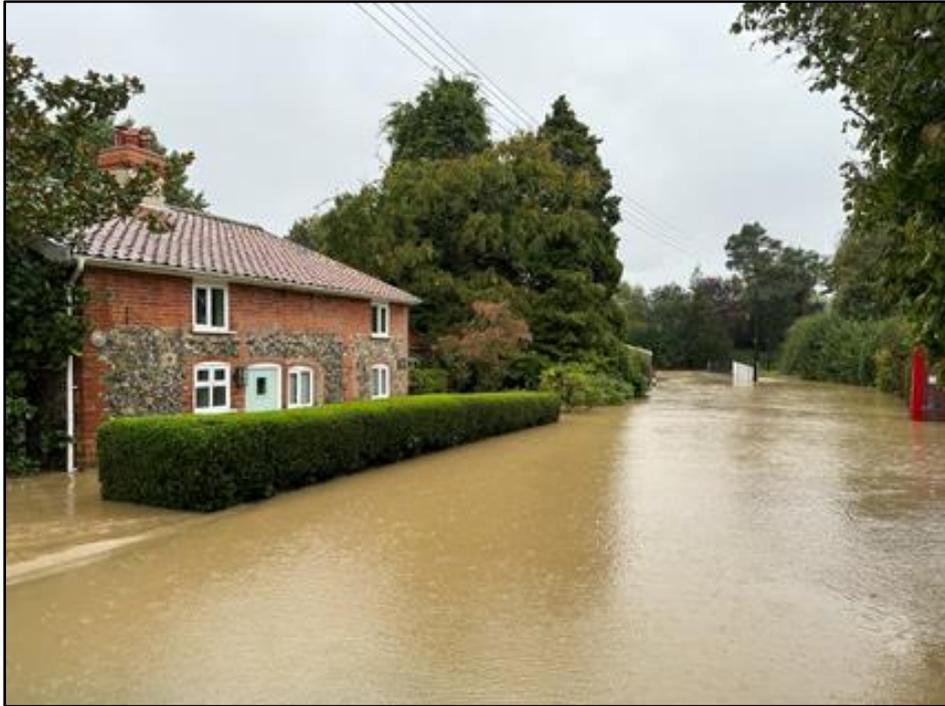
Image 1. Lower end of North Green Road

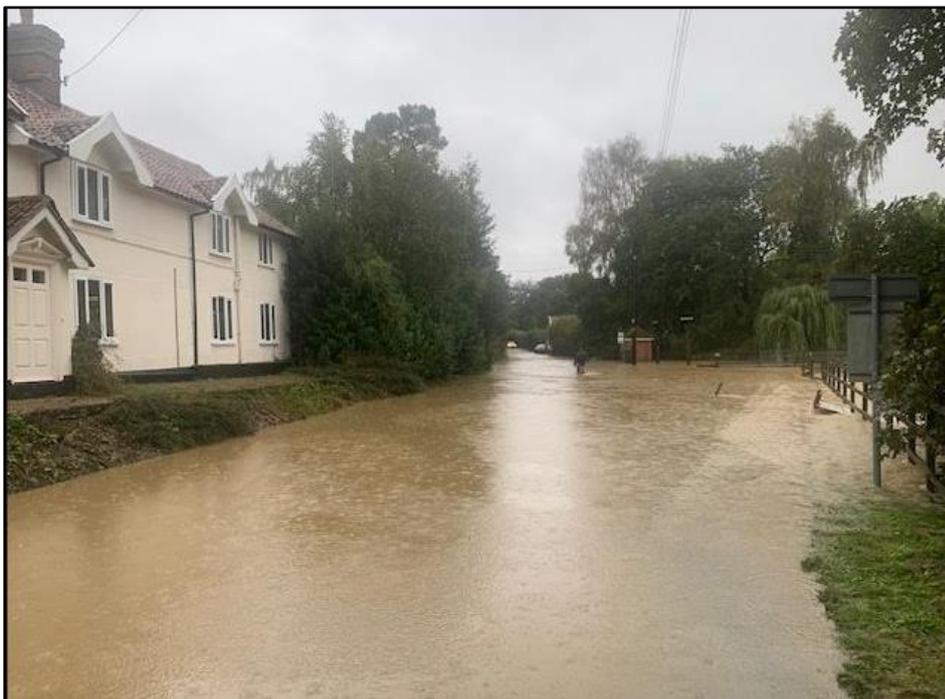
Image 2. Central Parham

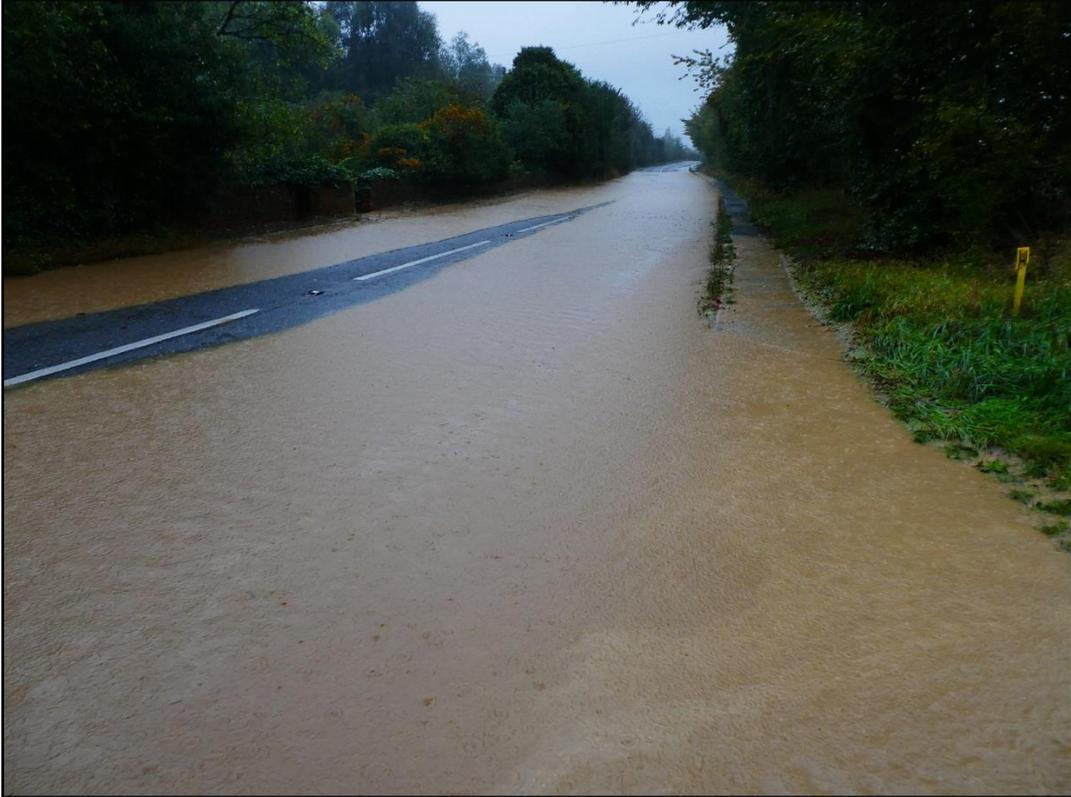
Image 3. Parham highway flooding

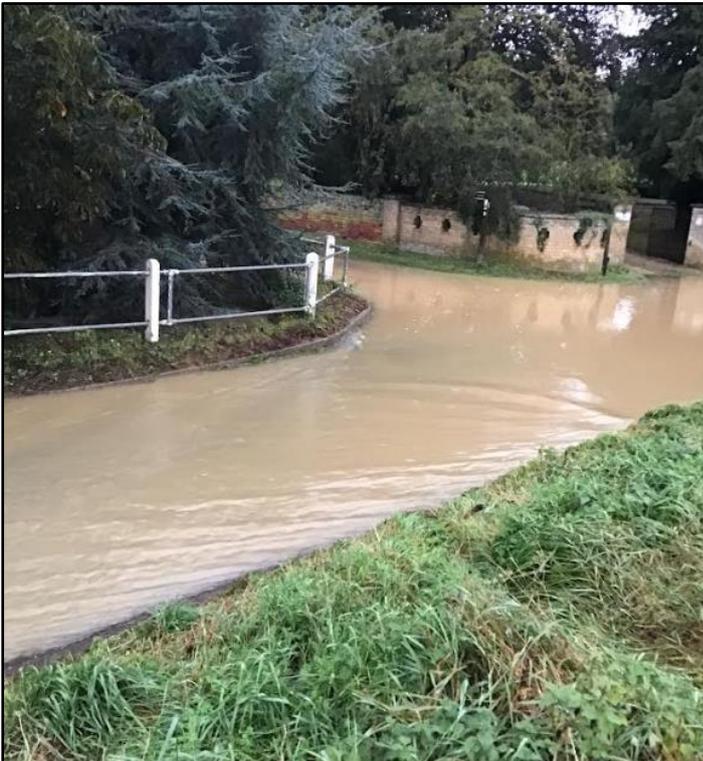
Image 4. Highway flooding outside Brick Lane

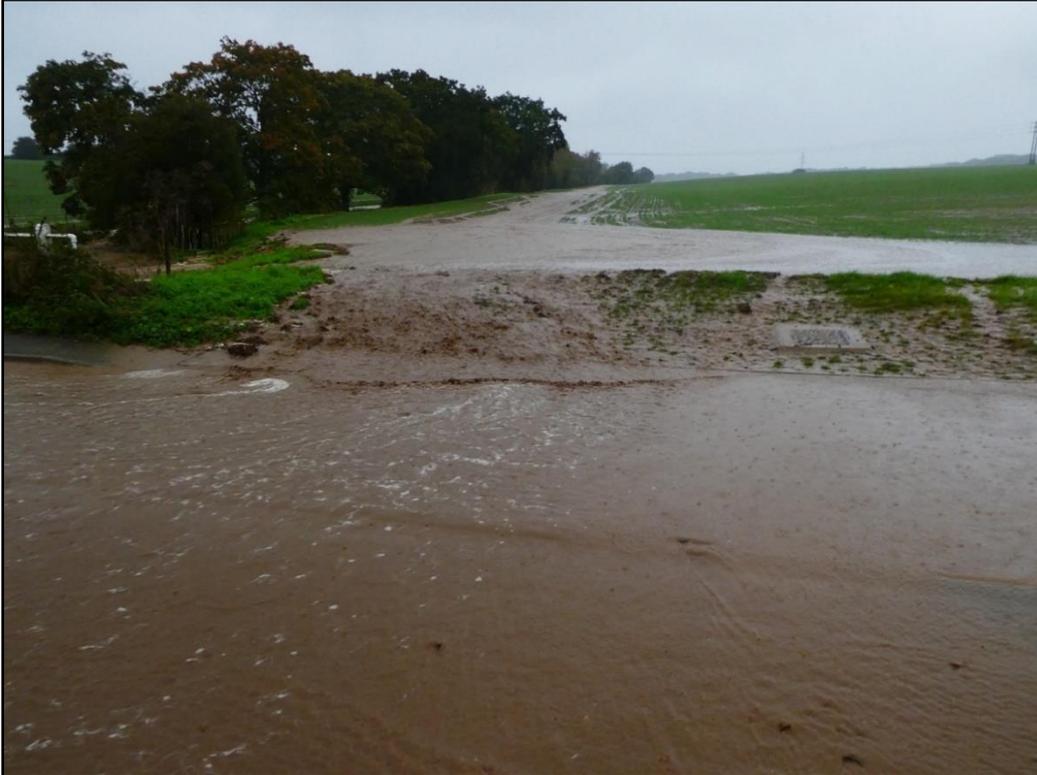
Image 5. Surface water flows from fields west of Hacheston

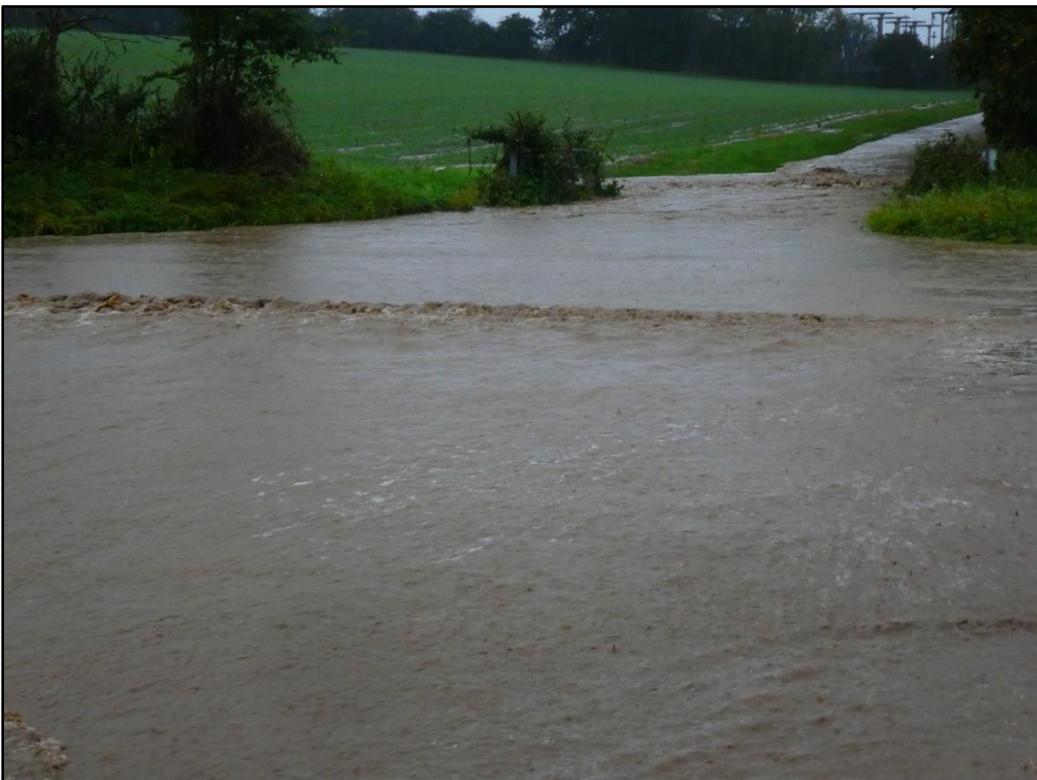
Image 6. Surface water runoff opposite Garnett's Garden Centre, Hacheston
