## Section 19 Flood and Water Management Act 2010

**Report Title: Green Road, Mendlesham Green**

**Report Reference: CR Number 340016**

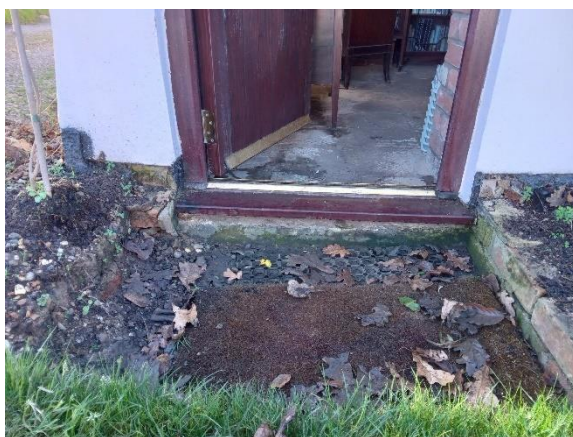
Front entrance to property, showing external step down at threshold

- **Absence of property level flood resilience:** it should be noted that resilience measures could have prevented ingress of water to the depth reported (80 mm) and may have been able to re-route surface water runoff away from the property. The threshold at the front door of the property, and the gradient of the front garden, dropping towards the

front door, are likely to have contributed to the volume of surface water entering the property. Similarly, an apparent absence of measures to deflect surface water from reaching and collecting at the external side wall of the property may have allowed the ingress of water into the external wall, resulting in mould forming on it internally. Further information is required to establish what actions could be taken and measures introduced to make this property more waterproof and flood resilient.

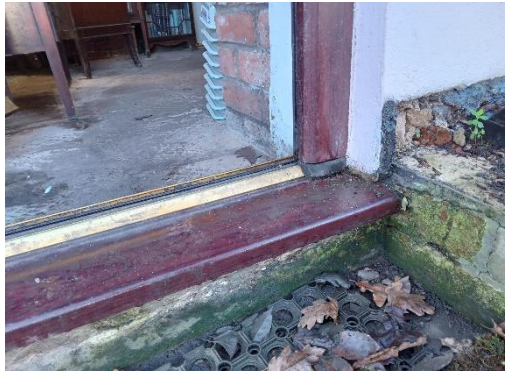
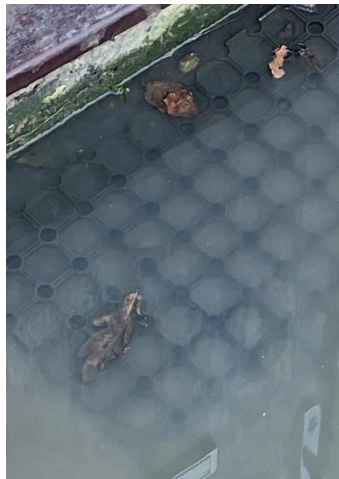
Images of front door threshold and effect of repeated events of surface water breaching the threshold, as well as having prolonged periods of standing water in this external low area.

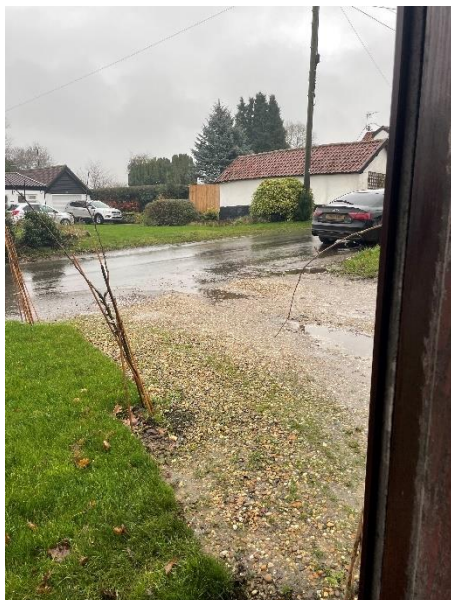
View of surface water on Green Road, running onto private drive at the front of the property

- **Highway drainage:** there is little on-site evidence of positive highway drainage features on this part of Green Road, and in particular immediately in front of the private driveway. Looking at the topography in the area and shape of the road, surface water will naturally drain off both the highway and adjacent private land in a generally southerly direction. The access to the private driveway, offers some of this surface water run off a route to drain away over ground. Further information is required to establish how surface water drains away at this location, and whether new highway or private drainage at this location is possible and could capture enough surface water to reduce flood risk.

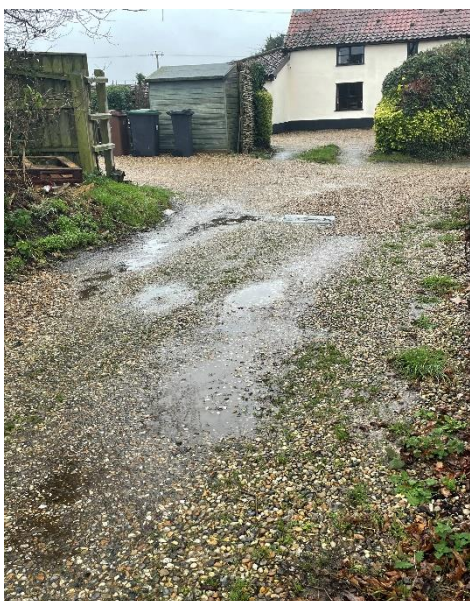
View of private drive with surface water collecting adjacent to property.

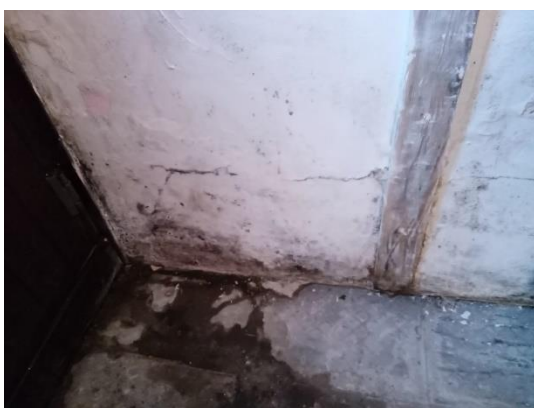
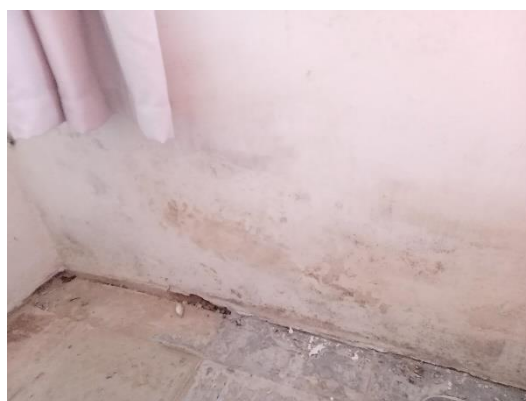
External wall at front of property, viewed from inside front room.

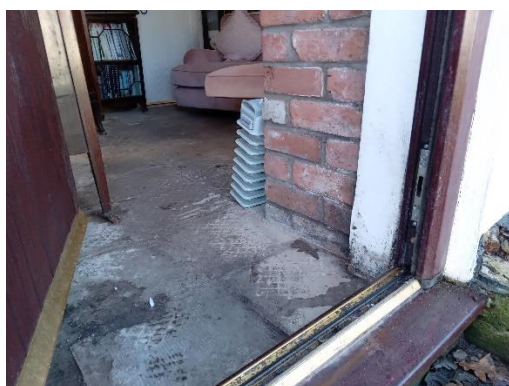
View into front room from outside front door, showing extent of where all floor coverings including floor tiles have lifted (and had to be removed) because of repeated internal flooding.

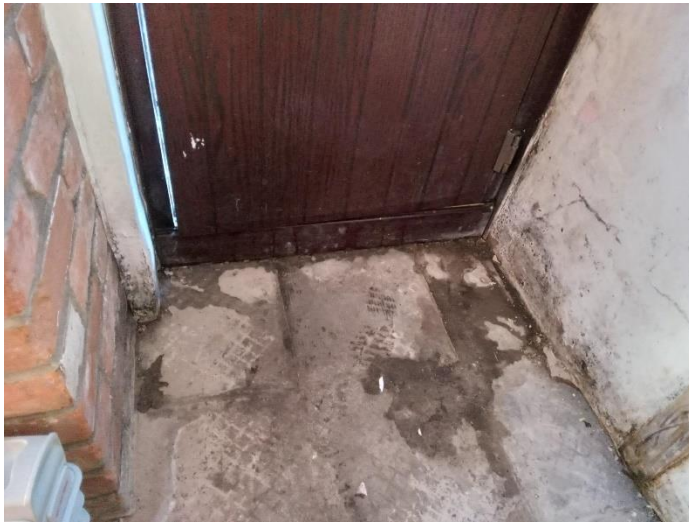
Front door, viewed from inside, floor tiles lifted (due to flood) and removed.

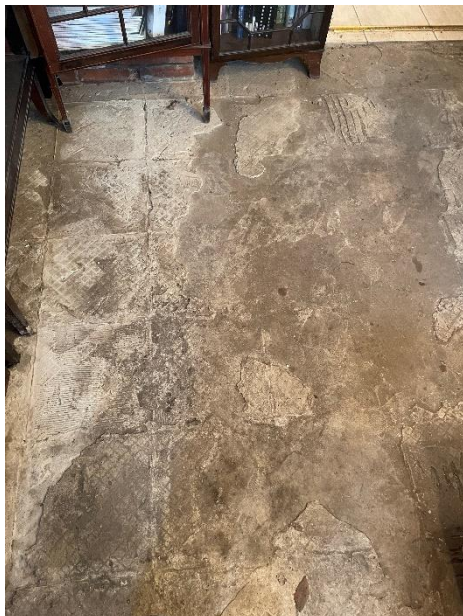
View of floor of front ground floor room showing water saturation of the foundation level.
