## Section 19 Flood and Water Management Act 2010

### Somersham Flood Investigation –

### Storm Babet 2023

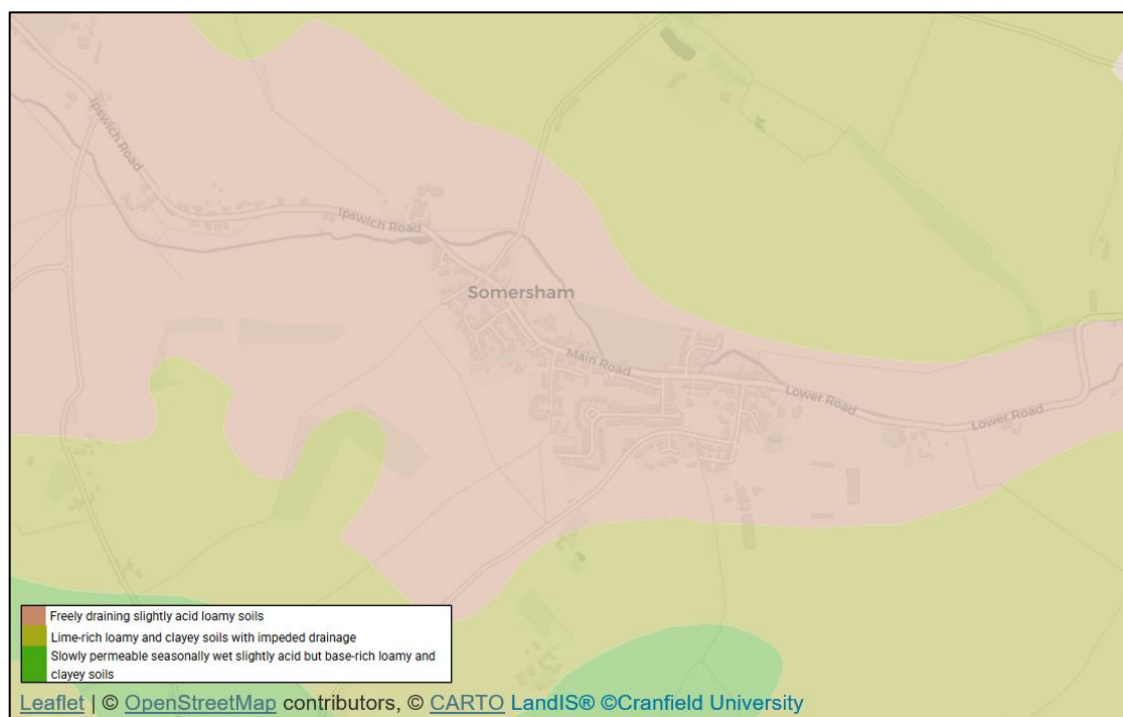
Figure 9. Soil map (LandIS Soils)

The soils immediately surrounding Somersham are predominantly freely draining, slightly acid loamy soils, meaning it holds moisture and nutrients well but also allows excess water to pass through easily, preventing waterlogging.

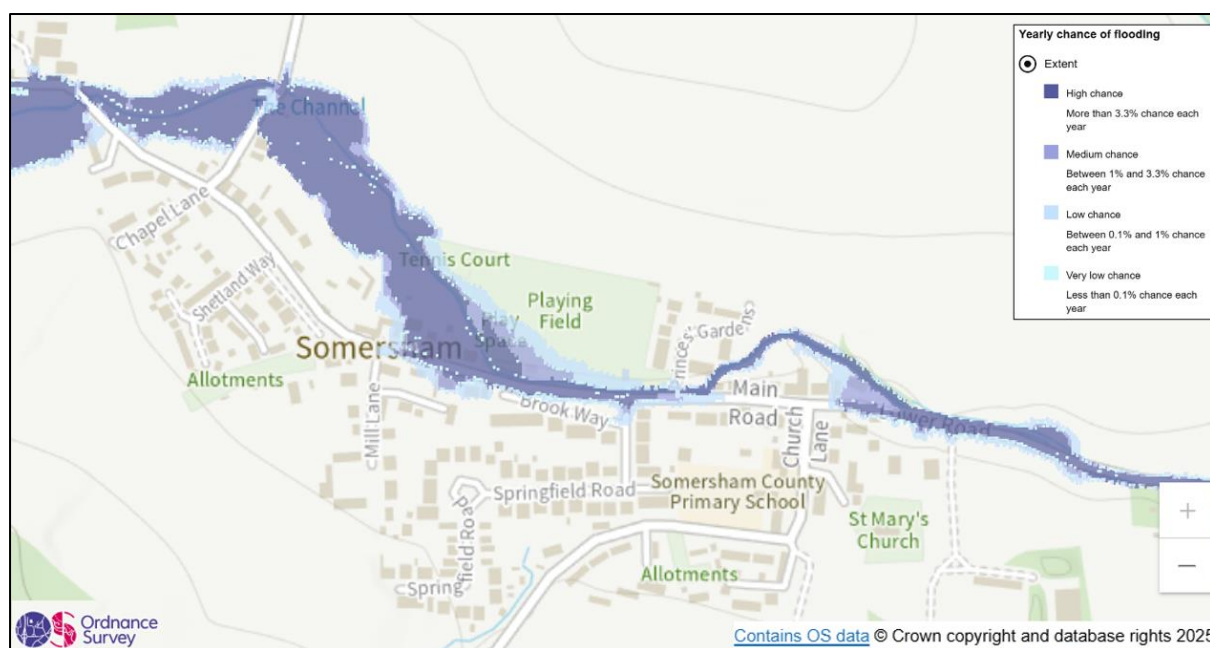
The floodwater flowpaths observed on Main Road during Storm Babet closely match the national fluvial flood risk mapping (see Figure 12). Sections of Main Road are characterised as having a high chance of fluvial flooding.

Figure 12. Fluvial flood risk on Main Road and Watering Close

This area also experienced flooding during the subsequent named storm event, Storm Ciaran in November 2023. Parts of Watering Close Lane are shown to be at a low to medium chance of fluvial flooding (see Figure 12).
