Section 19 Flood and Water Management Act 2010

Stonham Aspal Flood Investigation

Storm Babet 2023

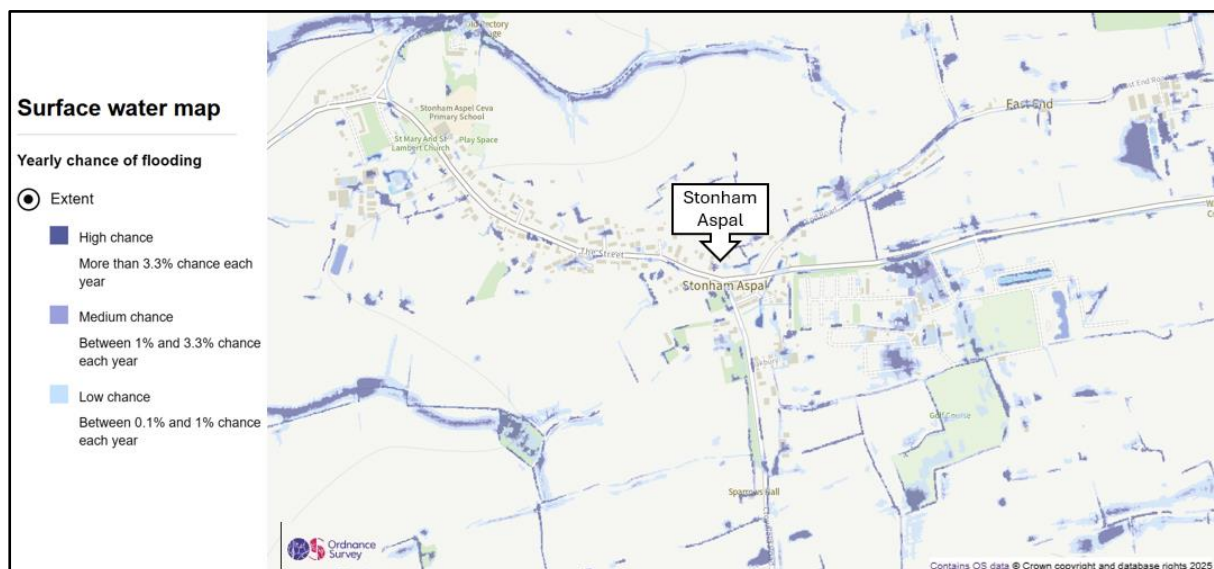
The parish of Stonham Aspal is projected to be at significant risk of pluvial flooding (Fig. 5). All affected property in East End Road and on land south of Pettaugh Road is projected to be at high pluvial flood risk. Both areas are at slightly lower levels relative to surrounding land, where surface water collects.

Fig. 5. Predicted flood risk from surface water (Environment Agency)

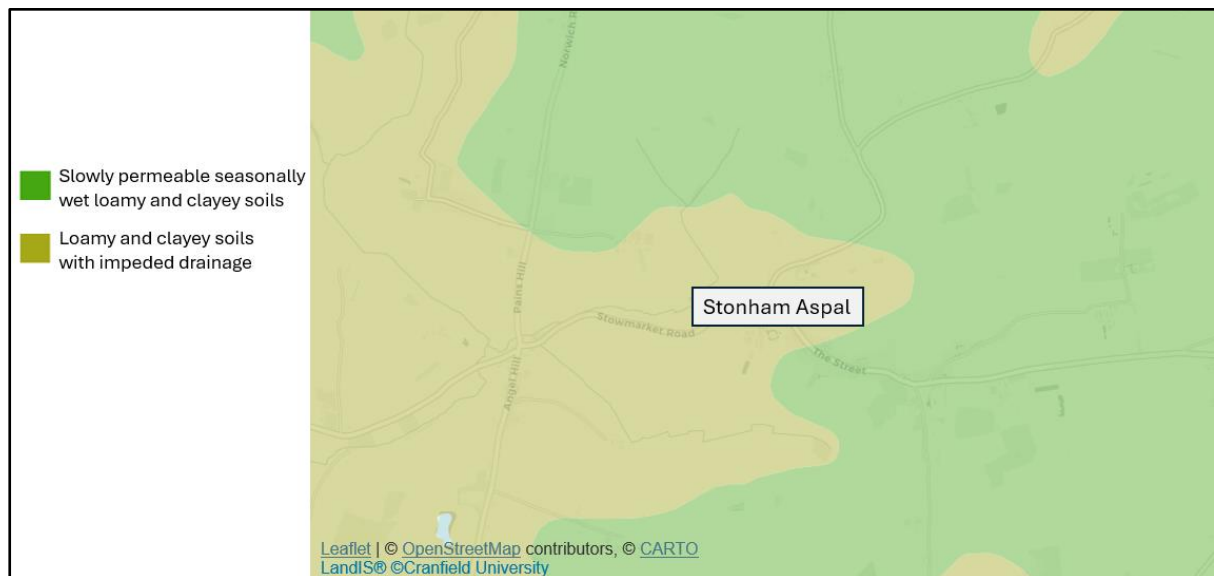
The soils surrounding Stonham Aspal are loamy and clayey with impeded drainage, or slowly permeable, meaning that water penetrates the ground more slowly, and surface water runoff is greater, particularly during intense rainfall (Fig. 7). However, the saturated nature of the soils leading up to the event would also have prevented some infiltration.

Fig. 7. Soil map of catchment area (LandIS® Soilscales)
