## Section 19 Flood and Water Management Act 2010

### Stowmarket Flood Investigation – Storm Babet 2023

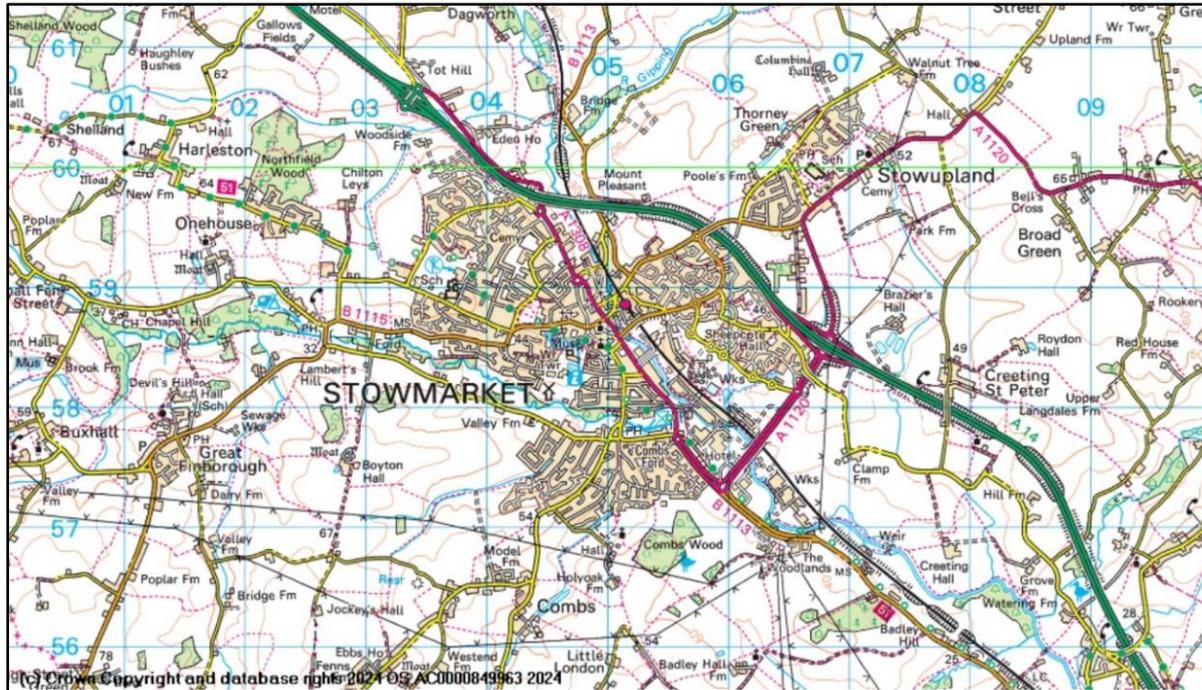
Figure 2. Investigation area map

The town of Stowmarket is located in the district of Babergh and Mid Suffolk, approximately 11 miles northwest of Ipswich and on the west side of the A14.

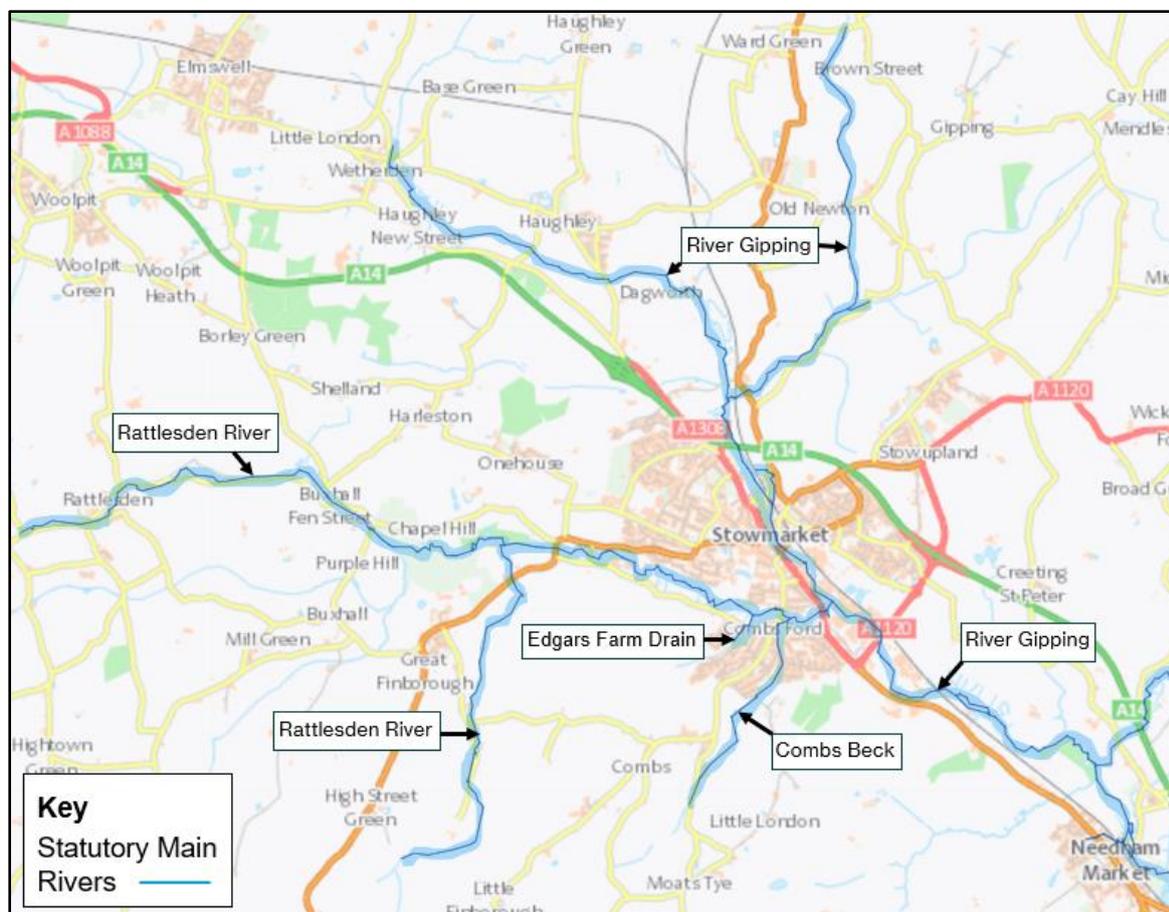
Figure 3 shows the statutory main rivers in and around Stowmarket. These include the River Gipping (flowing from the north) and the Rattlesden River (flowing from the west) which join in Stowmarket. Stowmarket is the confluence for a number of tributaries which also flow into the River Rattlesden from the south. These include Combs Beck and Edgars Farm Drain.

**Figure 3. Location of statutory main rivers**

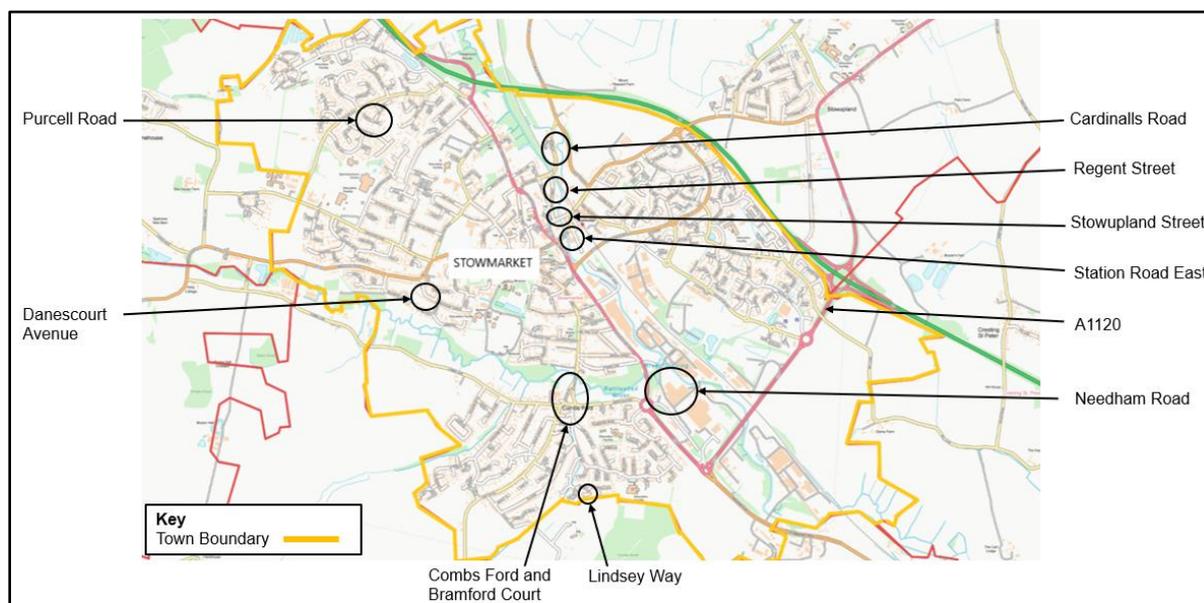
Property was reported as flooding internally in ten locations across the town and for the purposes of this investigation they will be described by road name, except for Combs Ford, which refers to the area:

1. Cardinalls Road
2. Regent Street
3. Stowupland Street
4. Station Road East
5. Purcell Road
6. Needham Road
7. Combs Ford
8. Bramford Court
9. Lindsey Way
10. Danescourt Avenue

**Figure 4. Locations where internal flooding of property was reported or major infrastructure was affected by flooding (A1120)**

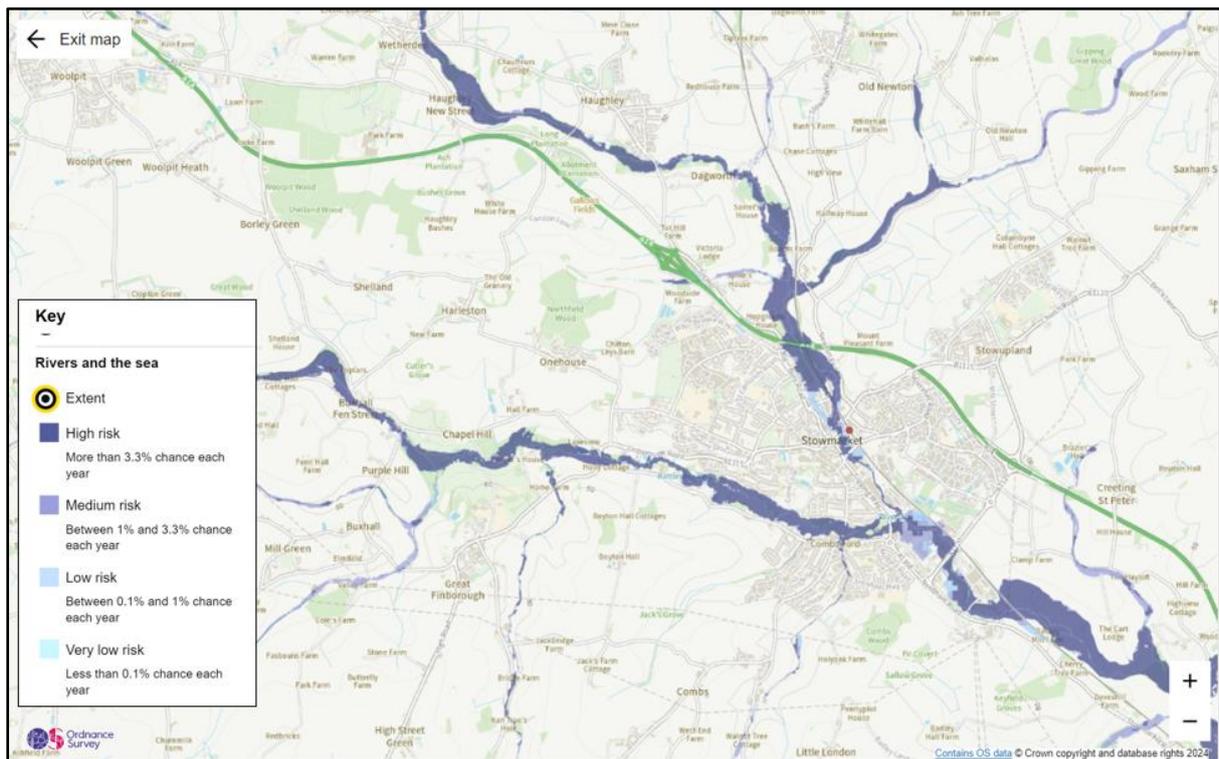
Fluvial flood risk in Stowmarket is associated primarily with the River Gipping, Rattlesden River and Combs Beck (Figure 5). This corresponds with affected property in Cardinals Road, Regent Street, Stowupland Street, Station Road East, Combs Ford, Bramford Court and Needham Road where flooding was attributed by residents to be partly or entirely due to fluvial flooding. Affected properties were projected to be in the high fluvial flood risk areas.

**Figure 5. Predicted flood risk from river water (fluvial)**

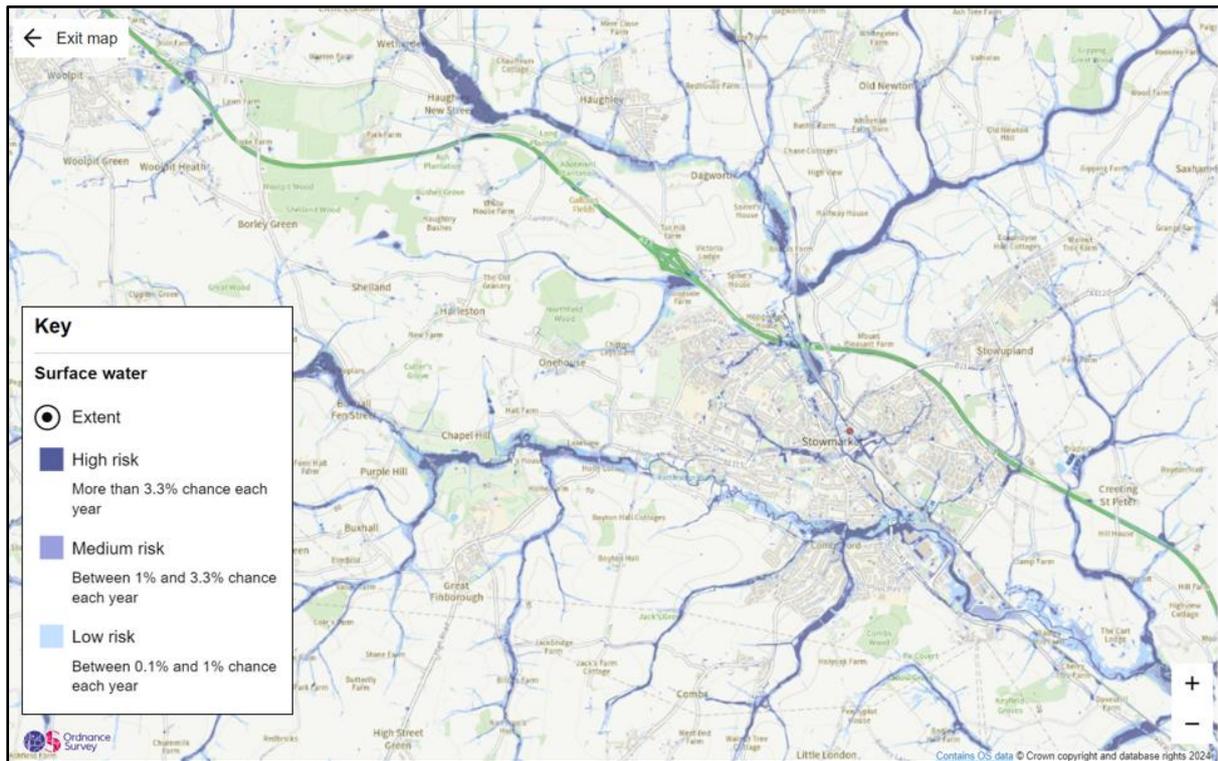
Stowmarket has significant surface water flow paths, predominantly channelling water from the south to the Rattlesden River and from the west, north and east towards the River Gipping (Figure 6). These flowpaths are associated with areas of surface water flood risk. There are also some isolated areas in the town predicted to be at surface water flood risk which are associated with low-lying locations where floodwater typically collects during a rainfall event.

Affected property in Cardinal's Road, Regent Street, Stowupland Street, Station Road East, Lindsey Way, Combs Ford, Bramford Court, Needham Road and Purcell Road was in areas predicted to be at risk of surface water flooding. The flooded section of the A1120 was also predicted to be at high risk of surface water flooding.

**Figure 6. Predicted flood risk from surface water (pluvial)**

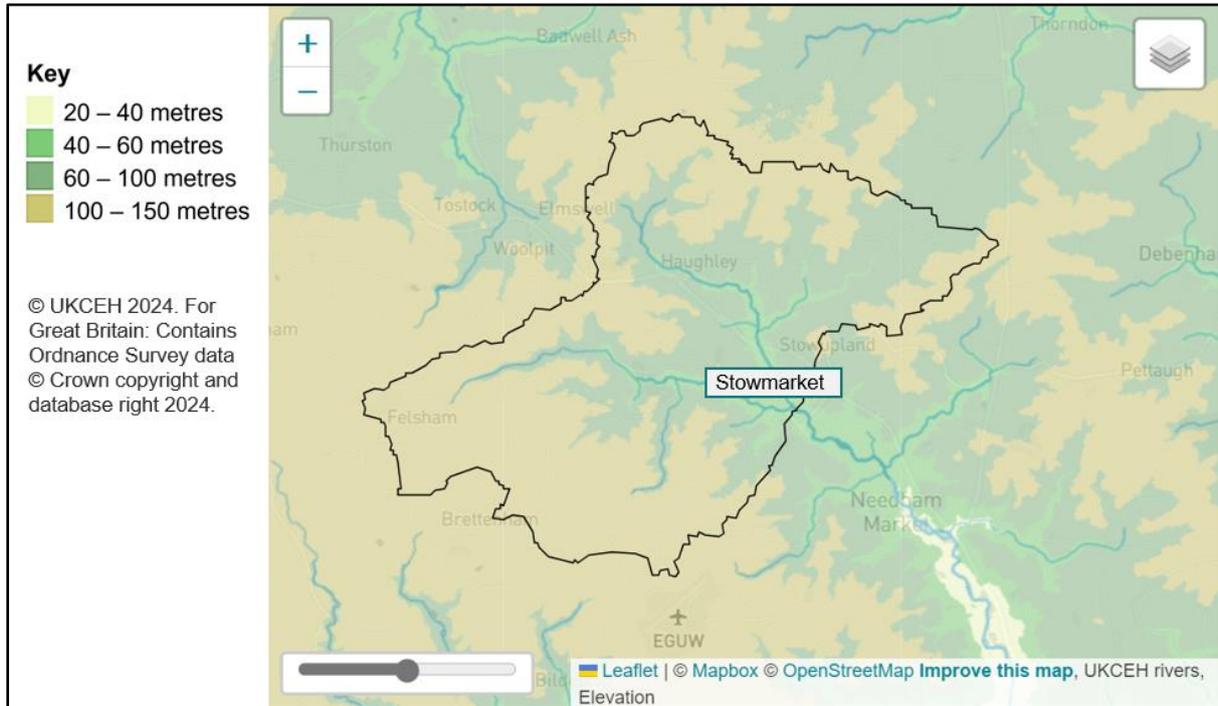
Stowmarket is an urban area situated on low lying land in the upper River Gipping catchment, which also includes the Rattlesden River and Combs Beck (Figure 7). Combs Beck joins the Rattlesden River in Stowmarket, which then converges with the

**Figure 7. Elevation map of catchment area (National River Flow Archive)**

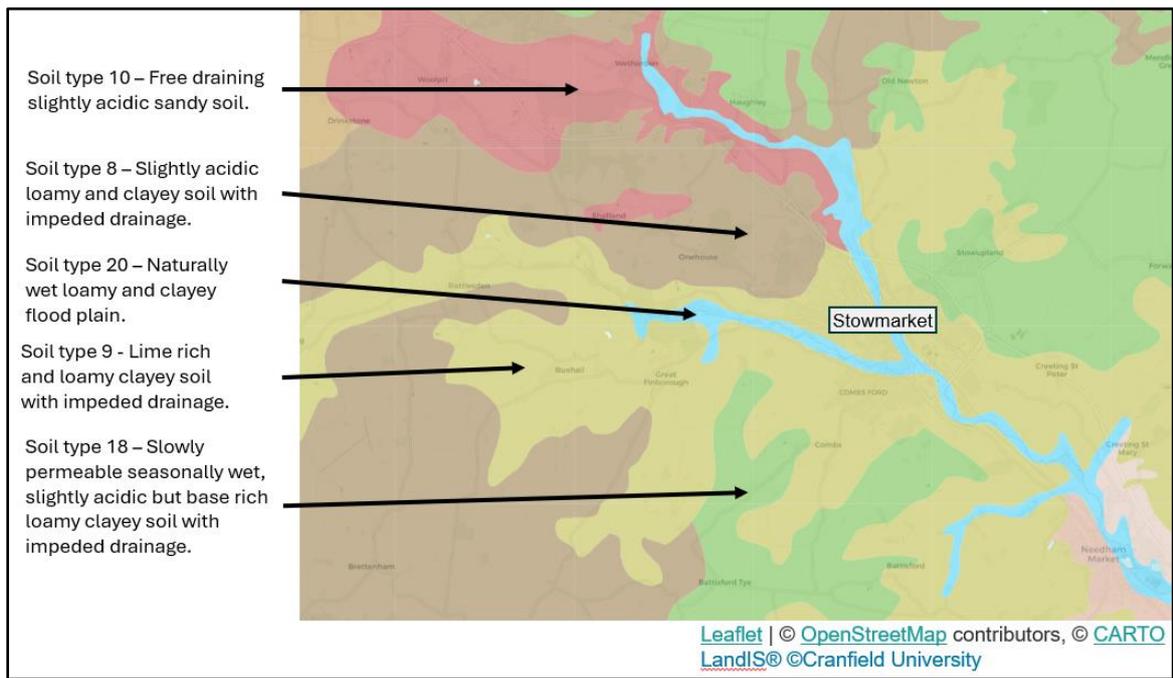
The soils surrounding Stowmarket are predominantly loamy and clayey with impeded drainage, meaning that water permeates more slowly and surface water runoff is greater, particularly during intense rainfall. However, the saturated nature of the soils leading up to Storm Babet would also have prevented some infiltration (Fig. 8).

**Figure 8. Soil map of catchment area (LandIS Soilsclapes)**

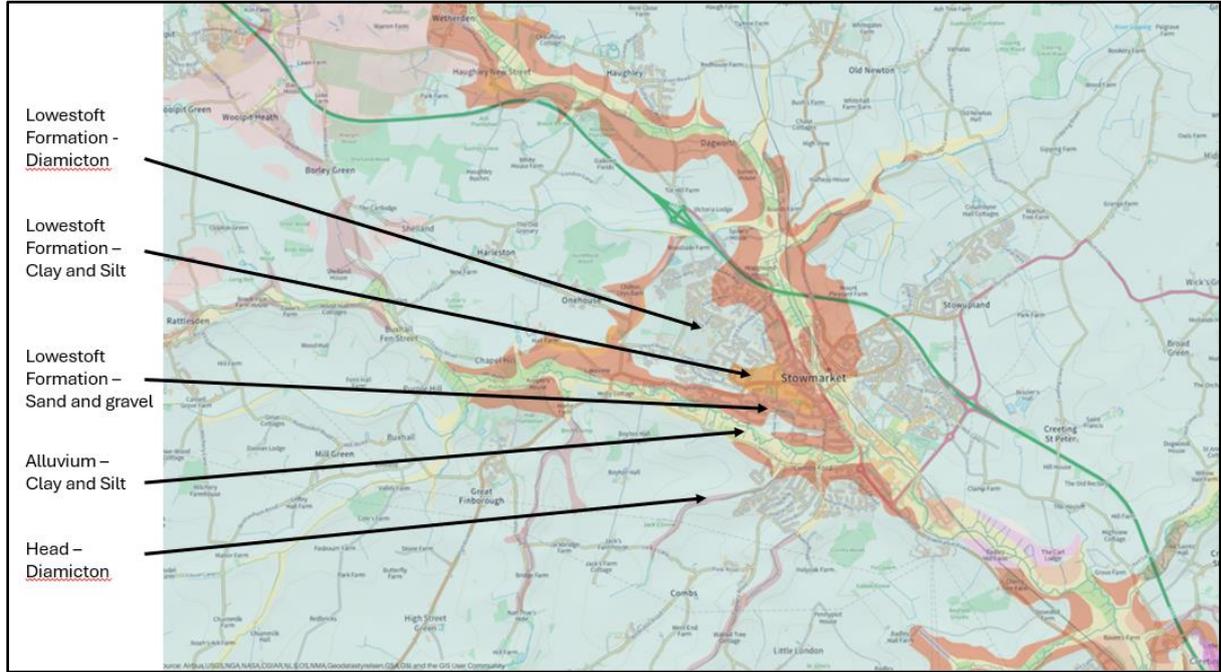
Figure 9 shows that much of the superficial geology surrounding Stowmarket is made up of ‘Lowestoft Formation – Diamicton’ which is described by the British Geological Survey as a diverse mixture of clay, sand, gravel, and boulders varying widely in size and shape. This is sometimes known as boulder clay. This generally has a low permeability meaning water will tend to flow off it before it can infiltrate, which also reflects the reports collected during Storm Babet.

**Figure 9. Superficial geology (BGS Viewer)**

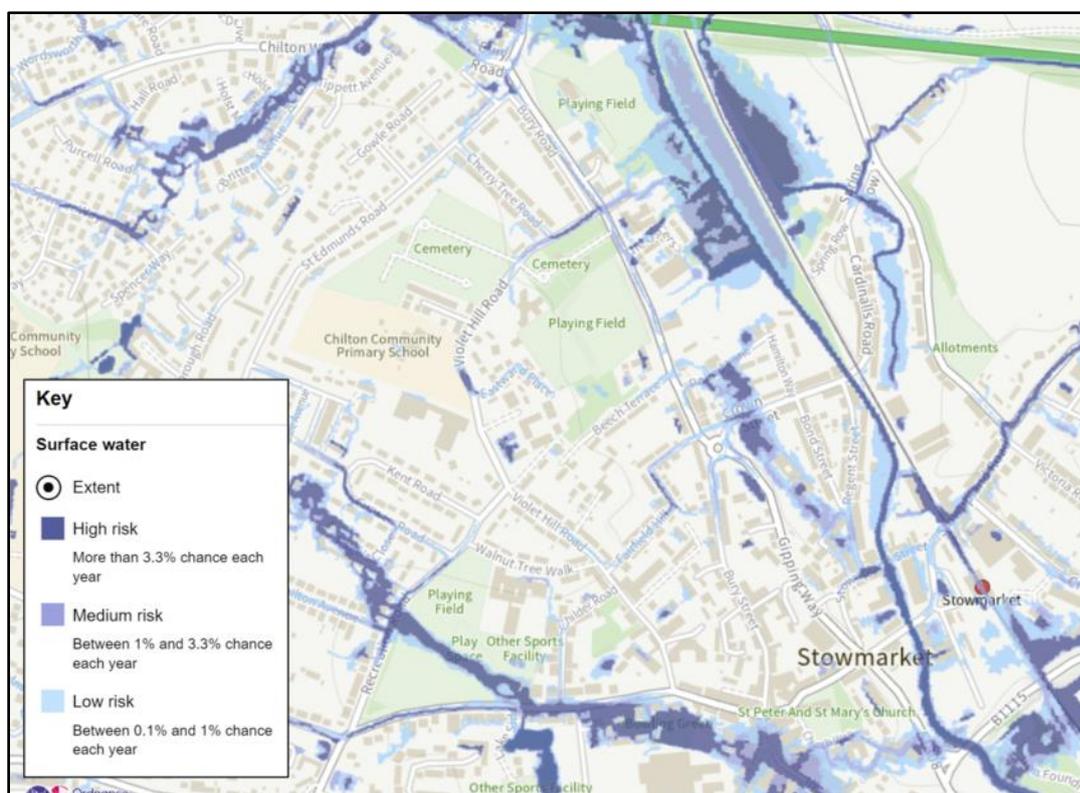
Projected areas of surface water and rivers flood risk for north Stowmarket (including Cardinalls Road, Regent Street, Stowupland Street, Station Road East and Purcell Road) are shown in Figures 10 and 11. Fluvial flooding in north Stowmarket is associated with Cardinalls Drain and the River Gipping. Approximately four residential properties and one commercial property were impacted within this area.

**Figure 10 Predicted flood risk from surface water (pluvial) in north Stowmarket**

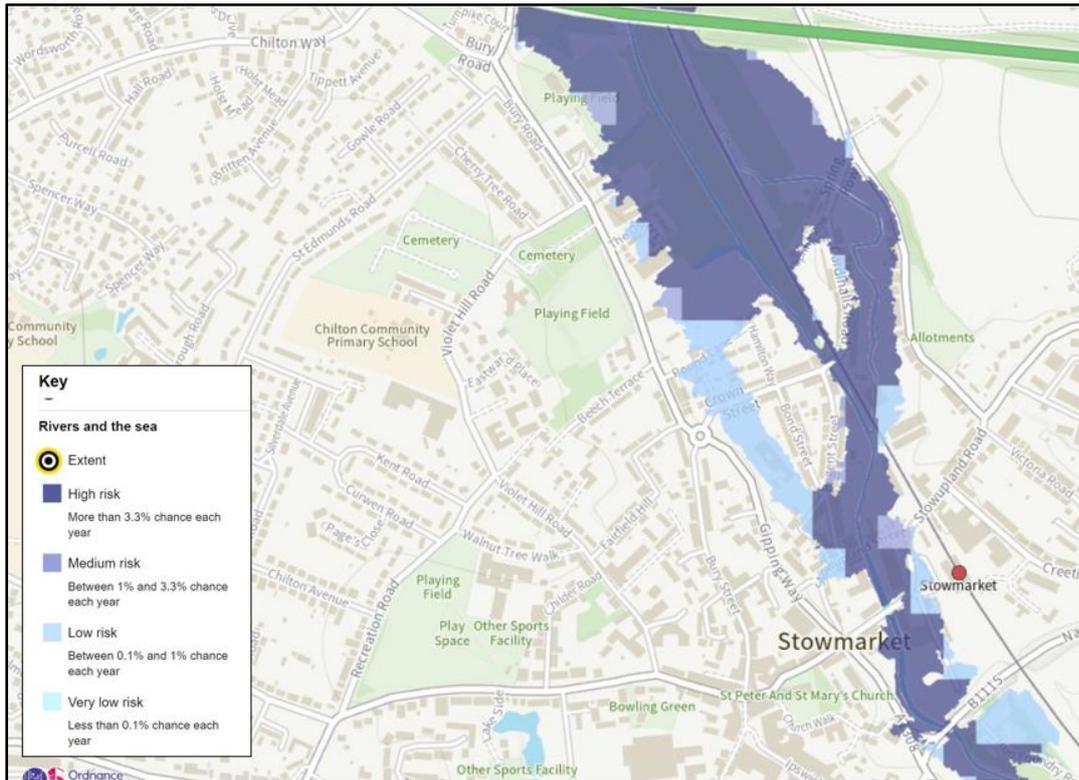
**Figure 11 Predicted flood risk from river water (fluvial) in north Stowmarket**  
 Descriptions of each investigation area in north Stowmarket are detailed below.

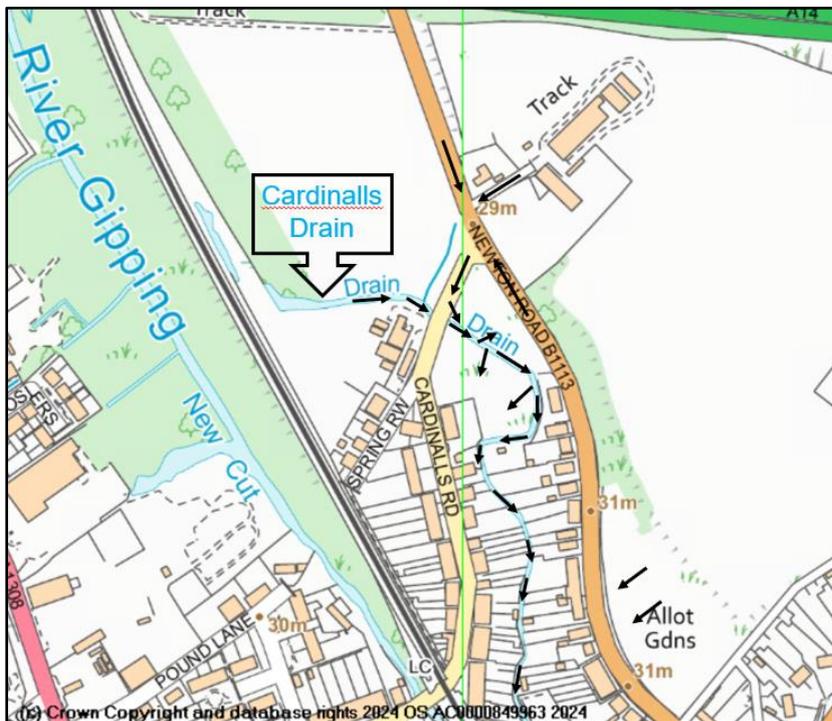
**Figure 12 Cardinals Road approximate floodwater flowpaths**

Cardinals Road is the northernmost road to suffer with internal flooding of property during Storm Babet. The affected property is projected to be at high risk of fluvial flooding and low risk of pluvial flooding, with water flow coming predominantly from the river, rather than overland run off. During Storm Babet, intense and prolonged rainfall caused Cardinals Drain to exceed its current capacity and overtop its banks to the rear of Cardinals Road, resulting in internal flooding to property. Silt build-up has reduced the capacity of Cardinals Drain.

- Residents to install Property Flood Resilience (PFR) via grant funded scheme.
- Residents to report obstructions in Cardinals Drain to the Environment Agency.
- Landowners to undertake targeted maintenance of Cardinals Drain between Spring Row and the Pump at the lower end of Cardinals Road as per riparian responsibilities.
- Relevant authority to inform landowners of riparian responsibilities.

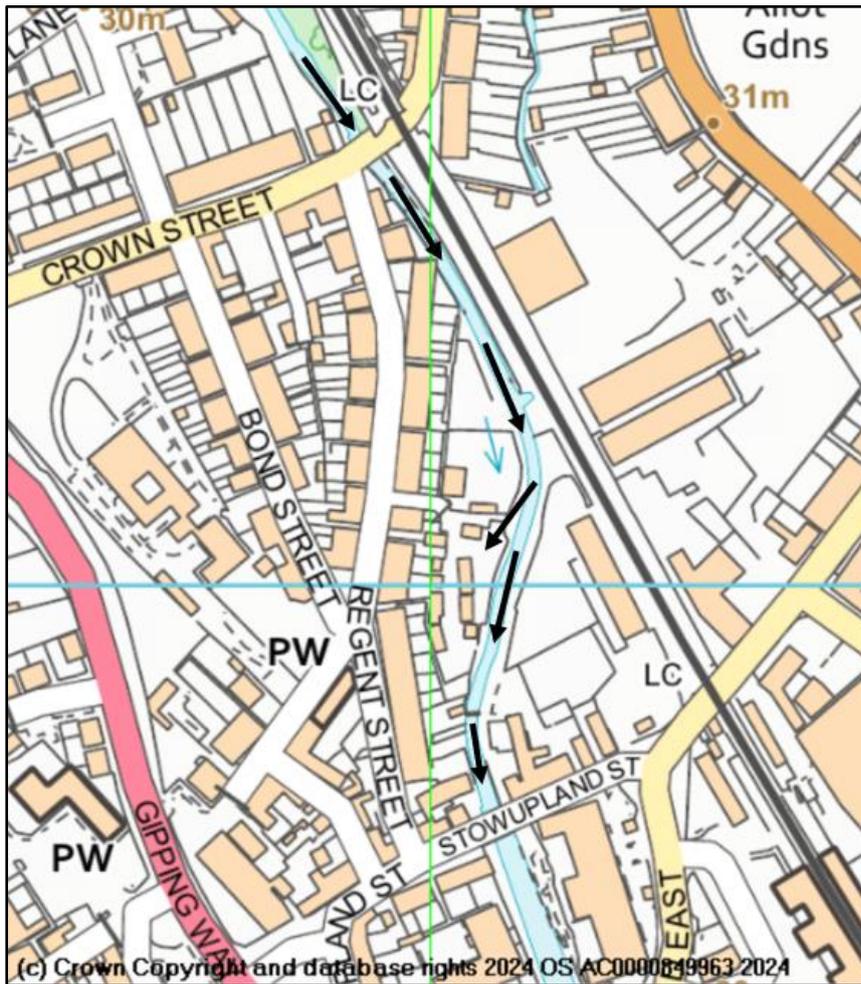
**Figure 13 Regent Street approximate floodwater flowpaths**

The River Gipping flows south behind properties on Regent Street. It is joined near the northern end of this stretch by water pumped into it from Cardinalls Drain. Affected property in Regent Street is projected to be at high risk of fluvial flooding and low risk of pluvial flooding with water flow coming predominantly from the river, rather than overland run off.

- Residents to install Property Flood Resilience (PFR) via grant funded scheme.
- Residents to report obstructions in the watercourse to the Environment Agency.
- Relevant authority to inform landowners of riparian responsibilities.
- Explore the potential for NFM measures which aim to attenuate surface water in the upper catchment of the River Gipping.

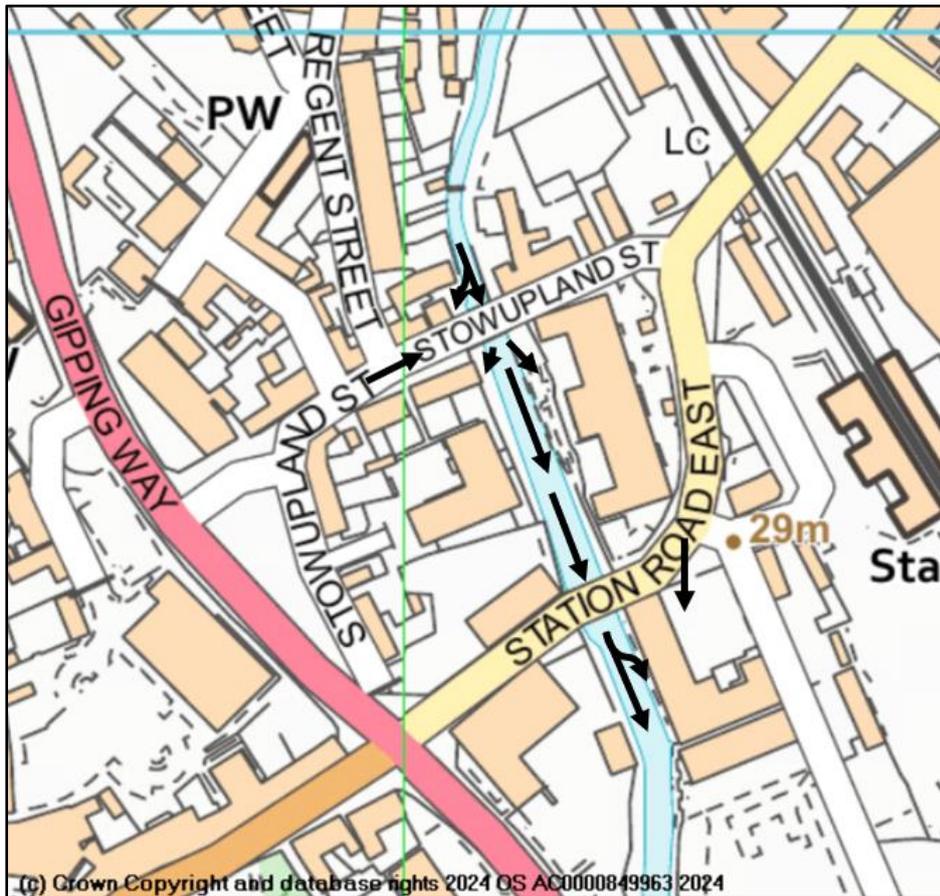
**Figure 14 Stowupland Street and Station Road East approximate floodwater flowpaths**

Affected property in Stowupland Street and Station Road East is projected to be at high risk of fluvial and pluvial flooding with water flow coming from the river and overland run off.

- Residents to install Property Flood Resilience (PFR) via grant funded scheme.
- Residents to report obstructions in the watercourse to the Environment Agency.
- Relevant authority to inform landowners of riparian responsibilities
- Explore the potential for NFM measures which aim to attenuate surface water in the upper catchment of the River Gipping.

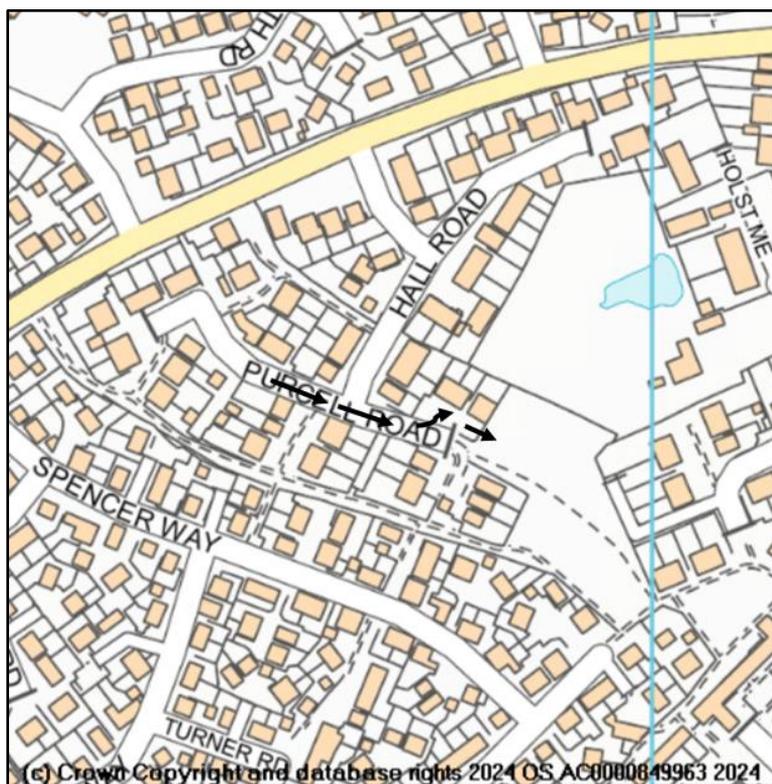
**Figure 15 Purcell Road approximate floodwater flowpaths**

Affected property in Purcell Road suffered internal flooding from surface water on the highway. The area is projected to be at medium surface water flood risk and during the event, residents reported that highways drainage was overwhelmed, unable to cope with the volume of floodwater. Surface water flowed down Purcell Road, travelling west to east, towards properties situated at a lower level, causing internal property flooding when floodwater breached property thresholds.

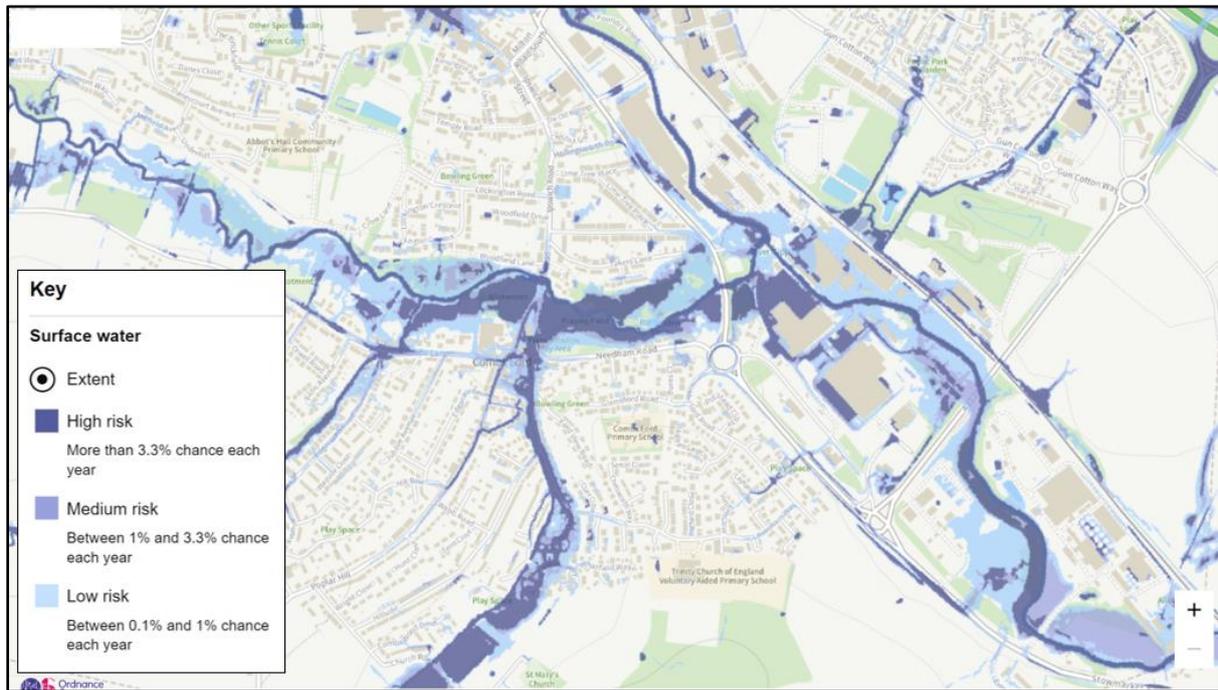
Predicted areas of surface water and rivers flood risk for south Stowmarket (including Needham Road, Combs Ford, Bramford Court, Danescourt Avenue, Lindsey Way and the A1120) are shown in Figures 16 and 17. Fluvial flooding in south Stowmarket is associated with the River Gipping, Rattlesden River and Combs Beck. Approximately five commercial properties and twelve residential properties were impacted within this area.

**Figure 16 Predicted flood risk from surface water (pluvial) in south Stowmarket**

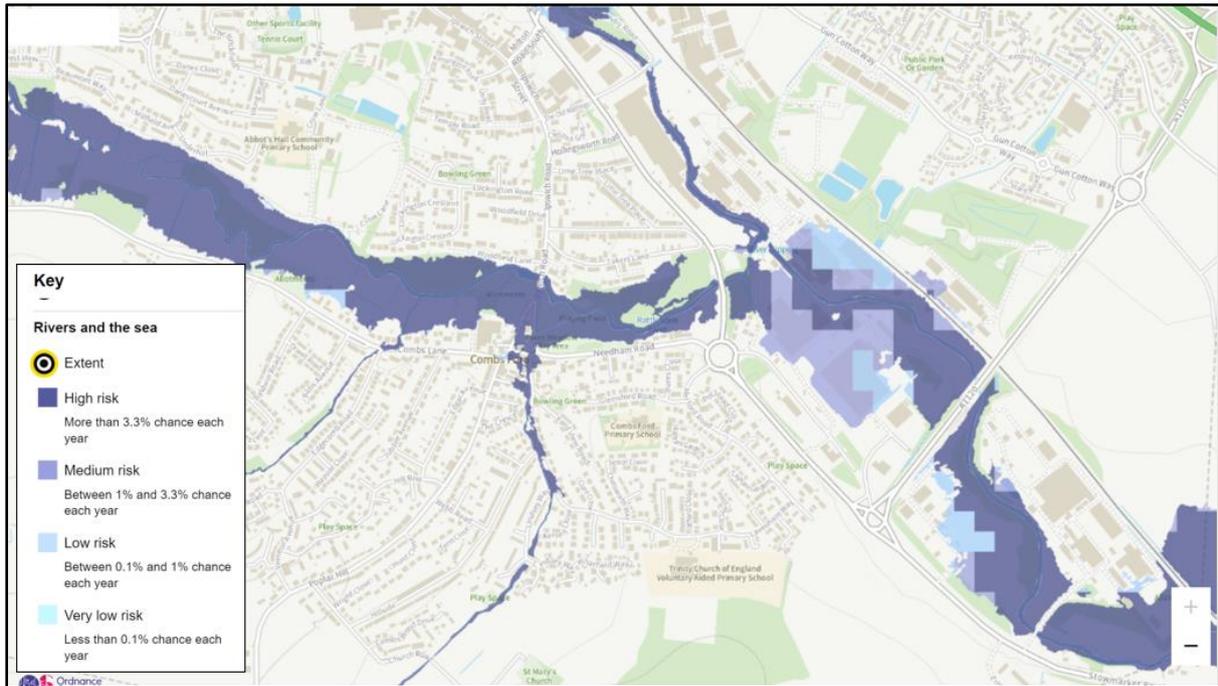
**Figure 17 Predicted flood risk from river water (fluvial) in south Stowmarket**

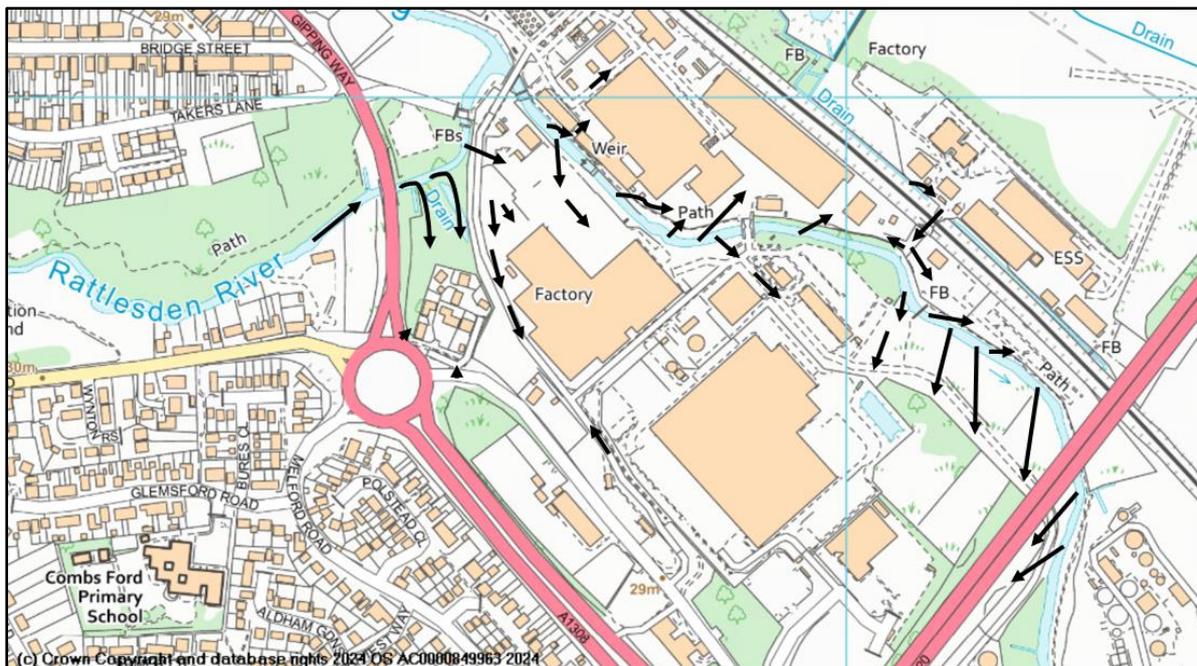
**Figure 18 Needham Road approximate floodwater flowpaths for residential and commercial property**

Commercial property to the east of the Gipping Way/Needham Road roundabout was impacted by flooding. Affected property in this location is predicted to be at high fluvial and pluvial flood risk, with water flow coming from rivers and overland run off.

At 2pm on 20<sup>th</sup> October 2023, floodwater was reported as exceeding the capacity of drains on the east side of the railway line and flowing southwest through an underpass beneath the railway line and on to the site, flooding eastern areas between the River Gipping and the railway. By 8pm, the River Gipping had overtopped adjacent to this area, contributing to flooding on the east and southeast side of the site. Roads on this side of the site are known to be vulnerable to flooding and are reported to flood typically 1-2 times per year. At 8pm, internal flooding, also caused by the River Gipping overtopping, was reported on the northeast of the site, close to the confluence of the Rattlesden River and the River Gipping. At 10pm, the River Rattlesden was also reported as overtopping and flooding the northwest of the site. Surface water also accumulated on the site due to the considerable amount of hard impermeable surfaces. Floodwater continued to rise on the site, causing further internal flooding until 2.30am on 21<sup>st</sup> October, when levels began to subside.

- Business to install Property Flood Resilience (PFR) via grant funded scheme.
- Business to report obstructions in the Rattlesden River and River Gipping to the Environment Agency.
- Relevant authority to inform landowners of riparian responsibilities.
- Explore the potential for NFM measures which aim to attenuate surface water in the upper catchment of the Rattlesden River.
- Explore the potential for NFM measures which aim to attenuate surface water in the upper catchment of the River Gipping.

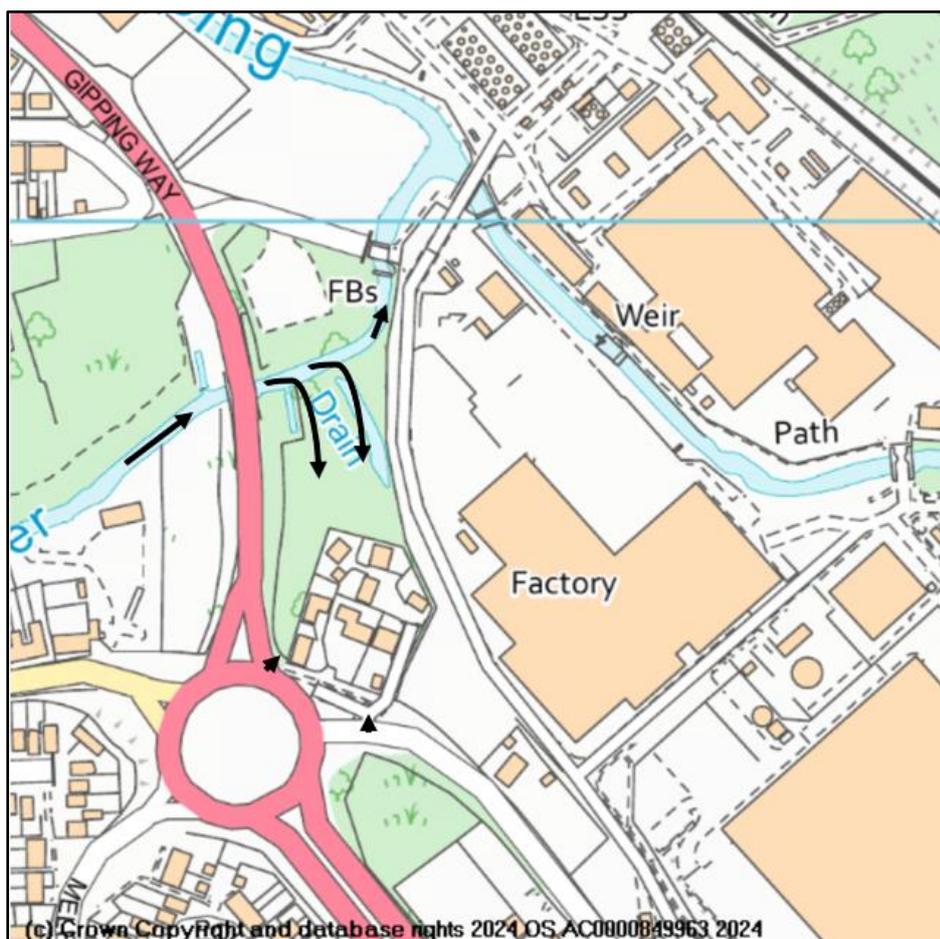
**Figure 19 Needham Road approximate flowpaths for residential property**

Affected residential property on the Rattlesden River floodplain, situated between the Gipping Way and Needham Road roundabout and commercial property to the east of the roundabout, is projected to be at high fluvial and pluvial flood risk, with water flow coming from rivers and overland run off. Impacted residential property in this location was reported to be flooded from the Rattlesden River overtopping and flowing south. This would have been compounded by surface water flowing north over roads from the south side of affected property. Internal flooding was reported to a depth of 20cm. This location also reported that rubbish and trees were obstructing the River Gipping.

- Residents to report obstructions in the Rattlesden River to the Environment Agency.
- Relevant authority to inform landowners of riparian responsibilities.
- Explore the potential for NFM measures which aim to attenuate surface water in the upper catchment of the Rattlesden River.

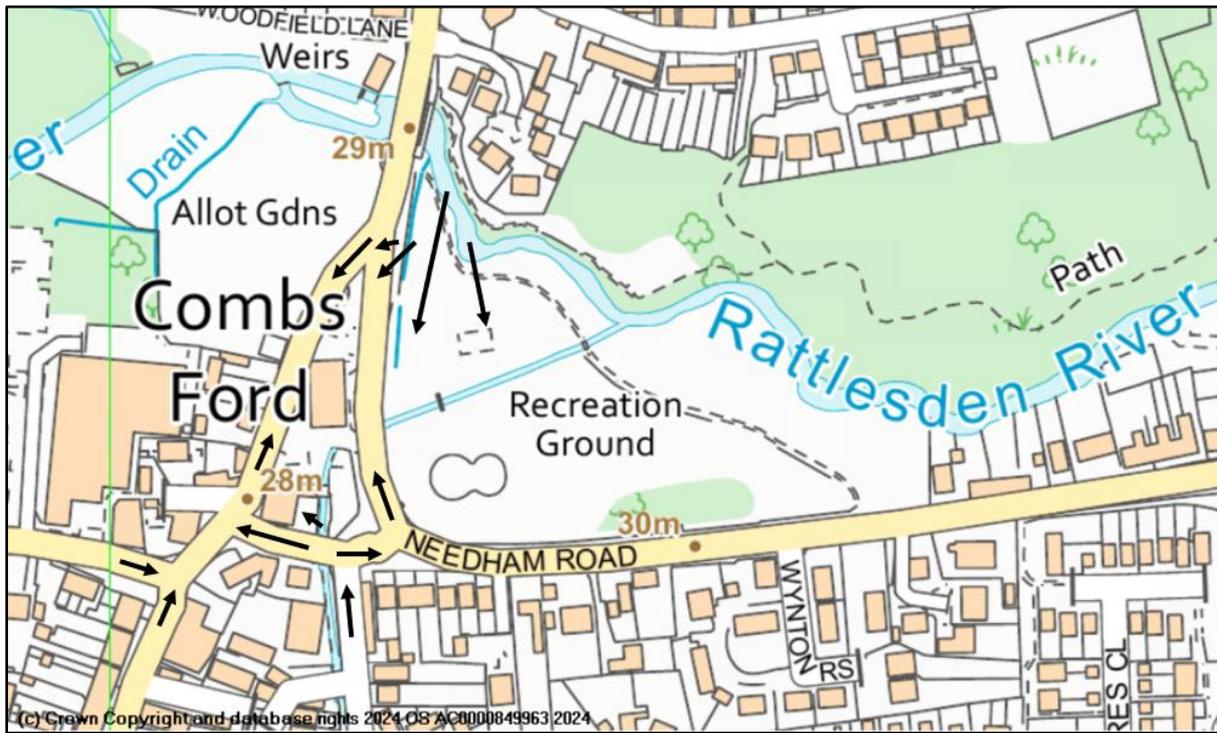
**Figure 20 Combs Ford approximate floodwater flowpaths**

Combs Ford is an area projected to be at high risk of pluvial and fluvial flooding, with fluvial flood risk arising from both Combs Beck and Rattlesden River. Combs Beck flows north through Combs Ford and turns east across Pikes Meadow to join the Rattlesden River.

- Intense and prolonged rainfall caused Rattlesden River to overtop, flowing south and flooding several commercial properties on Poplar Hill and Needham Road in Combs Ford.

- Residents to install Property Flood Resilience (PFR) via grant funded scheme.
- Residents to report obstructions in Combs Beck and the Rattlesden River to the Environment Agency.
- Explore the potential for NFM measures which aim to attenuate floodwater in the upper catchment of the Rattlesden River.
- Explore the potential for NFM measures which aim to attenuate floodwater in the upper catchment of Combs Beck.

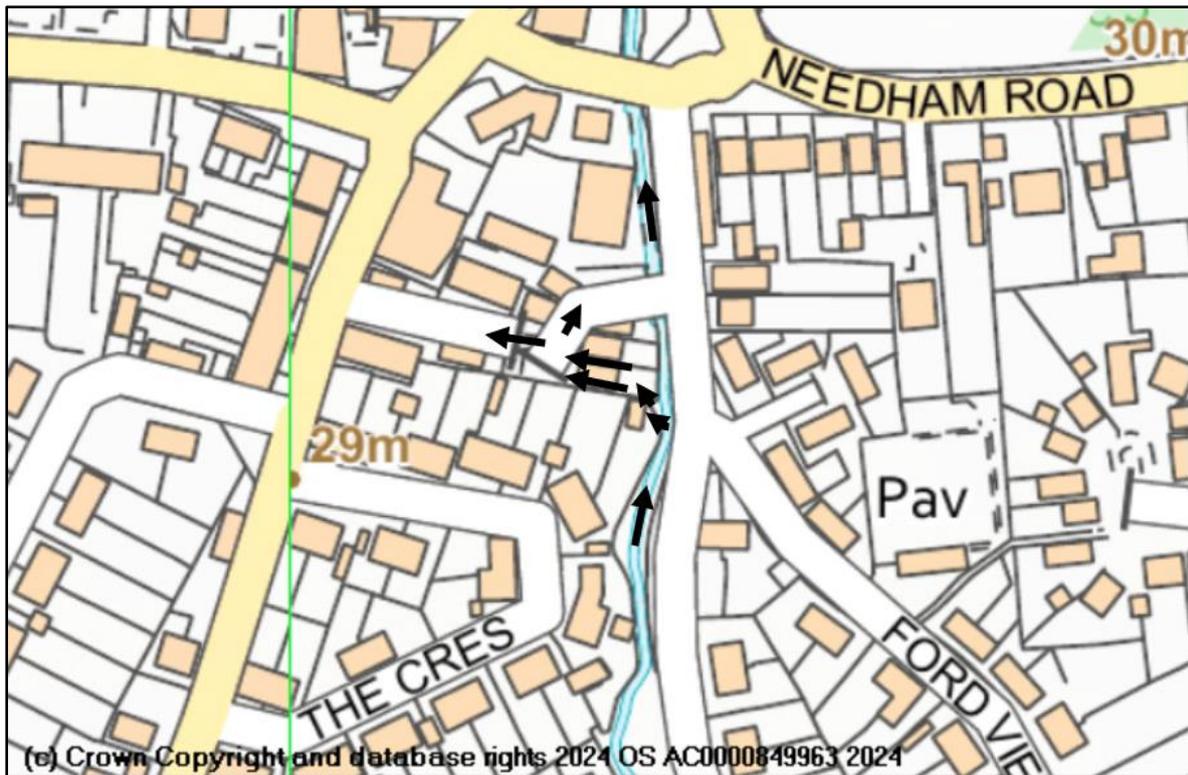
Figure 21 Bramford Court approximate floodwater flowpaths

Bramford Court is projected to be at high fluvial and pluvial flood risk with water flow coming from rivers and overland run off. Affected properties were flooded from Combs Beck overtopping its banks. Floodwater flowed across a section of low-lying bank through an adjacent garden area to the south of Bramford Court, entering Bramford

Court through the fence. It then continued to flow between property and flood further property in Bramford Court. Water levels in Combs Beck were reported as rising on the morning of the 20<sup>th</sup> October and reaching the level of the bridge into Bramford Court by midday. Flooding was also reported from highway surface water. However, drains in Bramford Court were reported by residents to be clear and were presumably overwhelmed by the extreme conditions.

- Intense and prolonged rainfall caused Combs Beck to overtop and floodwater to surround and enter property.,
- Surface water on the road in Bramford Court contributed to flooding.

- Residents to install Property Flood Resilience (PFR) via grant funded scheme.
- Residents to report obstructions in the watercourse to the Environment Agency.
- Environment Agency and/or riparian landowner to investigate whether raising the level of the low-lying bank on the west side of Comb's Beck, to the south of Bramford Court could reduce the flood risk to property without adversely impacting flood risk elsewhere.
- Explore the potential for NFM measures which aim to attenuate floodwater in the upper catchment of Combs Beck.

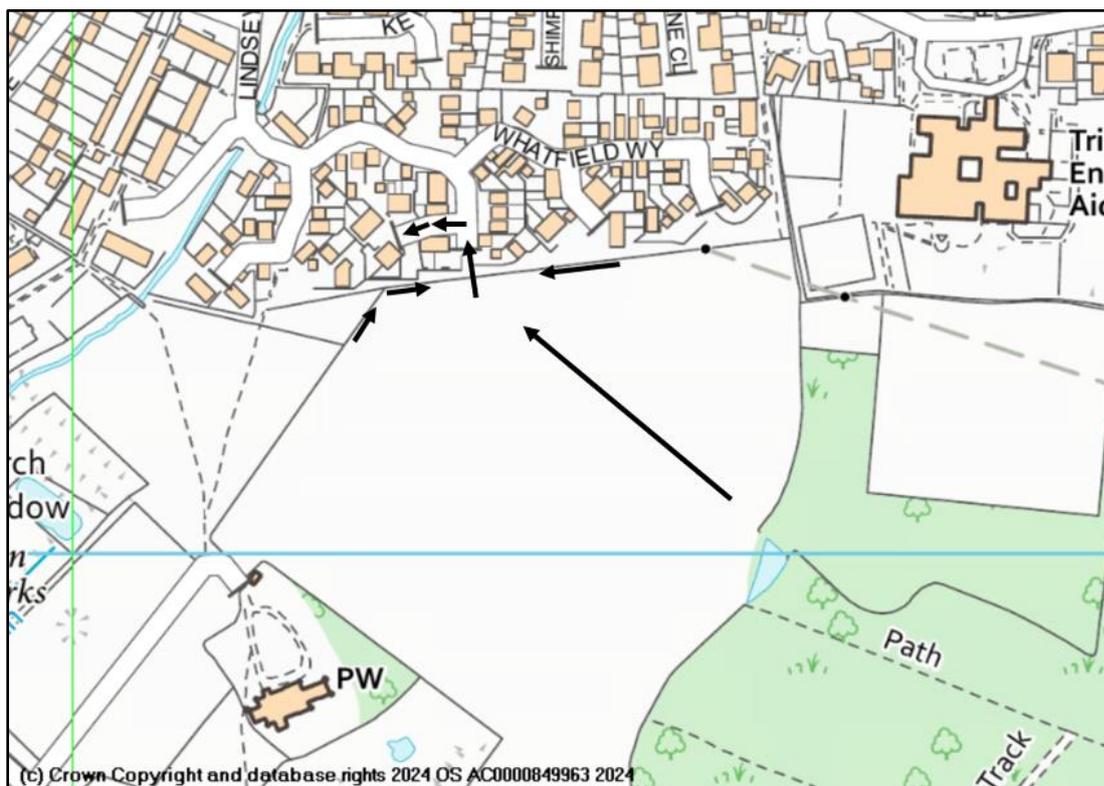
**Figure 22 Lindsey Way approximate floodwater flowpaths**

Affected property in the southeastern part of Lindsey Way is predicted to be at low pluvial flood risk and no fluvial flood risk. Property in this section of Lindsey Way was affected by surface water flooding from fields to the south which slope down northwest from Combs Wood towards Lindsey Way. Some of this floodwater overtopped a small ditch (which has partly filled with soil) at the bottom of the field and flowed between houses on to the highway. Highway drains were reported as being overwhelmed. Directly behind property in this section of Lindsey Way is a brick headwall with a piped opening across the section of the ditch which transports water from the west side of the field. This has a trash screen and is presumably intended to convey water from the ditch to the surface water drainage system in Lindsey Way. However, this section of ditch also overtopped, flooding property in Lindsey Way from the rear. Flooding of property in this section of Lindsey Way recurred during Storm Ciaran.

- Intense and prolonged rainfall caused surface water to flow northwest from Combs Wood down a field slope towards the southeastern section of Lindsey Way.
- Some of this floodwater overtopped a small ditch across its path and entered Lindsey Way directly.
- Highway drains in Lindsey Way were reported as being overwhelmed.

- Residents to install Property Flood Resilience (PFR) via grant funded scheme.
- Landowners to undertake targeted maintenance (clearing of soil and debris) to the east and west of brick headwall as per riparian responsibilities.
- Landowner(s) to investigate the function and condition of pipe transporting floodwater from ditch at rear of properties in Lindsey Way.
- Suffolk County Council Highways to ensure completion of cyclic maintenance of highway gullies on Lindsey Way.
- Investigate the potential for increasing the storage capacity of the ditch.
- Investigate the potential for additional natural flood management measures (for example bunds and buffer strips) in fields to the rear of affected property.

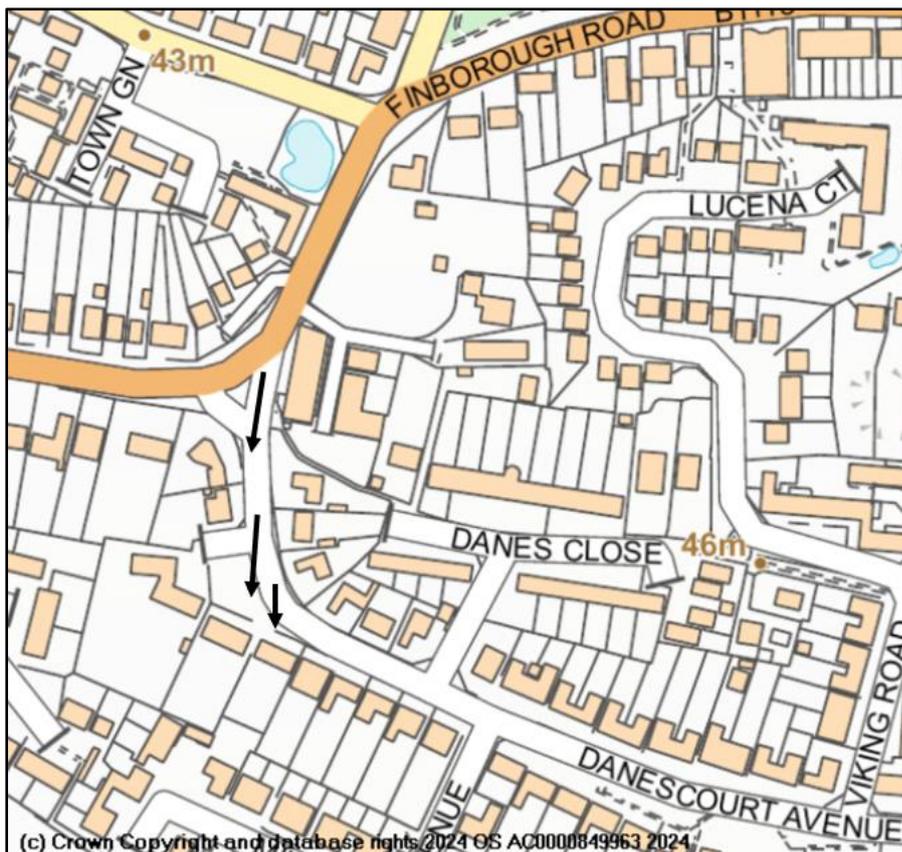
**Figure 23 Danescourt Avenue approximate floodwater flowpaths**

Affected property is not predicted to be at risk of flooding from fluvial or pluvial sources. However, during the event, surface water was experienced to be flowing south down

- Surface water flowed south down the western section of Danescourt Avenue.
- Highway drainage was overwhelmed and surcharging observed from manhole.
- Properties impacted were situated lower than the highway, causing water to be directed to property.

- Residents to install Property Flood Resilience (PFR) via grant funded scheme.
- Suffolk County Council Highways to ensure completion of cyclic maintenance of highway gullies on Danescourt Avenue.
