## Section 19 Flood and Water Management Act 2010

### Stowmarket Flood Investigation – Storm Babet 2023

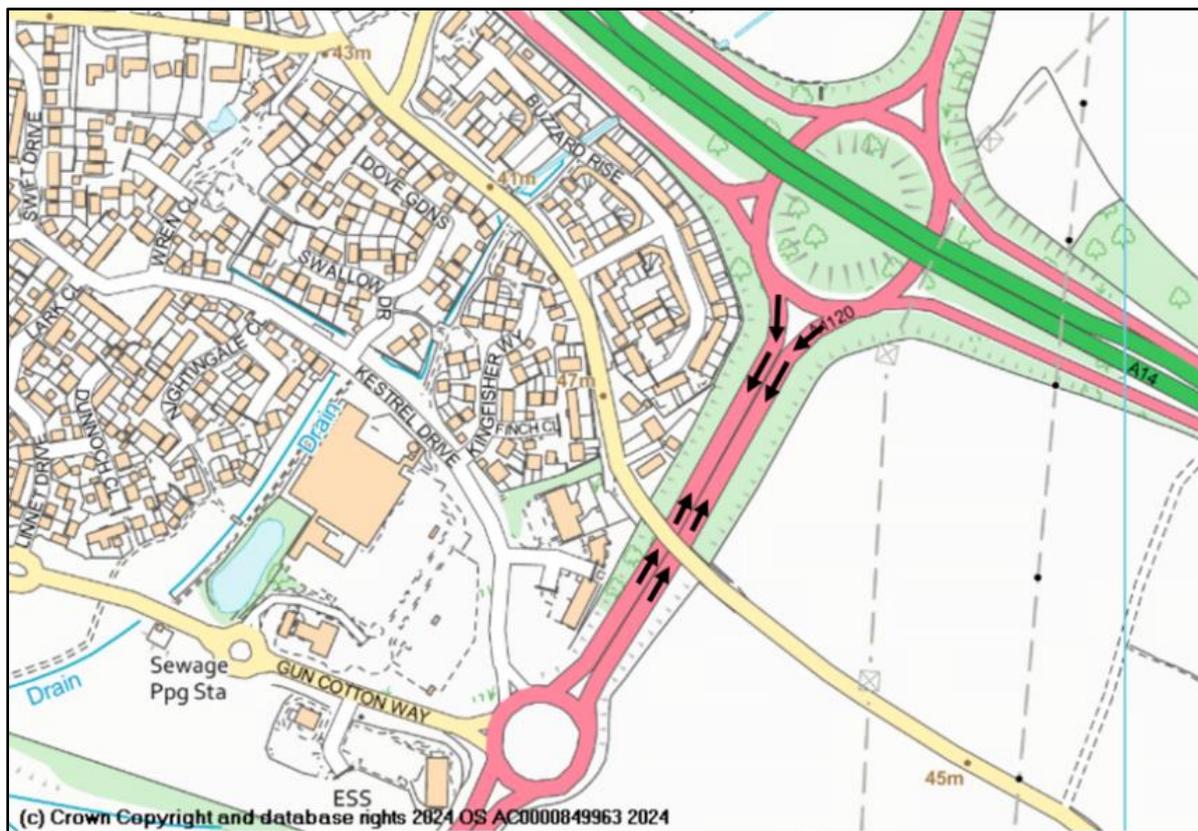
**Figure 24 A1120 approximate floodwater flowpaths**

Surface water flowed down highway gradients to collect on a section of the A1120, adjacent to the A14 junction roundabout. This resulted in the closure of Lane 1 of the northeast bound carriageway. Subsequently, extensive work has been undertaken to

clear and jet highway drainage assets. Further repair work to drainage in this area is being planned to complete this work through to outfalls.

Clear/repair drainage assets to outfalls on A1120 by A14 junction	Suffolk County Council Highways Authority	Jetting and CCTV video survey completed August 2024.

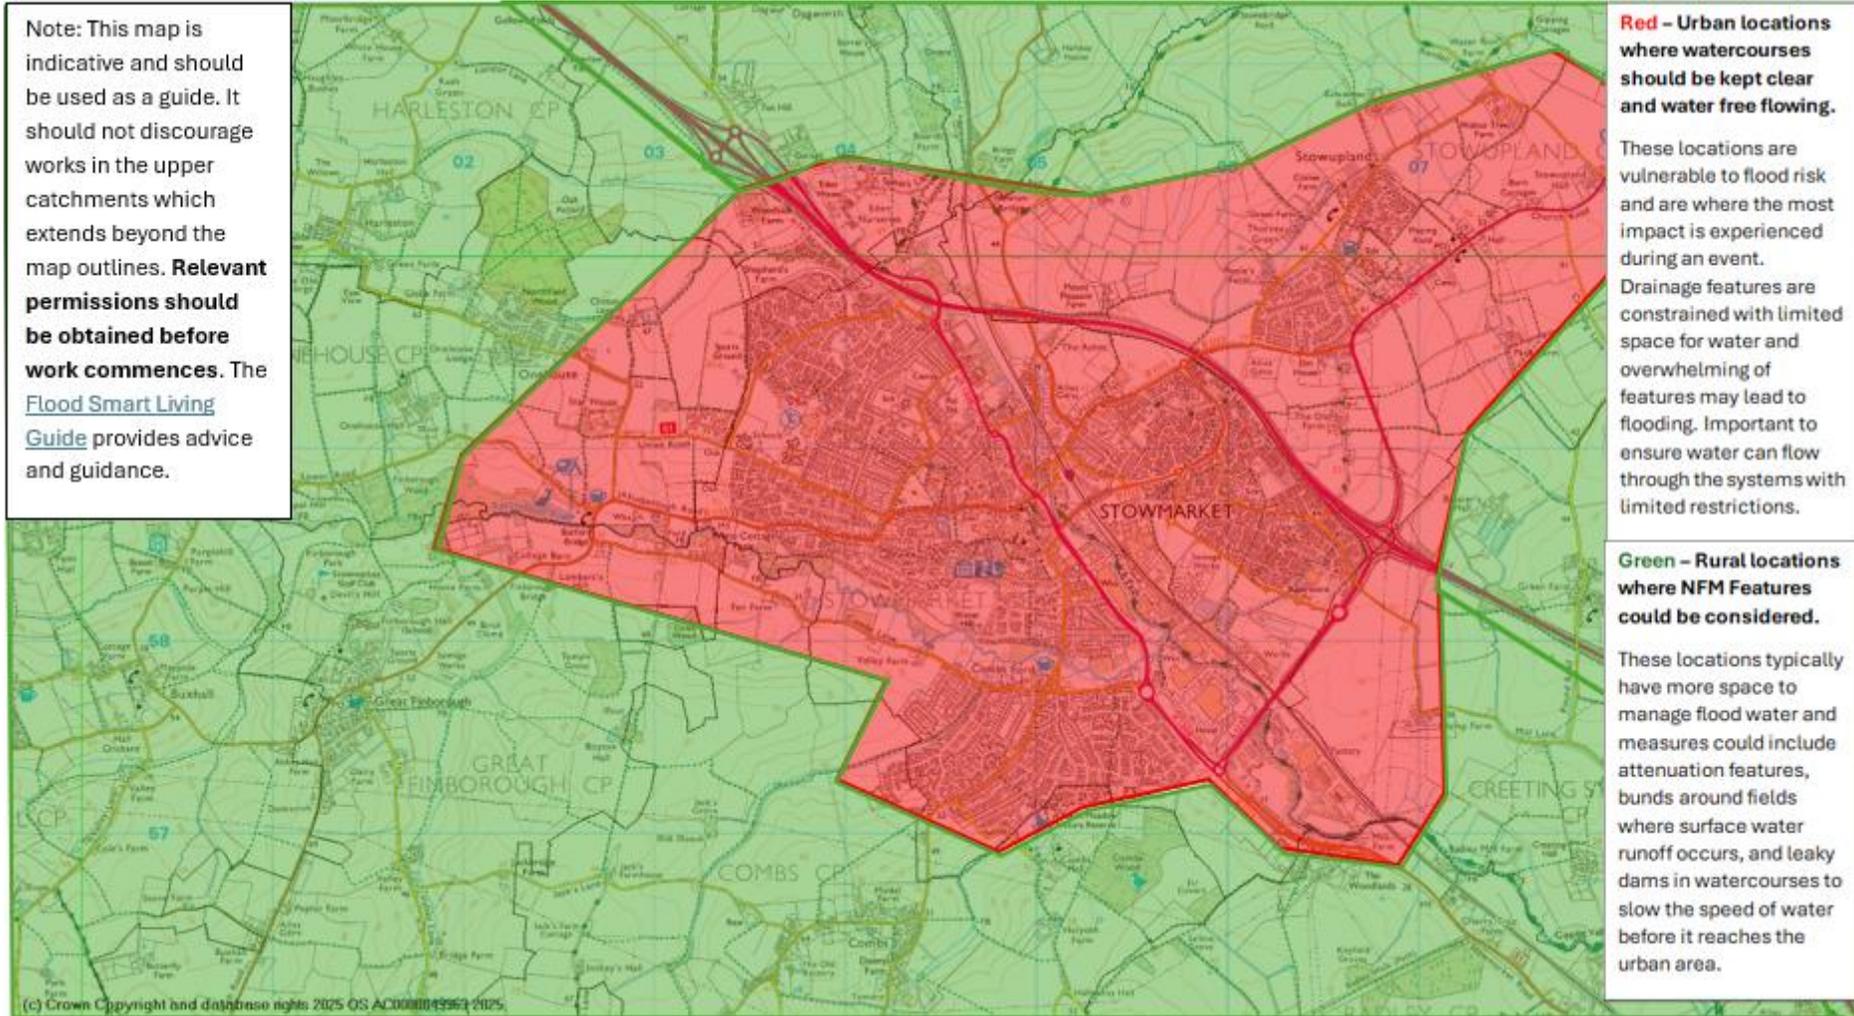
## APPENDIX A - Indicative locations for NFM and watercourse maintenance

Note: This map is indicative and should be used as a guide. It should not discourage works in the upper catchments which extends beyond the map outlines. **Relevant permissions should be obtained before work commences.** The [Flood Smart Living Guide](#) provides advice and guidance.

Explore potential NFM measures to 'slow the flow' and attenuate water in the upper catchment of Combs Beck, eg. leaky dams and attenuation ponds (see Appendix A)	Landowners, supported by relevant authority, resource dependant (SCC LLFA, EA )	12-24 months	No updated expected at this time.
