## Section 19 Flood and Water Management Act 2010

### Stowupland Flood Investigation –

### Storm Babet 2023

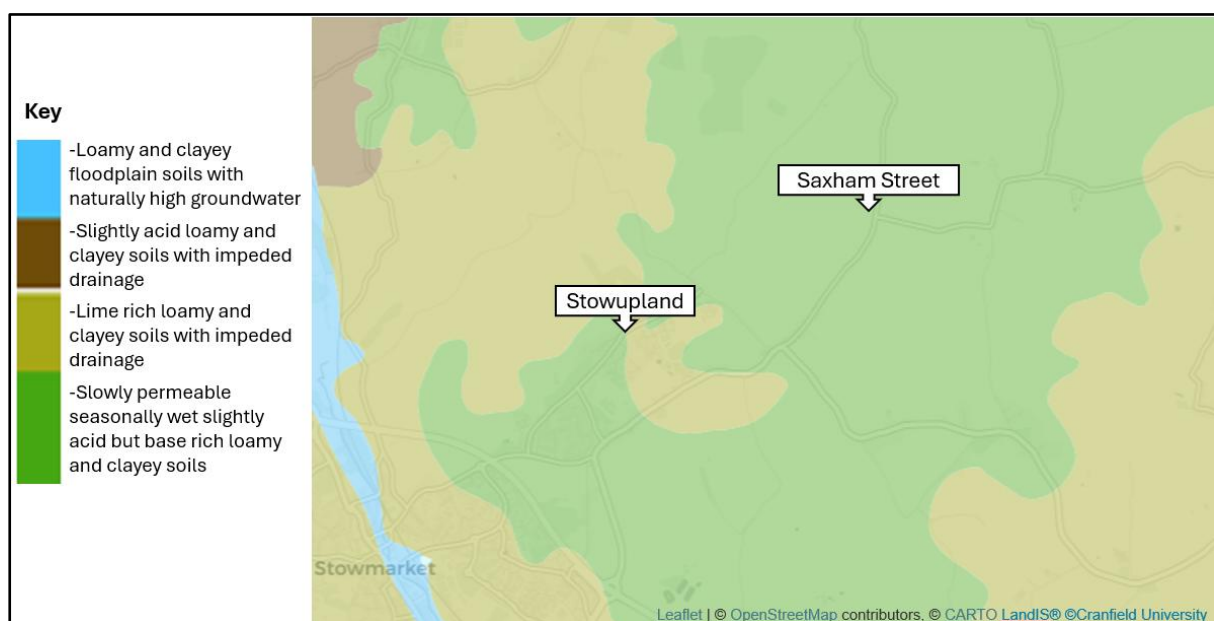
The soils surrounding Stowupland are loamy and clayey with impeded drainage, or slowly permeable, meaning that water penetrates the ground more slowly, and surface water runoff is greater, particularly during intense rainfall (Fig. 7). However, the saturated nature of the soils leading up to the event would also have prevented some infiltration.

**Figure 8. Soil map (LandIS® Soils)**
