## Section 19 Flood and Water Management Act 2010

### Ufford Flood Investigation –

### Storm Babet 2023

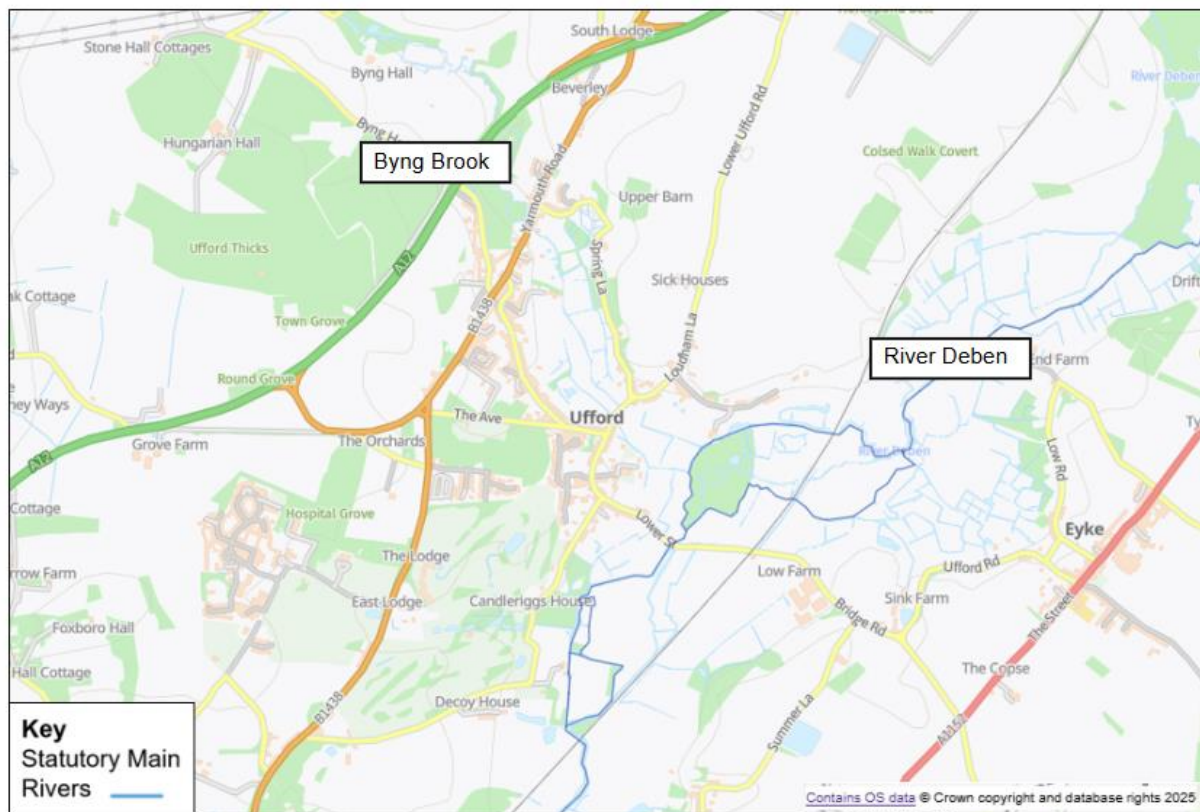
Figure 3 below, shows the most significant watercourses (designated main river) in and around Ufford. Byng Brook is an ordinary watercourse and flows north west to south east through the village before merging with the River Deben.

Figure 3. Location of statutory main river and ordinary watercourses
