## Section 19 Flood and Water Management Act 2010

### Ufford Flood Investigation –

### Storm Babet 2023

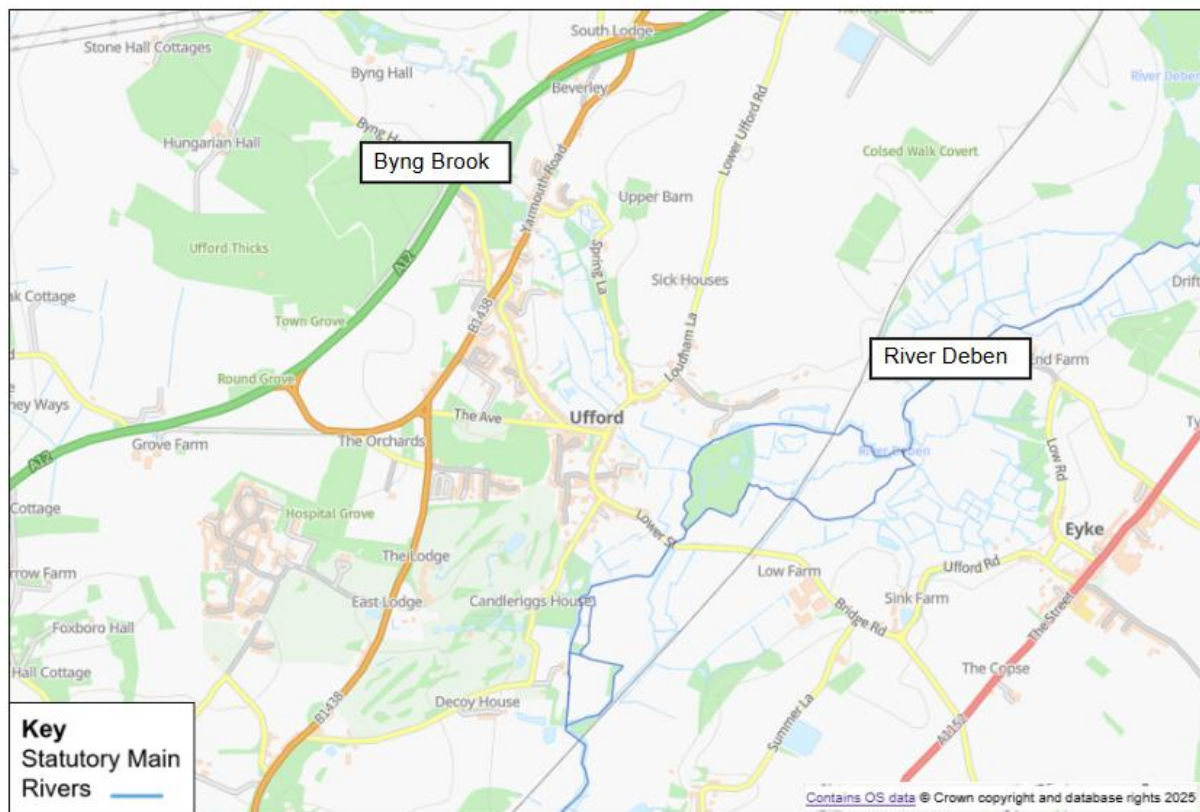
Figure 3 below, shows the most significant watercourses (designated main river) in and around Ufford. Byng Brook is an ordinary watercourse and flows north west to south east through the village before merging with the River Deben.

Figure 3. Location of statutory main river and ordinary watercourses

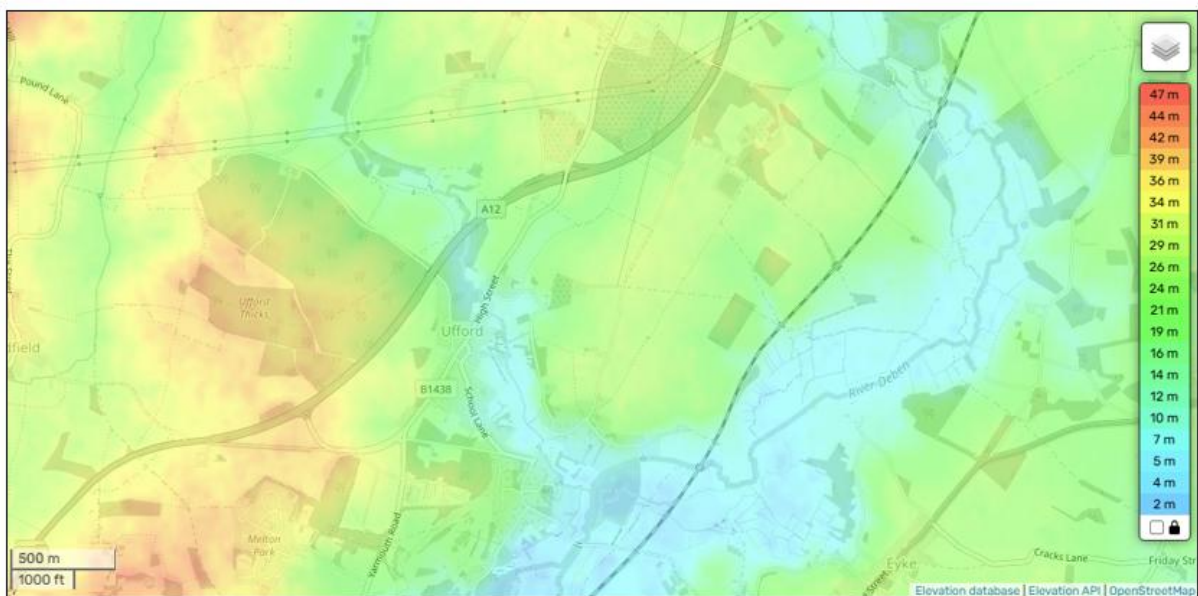
The village of Ufford is situated in the Byng Valley. The village is surrounded by higher ground to the west. Figure 7 shows the topography surrounding Ufford with gradient changes across the wider region. The village of Ufford is situated in a relatively flat and low-lying area, with some of the lowest points being along High Steet, School Lane and Lower Street. These locations were identified as being some of the worst affected areas during Storm Babet.

The low-lying nature of Ufford means that during high rainfall events, considerable overland flow paths converge upstream and flow through Ufford bringing floodwater within close proximity to properties. Overwhelmed drainage infrastructure may frequently be observed during these intense rainfall events.

Figure 8 - Ufford and surrounding topography (TessaDEM as cited in topographic-map.com)
