Section 19 Flood and Water Management Act 2010

Yoxford Flood Investigation –

Storm Babet 2023

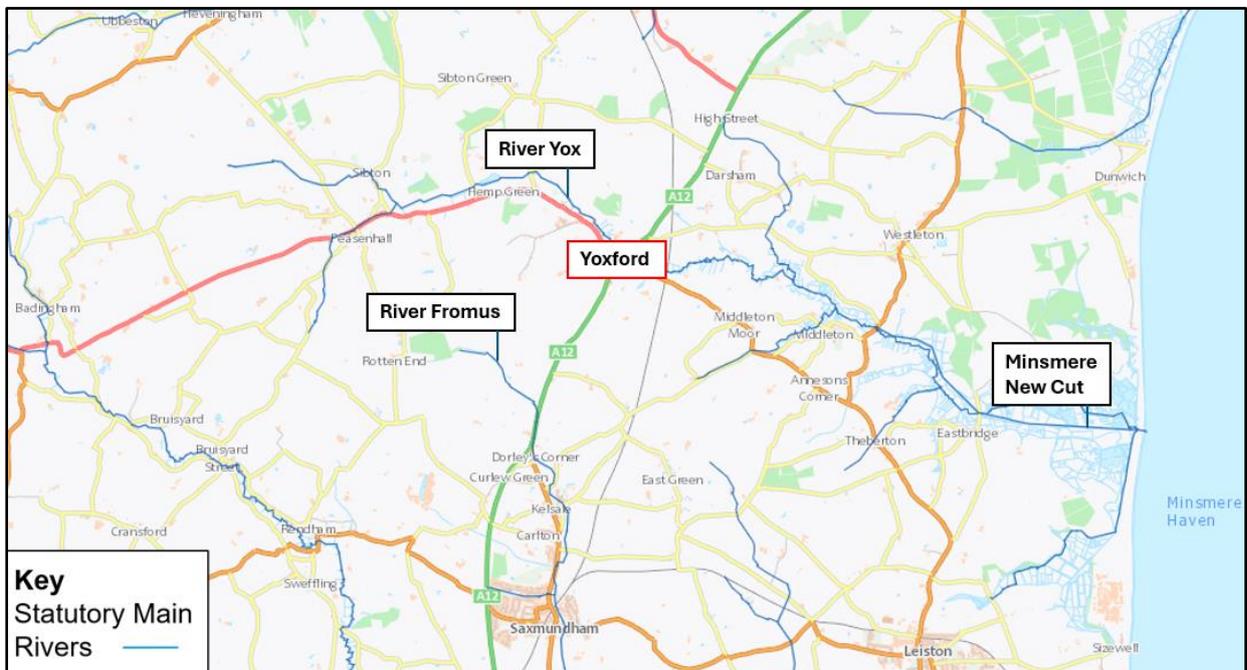
Figure 3. Location of statutory main rivers and significant ordinary watercourses near Yoxford

Figure. 3 shows the most significant watercourses in the area surrounding Yoxford. These include the river Yox, the Fromus and Minsmere New Cut, all statutory main rivers.

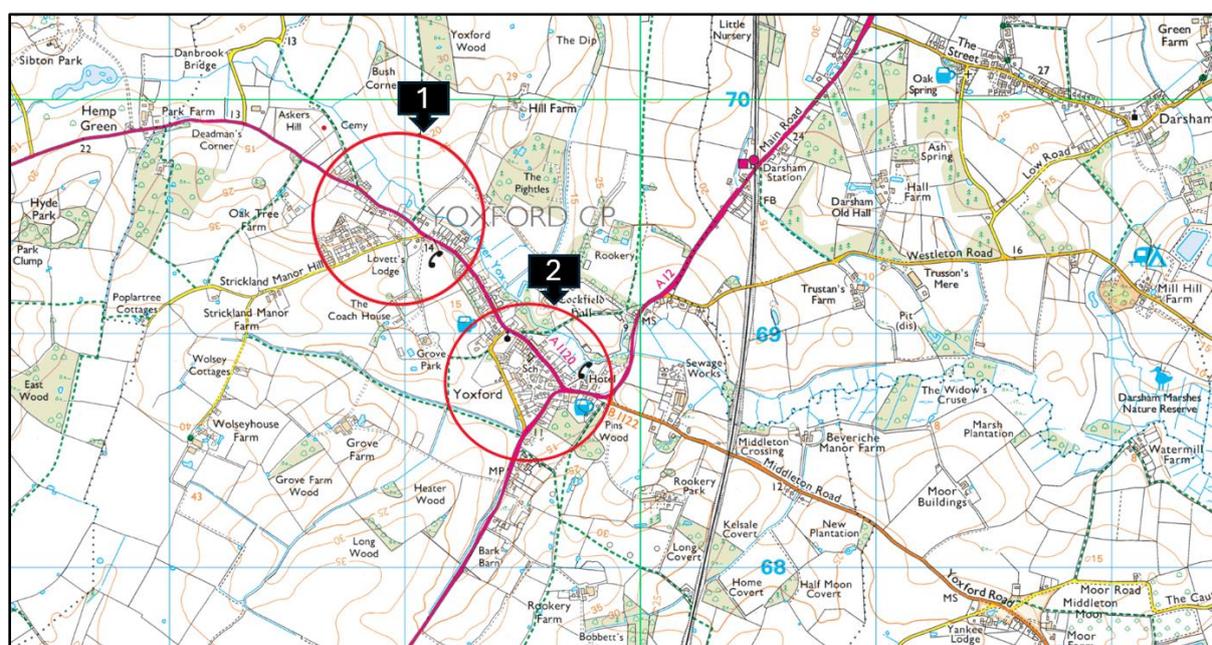
For the purposes of this investigation the various areas affected by flooding have been separated into two distinct locations (see Figure 4). The locations are as follows:

1. Little Street and The Lane
2. Old High Road, High Street and Brook Street

Figure 4. Yoxford investigation area map with locations

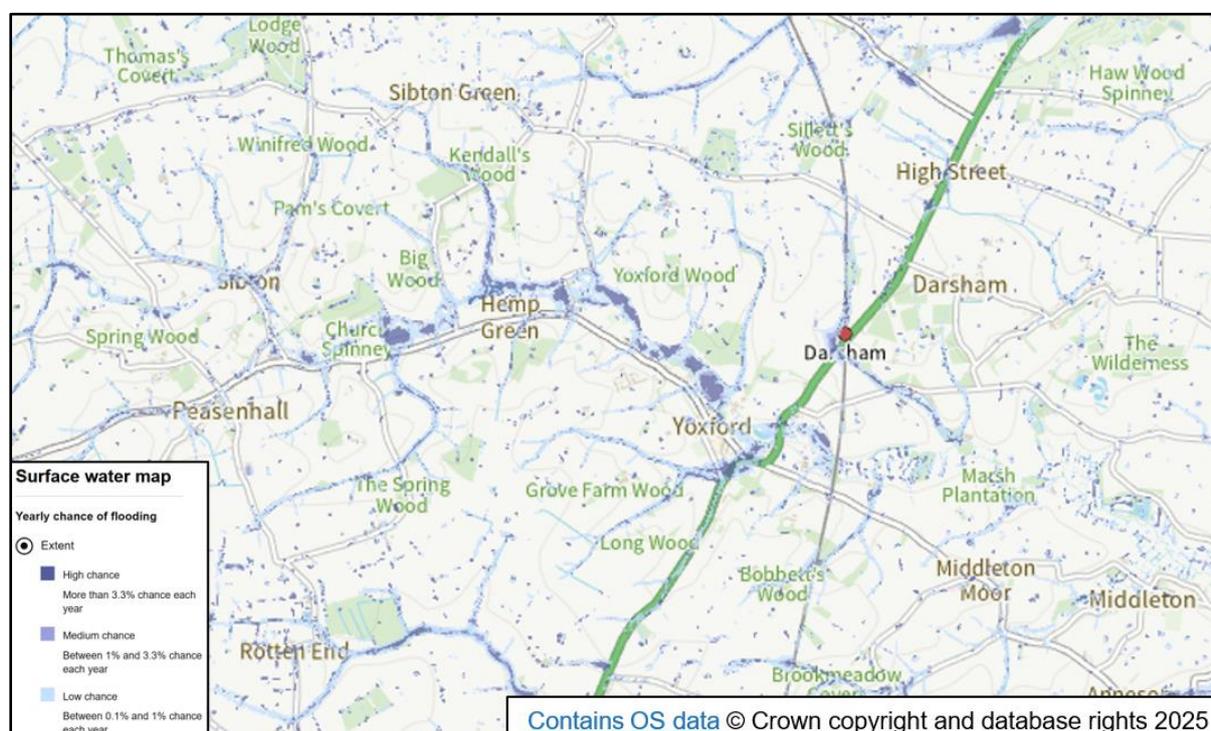
Figure 5. Surface water flood risk

The pluvial flood risk is prominent in the area around the junction of the A1120 and the A12 and on other sections of the A1120. Figure 5 highlights the pluvial (surface

water run-off from surrounding land and highways) flood risk in Yoxford. There are a number of isolated flow paths that come into the village from the west of the A1120 and A12, crossing the highway to reach the river Yox. Sections of Little Street, High Street, Old High Road and Brook Street are characterised as having a high chance of surface water flooding. These areas were significantly affected by flooding during Storm Babet.

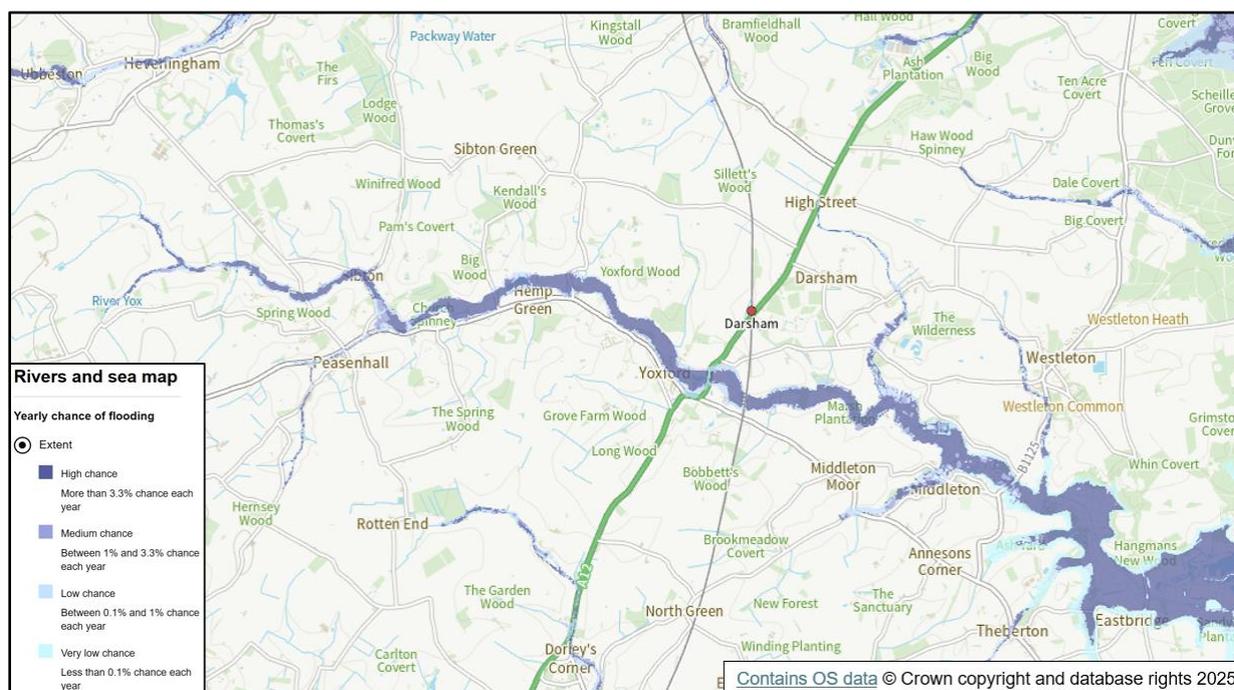
Figure 6. Flood risk from rivers and sea

Figure 6 shows the fluvial (from designated main river and ordinary watercourses) flood risk in Yoxford. Fluvial flood risk in the village is associated with the river Yox which flows through the village. In Yoxford, parts of The Lane, High Street and Brook Street are characterised as having a low chance of fluvial flooding. Some properties on High Street were affected by fluvial flooding during Storm Babet.

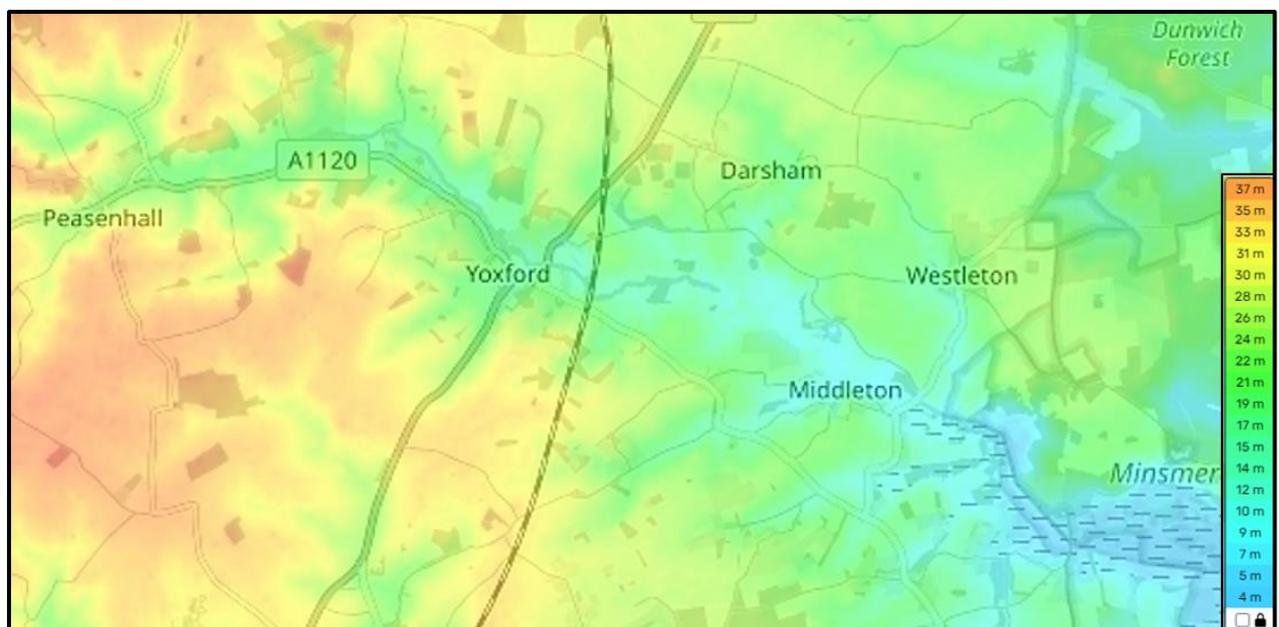
Figure 7 shows the topography and gradient changes surrounding Yoxford. The majority of the village is situated in the valley of the river Yox, lower than the surrounding land. The lowest point is along the section of the A12 close to the river crossing. This location was one of the worst affected areas during Storm Babet.

Figure 7. Yoxford and surrounding topography (TessaDEM as cited in topographic-map.com)

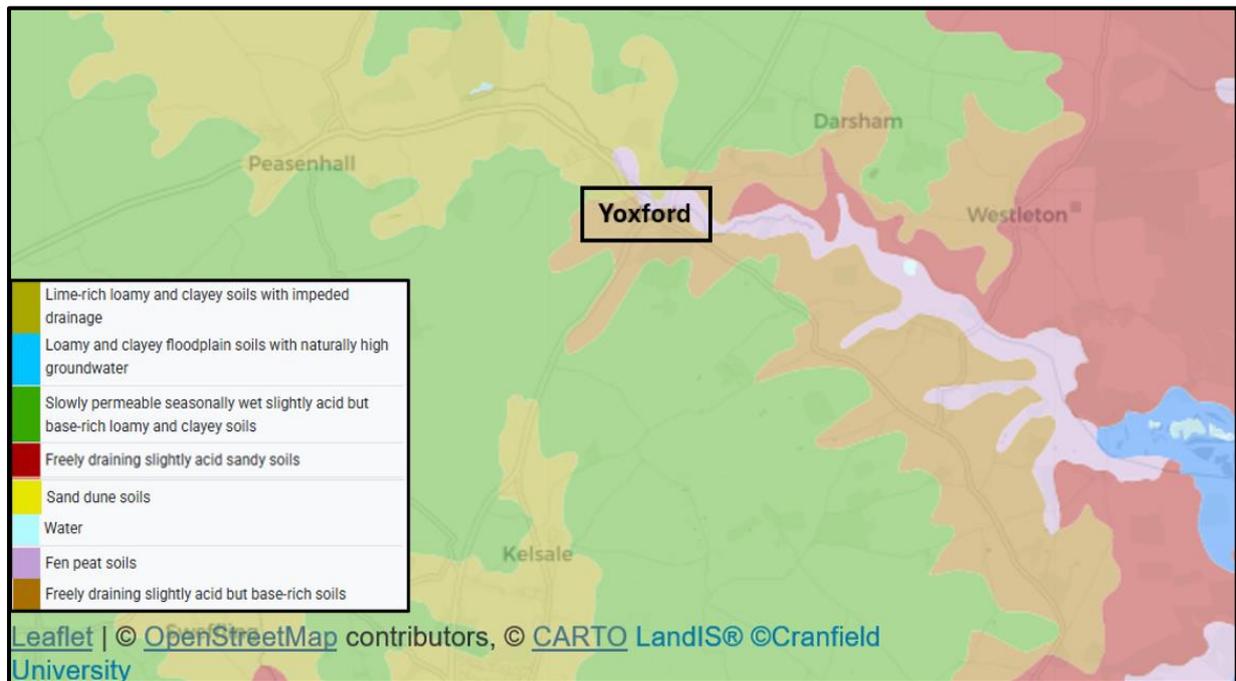
Figure 8. Soil map (LandIS Soils)

The soils more generally surrounding Yoxford are loamy and clayey which is described as slowly permeable and seasonally wet. The centre of the village is situated on a mixture of lime-rich loamy and clayey soils with impeded drainage, freely draining soils and floodplain soils surrounding the river Yox which usually have naturally high groundwater and tend to be wetter.

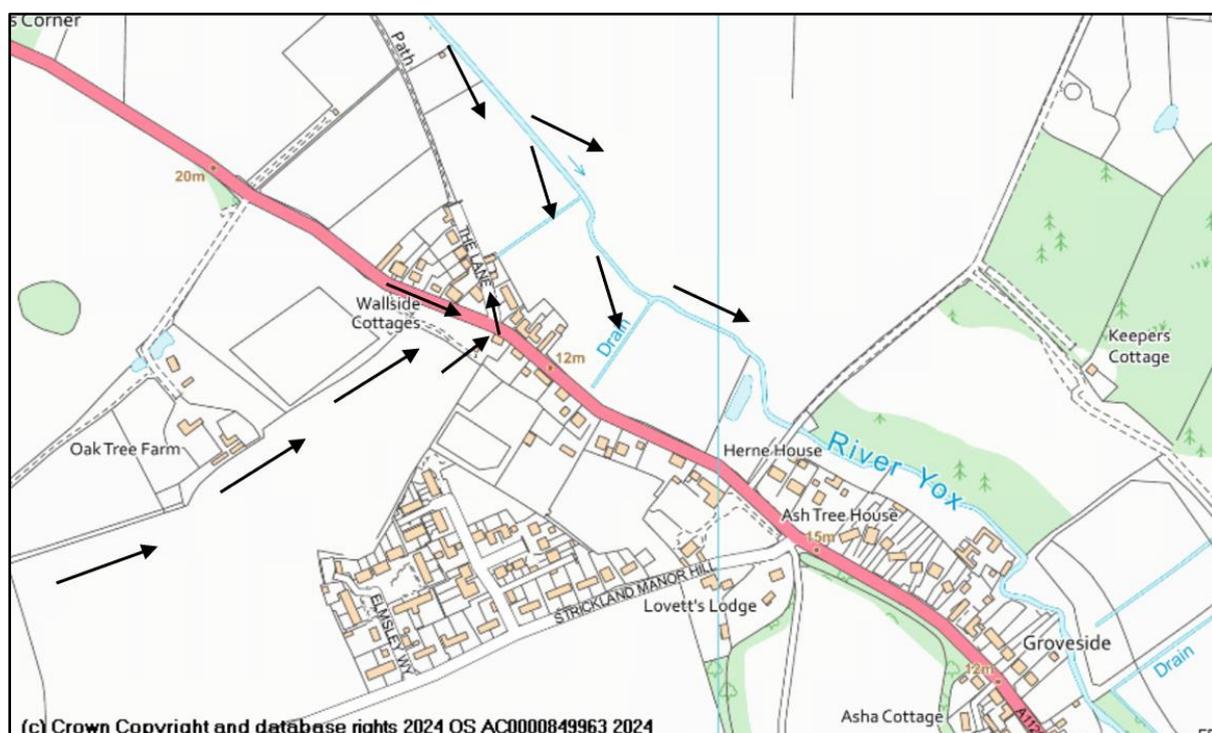
The primary cause of flooding on Little Street and The Lane was pluvial flooding. Following prolonged heavy rainfall on the morning of 20 October and the preceding two days, surface water flows running off the fields to the south of the A1120, crossed the A1120 and flowed onto The Lane (see Figure 9 & Image 2).

The surface water flows originated in the fields around and between Oak Tree Farm and Elmsley Way. Floodwater continued around and through gardens on Little Street impacting multiple properties from the side and rear. As the floodwater flowed in a torrent across the road, properties on The Lane were severely flooded from the front. Many of the properties are below road level with dropped kerbs in front, with the downward gradient from the road enabling the spread of the floodwater. Several residents commented on the sheer amount and velocity of water cascading off the upper fields, across the road and toward properties on The Lane. The highway was submerged (see Image 1).

Figure 9. Approximate flood water flow routes affecting Little Street and The Lane

- Residents to install Property Flood Resilience (PFR) via grant funded scheme.
- Investigate potential NFM projects to 'slow the flow' and attenuate water on overland flowpaths (leaky dams, restoration of watercourses, storage ponds etc.) in the fields south of the A1120 opposite The Lane.
- Suffolk Highways to ensure the completion of highway drainage asset cyclic maintenance on the A1120 and on The Lane.
- Riparian landowners to carry out appropriate watercourse maintenance to reduce flood risk as necessary as per their riparian responsibilities.

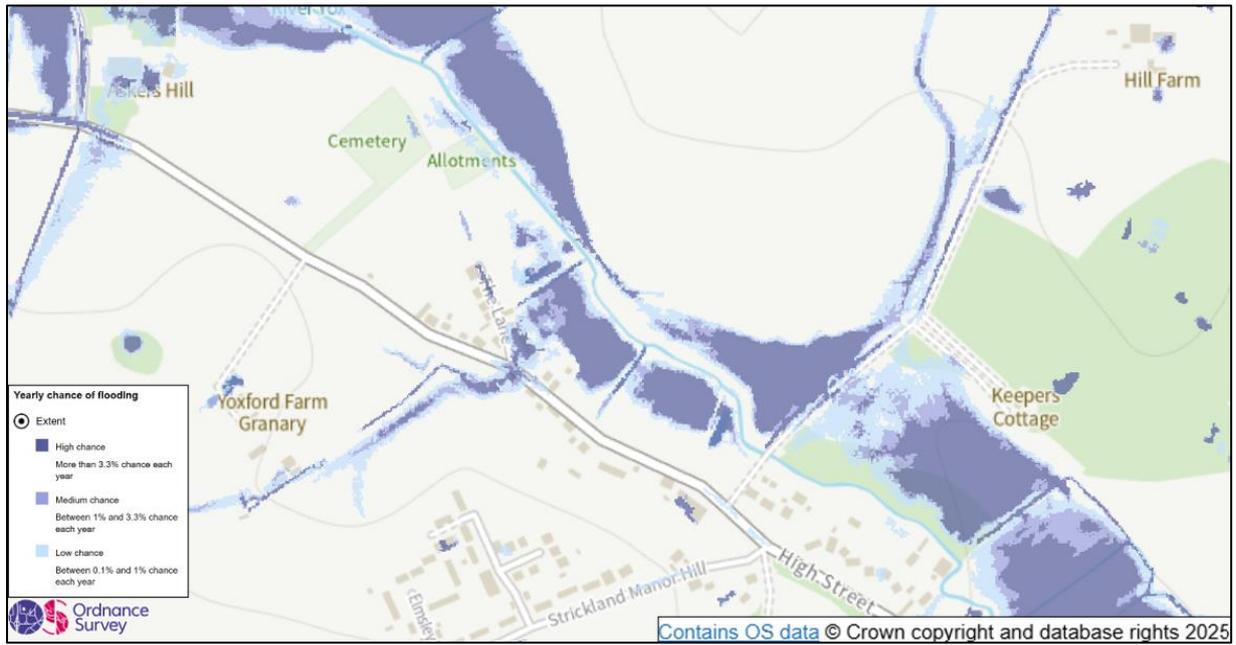
The observed surface water flowpaths that directly affected properties on The Lane correlate closely with the surface water flood risk national mapping (see Figure 10). This is characterised as having a high chance of flooding each year.

Figure 10. Surface water flood risk on Little Street and The Lane

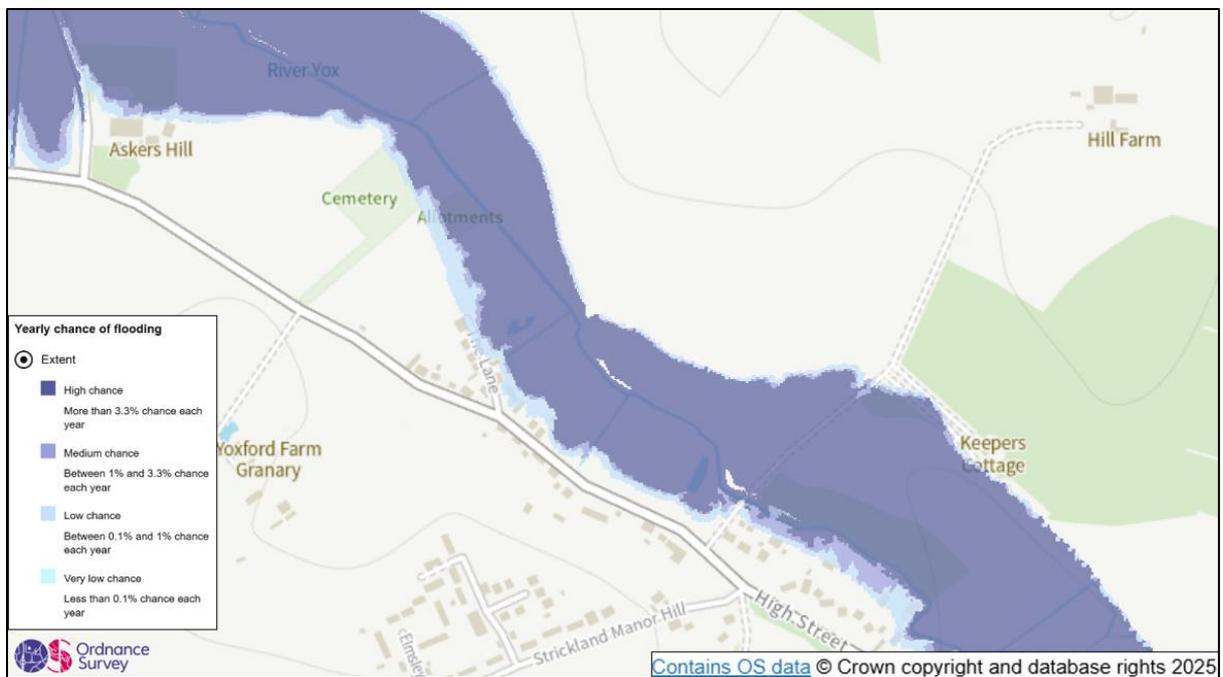
It should be noted that properties in this location did not flood directly from the River Yox, but water levels were very high and rising into the fields behind the properties on The Lane. Fluvial flooding risk on The Lane is shown on Figure 11 below.

Figure 11. Flood risk from rivers and sea on Little Street and The Lane

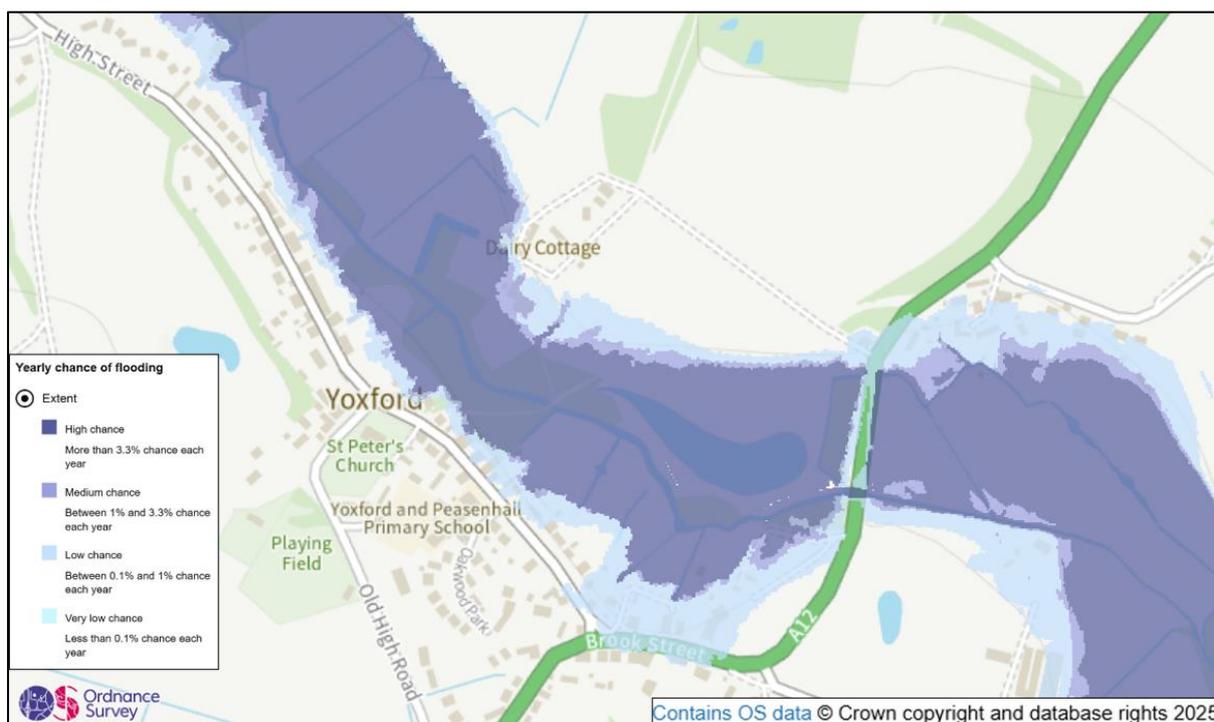
As the river overtopped its banks the floodwater travelled along the drainage channels into the lowest situated properties. Flood risk to properties along the High Street range from a low to high chance of flooding from the river each year (see Figure 12).

Figure 12. Flood risk from rivers and sea on High Street and Brook Street

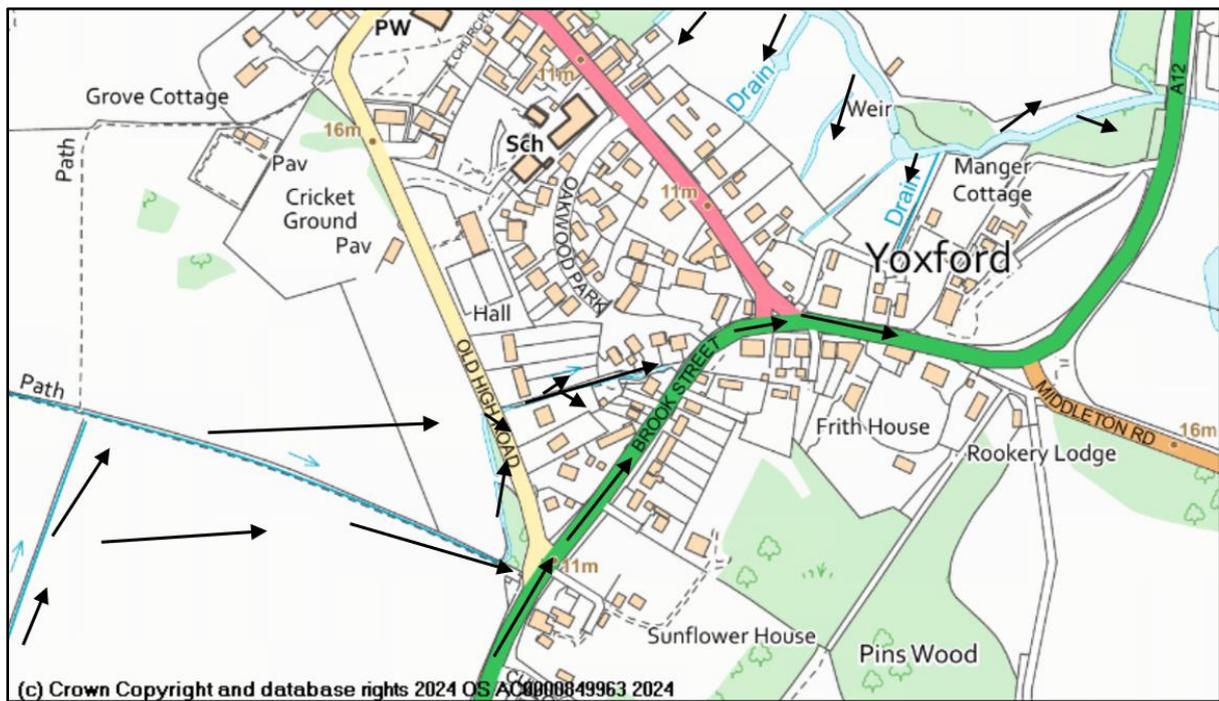
Properties were then flooded internally on Old High Road as the watercourse was overwhelmed and floodwater flowed through rear gardens (see Figure 13).

Figure 13. Approximate flood water flow routes affecting Old High Road, High Street and Brook Street

- Residents to install Property Flood Resilience (PFR) via grant funded scheme.
- Investigate potential NFM projects to 'slow the flow' and attenuate water on overland flowpaths in the fields (leaky dams, restoration of watercourses, storage ponds etc.) west of Old High Road and the A12 Main Road.
- Riparian landowners to carry out appropriate watercourse maintenance to reduce flood risk as necessary as per their riparian responsibilities.
- The Environment Agency to investigate if additional in channel maintenance of the river Yox through Yoxford is required.
- Suffolk Highways to ensure the completion of highway drainage asset cyclic maintenance on Old High Road and the A1120 / A12 junction.

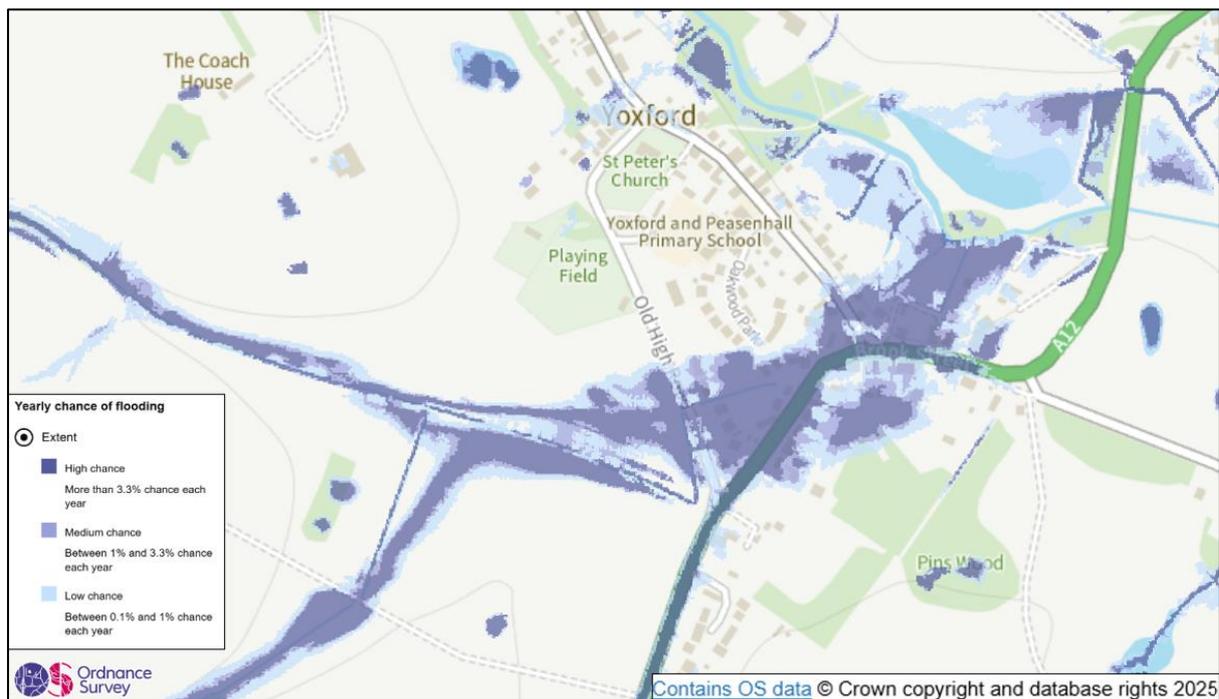
Figure 14. Surface water flood risk on Old High Road, High Street and Brook Street

A wide area centred around the A1120 / A12 junction is considered to be at a High yearly chance of surface water flooding (see Figure 14 & Image 5). The flood extents shown on the national flood mapping closely matches the observed floodwater limits seen during Storm Babet.

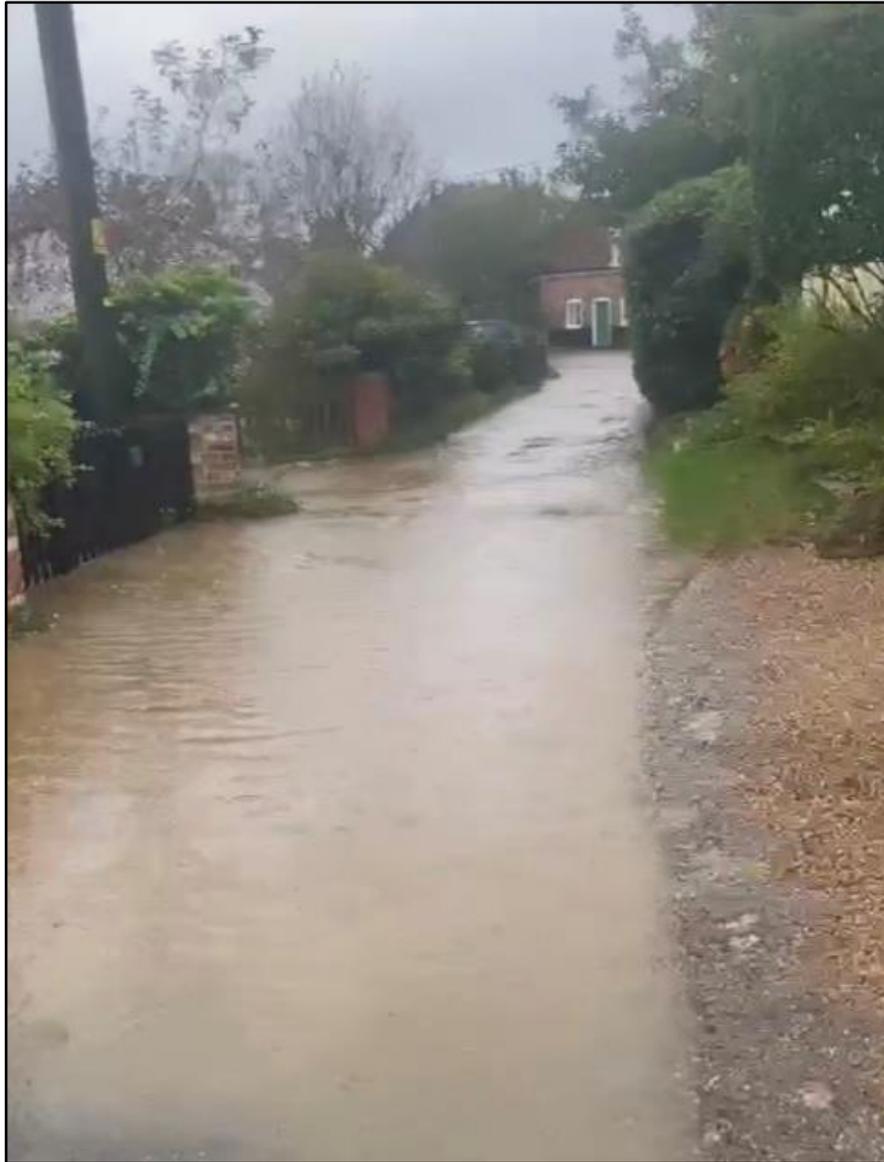
Image 1. Flooding on The Lane

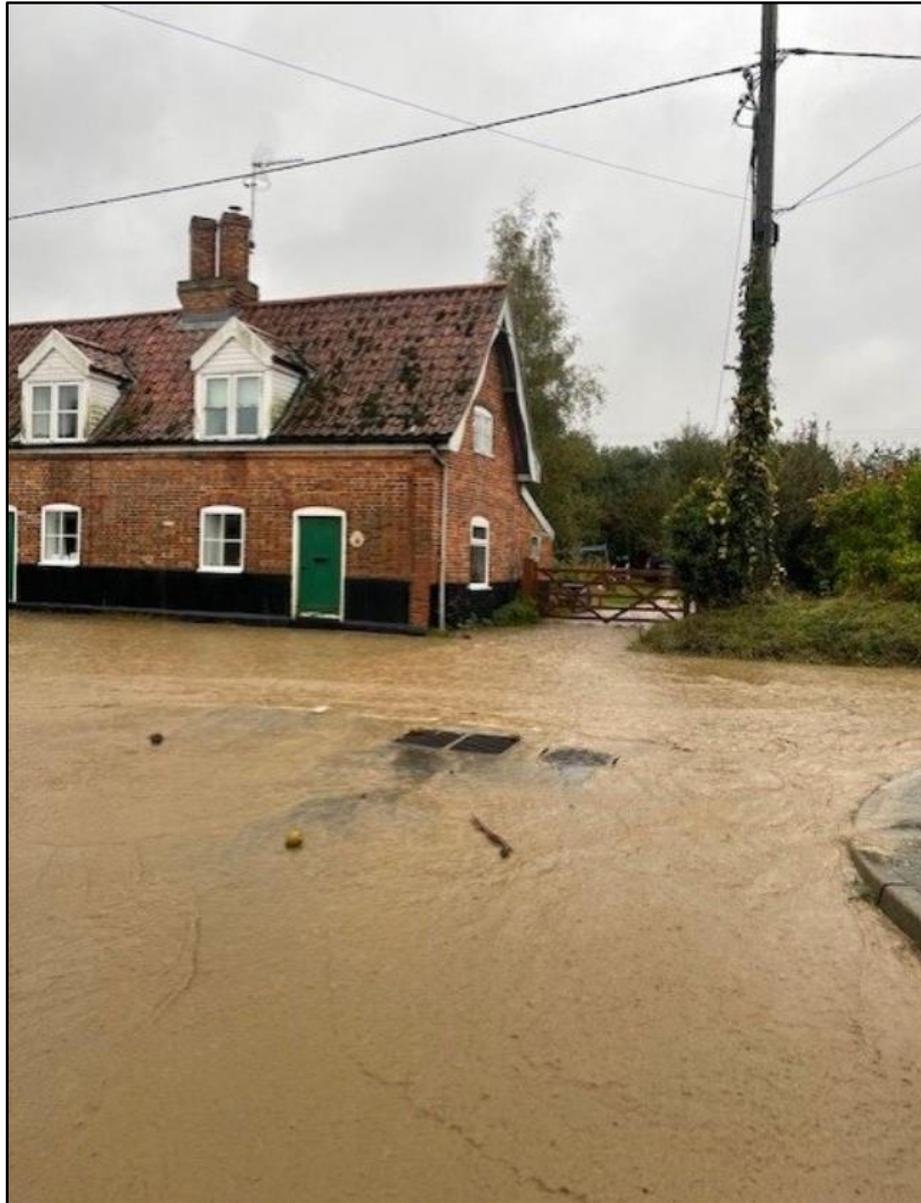
Image 2. View from The Lane onto the A1120

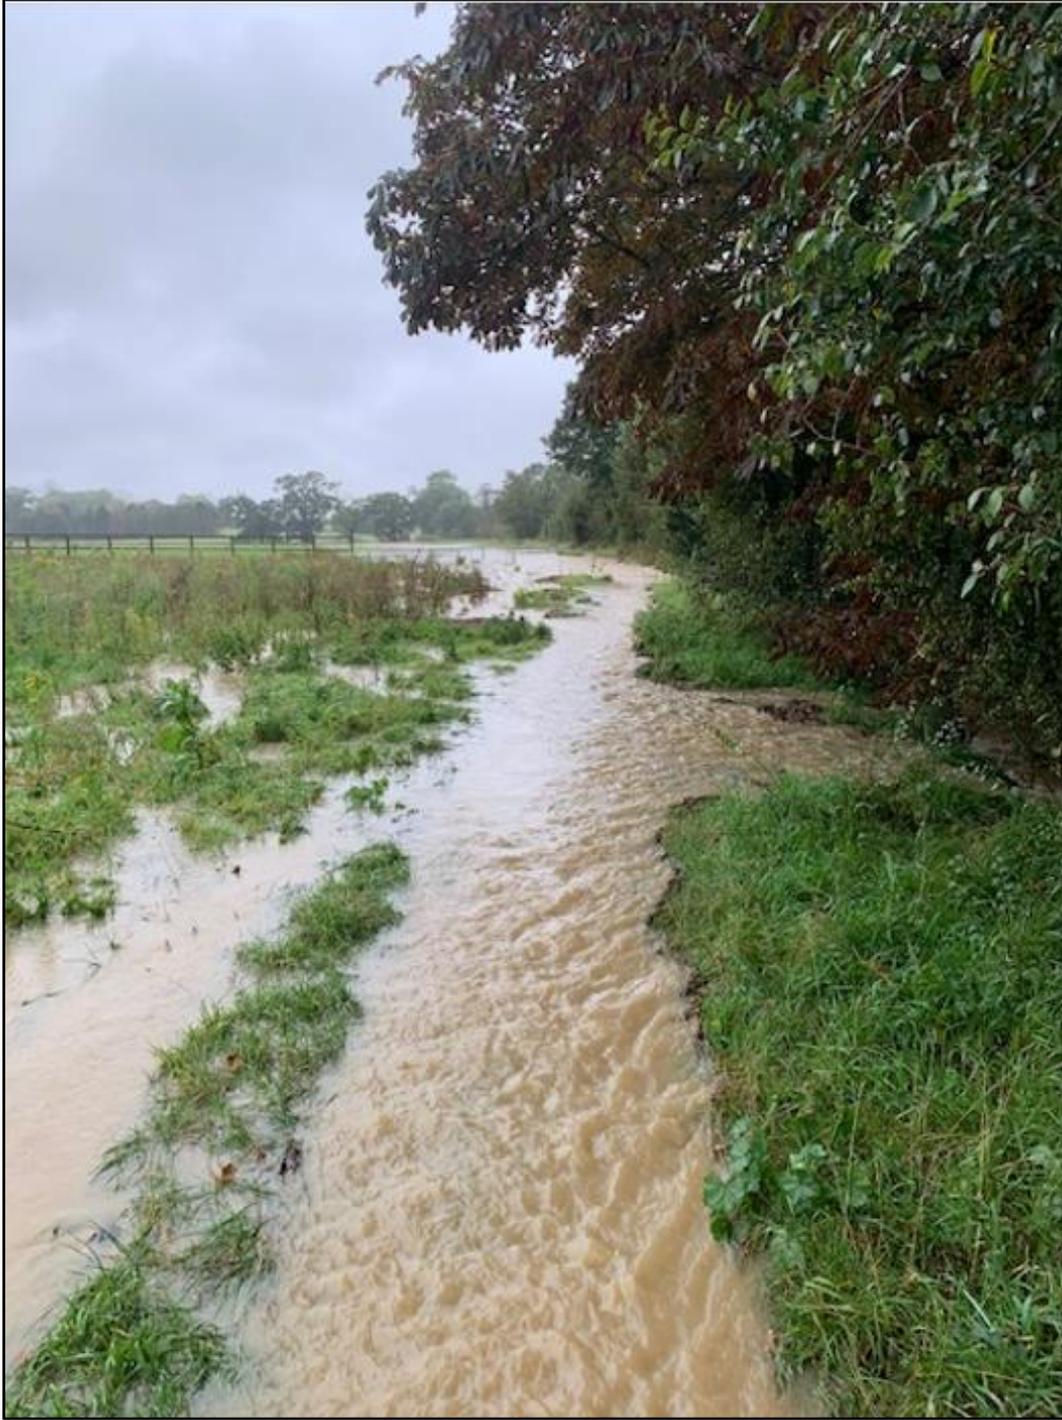
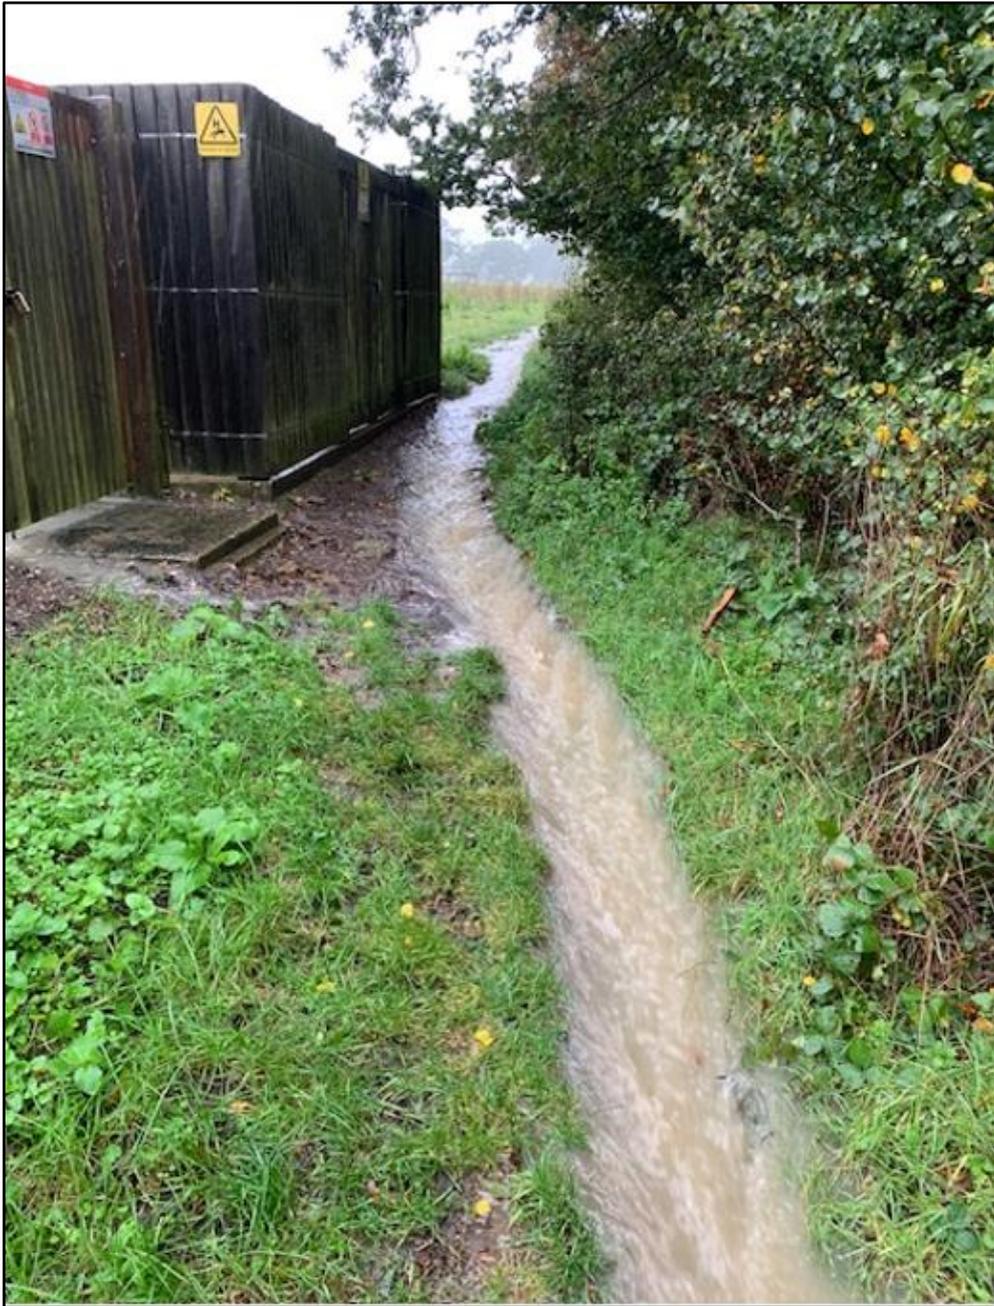
Surface water flowed from the five fields area (west of A12) along the footpath onto the A12 / Brook street from 11am onwards (Images 3 & 4). These surface water flows overwhelmed the capacity of the small roadside ditch. The amount of floodwater pooling along the highway rapidly exceeded the capacity of the existing drainage assets.

Image 3. Surface water flows on field west of the A12

Image 4. Surface water flowing on footpath toward the A12

Explore potential NFM projects to 'slow the flow' and attenuate water on overland flow paths in the fields west of Old High Road and the A12 Main Road E.g. leaky dams, woody debris installation, restoration of watercourses, storage ponds, wetland areas	Landowners, supported by relevant authority, resource dependant (SCC LLFA, EA, IDB)	12 - 24 months	Ongoing – No updated expected at this time.

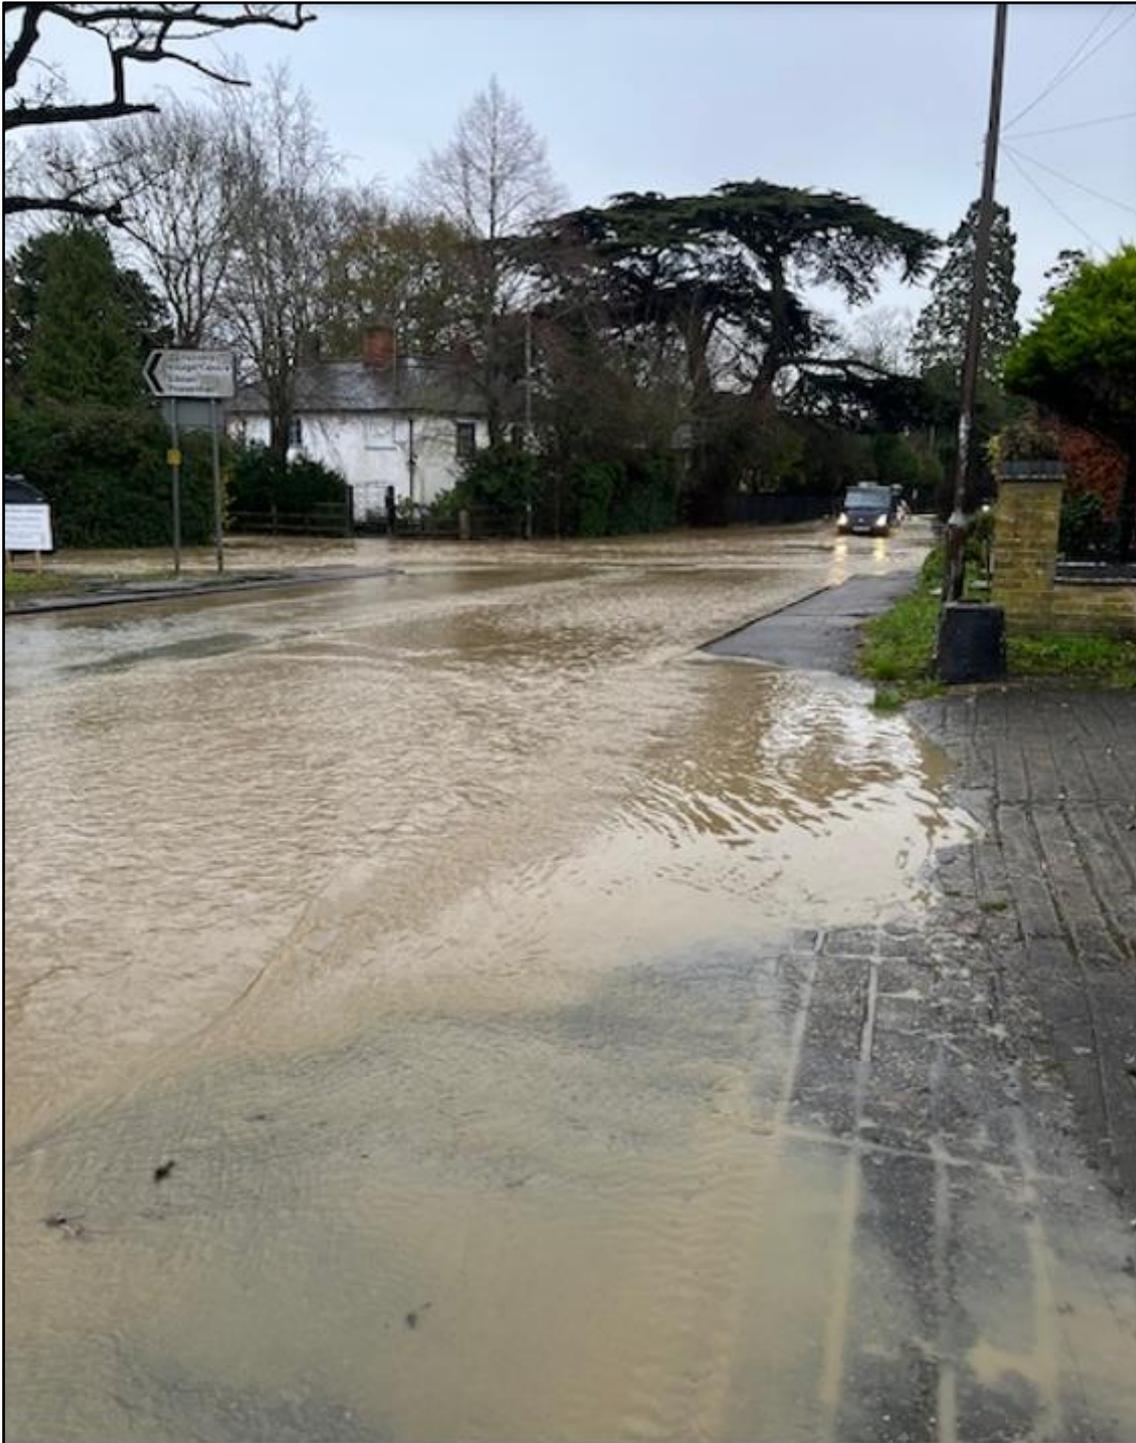
Image 5. Flooding on the A1120, A12 junction

Suffolk Highways to ensure the completion of highway drainage asset cyclic maintenance on Old High Road and the A1120 / A12 junction	Suffolk Highways	Annually	Complete - Update from Suffolk Highways: All assets were cleaned and jetted. They are running as expected. No further work is needed currently.
Riparian landowners to carry out appropriate watercourse maintenance to reduce flood risk as necessary as per their riparian responsibilities.	Riparian landowners	N/A	Update from Yoxford Parish council: Residents and landowners have been fully informed and reminded about their riparian rights and obligations in respect of watercourses.
Medium Term Actions (e.g. longer planning timescales and potential need to source funding but potential for greater impact)			
Explore potential NFM projects to 'slow the flow' and attenuate water on overland flow paths in the fields south of the A1120 opposite The Lane E.g. leaky dams, woody debris installation, restoration of watercourses, storage ponds, wetland areas	Landowners, supported by relevant authority, resource dependant (SCC LLFA, EA, IDB)	12 - 24 months	Ongoing – No updated expected at this time.

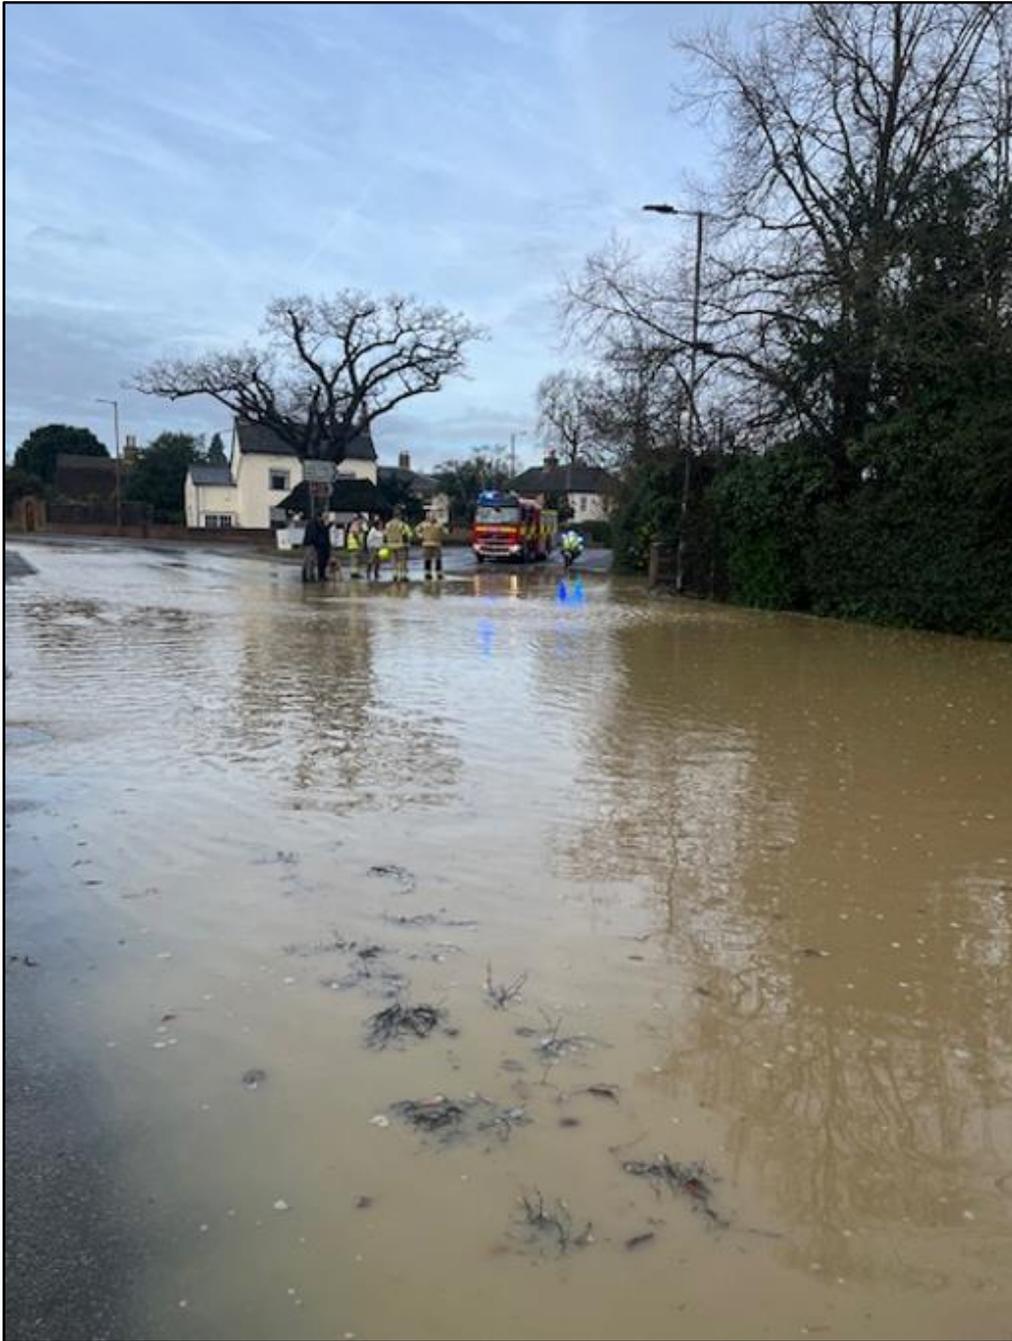
A property on Brook Street was flooded directly from the highway (see Image 6). As the extent of the floodwater grew throughout the morning into early afternoon, water entered through the air grates and the front door. Residents stated that at the time of Storm Babet, some of the highway drainage assets in and around the A1120 / A12 junction were blocked and or not fully operational.

Image 6. Flooding on Brook Street
