## Section 19 Flood and Water Management Act 2010

### Witnesham & Swilland Flood Investigation –

### Storm Babet 2023

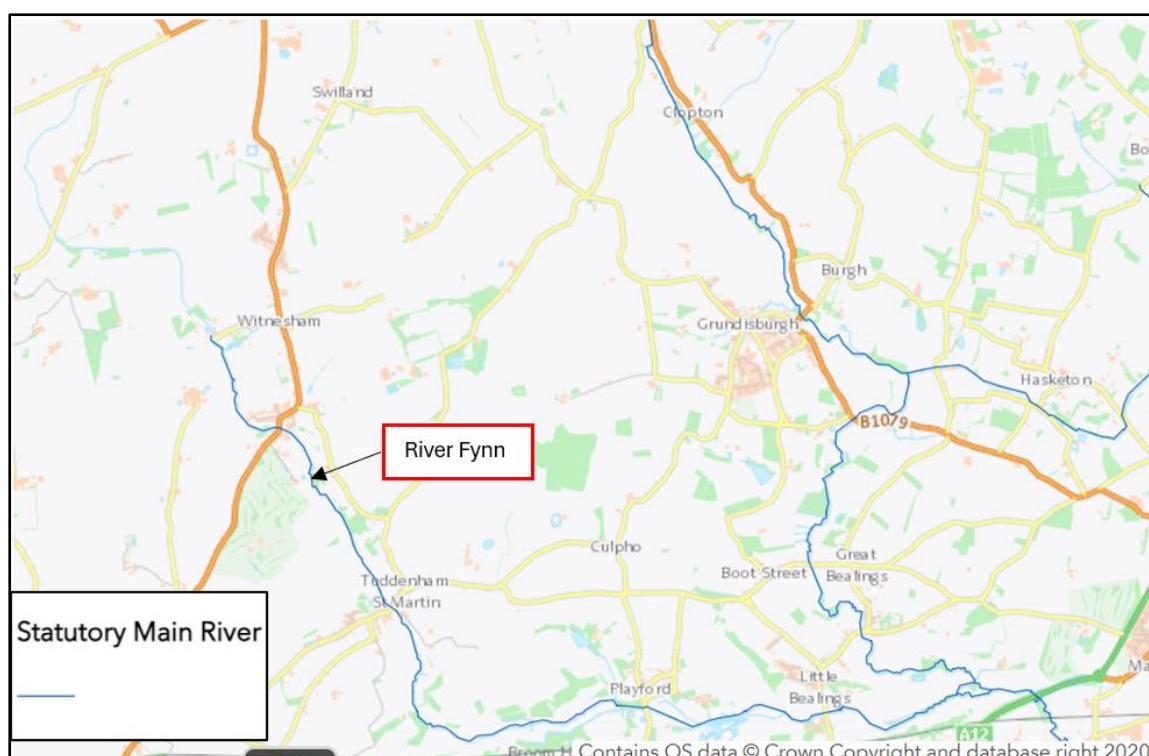
*Figure 3. Location of statutory main rivers and significant ordinary watercourses*

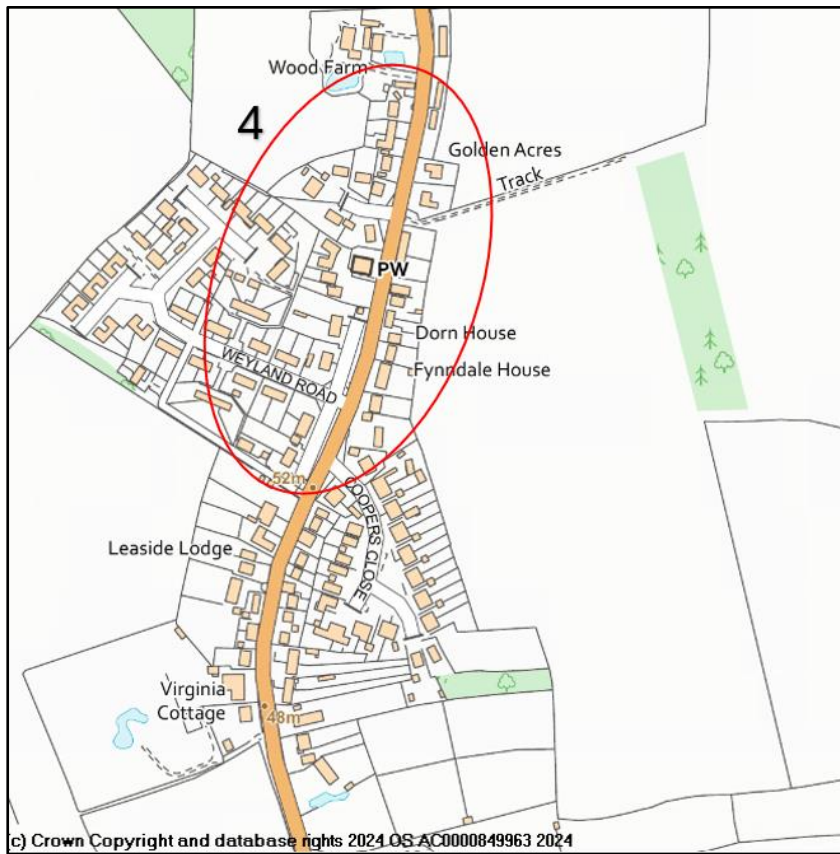
Figure 5. Witnesham investigation area map with location (2)

For the purposes of this investigation the various areas affected by flooding have been separated into five distinct locations (see Figures 4, 5 & 6). The locations are as follows:

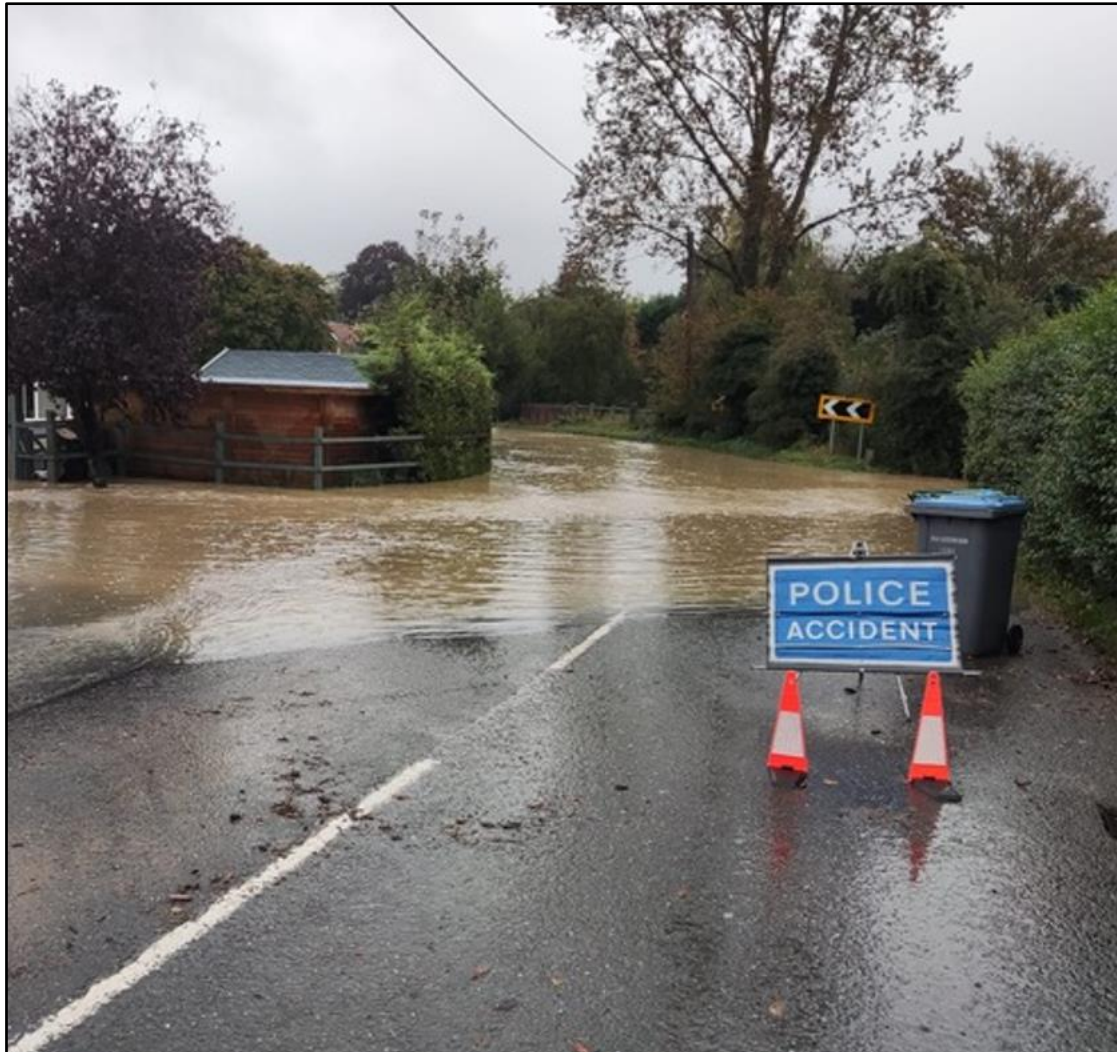
*Image 1 - Looking north towards River Fynn road bridge*

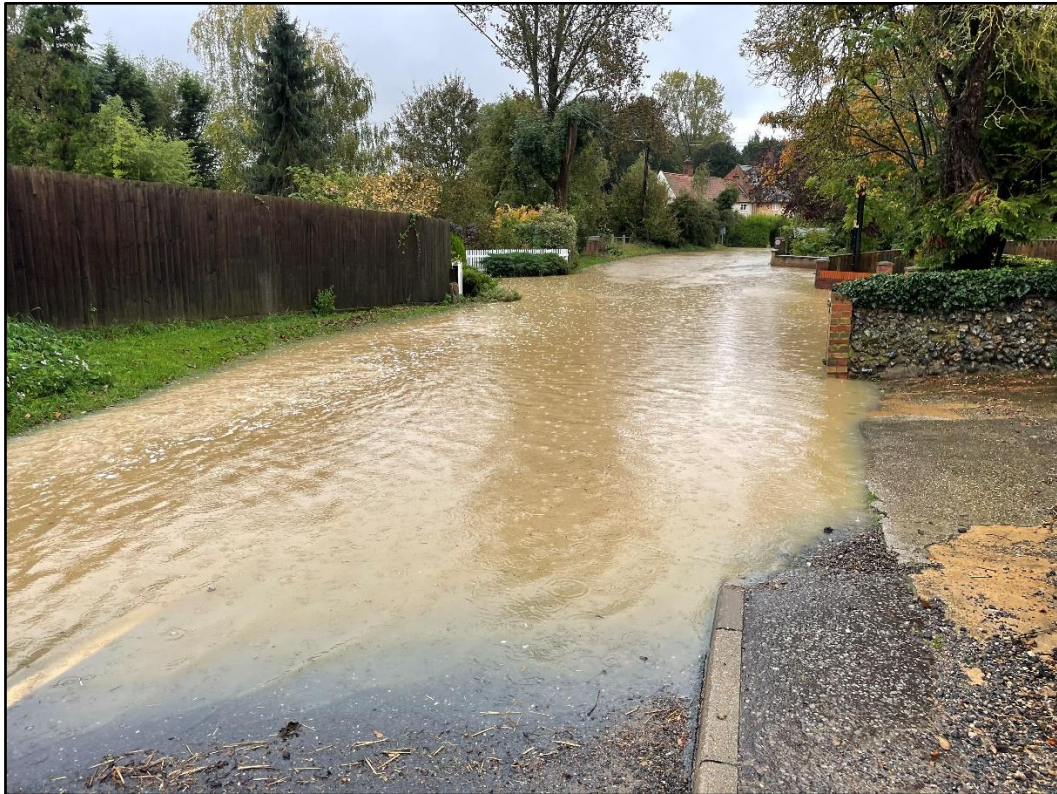
*Image 2 - Looking south towards River Fynn road bridge*

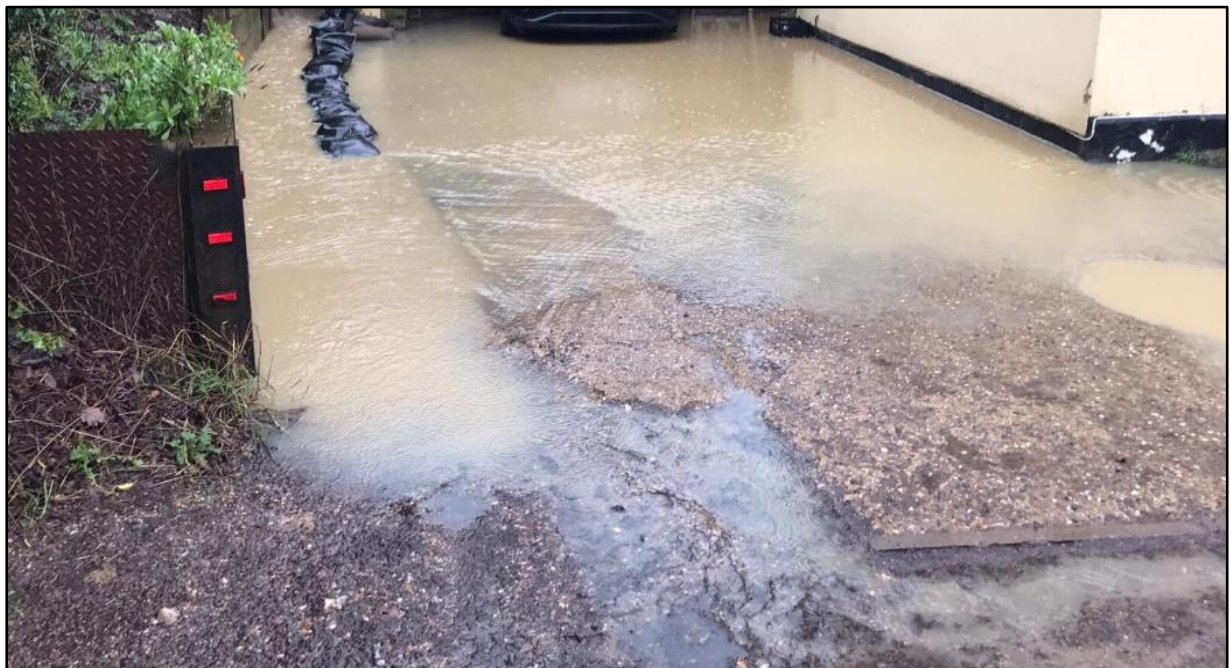
front and side as the capacity of the culvert below the road was exceeded (see Image 3). There is a culvert under Tuddenham with a restricted inlet from the upstream watercourse. It was reported that the culvert may have been partially blocked or damaged during the event. The small inlet connection from the channel into the culvert likely acted as a particular pinch point, due to its size, reducing the ability of the pipe to convey the floodwater. The floodwater on Tuddenham Lane reached its highest level sometime between 10 – 11am.

*Image 3 - Watercourse overflowing onto Tuddenham Lane*

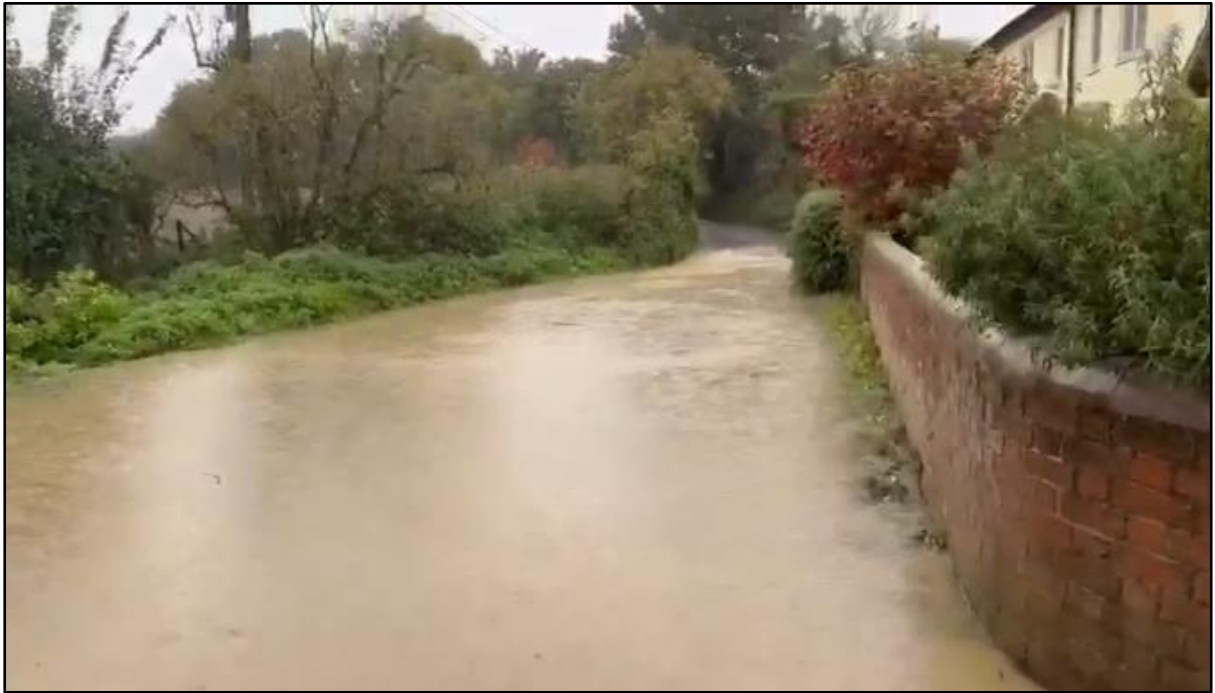
The floodwater on the highway was unable to drain away, as the highway gullies and kerb offlets were blocked up with silt (see Image 4). The roadside ditch was overgrown with vegetation reducing conveyance capacity, and it overflowed further adding to the floodwater (see surface water flood risk on Tuddenham Lane, Figure 16). This ditch has been subsequently cleared post Storm Babet, with the blocking vegetation and debris removed.

*Image 4 - Floodwater on Tuddenham Lane*

| CCTV the culvert below Tuddenham Lane from the watercourse connection to the brick outfalls, to check for blockages, capacity size and or defects and fully establish the drainage routes. | SCC Highways Authority | 12 - 24 months | No update expected at this time |

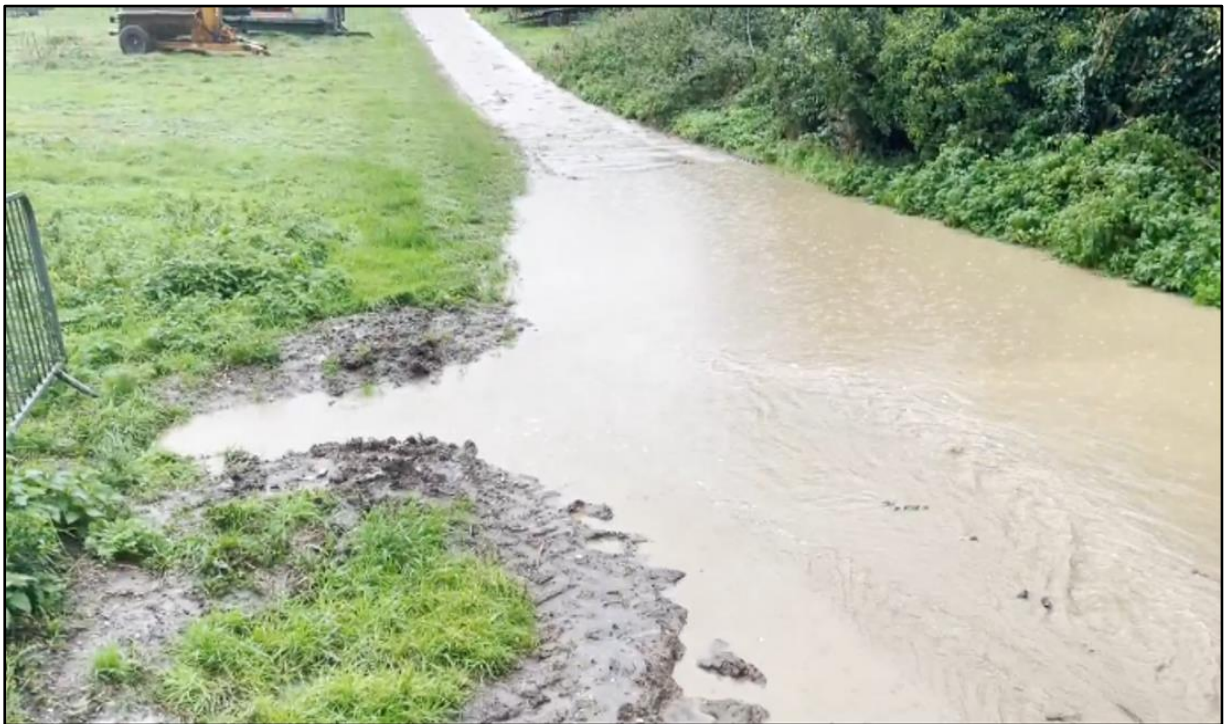
*Image 5 - Surface water runoff from Witten's Meadow construction site towards Mow Hill (photo looking southwest)*

The large amount of surface water which was unattenuated on site in the absence of the surface water management features which had not been constructed before any other development began was observed flowing south into The Gull and accumulating at the entry into the piped watercourse. This was immediately recognised as a potential contribution to the flooding.

| Introduce pro-active observation of Construction Surface Water Management Plan compliance when developments commence (as per updated condition above). Ensure developers better communicate their implementation of mitigation. | SCC LLFA, East Suffolk Council – Local Planning Authority | 6 months | <p><b>Ongoing</b></p> <p>Work is ongoing by SCC LLFA to introduce a pre-commencement trigger to the Construction Surface Water Management Plan (CSMWP) condition. This will ensure the start of works is clearly identified, allowing us to proactively monitor CSWMP implementation—particularly on high-risk sites.</p> |

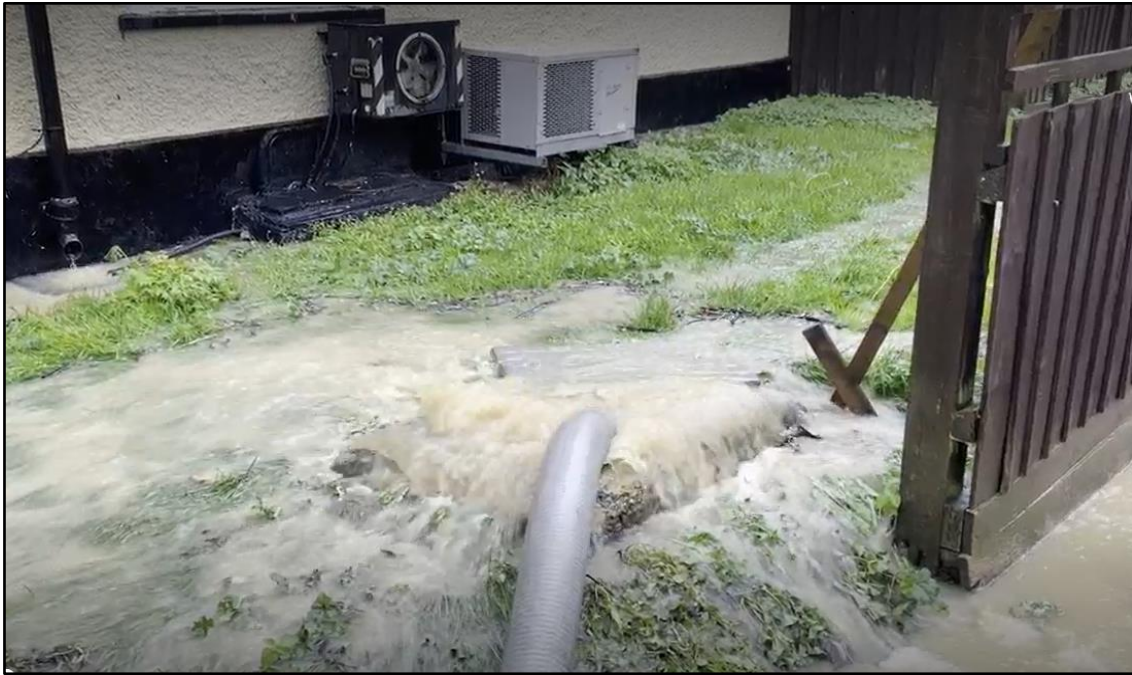
The amount of water flowing into the piped watercourse far exceeded its capacity, resulting in floodwater surcharging from manhole covers along its length and directly flooding adjacent properties from the front (see Image 6). Significant internal flooding of the properties began from late morning onwards, with highest floodwater levels reported around 2pm. Some properties were entirely surrounded by the floodwater.

*Image 6 - Surcharging manhole outside Barley Mow public house*

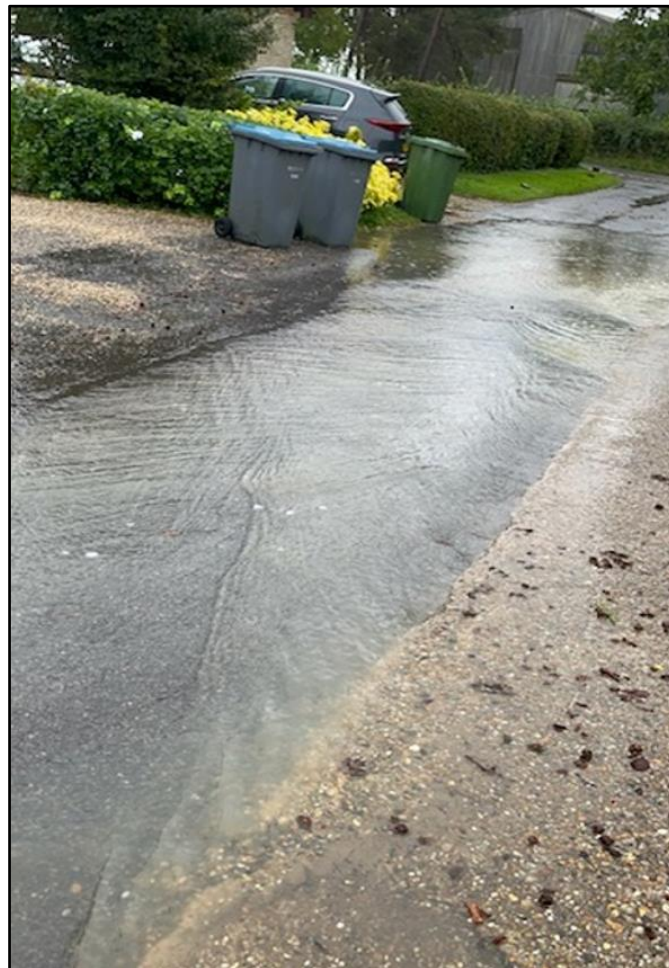
*Image 7 - Surface water flowing along Church Lane, Swiland*
