# Section 19 Flood and Water Management Act 2010

## Report Title: Northgate Street, Bury St Edmunds

CRNos. 371158, 372158, 287916, 286701 & 287916

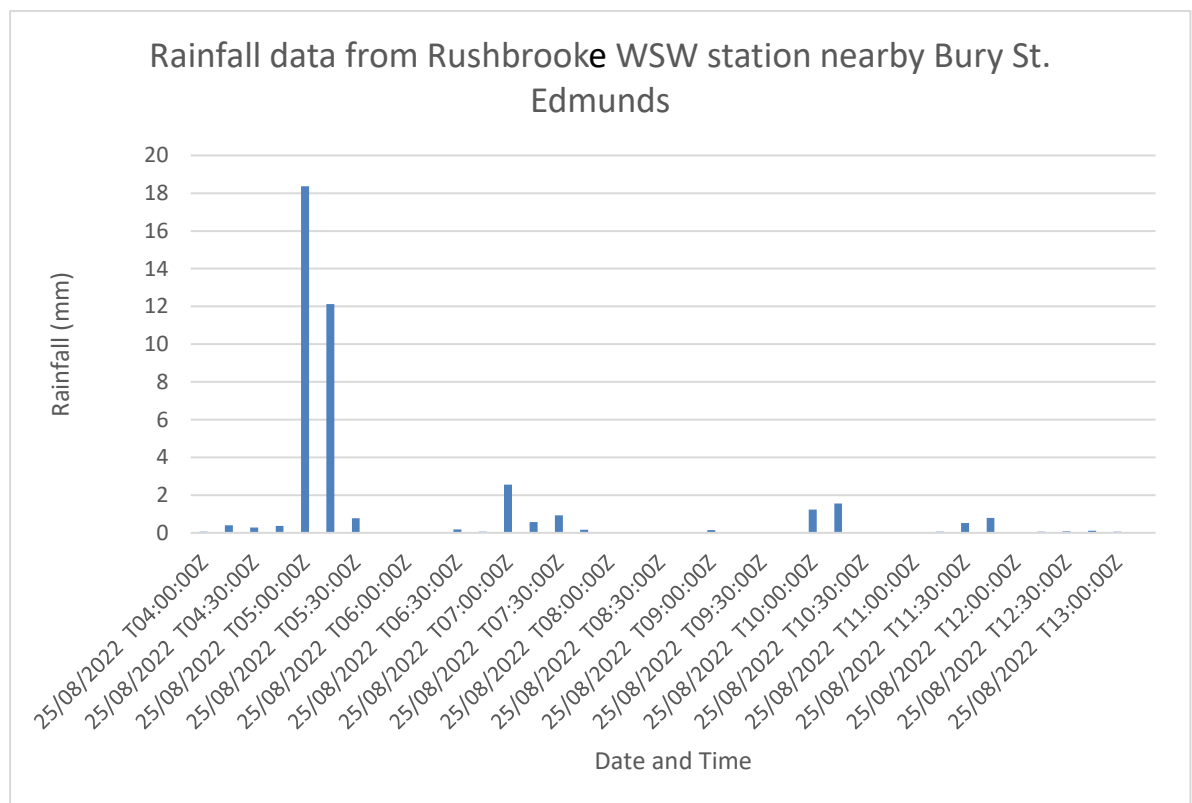
- 42mm within 9 hours from 04:00 to 13:00
- 18mm within 15 minutes at its peak
- 30mm within 30 minutes from 05:00 – 05:30

*Table 1: Rainfall data from Rushbrooke WSW station nearby Bury St. Edmunds on the day of the event*

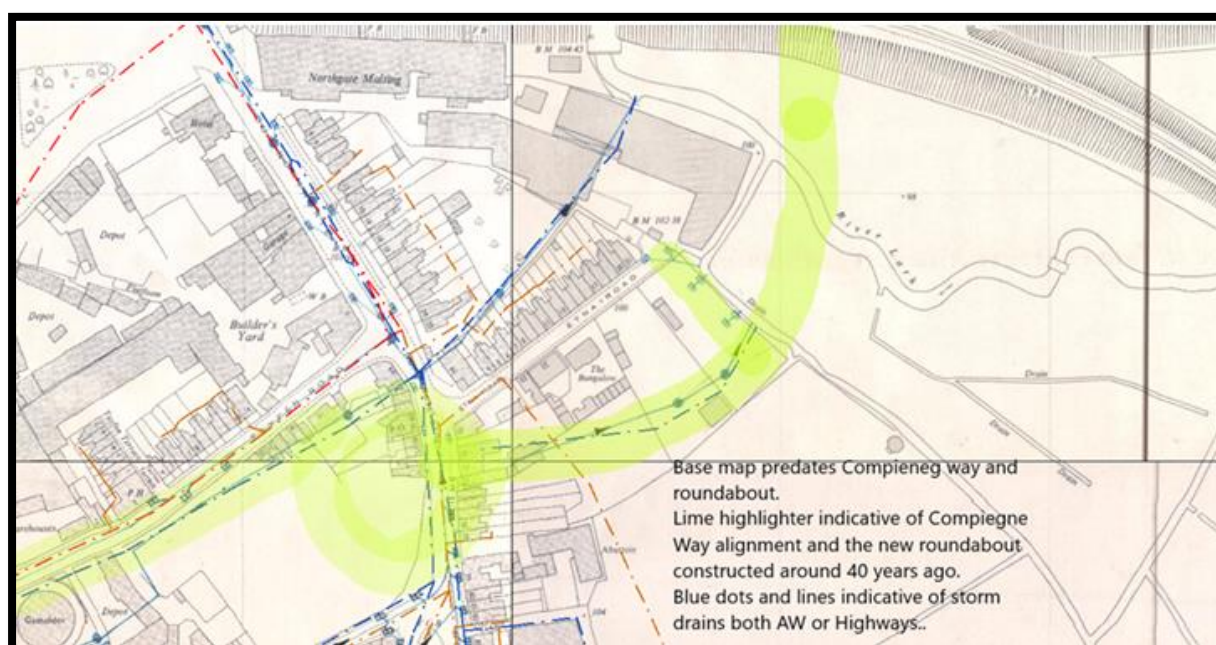
*Figure 2: A Map showing the proposed construction of Compiegne Way with the blue dots representing storm drains, both Anglian water and Highways assets.*

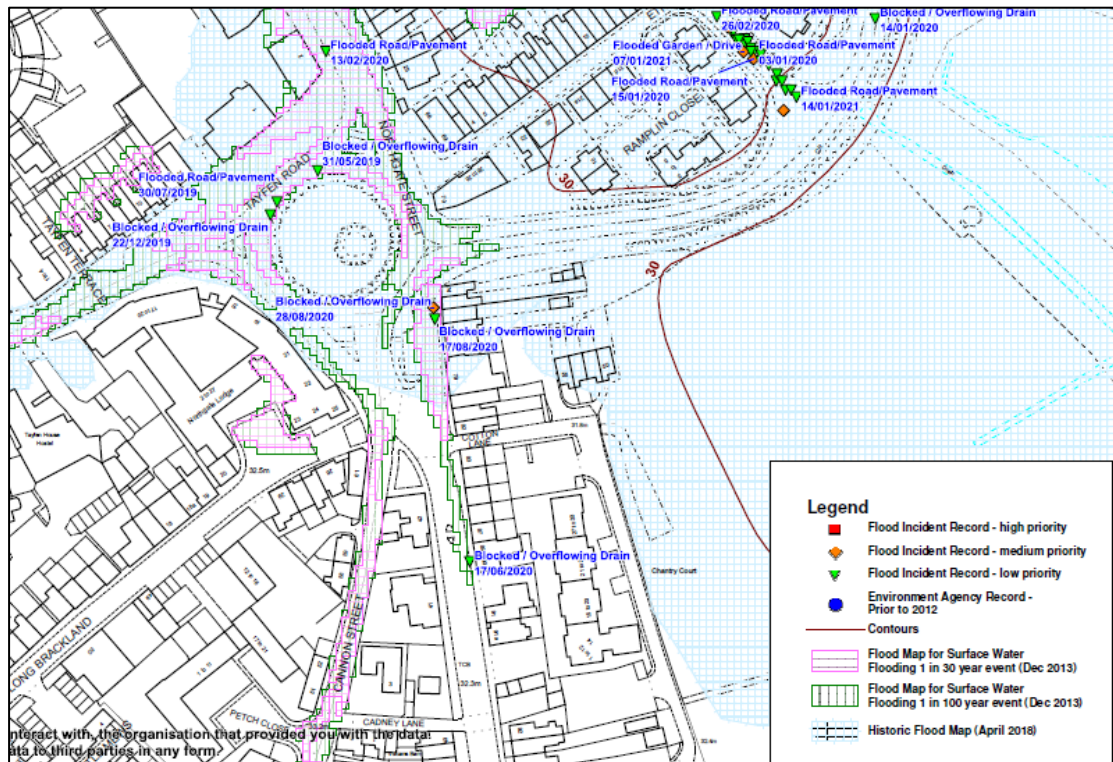
The Environment Agency 'Long Term Flood Risk' (<https://check-long-term-flood-risk.service.gov.uk/map>) maps identify that neither tidal (sea) or fluvial (river) flooding represent a significant risk in this location. Pluvial (surface water) flooding however is recorded to represent a high risk at this location (>3.33% annual chance of flooding). Additionally, there is a risk of these properties being affected by reservoir flooding, although we know that not to be a cause of this event.

Figure 3: An extract of the map showing the pluvial flood risk, focused in on the target area, the full map can be found at the end of this document.
