## Section 19 Flood and Water Management Act 2010

### Bredfield Flood Investigation

#### Storm Babet 2023

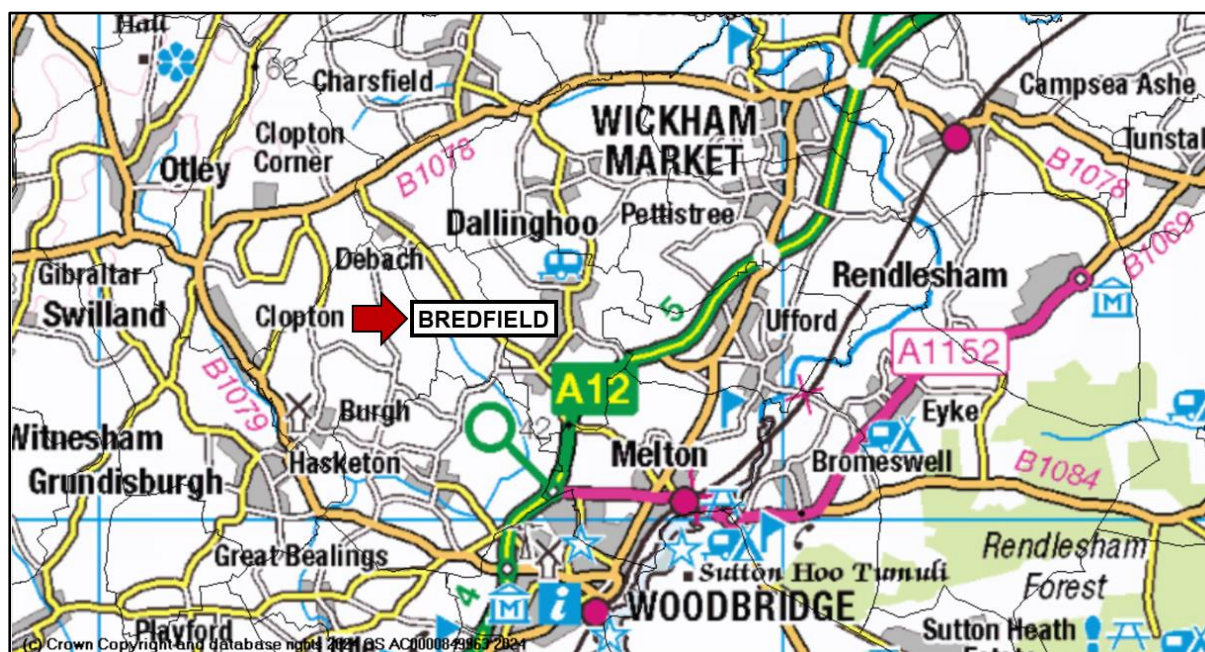
**Fig. 2. Investigation area map**

The village of Bredfield is located in the district of East Suffolk District Council, approximately 2½ miles north of the town of Woodbridge and 2½ miles southwest of the village of Wickham Market (Fig. 2).

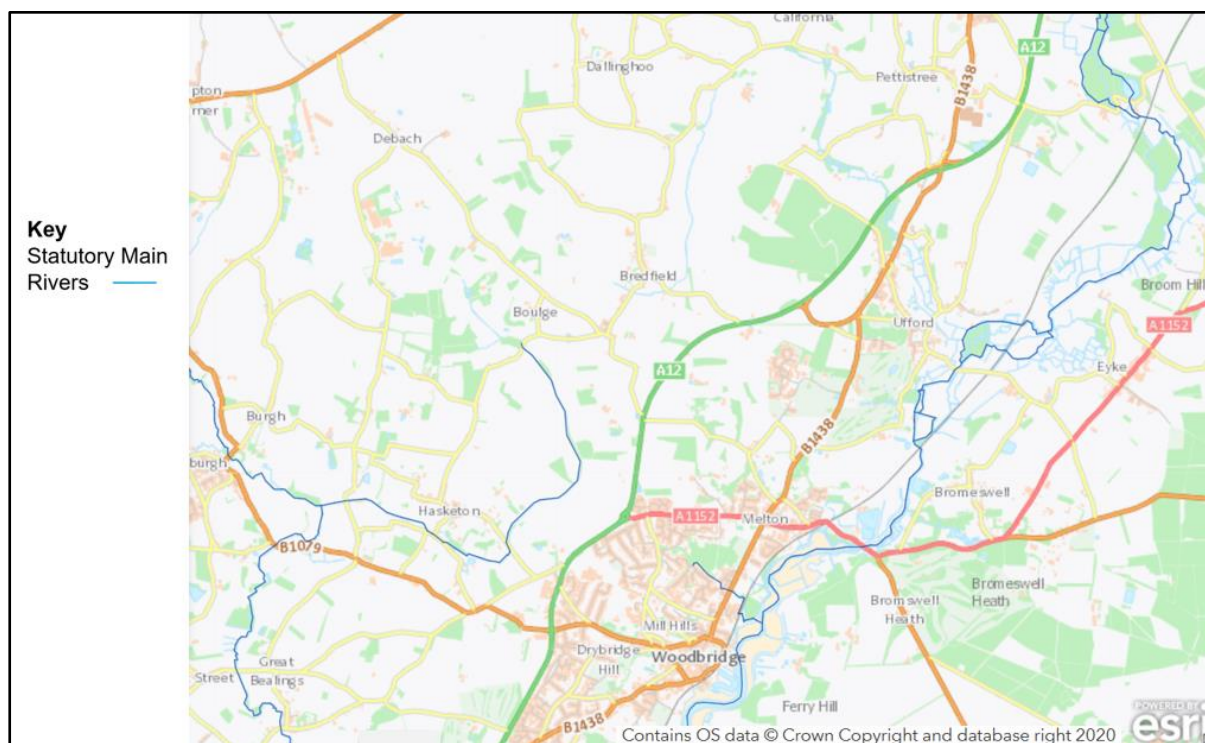
**Fig. 3 Location of statutory main rivers**

Figs. 3 and 4 show the location of main rivers and significant ordinary watercourses in the vicinity of Bredfield. Main rivers did not have a role in the observed flooding, but ordinary watercourses, including Byng Brook, did have a role in the flooding at Bredfield.

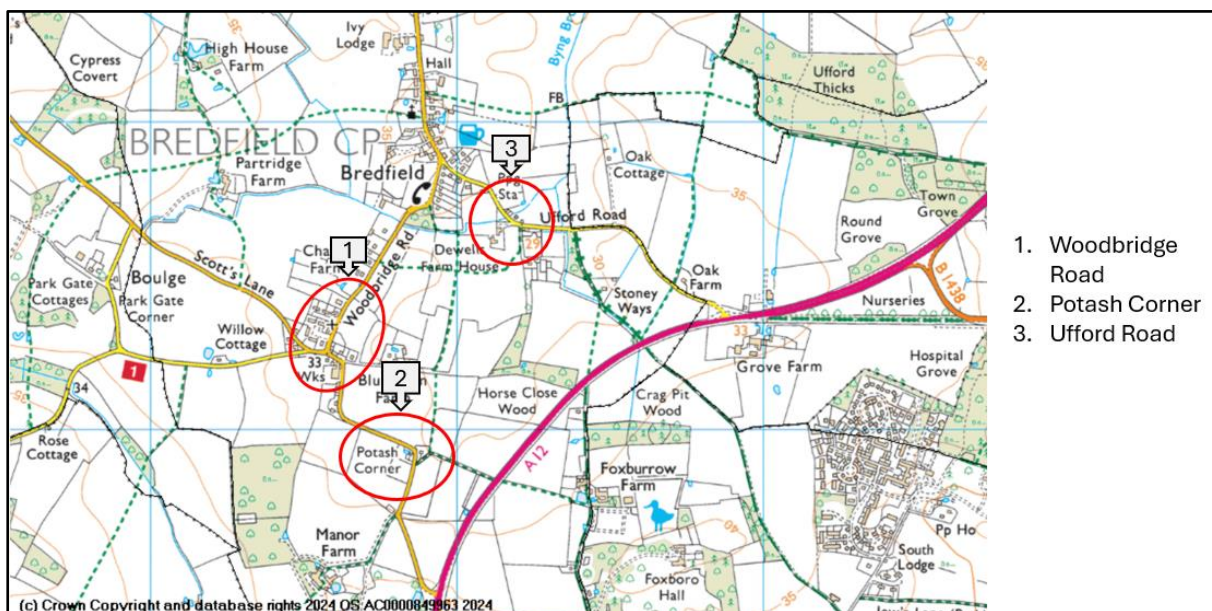
**Fig. 5 Distinct flood zones where property was internally flooded**

For the purposes of this investigation the various areas affected by flooding have been separated into three distinct zones:

1. Woodbridge Road
2. Potash Corner (road C309)
3. Ufford Road

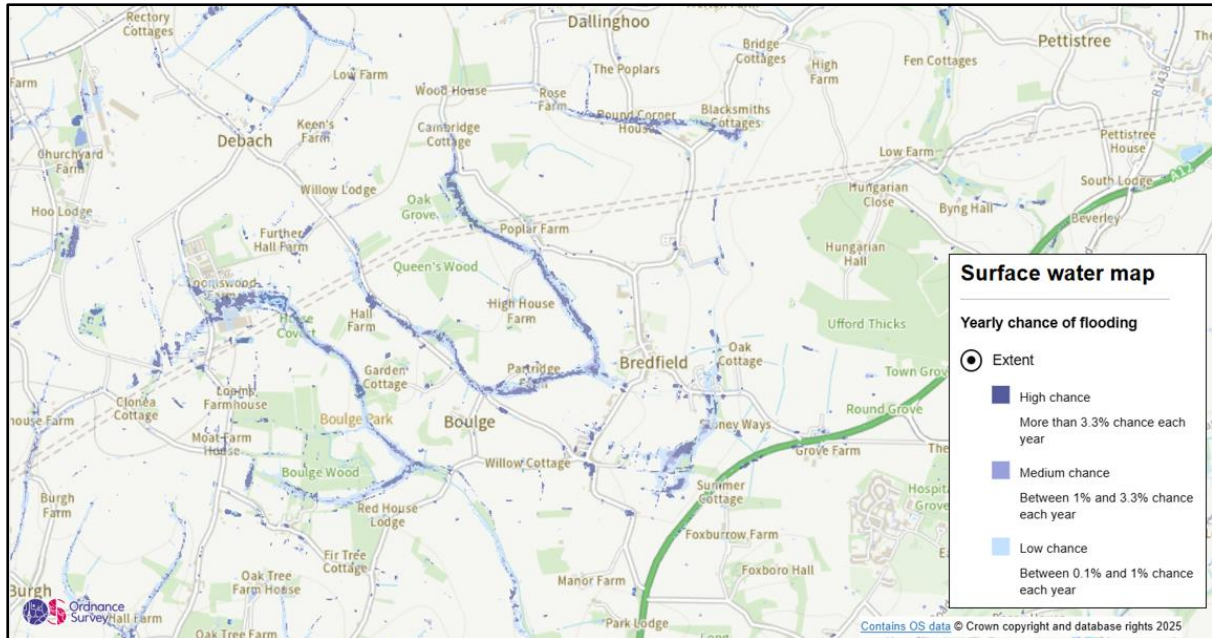
**Fig. 6 Predicted flood risk from surface water**

The parish of Bredfield is at significant risk of pluvial flooding (Fig. 6). Areas of surface water flood risk which are projected in areas of property affected by internal flooding are mostly located to the west, south and east of the northern Bredfield village settlement.

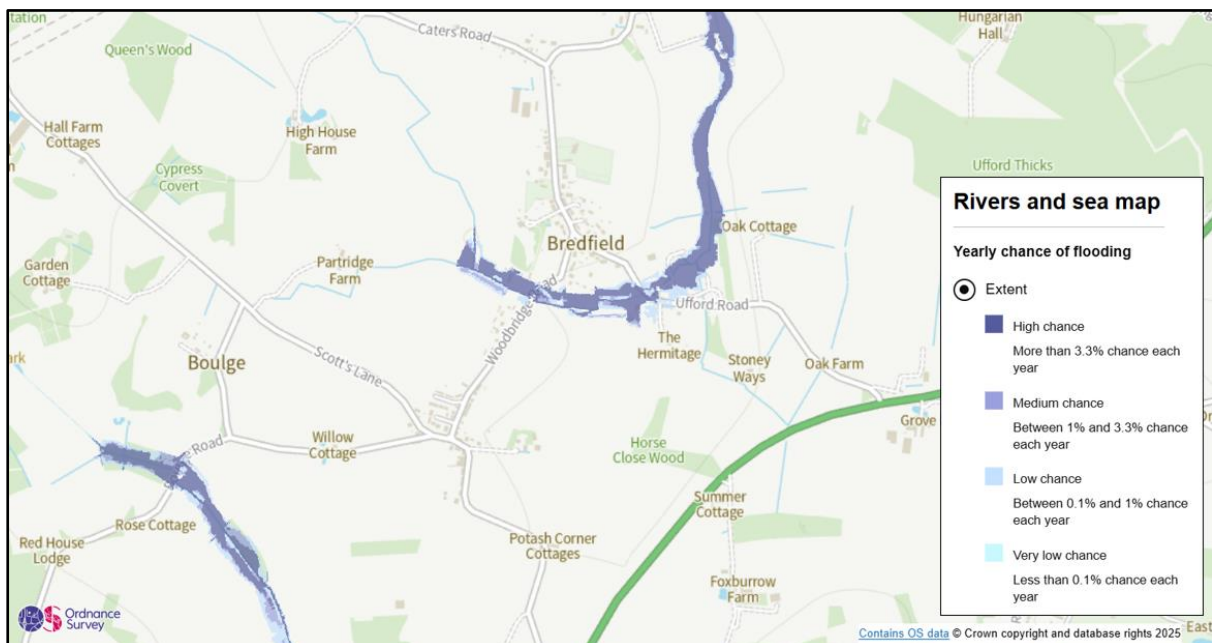
**Fig. 7. Predicted flood risk from rivers**

Fluvial flood risk in Bredfield is associated with Byng Brook, which follows an arc from west to east, on the south side of the northern Bredfield village settlement.

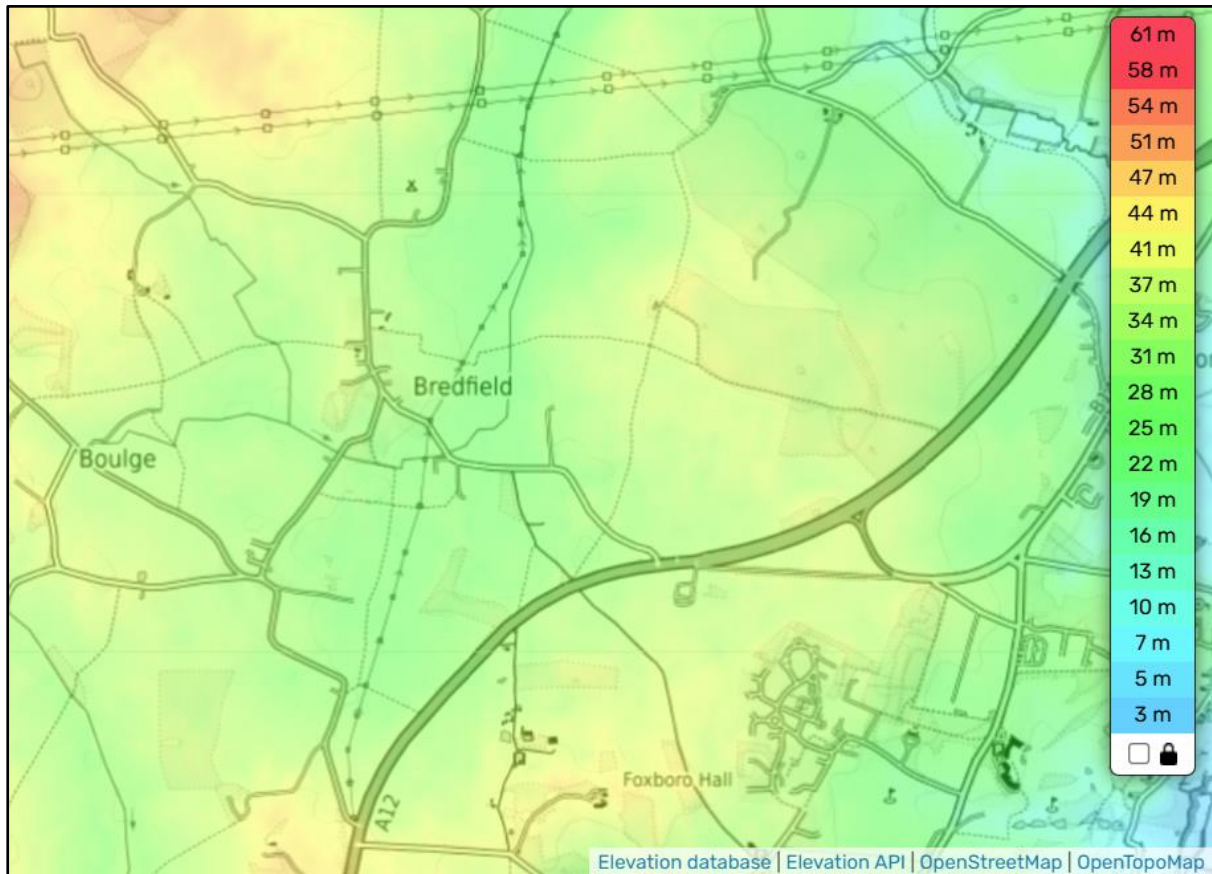
**Fig. 8 Elevation map of catchment area**

The low-lying nature of areas of the village means that during high rainfall events considerable flows of water converge and then drain away relatively slowly (see Fig. 8). Overwhelmed infrastructure and watercourses may be observed during these intense rainfall events.

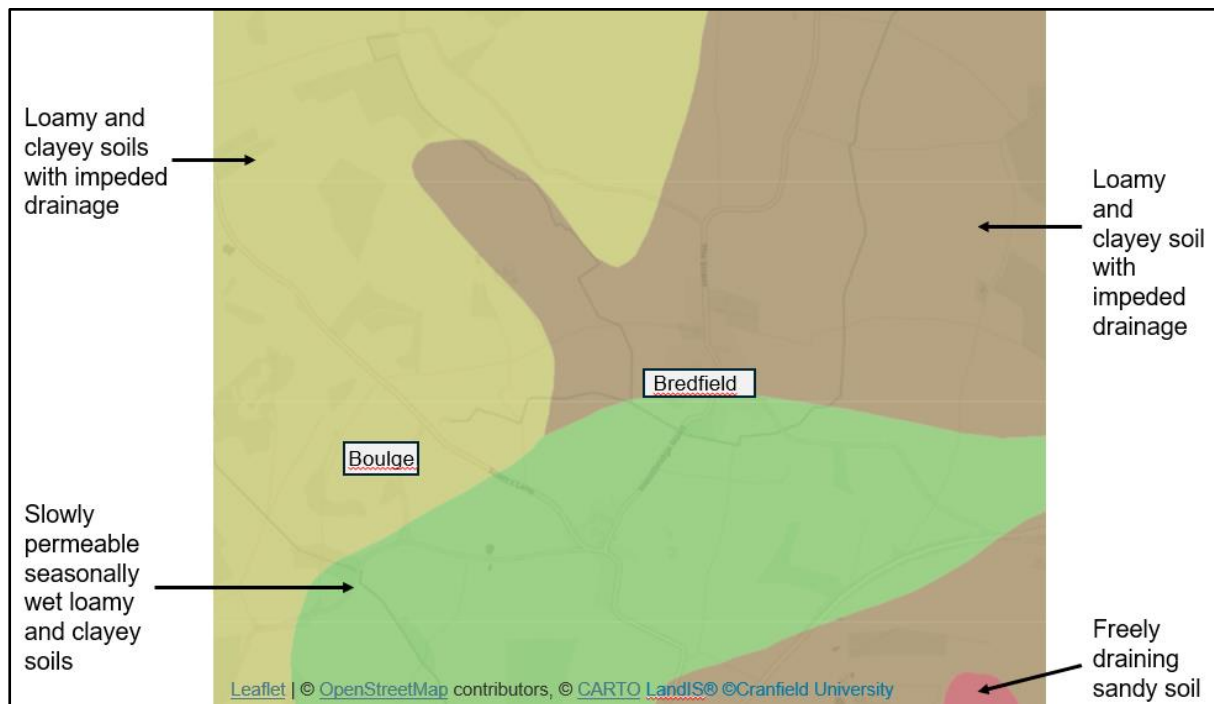
**Fig. 7. Soil map of catchment area (LandIS Soils)**

The soils surrounding Bredfield are loamy and clayey with impeded drainage, meaning that water permeates more slowly and surface water runoff is greater, particularly during intense rainfall (Fig. 8). However, the saturated nature of the soils leading up to the event would also have prevented some infiltration.

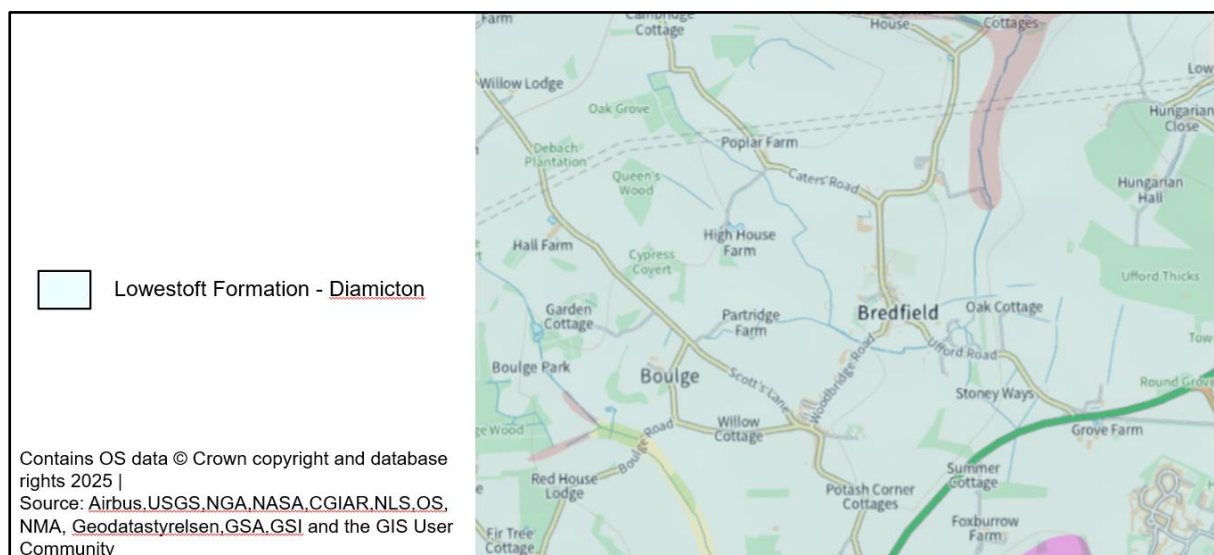
**Fig. 8. Superficial geology (British Geological Society)**

Fig. 10 shows that much of the superficial geology surrounding Bredfield is made up of 'Lowestoft Formation – Diamicton' which is described by the British Geological Survey as a diverse mixture of clay, sand, gravel, and boulders varying widely in size and shape. This is sometimes known as boulder clay. This generally has a low permeability meaning water will tend to flow off it before it can infiltrate, which also reflects the reports collected during Storm Babet.

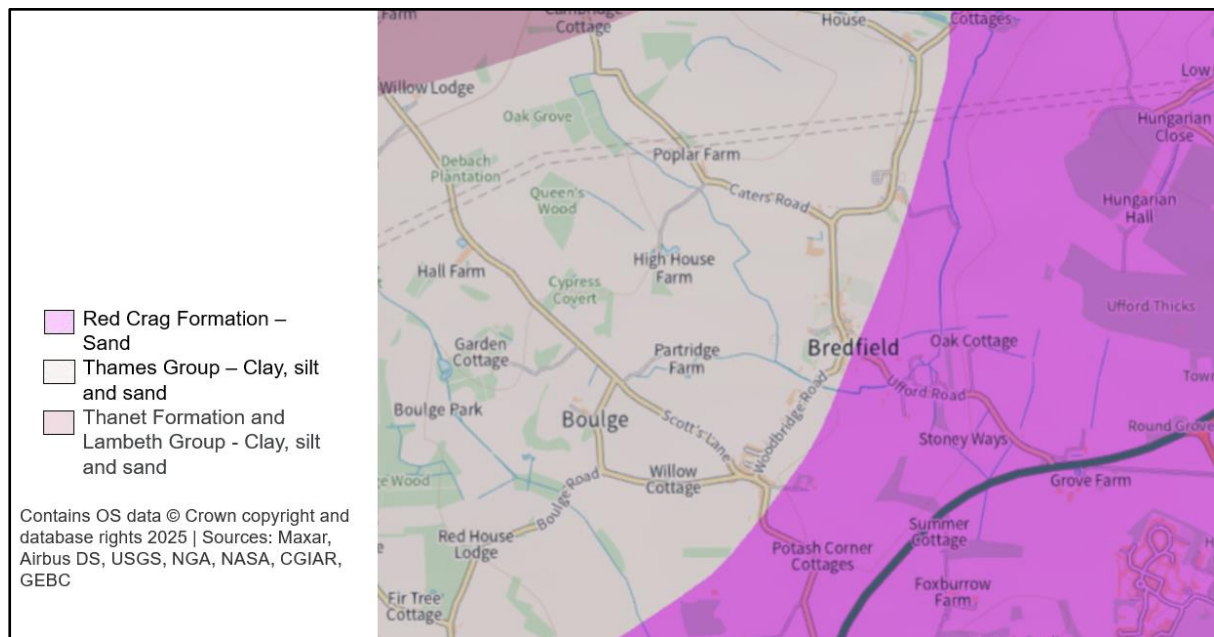
**Figure 9 Bedrock geology (British Geology Society)**

The bedrock in Bredfield and the surrounding area is a mixture of Thames Group - Clay, silt and sand; Red Crag Formation – Sand and Thanet Formation and Lambeth Group - Clay, silt and sand (Fig. 11).
