Section 19 Flood and Water Management Act 2010
Wetheringsett-cum-Brockford Flood Investigation – Storm
Babet 2023

Name	Date
Report Author	John Jousiffe	
Responsible Officer:	John Jousiffe	
Checked by:	Ellie Beecroft	17/09/2024
RMA Review:		08/10/2024
Approved by:	Matt Hullis	08/11/2024
Date Published		11/11/2024
Date Report Closed

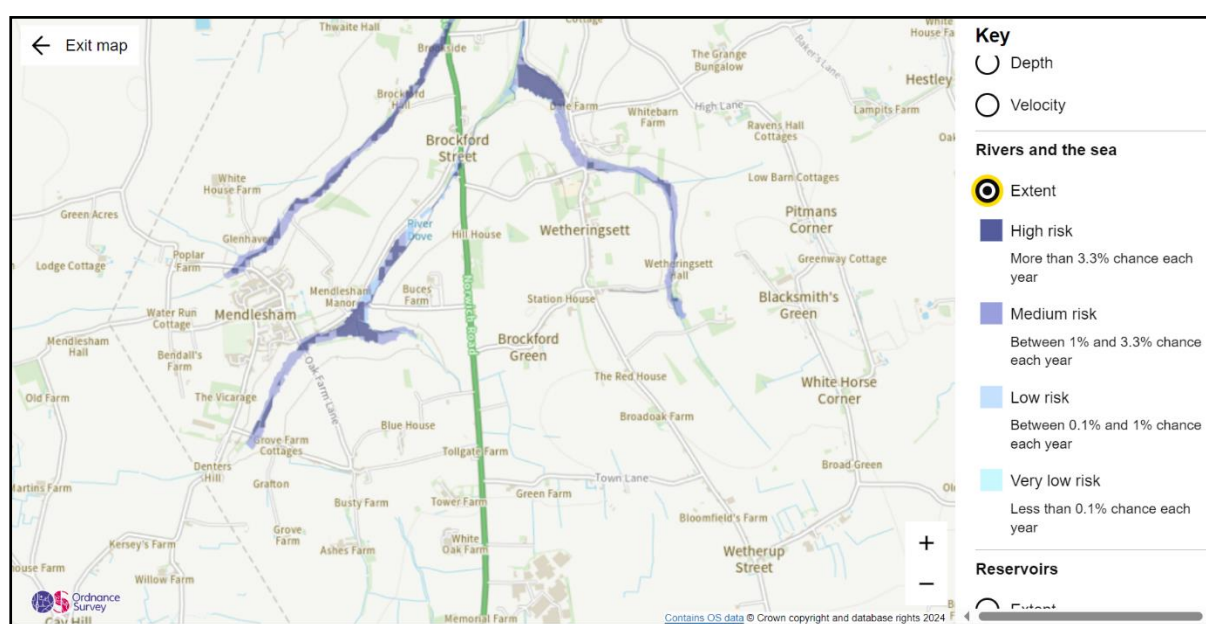
Figure 7 – Fluvial Flood risk map

Fluvial flood risk, described as water overflowing out of watercourses, is evident in the area. The River Dove (designated main river) runs through the Brockford Street area, flowing south to north. There is a significant watercourse that flows through Wetheringsett, before discharging into the River Dove, just north of the village. The map shows significant flood risk to central Wetheringsett and Brockford Street from the watercourses, in particular where the river crosses the A140, northwest Wetheringsett and the southern end of Brockford Road, see figure 7.

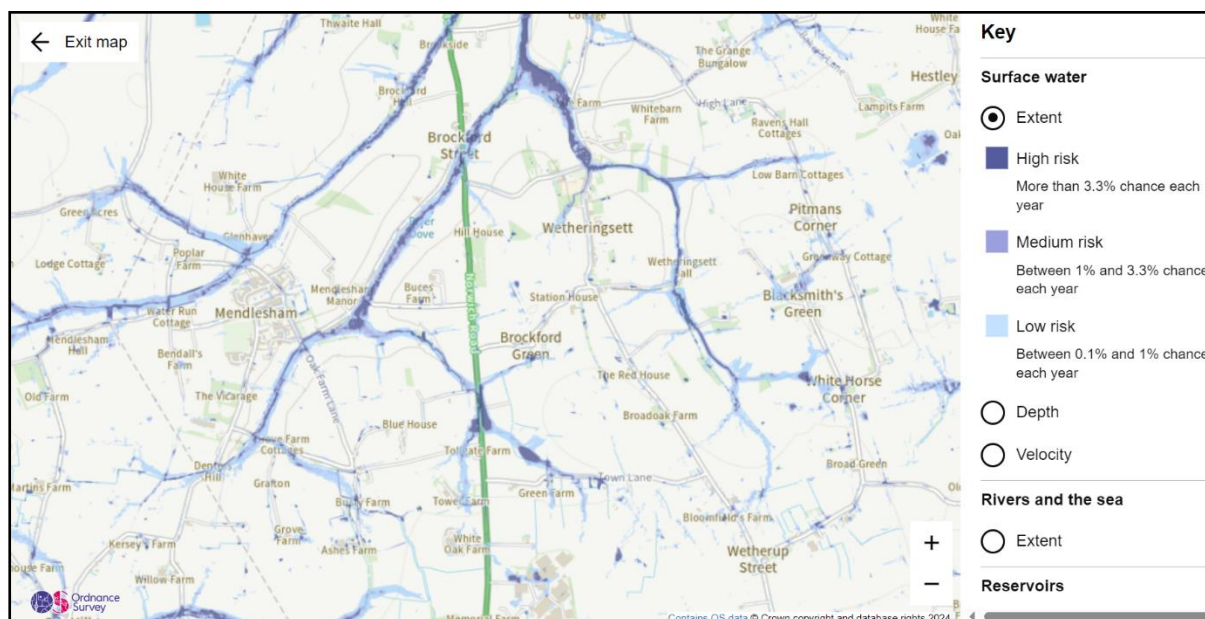
Figure 8 – Surface water flood risk map

The catchment is also at risk from pluvial flood risk (surface water run-off from surrounding land). As seen in figure 8, the flow paths roughly following the line of existing watercourses but also identifies changes in topography and localised low points of risk. Areas include Wetherup Street and Station Road.

As shown in figure 8, there are several flood flow paths which travel from south to north, flowing through Brockford Street and Wetheringsett. These areas are low-lying and noticeably shallower than the surrounding catchment and will be expected to be the primary locations to experience flooding during high rainfall events.

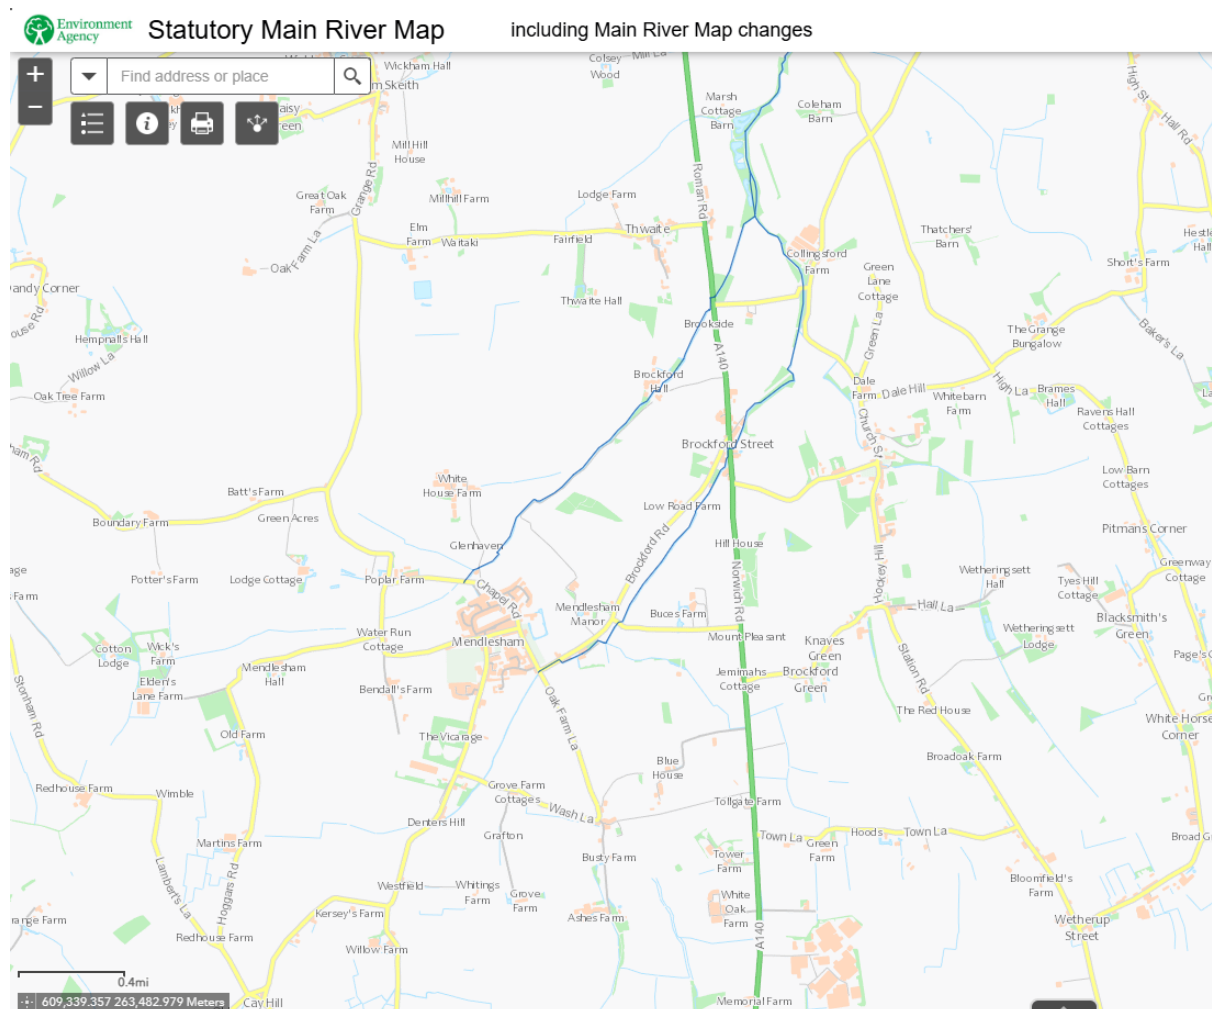
Figure 9 - Statutory main river map

Areas of Wetheringsett and Brockford Street are significantly lower lying than the surrounding topography to the east, south and west, causing all flow paths in the area to converge in these low spots before continuing their flow north towards the Waveney River (figure 9).

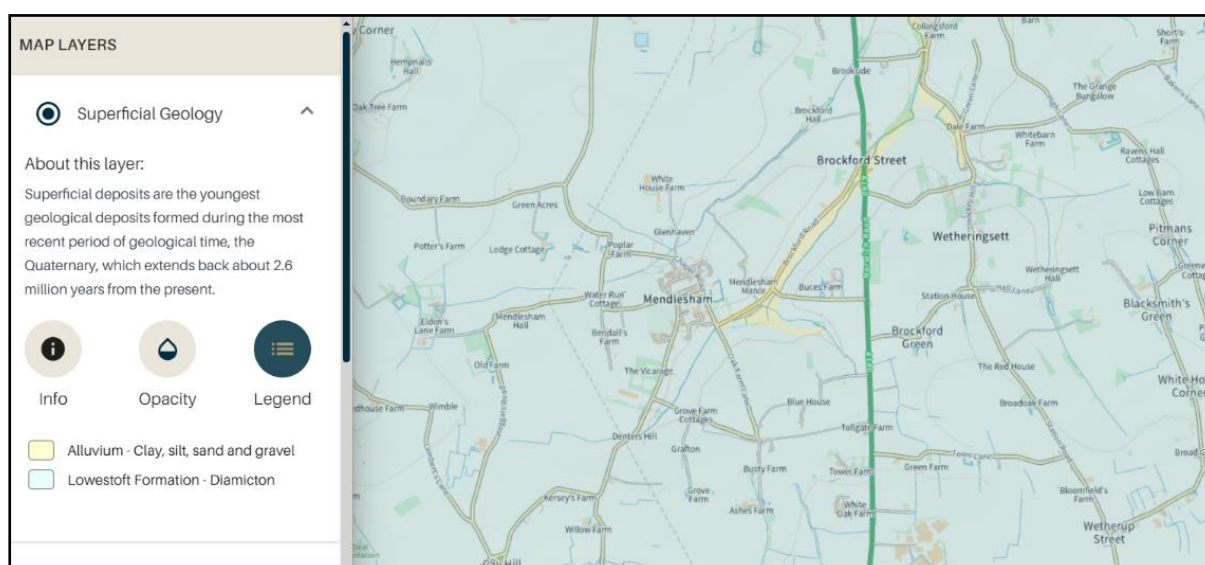
Figure 11 - Superficial Geology

The superficial geology in the area is primarily ‘Lowestoft Formation – Diamicton’ which is described by the British geological survey as a diverse mixture of clay, sand, gravel, and boulders varying widely in size and shape. This is sometimes known as boulder clay. This soil generally has a low permeability meaning water will tend to flow off it before it can infiltrate, which reflects the reports collected during Storm Babet.

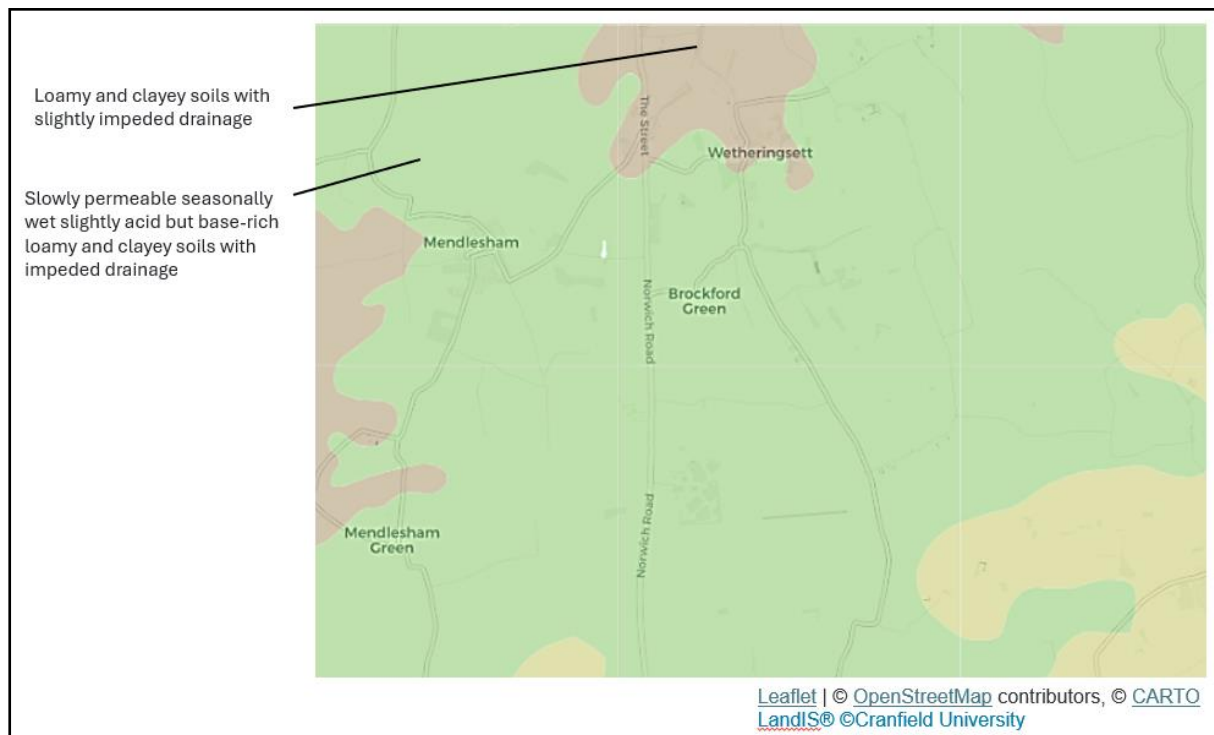
Figure 12 - Area map of soil composition

The soils in the area are primarily comprised of slowly permeable seasonally wet loamy and clayey soils with impeded drainage (see figure 12). This matches descriptions from the event of significant levels of surface water runoff and limited infiltration into the ground.
