Section 19 Flood and Water Management Act 2010

Framsden Flood Investigation – Storm Babet 2023

Name	Date
Report Author	Susie Clark	
Responsible Officer:	Susie Clark	
Checked by:	Ellie Beecroft	17/10/2024
RMA Review:		08/11/2024
Approved by:	Matt Hullis	27/11/2024
Date Published		29/11/2024
Date Report Closed

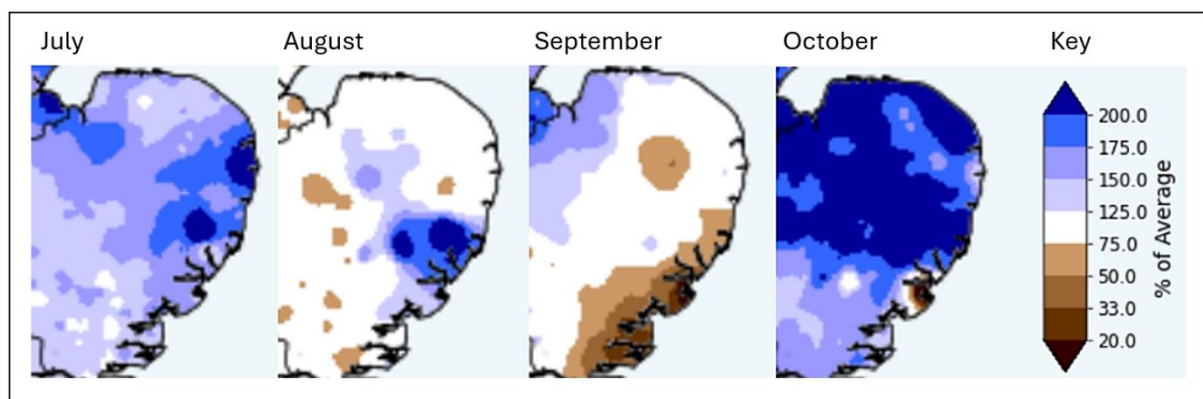
Figure 1. Average monthly rainfall (July – October 2023) as a percentage of the historic average monthly rainfall

The following maps illustrate the extent to which the rainfall in the months preceding Storm Babet exceeded the average monthly rainfall for July to October in recent years in Suffolk.

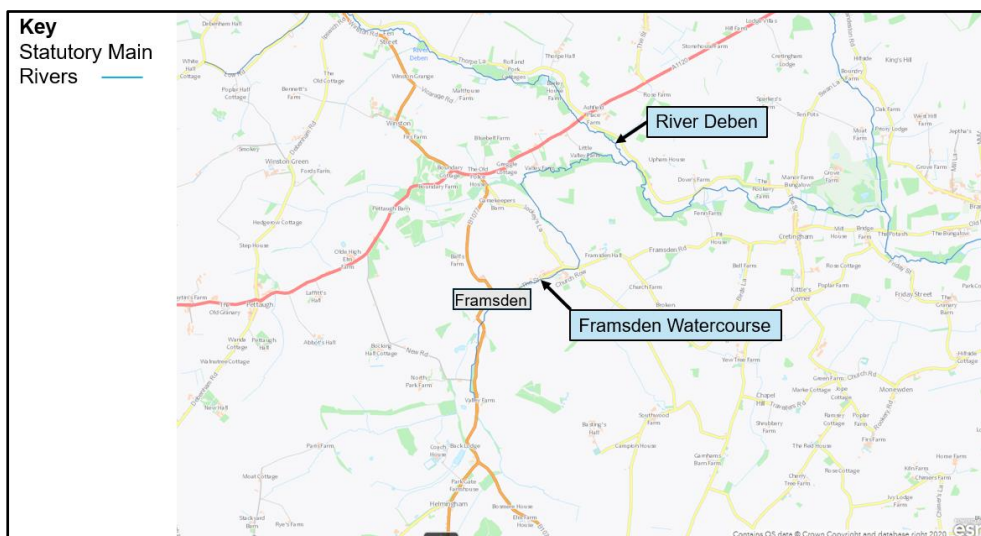
Figure 3. Location of statutory main rivers and significant ordinary watercourses

Figure 3 shows the most significant watercourses in and around Framdsen, including the Framdsen watercourse, a statutory main river which flows approximately parallel and south of The Street through the village of Framdsen. This joins the River Deben (also a statutory main river) at the eastern boundary of the parish.

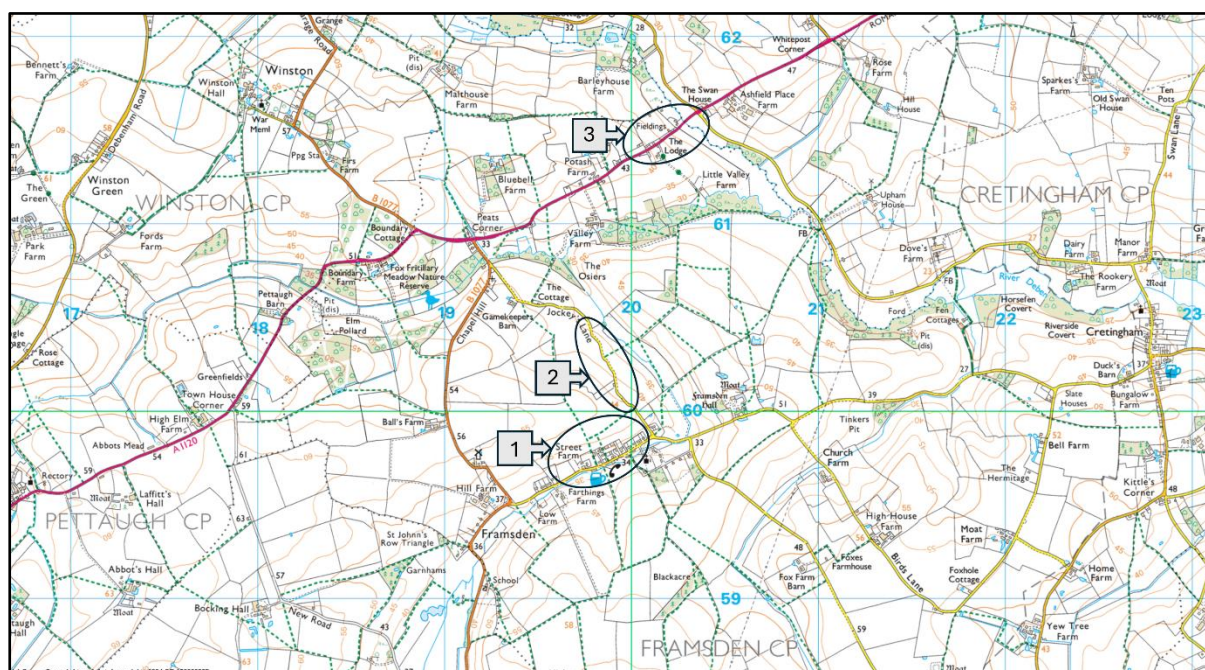
Figure 4. Distinct flood zones

For the purposes of this investigation the various areas affected by flooding have been separated into three distinct zones:

1. The Street
2. Jockey's Lane
3. Eastern section of A 1120 (Framdsen)

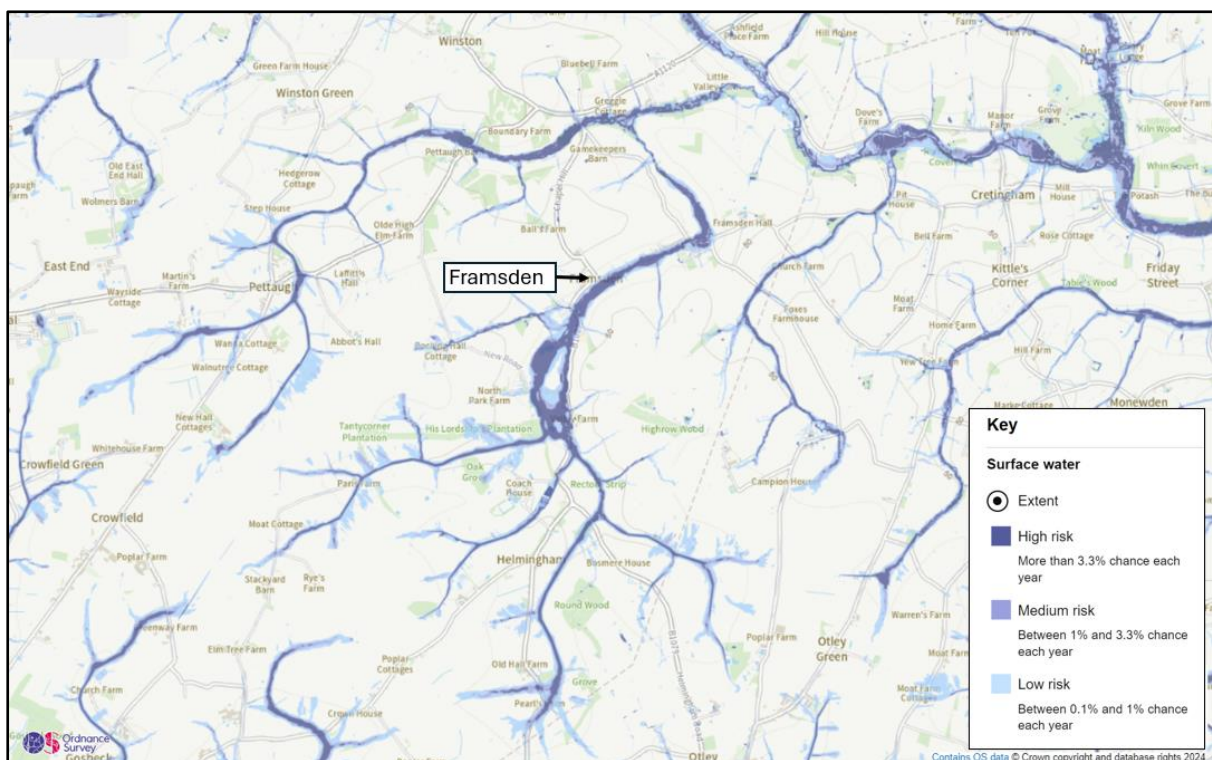
Figure 5. Projected flood risk from surface water

Framdsen parish has significant surface water flow paths, which channel water from the southwest, through the village (where properties were impacted) and then towards the River Deben (Fig.5). Framdsen village and an area immediately upstream, to the southwest of Framdsen, are projected to be at high risk of surface water flooding. Additionally, there is an area of high surface water flood risk beside the River Deben, on and adjacent to the eastern end of the A1120, where impacted property is also located. During Storm Babet, localised surface water flooding was also reported to property to the northeast of Framdsen on Jockey's Lane and surface water and groundwater flooding to property further up the east-facing slope from the River Deben on the A1120. These locations are not shown to be at significant surface water flood risk on national mapping.

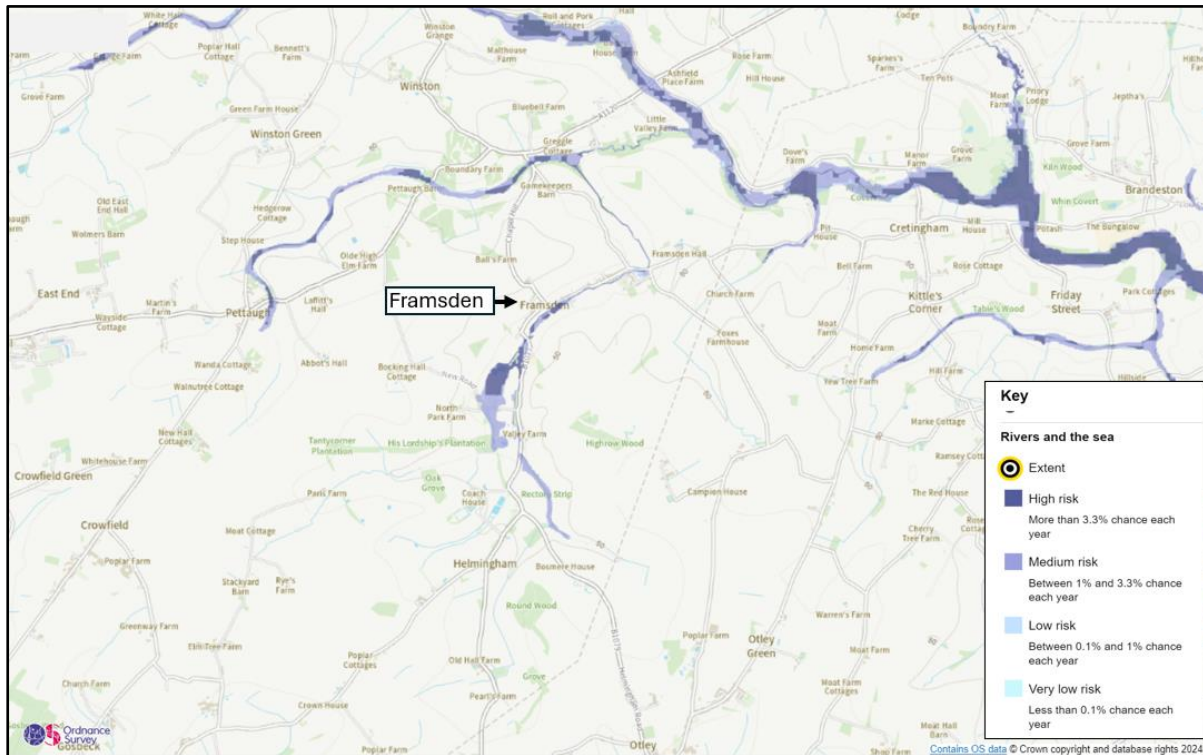
Figure 6. Projected flood risk from rivers

Fluvial flood risk in Framdsen village is associated with Framdsen watercourse (designated main river), which runs south of The Street (Fig.6). In the eastern part of the village, where most of the impacted properties are located, the river is projected to remain mostly in channel during high, medium and low risk scenarios. However, during

Storm Babet, flood water is reported to have overtopped the river in this section of the village and combined with surface water. East of the junction between The Street and Jockey Lane is an area which is at risk of surface water and fluvial flooding where considerable volumes of water also accumulated during Storm Babet. Fluvial flood risk from the River Deben also affects the eastern end of the A1120 in the parish, where properties were affected by flooding.

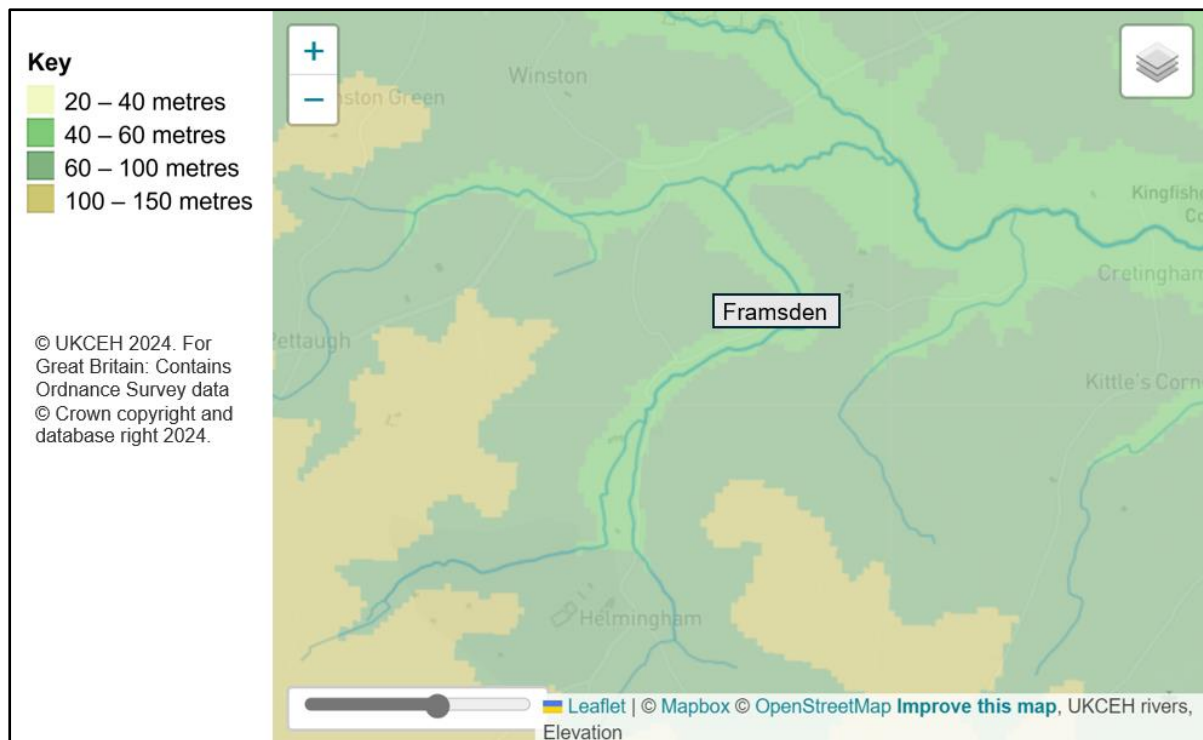
Figure 7. Elevation map of catchment area (National River Flow Archive)

The low-lying nature of the village means that during high rainfall events considerable flows of water converge towards Framdsen and the River Deben (see Fig. 7). Overwhelmed infrastructure and watercourses may be observed during these intense rainfall events.

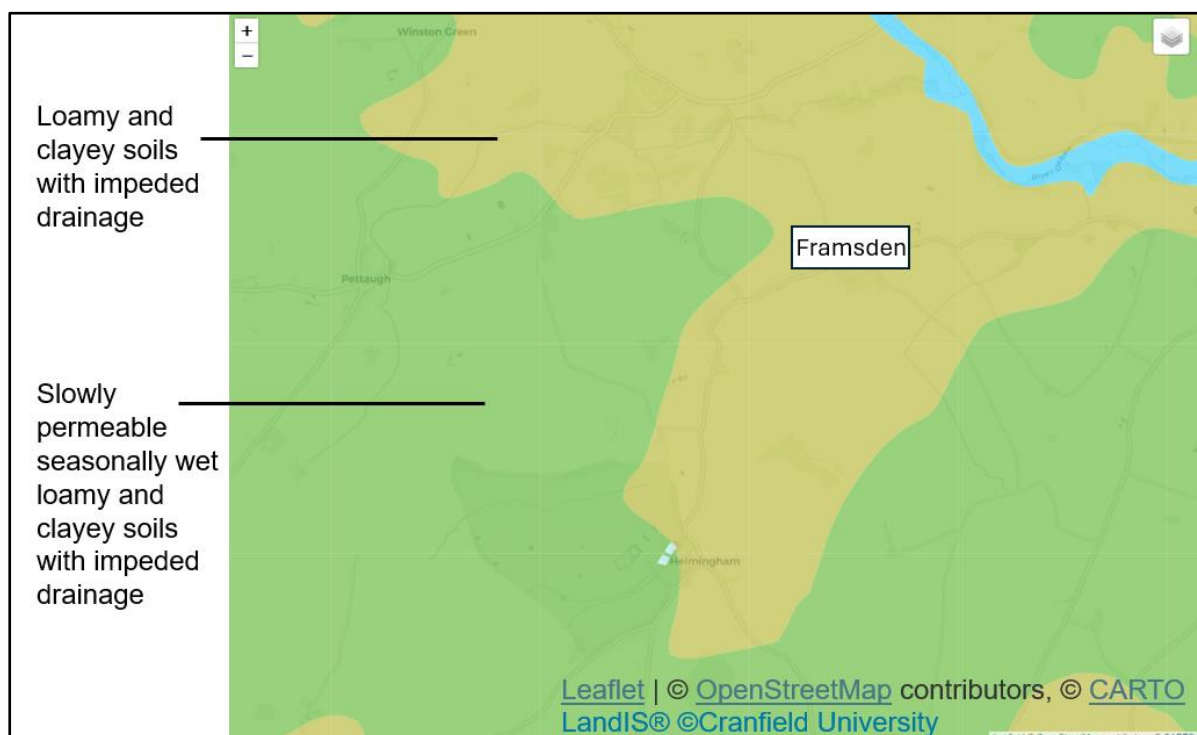
Figure 8. Soil map of catchment area (LandIS Soilscales)

The soils surrounding Framdsen are loamy and clayey with impeded drainage, meaning that water permeates more slowly and surface water runoff is greater, particularly during intense rainfall. However, the saturated nature of the soils leading up to the event would also have prevented some infiltration.

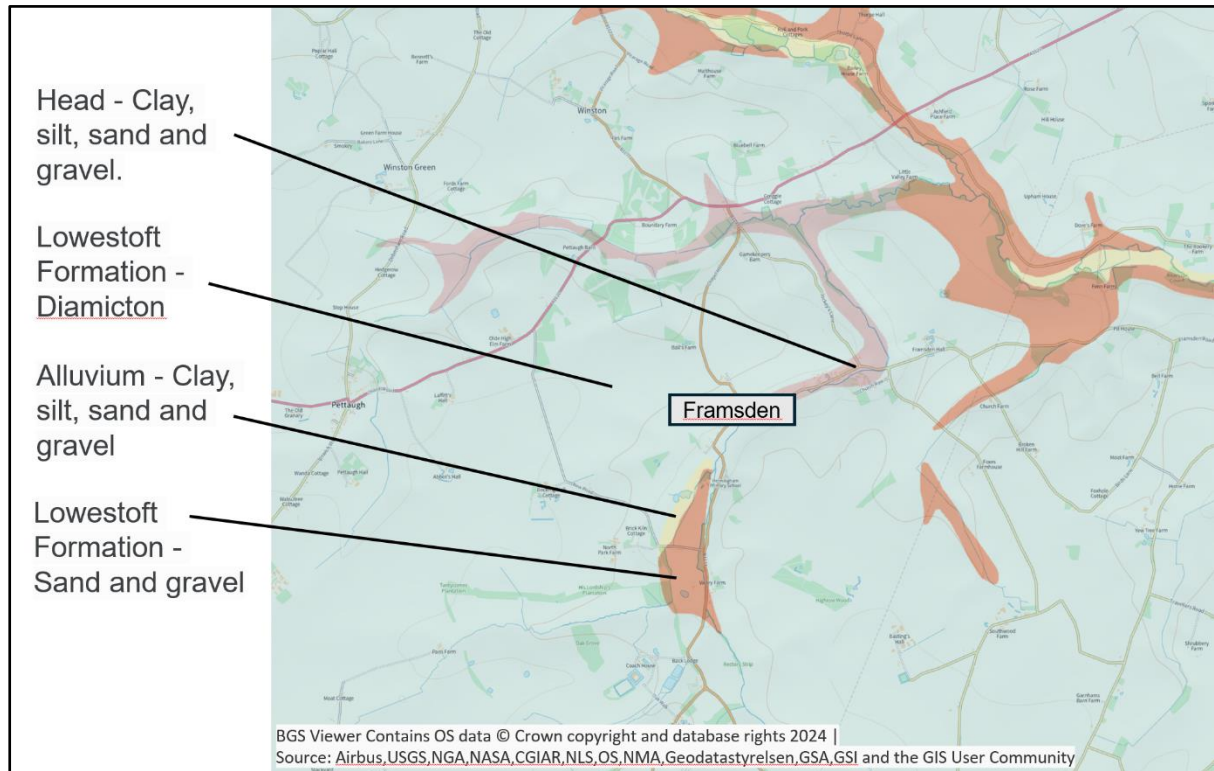
Figure 9. Superficial geology (BGS Viewer)

Fig. 9 shows that much of the superficial geology surrounding Framsdén is made up of 'Lowestoft Formation – Diamictón' which is described by the British Geological Survey as a diverse mixture of clay, sand, gravel, and boulders varying widely in size and shape. This is sometimes known as boulder clay. This generally has a low permeability meaning water will tend to flow off it before it can infiltrate, which also reflects the reports collected during Storm Babet.
