## Section 19 Flood and Water Management Act 2010

### Hoxne Flood Investigation – Storm Babet 2023

Name	Date
Report Author	Stephen Quinn	
Responsible Officer:	Stephen Quinn	
Checked by:	Ellie Beecroft	16/09/2024
RMA Review:		08/10/2024
Approved by:	Matt Hullis	24/10/2024
Date Published		28/10/2024
Date Report Closed

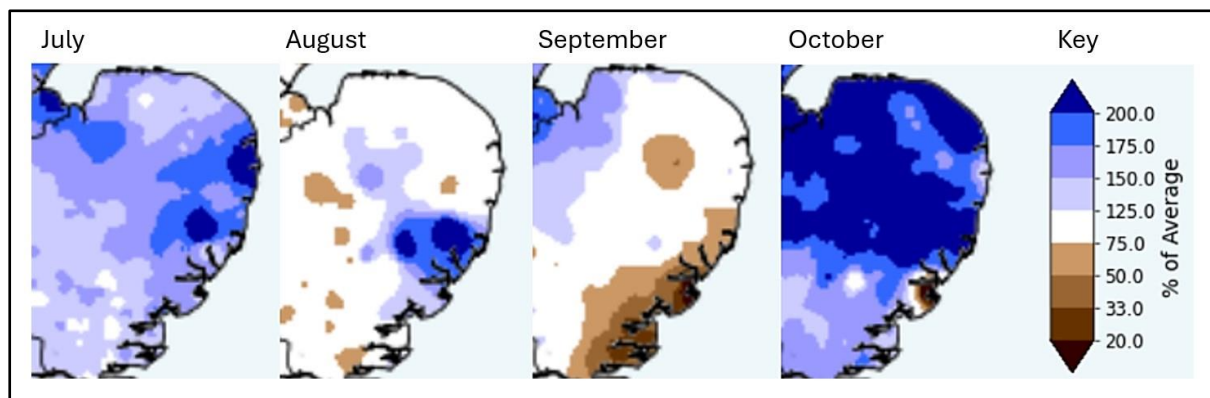
*Figure 1. Average rainfall in East Anglia between July and October 2023 as a percentage of the historical average monthly rainfall*

The Environment Agency river level measuring stations indicated many flows close to or exceeding their highest on record, and the weather remained wetter than average for the rest of the month. October 2023 was the joint wettest on record in the east of England since 1871. During Storm Babet, Suffolk saw the heaviest rainfall across East Anglia causing significant flooding of roads and properties. The river systems rose rapidly across whole catchments due to the existing conditions, which was unusual as storms will often impact a small area and result in a steady progression of flood water downstream. A major incident was declared by the Suffolk Resilience Forum (SRF) in the afternoon of the 20<sup>th</sup> of October due to significant impacts on communities and disruption to the road and rail networks.

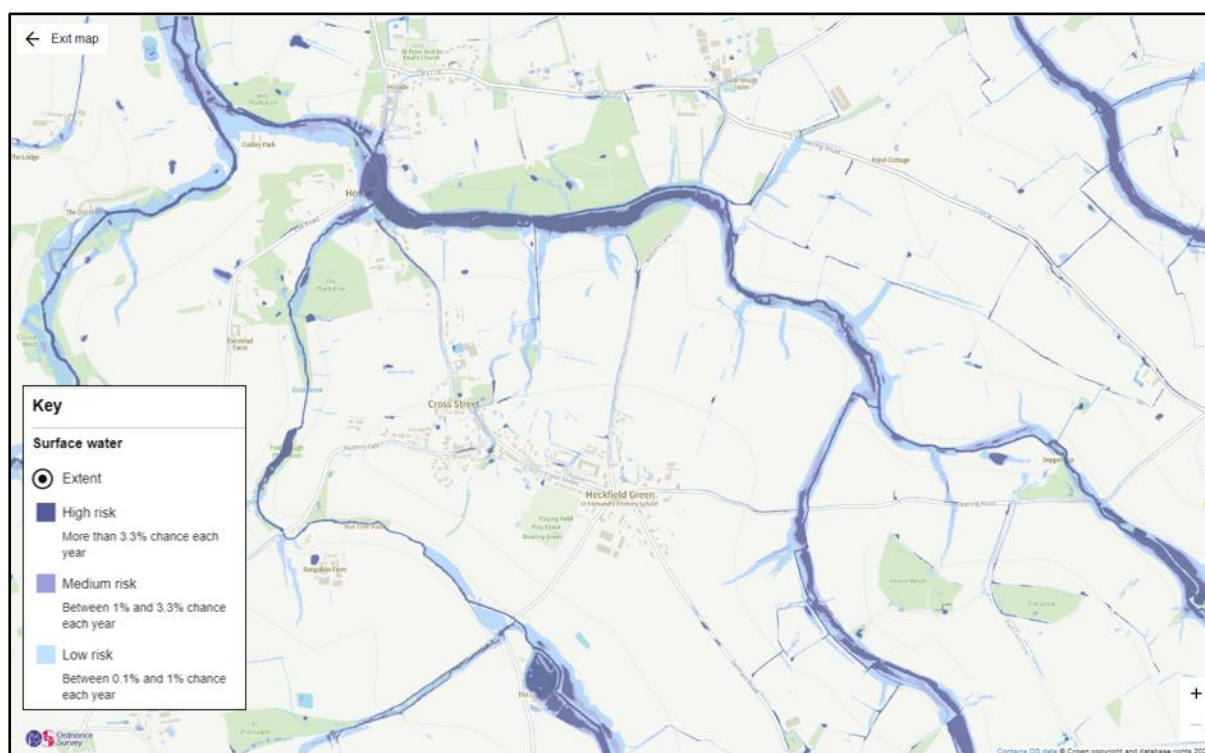
Figure 5. Predicted surface water flood risk

Figure 5 highlights the predicted pluvial (surface water run-off from surrounding land and ditches) flood risk in and around Hoxne, with four main flow paths coming into the village from the southwest, south, southeast and east, closely aligned with Gold Brook and Chickering Beck. Flatter areas at high risk of surface water flooding include south central Hoxne, the flood plain surrounding Chickering Beck to the east of Hoxne and the Denham Low Road to the south of Hoxne.

There is significant risk of surface water flooding on Green Street and Cross Street. These areas were affected by flooding during Storm Babet.

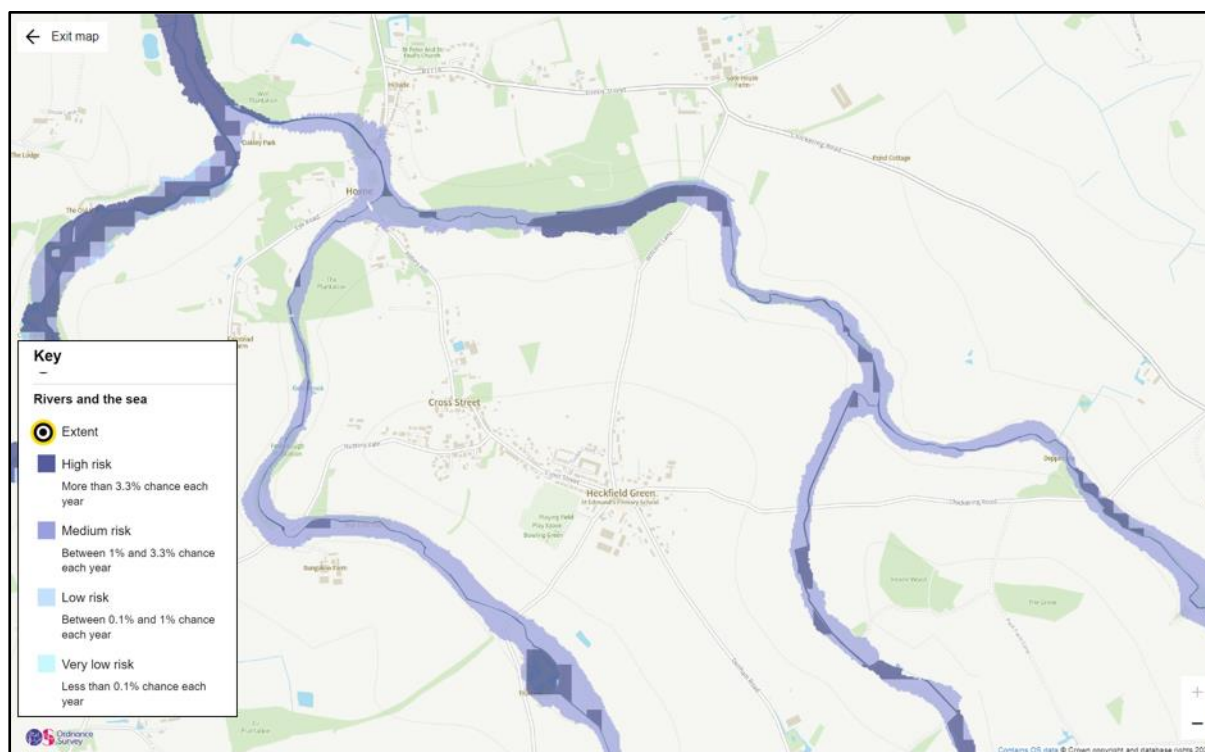
*Figure 6. Predicted flood risk from rivers and sea*

Figure 6 highlights the predicted fluvial (from designated main river and ordinary watercourses) flood risk in and around Hoxne. Fluvial flood risk around Hoxne is associated with the Chickering Beck and Gold Brook watercourses. Areas at high risk of fluvial flooding include the Denham Low Road, Low Street, Abbey Hill and parts of Chickering Road. These areas were affected by flooding during Storm Babet.

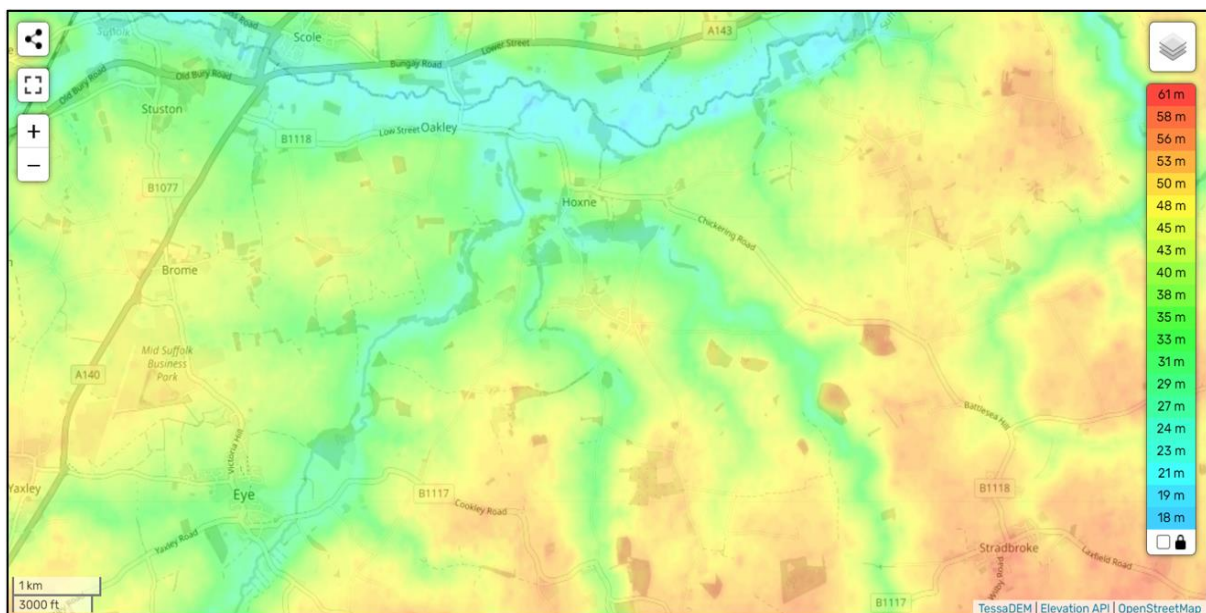
Figure 7. Hoxne and surrounding topography (National River Flow Archive)

Figure 7 shows the topography surrounding Hoxne and the gradient changes across the village. Low Road, Abbey Hill and Nuttery Vale are among the lowest lying locations in Hoxne. These were identified as being some of the worst affected areas following Storm Babet.

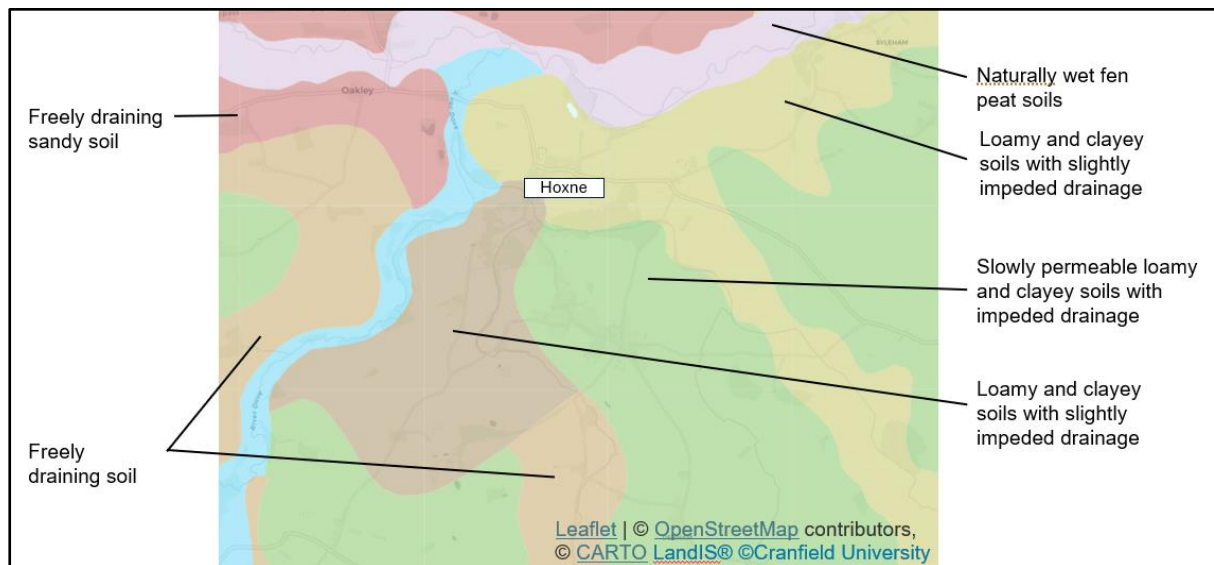
Figure 8. Hoxne and surrounding soils (LandIS Soilscape)

With regards to soils, Hoxne is situated mostly on sand and gravels with a mixture of clay and silts. To the east and immediately south of the village they are described as loamy and clayey, with impeded drainage. To the west and further due south of Hoxne village, soils are more freely draining, allowing water to permeate more rapidly and therefore reducing the amount of surface water run-off. The floodplain soils surrounding the Gold Brook and Chickering Beck watercourses usually have naturally high groundwater and tend to be wetter.

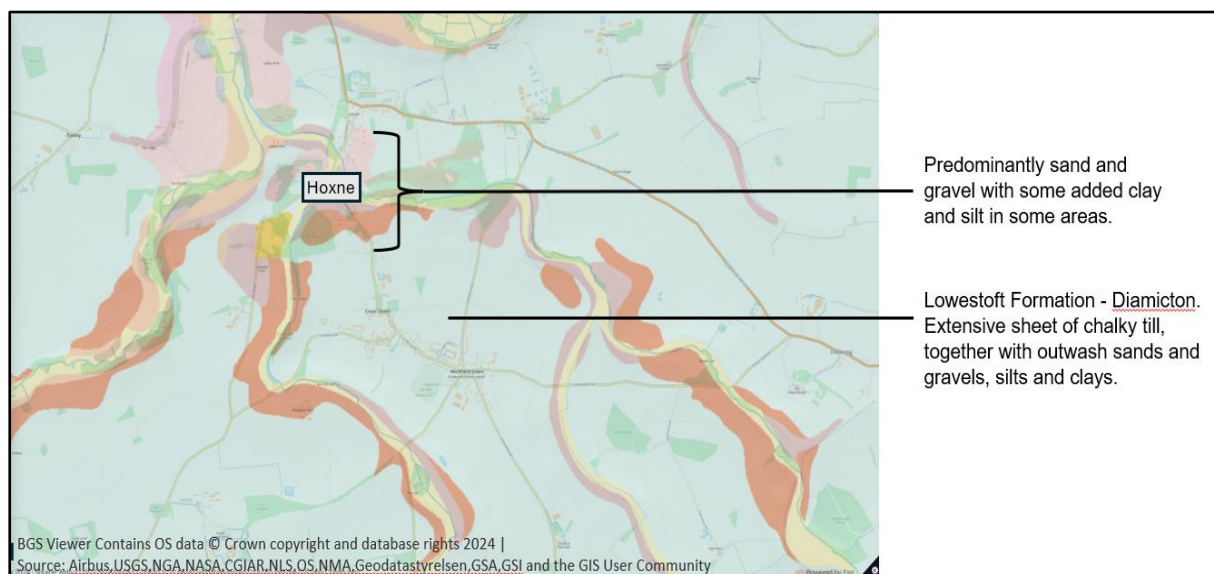
Figure 9. Superficial geology (BGS Geology Viewer)

Lowestoft Formation 'Diamicton' surrounds the village more generally which is described by the British geological survey as a diverse mixture of clay, sand, gravel, and boulders varying widely in size and shape. This generally has a low permeability meaning water will tend to flow off it before it can be infiltrated, which reflects some of the reports from the Storm Babet event.
