Section 19 Flood and Water Management Act 2010

Hundon Flood Investigation –

Storm Babet 2023

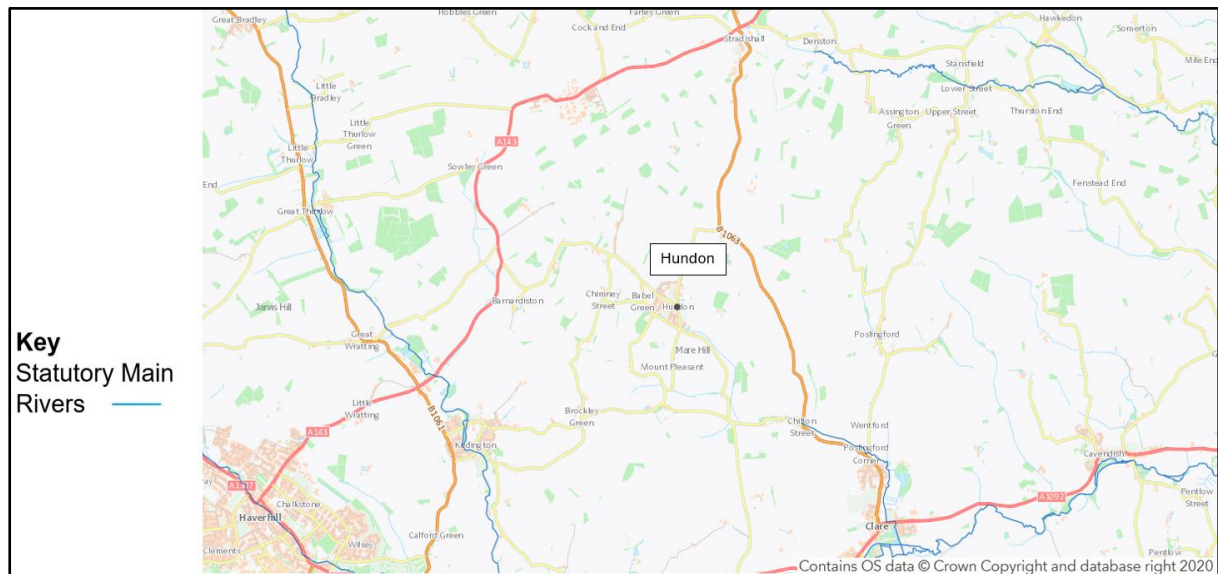
Figure 3. Location of statutory main river and ordinary watercourses

Figure. 3 below, shows the most significant watercourses in the Hundon area.

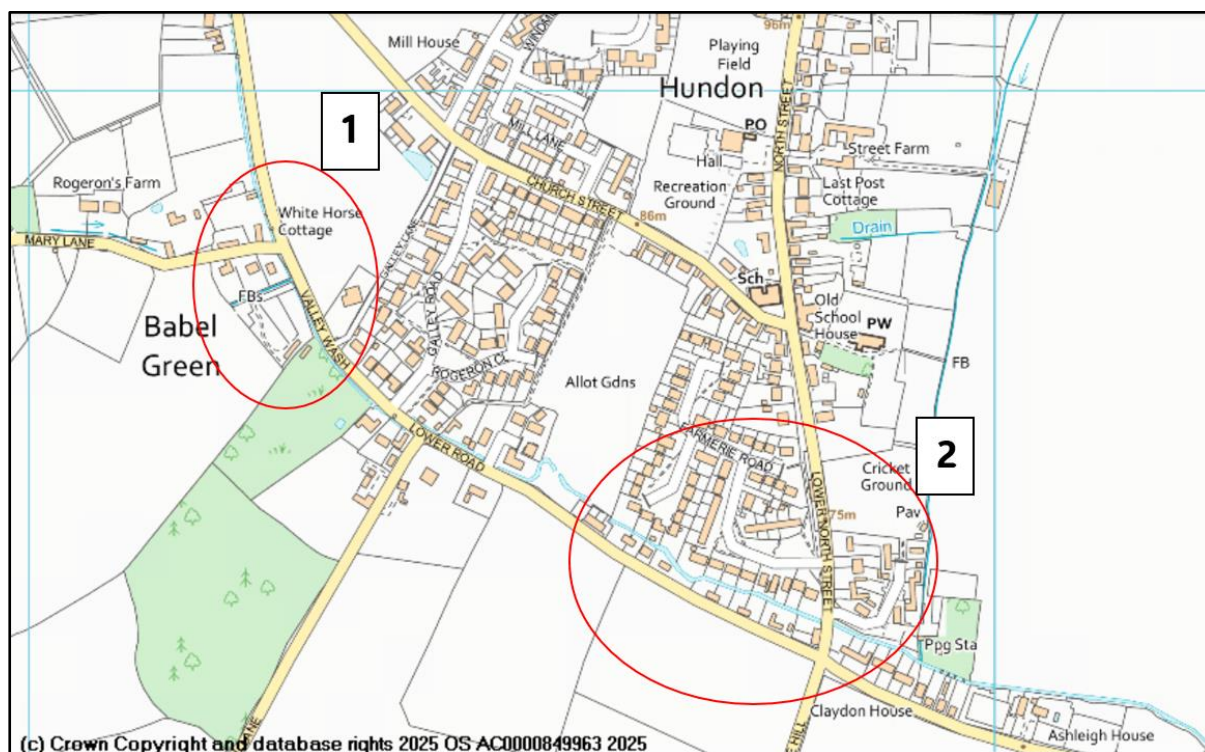
Figure 4. Hundon investigation area map with locations

For the purposes of this investigation the areas affected by flooding have been separated into two distinct locations (see Figure 4). The locations are as follows:

1. Mary Lane and Valley Wash
2. Lower North Street, Farmerie Road and Lower Road

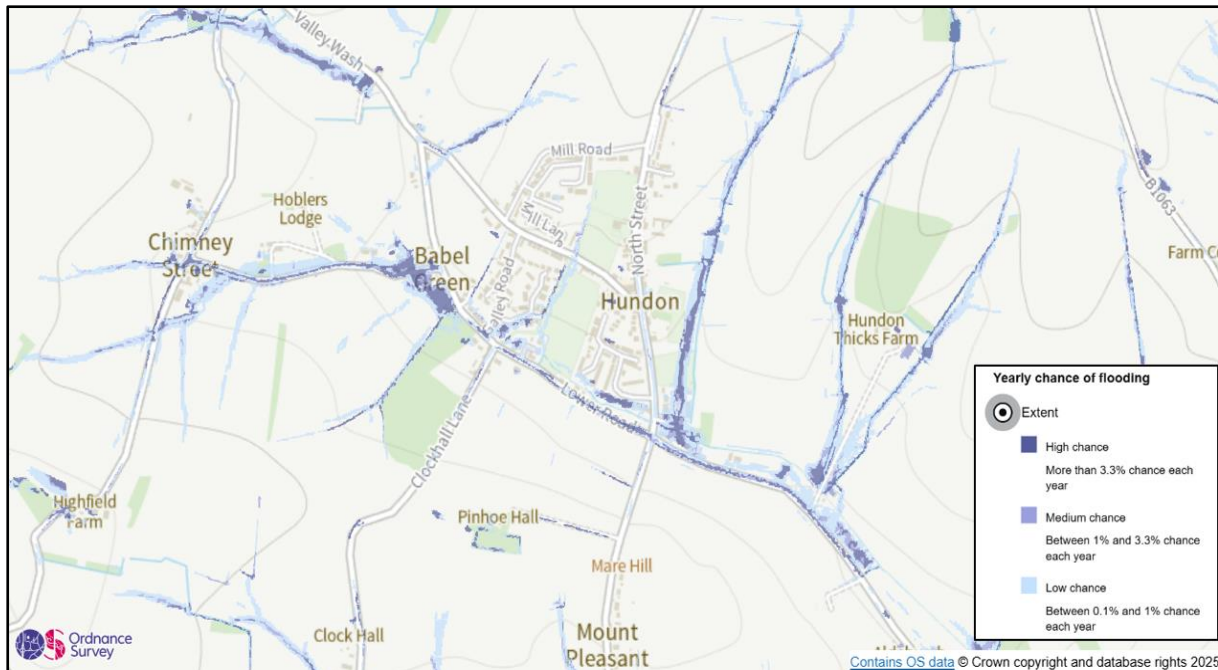
Figure 5. Surface water flood risk

Figure 5 highlights the predicted pluvial (surface water run-off from surrounding land and highways) flood risk in Hundon, with multiple flow paths from the north, west and southwest flowing through the village and into the Chilton Brook.

There is a high chance of surface water flooding on sections of Mary Lane, Valley Wash, Lower Road, Farmerie Road and Lower North Street. These areas were all affected by flooding during Storm Babet.

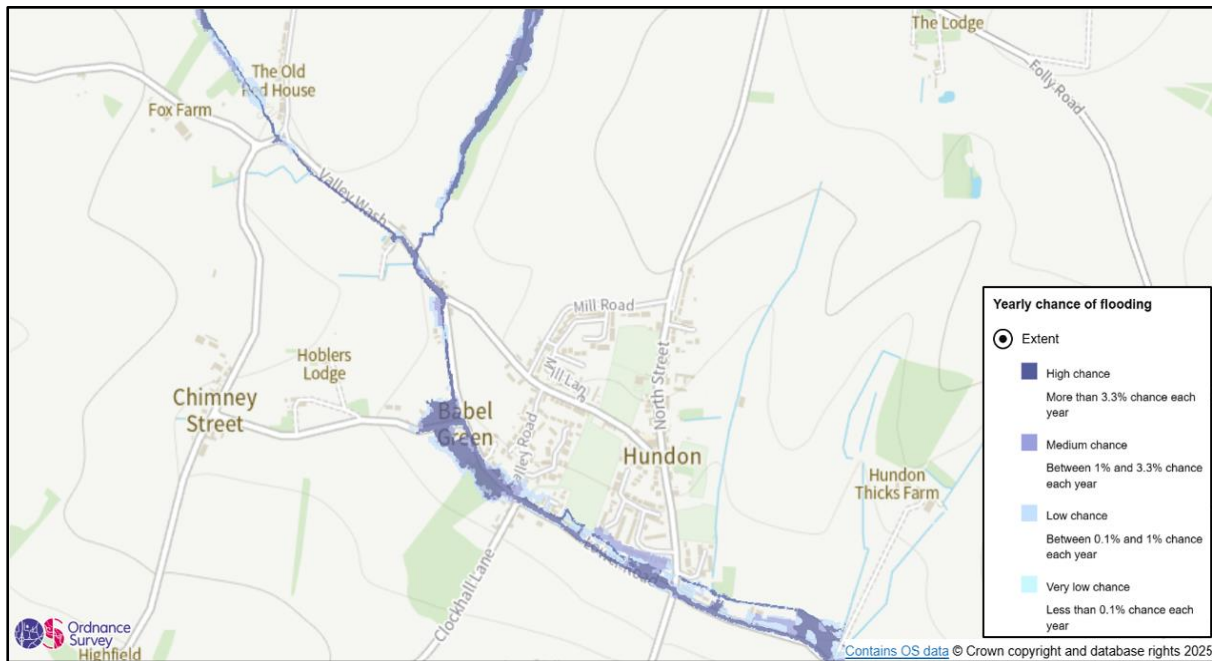
Figure 6. Flood risk from rivers and sea

Figure 6 shows the predicted fluvial (from designated main river and ordinary watercourses) flood risk in Hundon. The fluvial flood risk in Hundon is predominantly associated with the Chilton Brook which passes through the village.

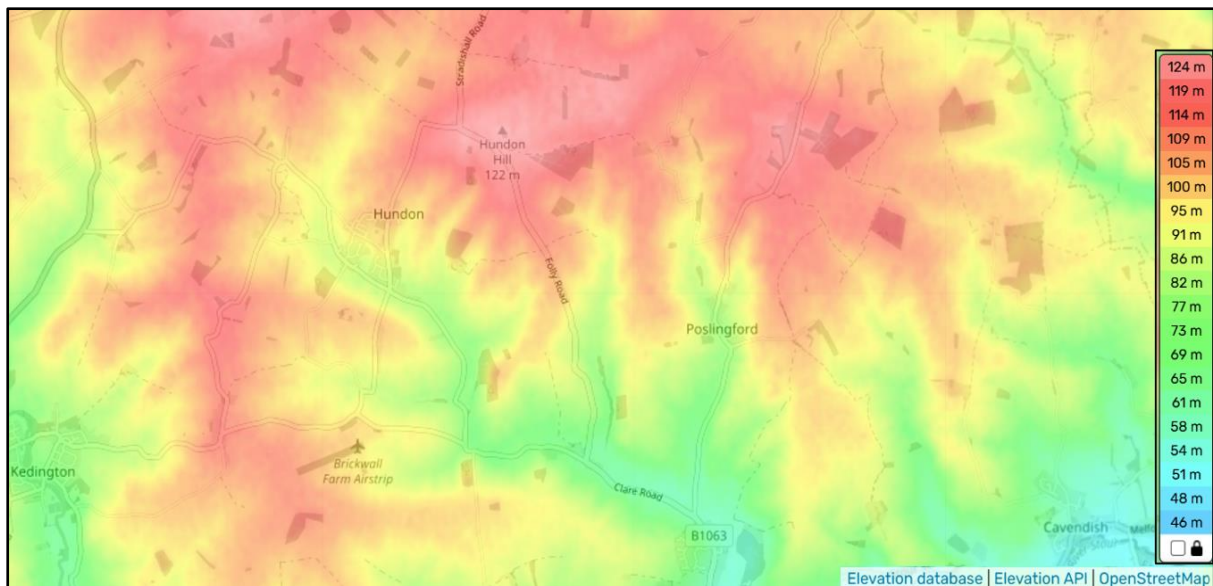
Figure 7. Hundon and surrounding topography (TessaDEM as cited in topographic-map.com)

Figure 7 shows the topography surrounding Hundon with gradient changes across the wider village. Some of the lowest points in Hundon are along Lower Road adjacent to the Chilton Brook. The junction of Lower Road and Lower North Street is lower than the surrounding land to the north and south. These locations were identified as being some of the worst affected areas during Storm Babet.

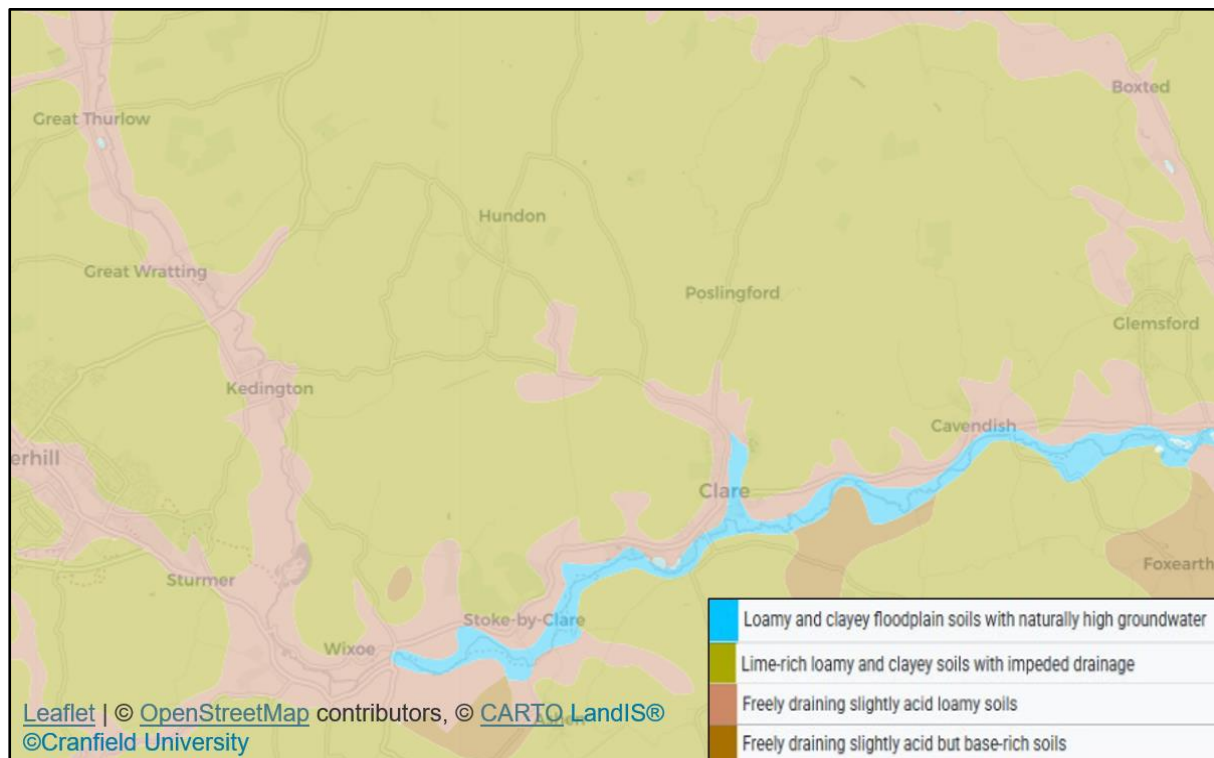
Figure 8. Soil map (LandIS Soilscape)

The soils more generally surrounding Hundon are loamy and clayey with impeded drainage, meaning that water permeates more slowly and surface water runoff is greater. The floodplain soils surrounding the Chilton Brook further downstream are more freely draining, usually having naturally high groundwater and tend to be wetter.

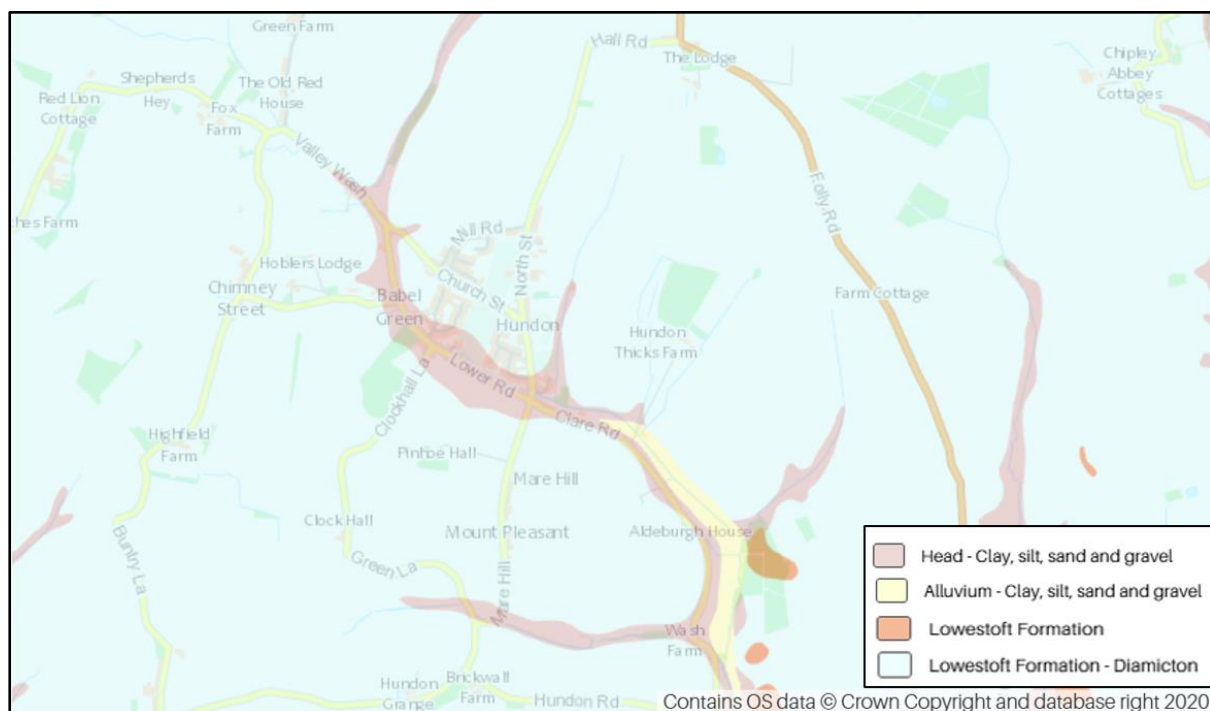
Figure 9. Superficial Geology (BGS Viewer)

Lowestoft Formation 'Diamicton' surrounds Hundon which is described by the British geological survey as a diverse mixture of clay, sand, gravel, and boulders varying widely in size and shape. This generally has a low permeability, meaning water will tend to flow off it before it can be infiltrated, which reflects some of the reports from the Storm Babet event.

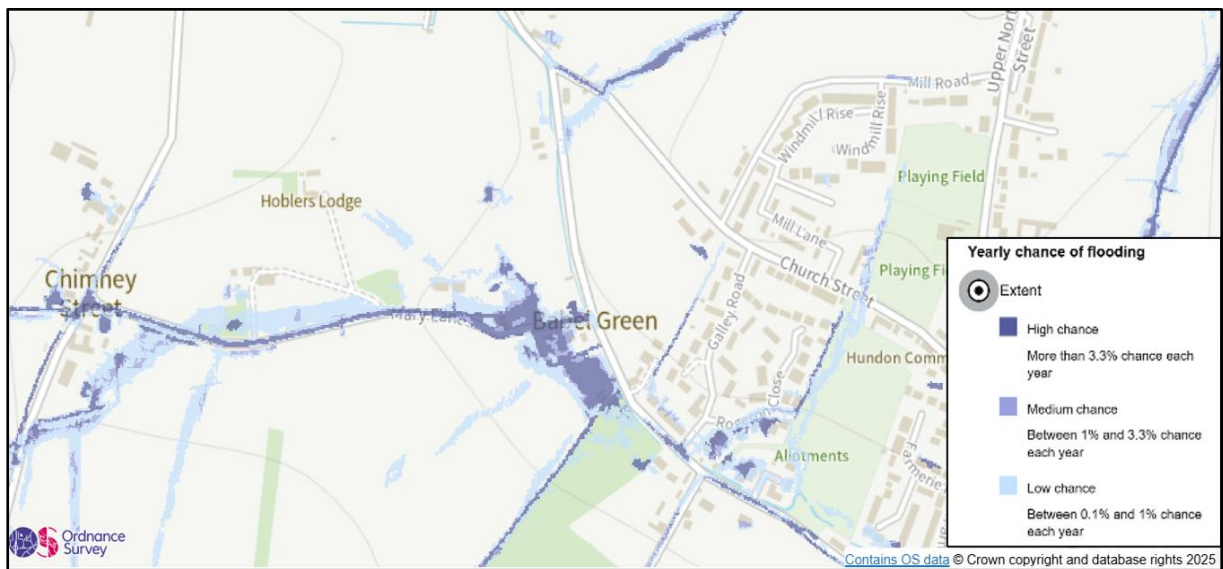
Figure 11. Surface water flood risk on Mary Lane and Valley Wash

The floodwater flowpaths observed in this location during Storm Babet closely match the national surface water and fluvial flood risk mapping (see Figures 11 & 12). Mary Lane is characterised as having a high chance of surface water flooding, whilst sections of Valley Wash are shown to be highly susceptible to fluvial flooding from Chilton Brook (classified as an ordinary watercourse in this location before it becomes main river at Chilton Street).

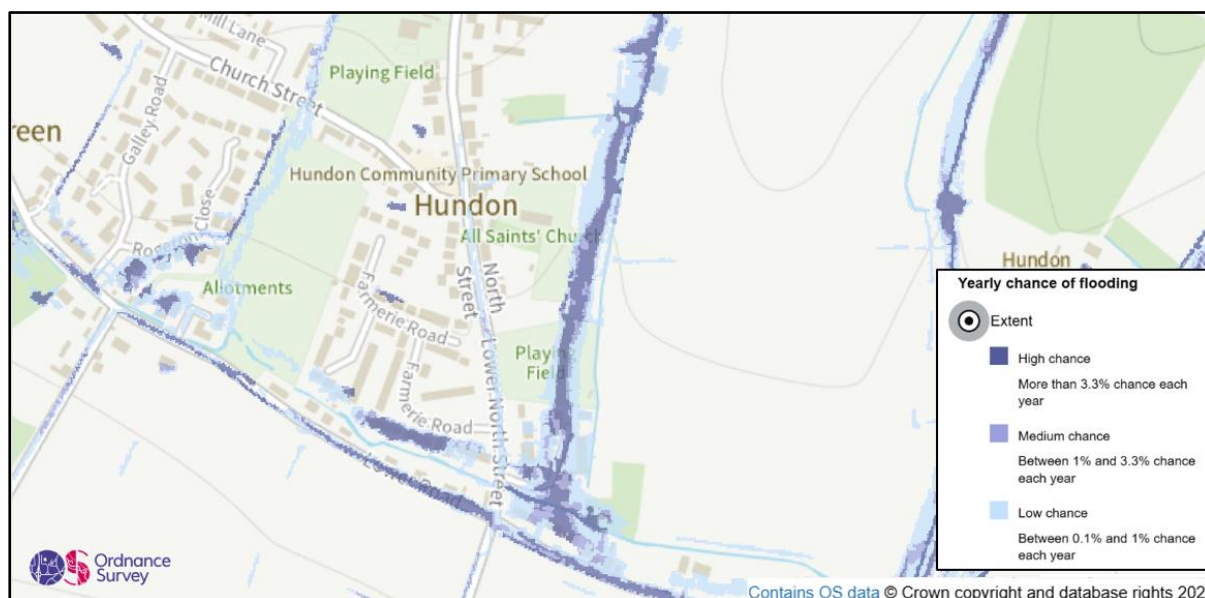
Figure 14. Surface water flood risk on Lower North Street, Lower Road and Farmerie Road

Residents have reported that the flow of the floodwater in the ditch was hindered by overgrown vegetation in the channel and a potentially blocked culverted section of the watercourse. Figure 14 shows the yearly chance of surface water flooding on Lower North Street.

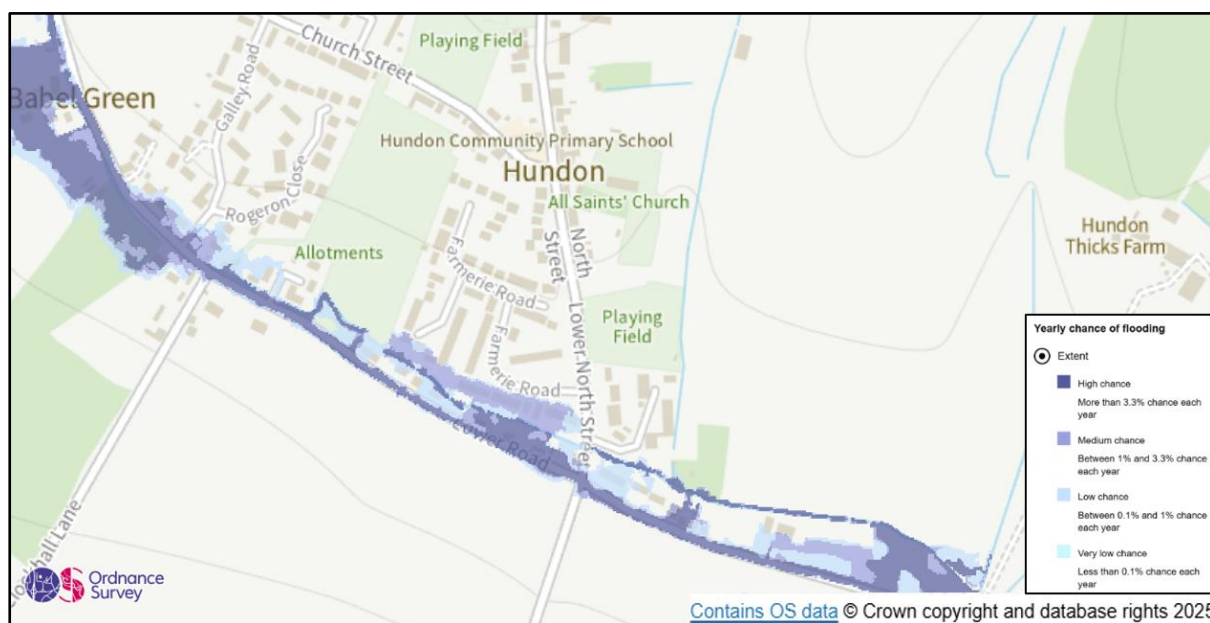
Figure 15. Fluvial flood risk on Lower North Street, Lower Road and Farmerie Road

Resident reports cited a general lack of maintenance within the Brook with the resultant overgrown vegetation causing blockages and holding up the flow of water.

There are also sections of the channel where historically, the capacity has been reduced over time, through straightening and narrowing. This has been contributed by various locations in which unconsented works have been undertaken along this stretch of the Brook. These alterations to the channel have likely contributed to the flooding as did a number of other nearby culverted sections. Taken together cumulatively, the floodwater flows were restricted in an area already greatly susceptible to both surface water and fluvial flooding (see Figures 14 & 15), and flooding is likely in this location irrespective of additional restrictions in the channel. The Lead Local Flood Authority has investigated and concluded no further action is to be taken regarding the unconsented works in this location.
