Section 19 Flood and Water Management Act 2010

Report Title: Garrison Lane, Felixstowe

CRNos. 325731, 326167

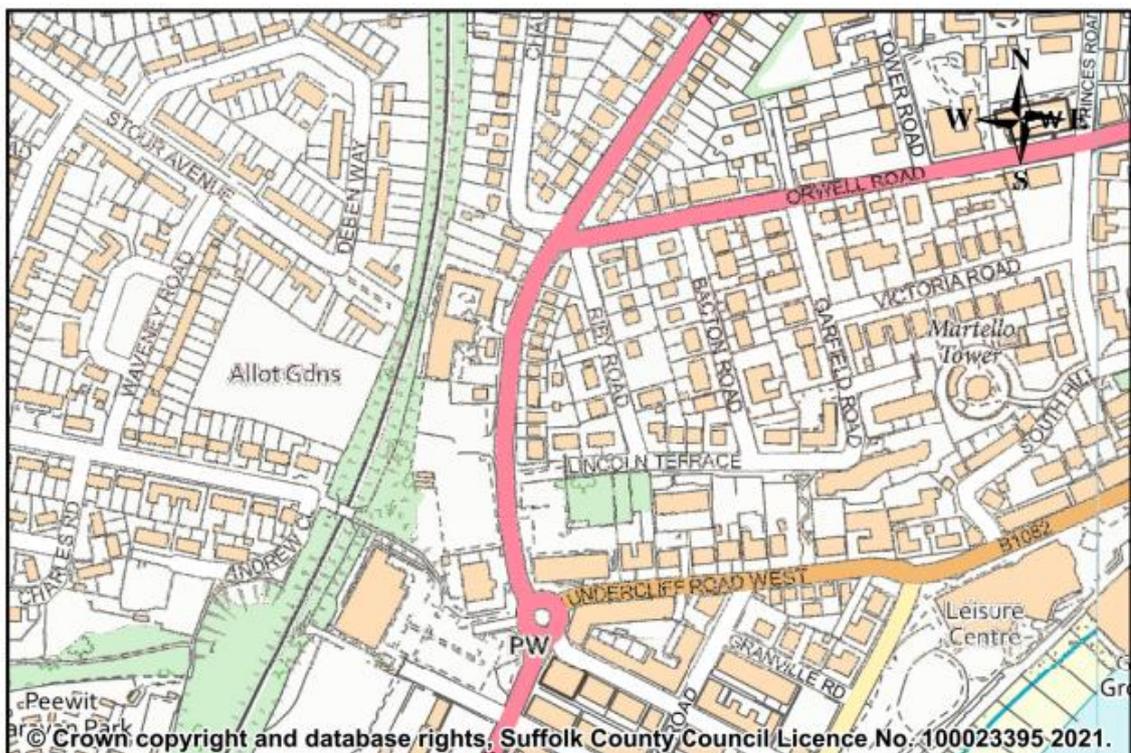
Figure 1 - Investigation Area Map

The properties which experienced flooding on Garrison Lane are located at a low point part way down the hill where the topography directs overland flows towards and past the site.
