Section 19 Flood and Water Management Act 2010

Marlesford Flood Investigation –

Storm Babet 2023

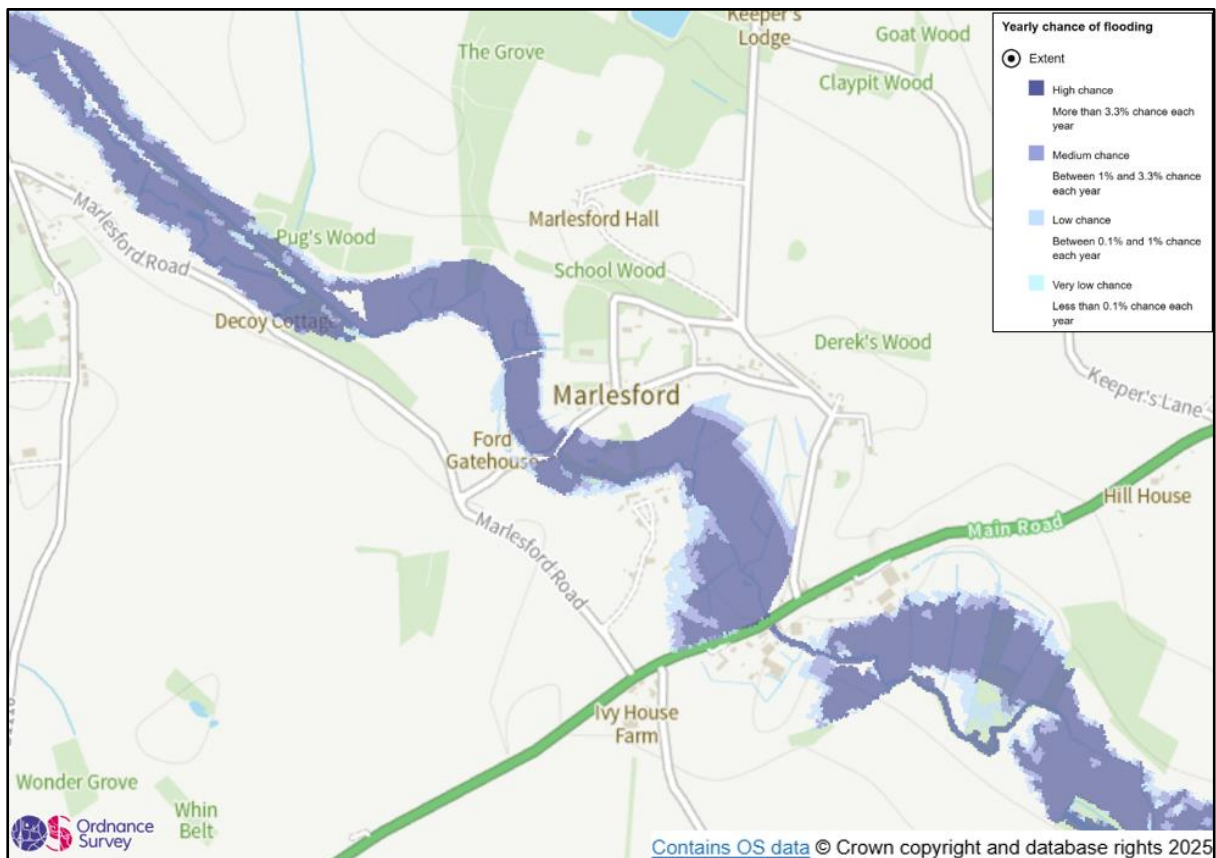
Figure 6. Flood risk from rivers and sea

Figure 6 shows the predicted fluvial (from designated main river and ordinary watercourses) flood risk in Marlesford. Fluvial flood risk in Marlesford is predominantly associated with the river Ore which passes through the village.

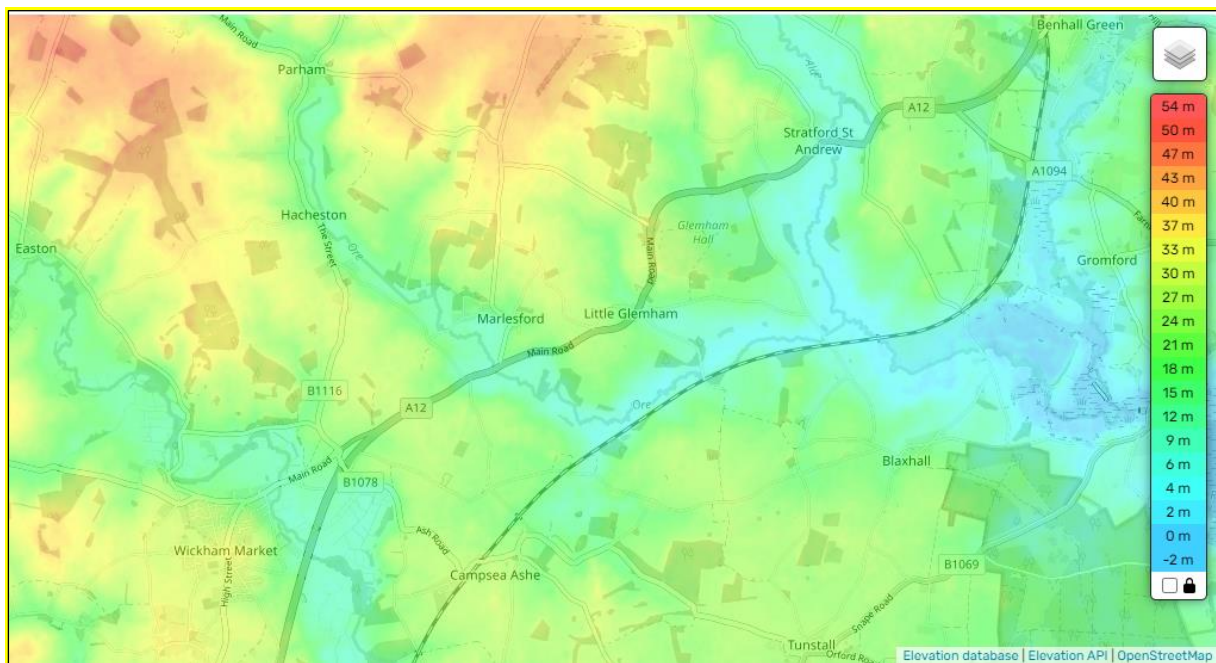
Figure 7. Marlesford and surrounding topography (TessaDEM as cited in topographic-map.com)

Figure 7 shows the topography surrounding Marlesford with gradient changes across the wider village. One of the lowest points in Marlesford is at the A12 road bridge over the river Ore. The junction of Church Road with Ford Road and Low Road is lower than the surrounding land to the north and west. These locations were identified as being some of the worst affected areas during Storm Babet.
