Section 19 Flood and Water Management Act 2010

Needham Market Flood Investigation – Storm Babet 2023

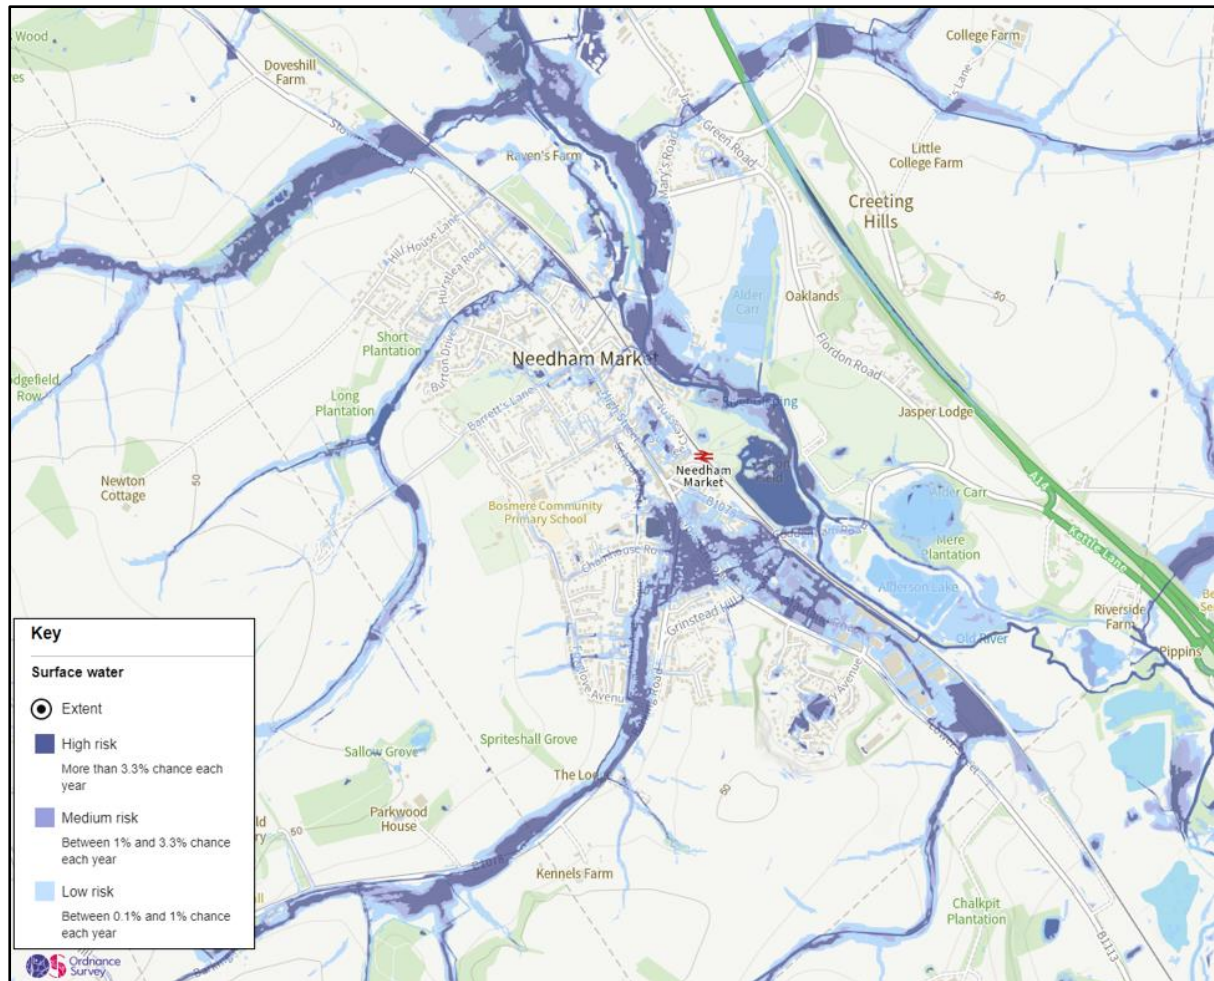
Figure 5 - Predicted Pluvial Flood Risk

Figure 5 highlights the predicted pluvial (surface water run-off from surrounding land and ditches) flood risk within Needham Market, with five main flow paths coming into the town. This indicates that there is significant risk of surface water flooding on Barking Road, Foxglove Avenue, Hargrave Avenue, Pinecroft Way, Limetree Close, Hawks Mill Street, Crown Street and Highland Close. These areas were all affected by flooding during Storm Babet.

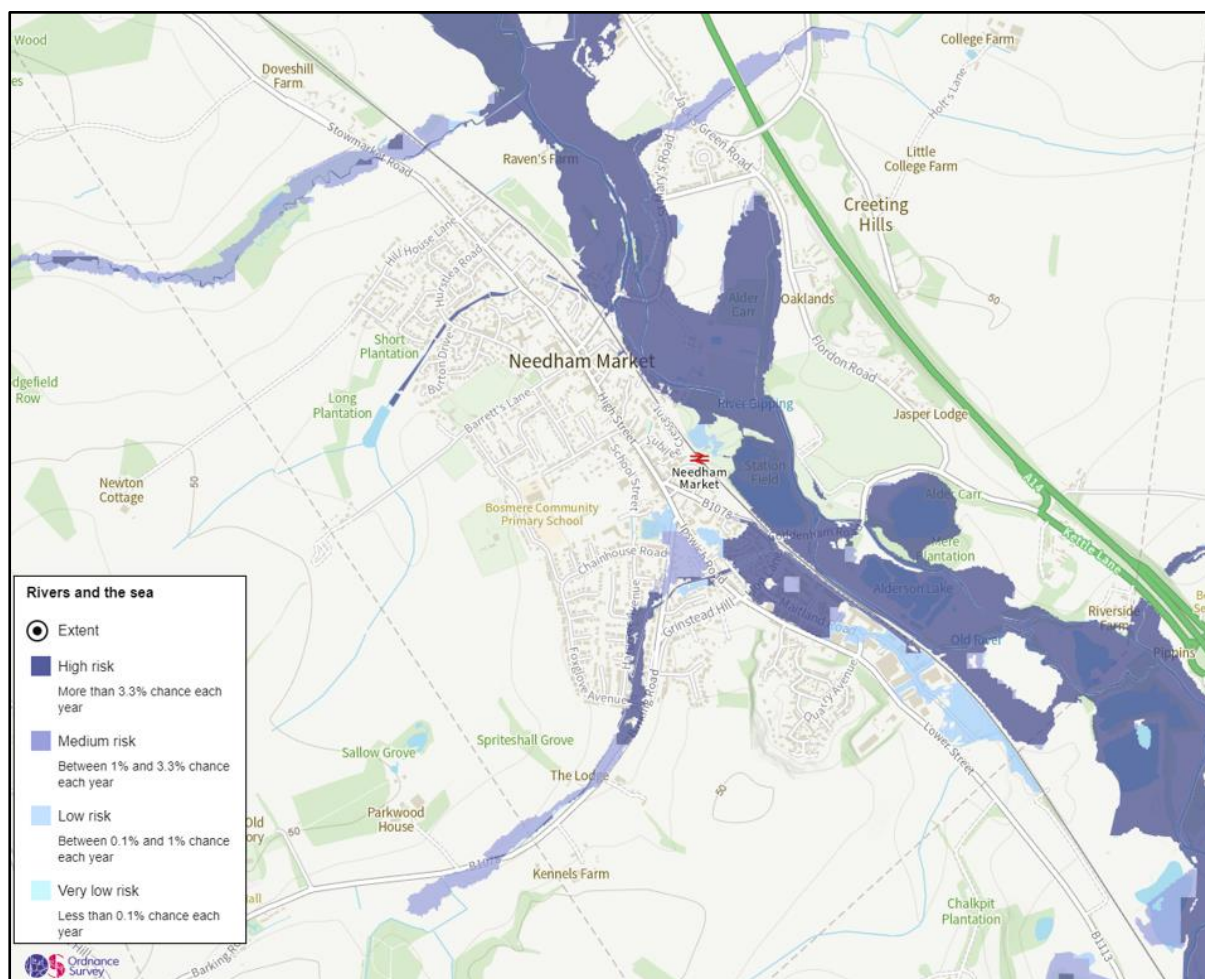
Figure 6 - Predicted Fluvial Flood Risk

Figure 6 highlights the predicted fluvial (from designated main river) flood risk within Needham Market. The main fluvial influences consist of the main river Gipping, the Lion Barn drain and the Orchard Gate watercourse. The Hawks Mill area, Crown Street, Pinecroft Way, Maitland Road, Barking Road and some areas of Foxglove Avenue are shown as being at risk for fluvial flooding. These areas were affected by flooding during Storm Babet.

Further east along Coddensham Road properties were also flooded when the main River Gipping overtopped its banks with reports indicating the floodwater was between 2 -3 ft deep on the road. The observed floodwater extents and pathways from the watercourse match closely with the flood extents shown on the national surface water flood risk mapping (Figure 6).

Flooding was likely caused by a combination of factors; a blockage in the culvert, the tall brick headwall of the footbridge blocking any flow downstream and the elevated height of the watercourse's northern bank. The observed floodwater extents and pathways from the watercourse match closely with the flood extents shown on the national surface water flood risk mapping (Figure 6).

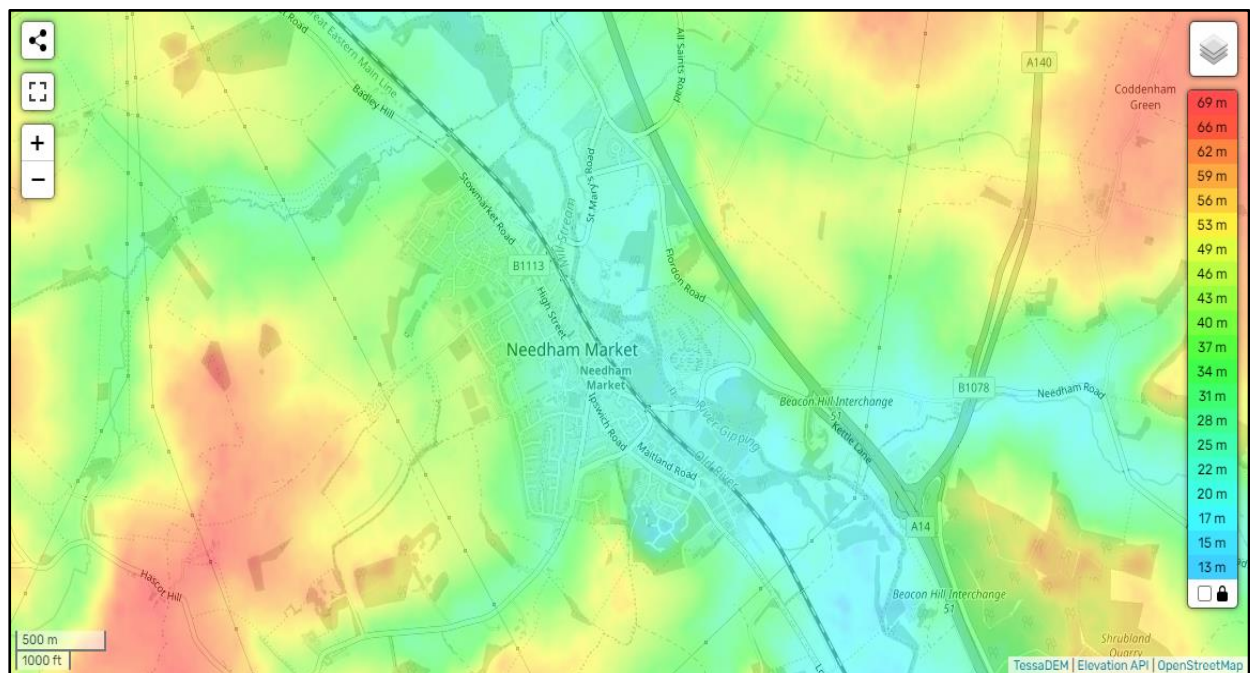
Figure 7 - Needham Market and surrounding topography

Figure 7 shows the topography surrounding Needham Market and the gradient changes across the town. Hawks Mill, Pinecroft Way, Limetree Close, Maitland Road and Lion Lane are among the lowest lying locations in Needham Market. These were identified as being some of the worst affected areas following Storm Babet.

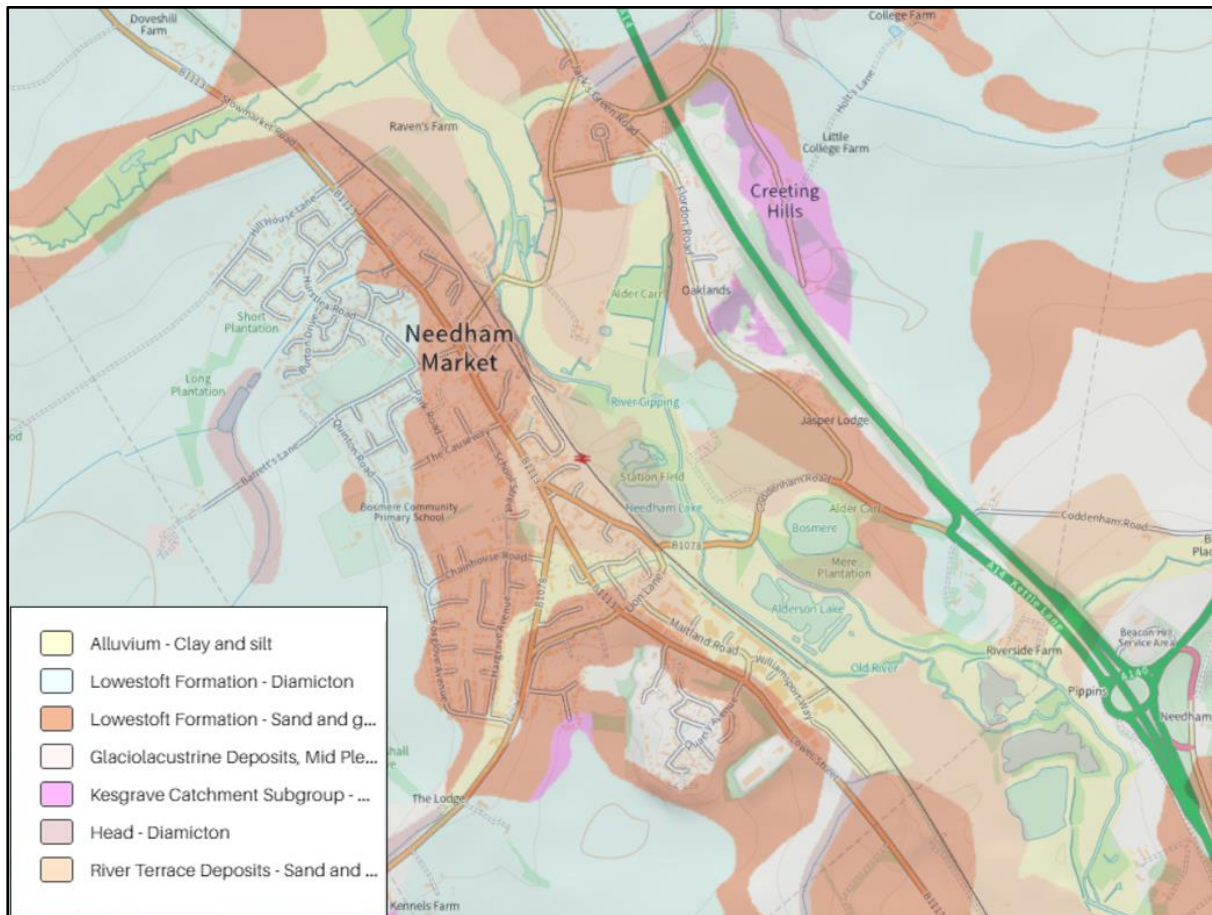
Figure 8 - Needham Market town centre and underlying superficial geology (British Geological Survey, 2024)

Needham Market itself sits mostly on Lowestoft Formation - sand and gravel and alluvium which is described by the British Geological Survey as a mixture of clay and silts. These alluvium floodplain soils usually have naturally high groundwater and tend to be wet.

Lowestoft Formation 'Diamicton' surrounds the town more generally which is described by the British geological survey as a diverse mixture of clay, sand, gravel, and boulders varying widely in size and shape. This generally has a low permeability meaning water will tend to flow off it before it can be infiltrated, which reflects reports from the event.

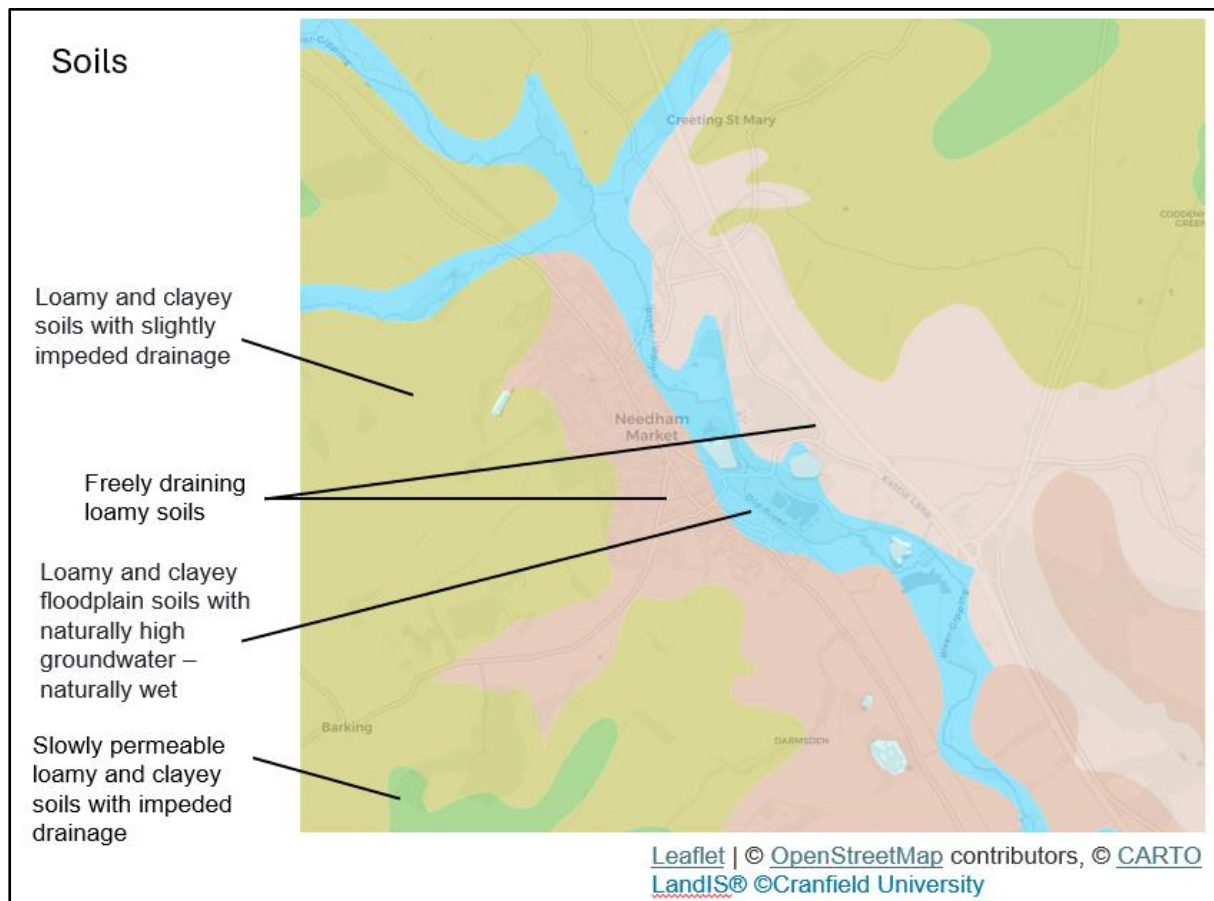
Figure 9 - Needham Market and surrounding soils

With reference to soils in the wider catchment, immediately around Needham Market, they are described as loamy and clayey soils with slightly reduced infiltration. This is sometimes known as boulder clay. At the higher levels surrounding the town, the soil is described as slowly permeable, seasonally wet, loamy and clayey soils with reduced infiltration (LandIS, Cranfield University, 2024). Lower rates of infiltration to ground means that more surface water will stay on the surface and not be absorbed, potentially contributing to flood water (see Figure 9).

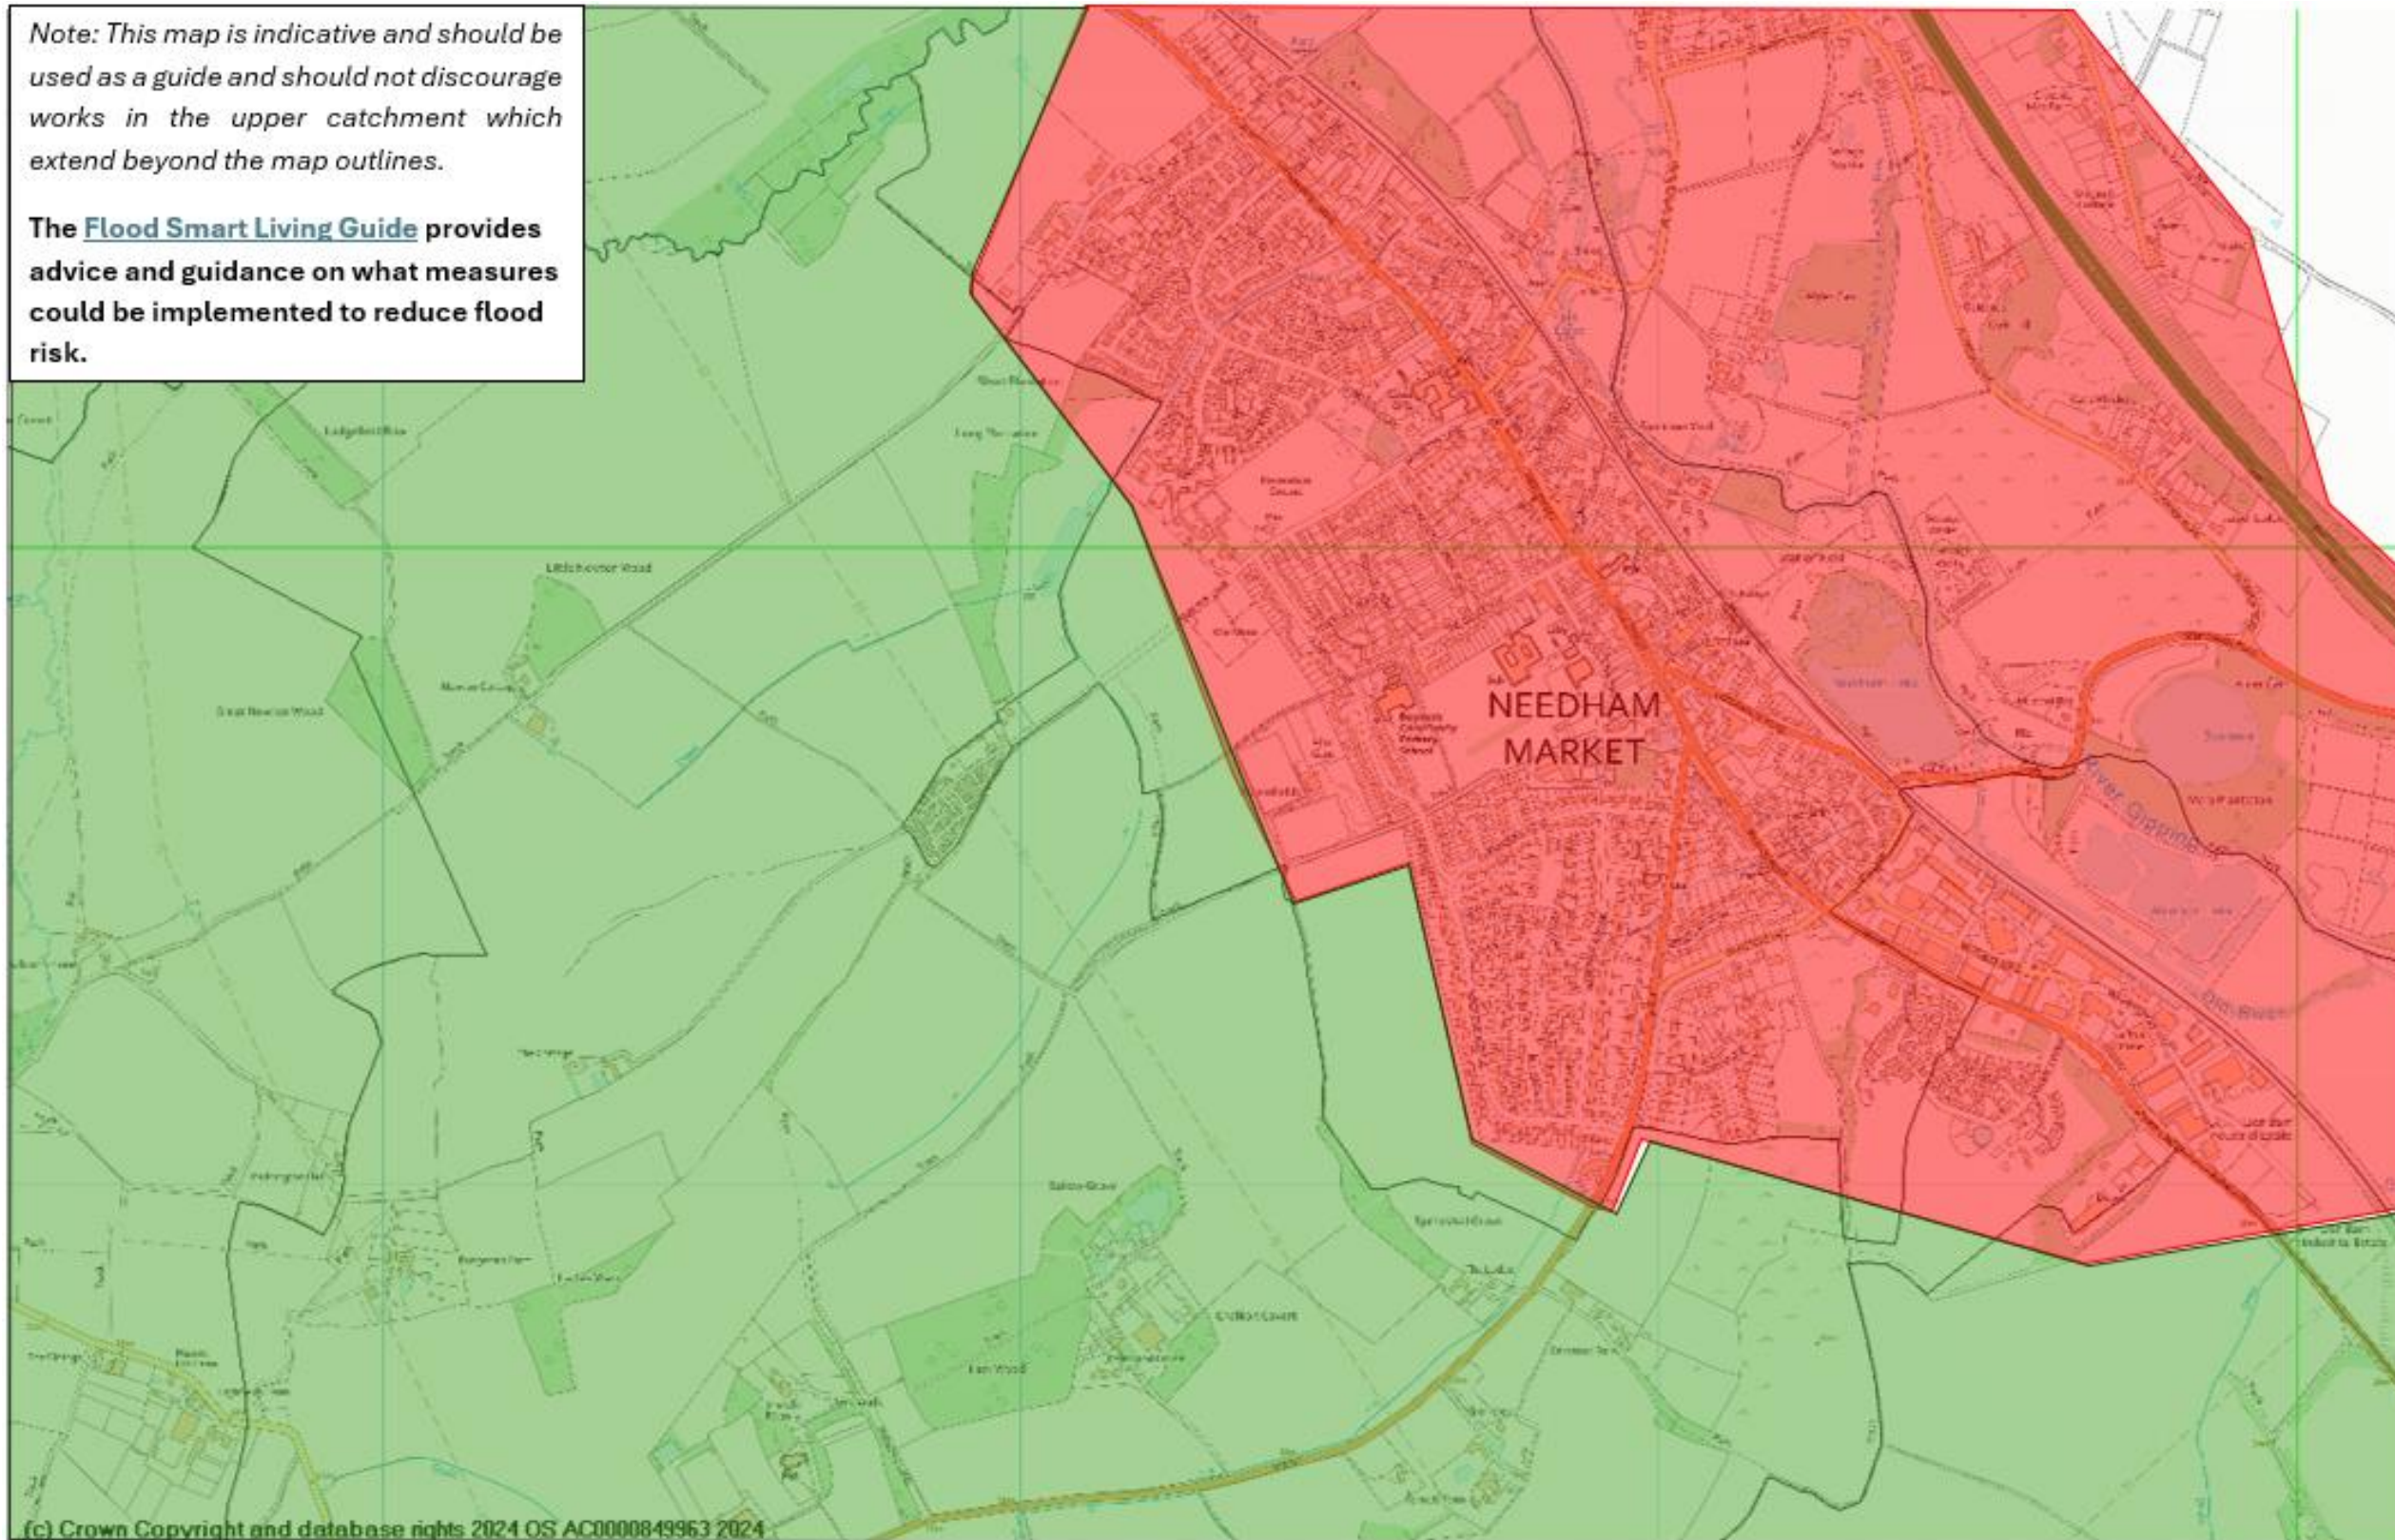
Red – Urban locations where watercourses should be kept clear and water free flowing.

These locations are vulnerable to flood risk and are where the most impact is experienced during an event. Drainage features are constrained with limited space for water and overwhelming of features may lead to flooding. Important to ensure water can flow through the systems with limited restrictions.
