Section 19 Flood and Water Management Act 2010

Bredfield Flood Investigation

Storm Babet 2023

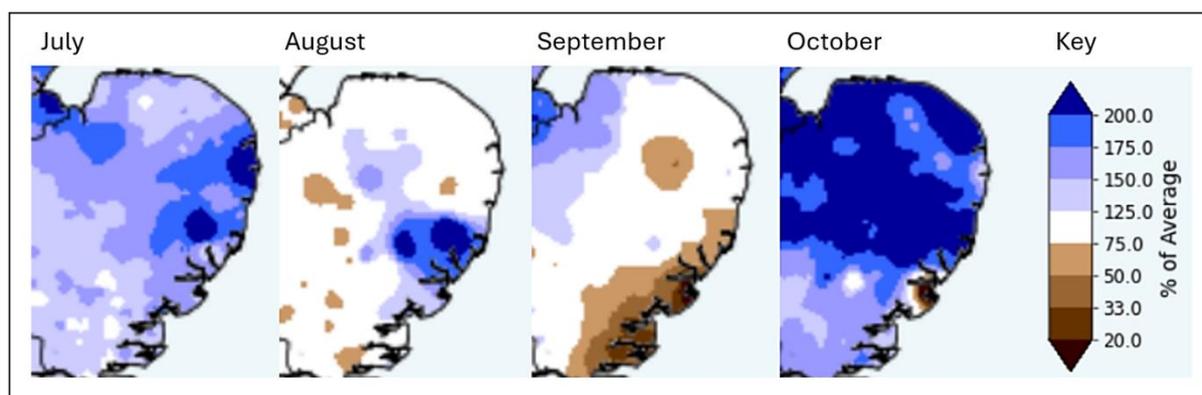
Fig. 1. Average monthly rainfall (July – October 2023) as a percentage of the historic average monthly rainfall

The following maps illustrate the extent to which the rainfall in the months preceding Storm Babet exceeded the average monthly rainfall for July to October in recent years in Suffolk.

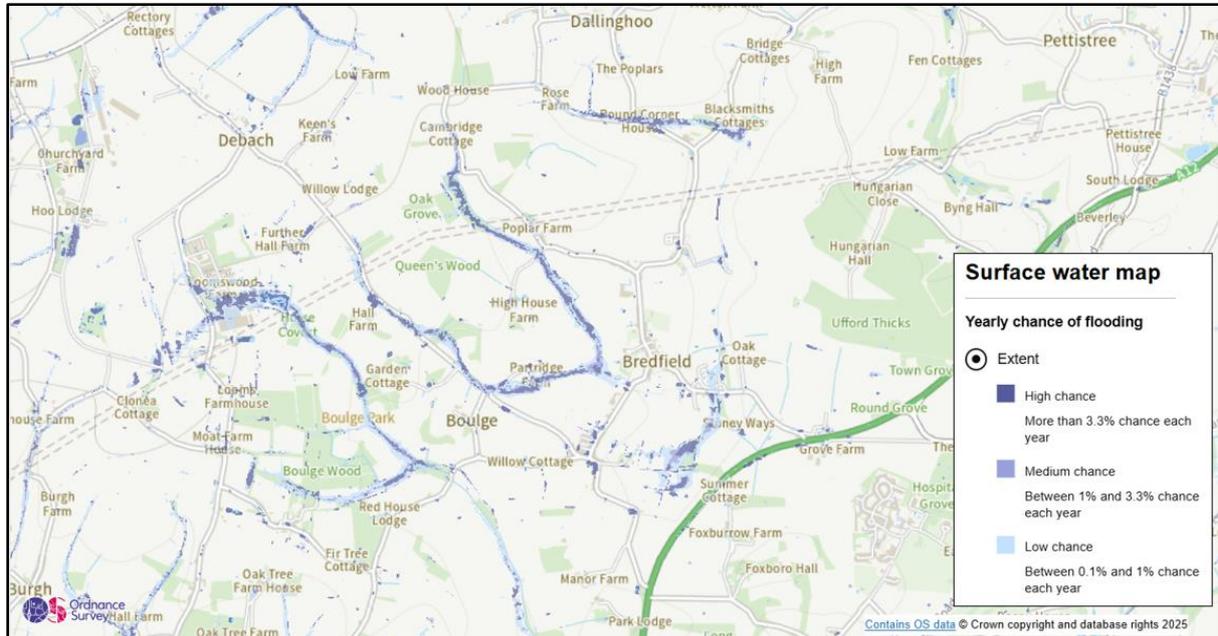
Fig. 6 Predicted flood risk from surface water

The parish of Bredfield is at significant risk of pluvial flooding (Fig. 6). Areas of surface water flood risk which are projected in areas of property affected by internal flooding are mostly located to the west, south and east of the northern Bredfield village settlement.

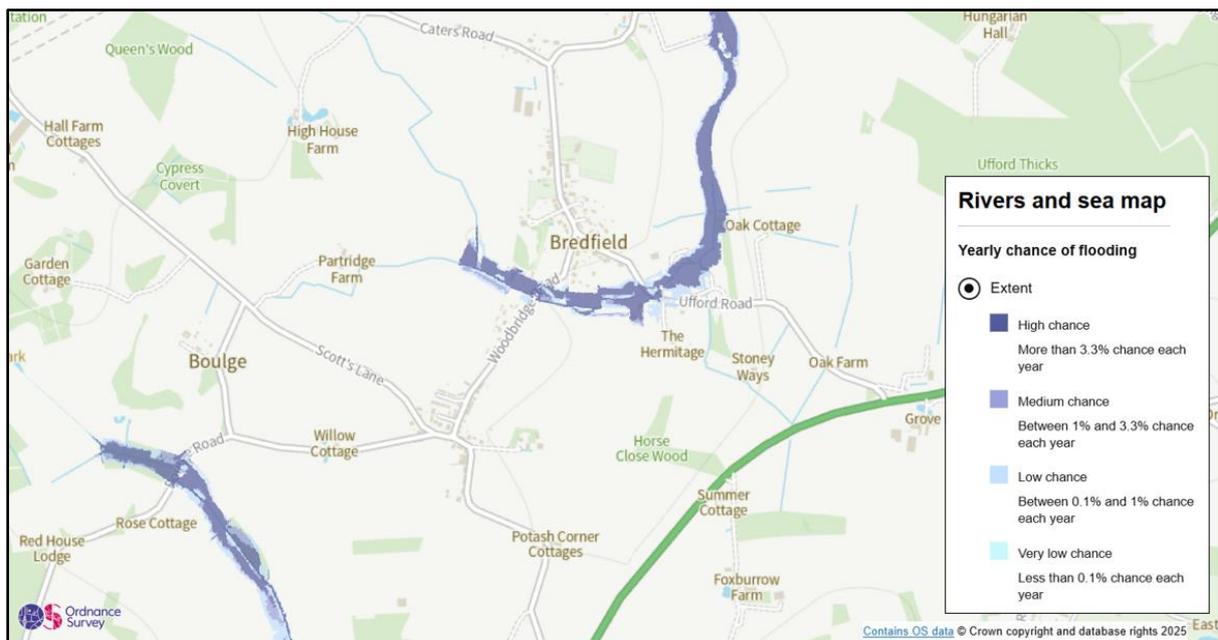
Fig. 7. Predicted flood risk from rivers

Fluvial flood risk in Bredfield is associated with Byng Brook, which follows an arc from west to east, on the south side of the northern Bredfield village settlement.

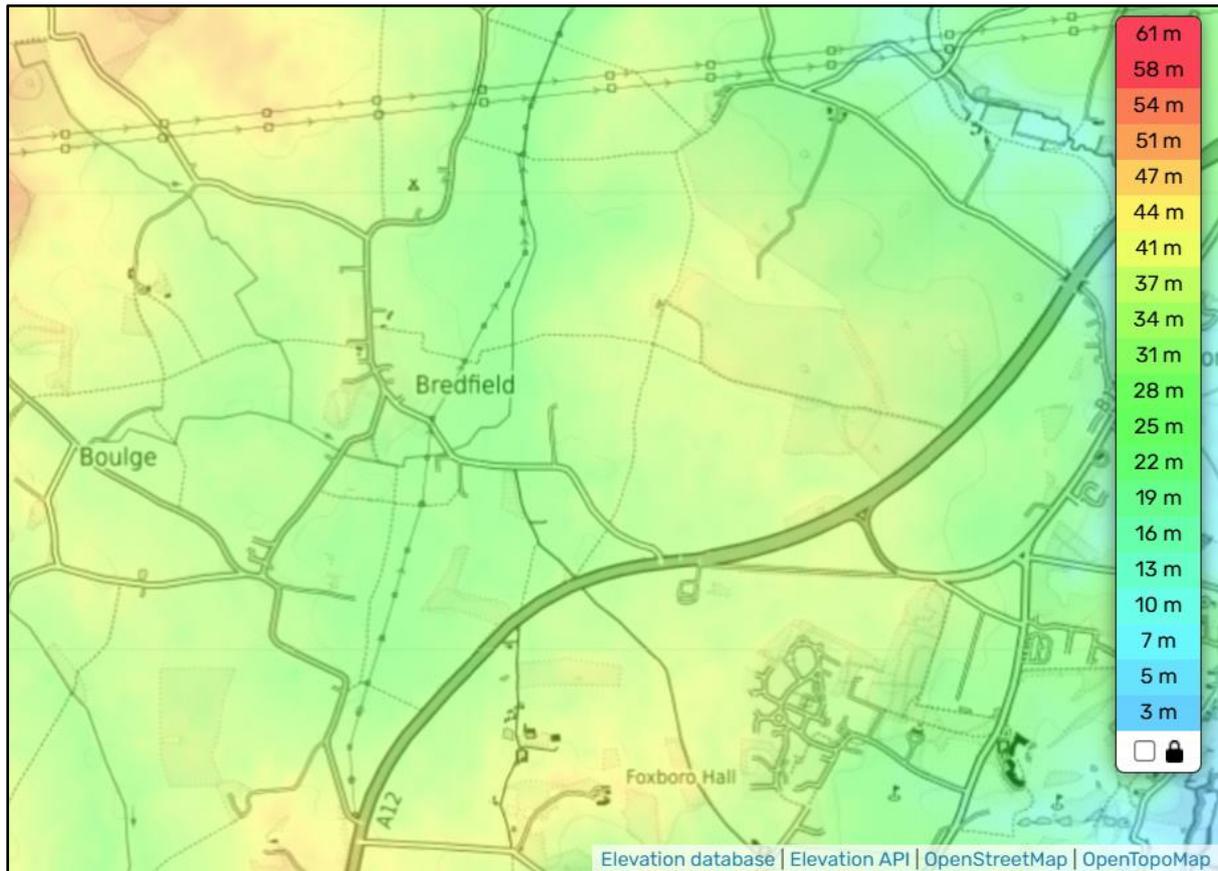
Fig. 8 Elevation map of catchment area

The low-lying nature of areas of the village means that during high rainfall events considerable flows of water converge and then drain away relatively slowly (see Fig. 8). Overwhelmed infrastructure and watercourses may be observed during these intense rainfall events.

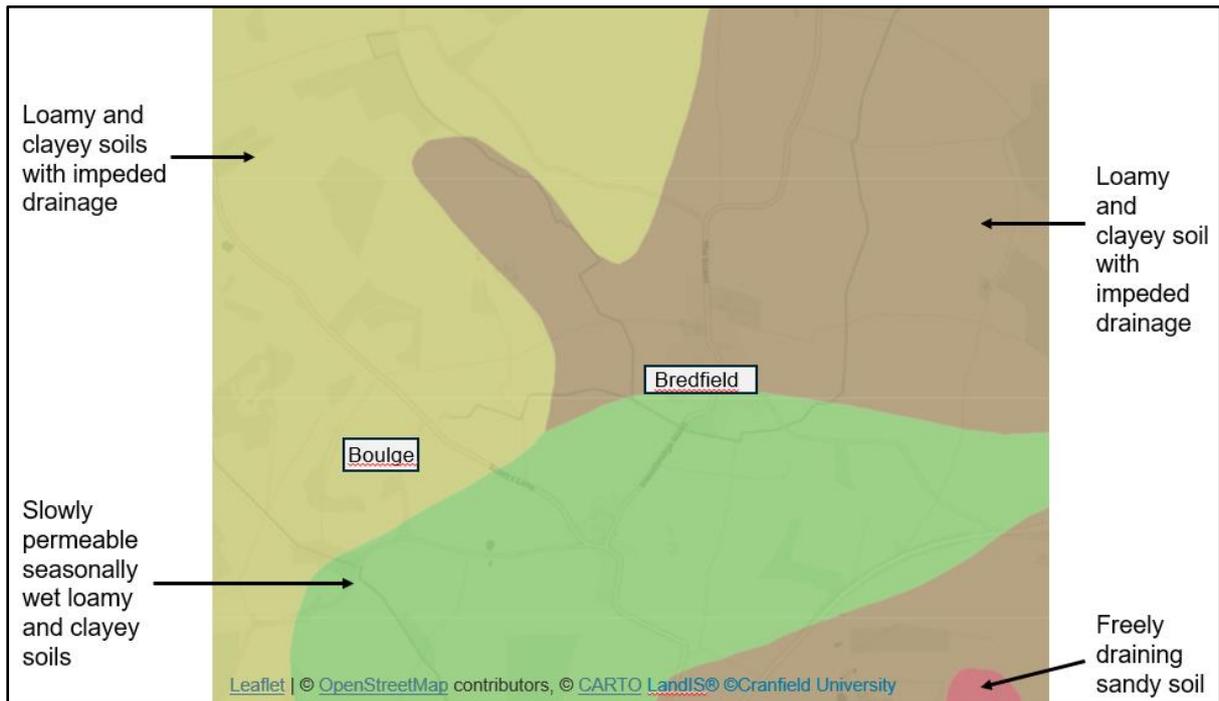
Fig. 7. Soil map of catchment area (LandIS Soils)

The soils surrounding Bredfield are loamy and clayey with impeded drainage, meaning that water permeates more slowly and surface water runoff is greater, particularly during intense rainfall (Fig. 8). However, the saturated nature of the soils leading up to the event would also have prevented some infiltration.

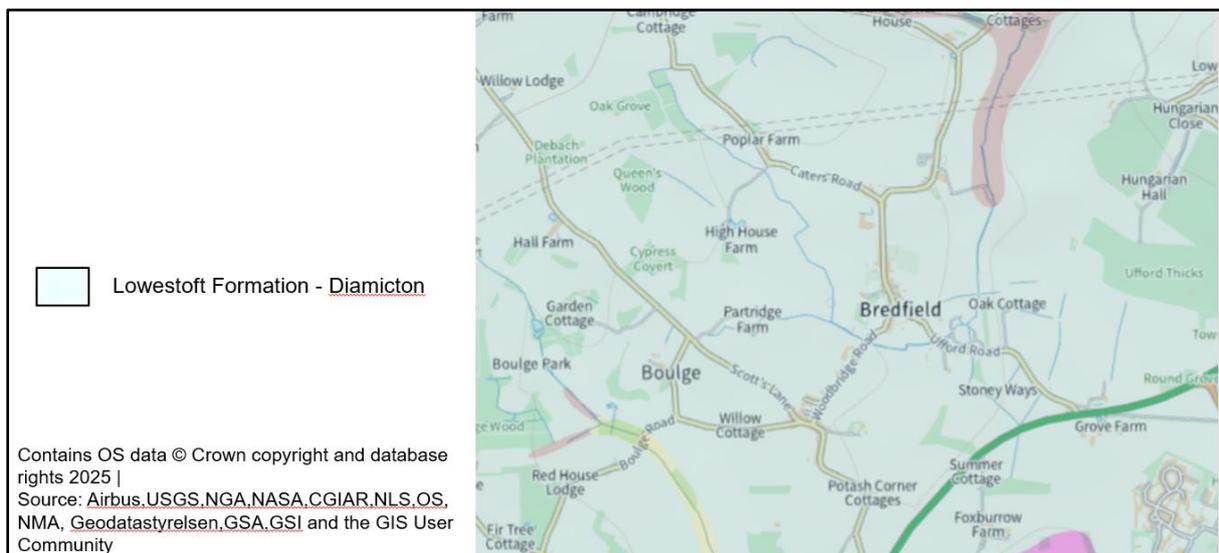
Fig. 8. Superficial geology (British Geological Society)

Fig. 10 shows that much of the superficial geology surrounding Bredfield is made up of 'Lowestoft Formation – Diamicton' which is described by the British Geological Survey as a diverse mixture of clay, sand, gravel, and boulders varying widely in size and shape. This is sometimes known as boulder clay. This generally has a low permeability meaning water will tend to flow off it before it can infiltrate, which also reflects the reports collected during Storm Babet.

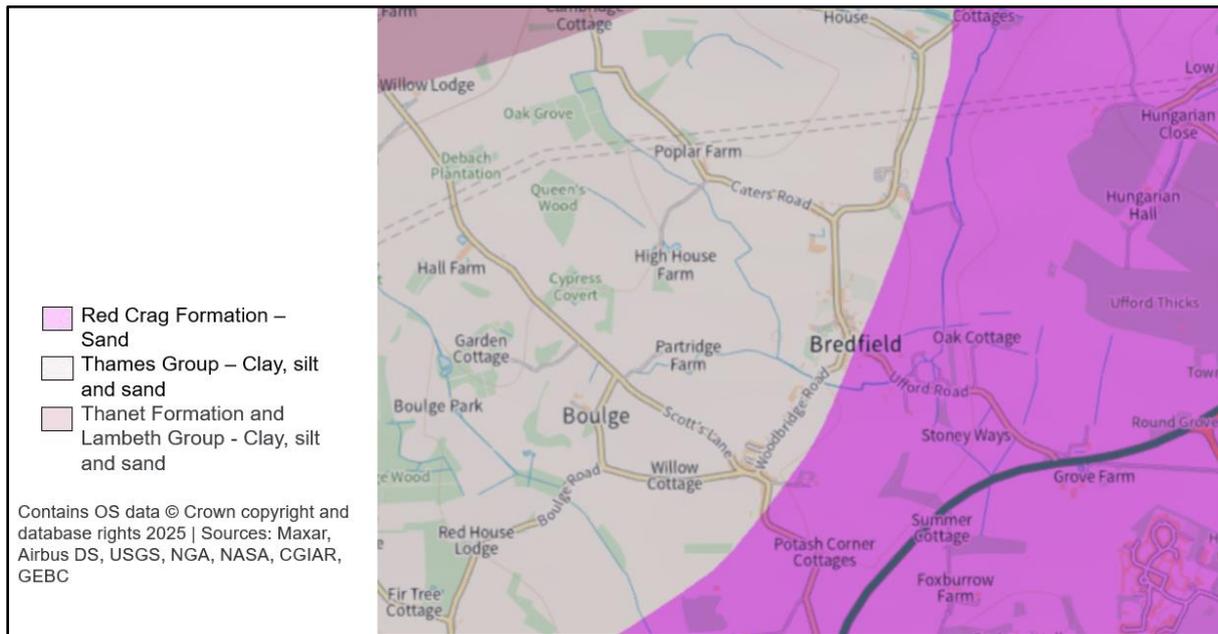
Figure 9 Bedrock geology (British Geology Society)

The bedrock in Bredfield and the surrounding area is a mixture of Thames Group - Clay, silt and sand; Red Crag Formation – Sand and Thanet Formation and Lambeth Group - Clay, silt and sand (Fig. 11).

During short term intense rainfall events, soil composition and superficial geology become more influential in affecting the volume of surface water runoff. Combined with the topography within the catchment, these make Bredfield susceptible to extreme rainfall events. Saturated ground and high rainfall, like that of Storm Babet, will further emphasise the vulnerability of the parish and localised flooding could be experienced.
