## Section 19 Flood and Water Management Act 2010

### Charsfield Flood Investigation – Storm Babet 2023

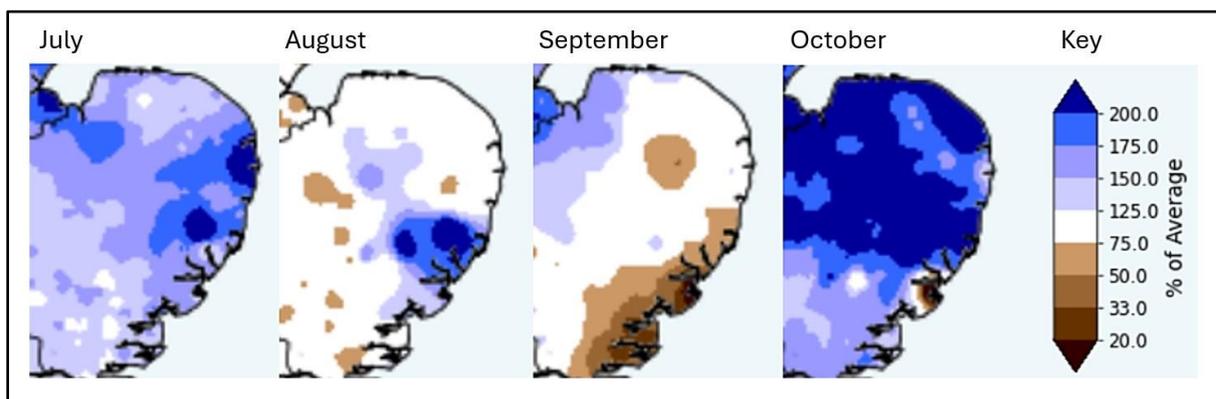
*Figure 1 - Average rainfall in East Anglia between July and October 2023 as a percentage of the historical average monthly rainfall*

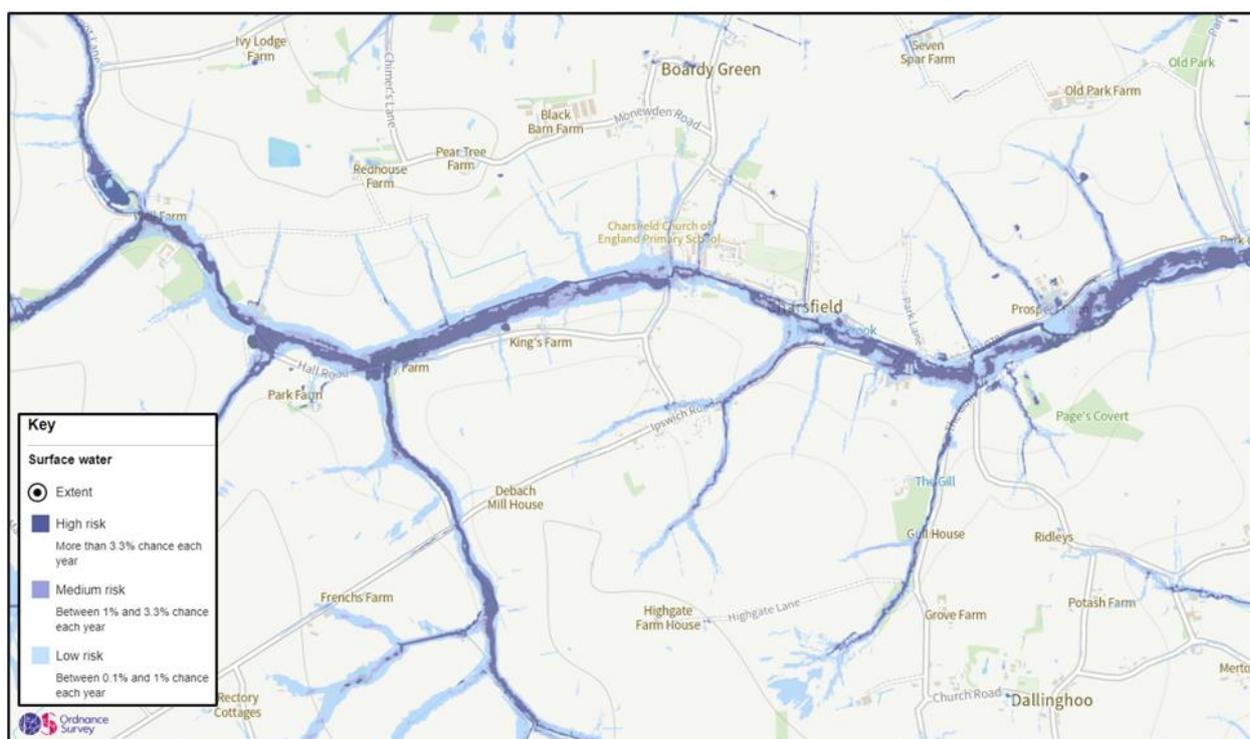
Figure 5 - Predicted surface water flood risk

Figure 5 highlights the predicted pluvial (surface water run-off from surrounding land) flood risk within Charsfield, with multiple floodwater flow paths flowing into the village. There is significant risk of surface water flooding in Charsfield, with Chapel Lane, St. Peter's Close, Church Road, Hall Road and The Street all identified to be at risk. These areas were affected by flooding during Storm Babet.

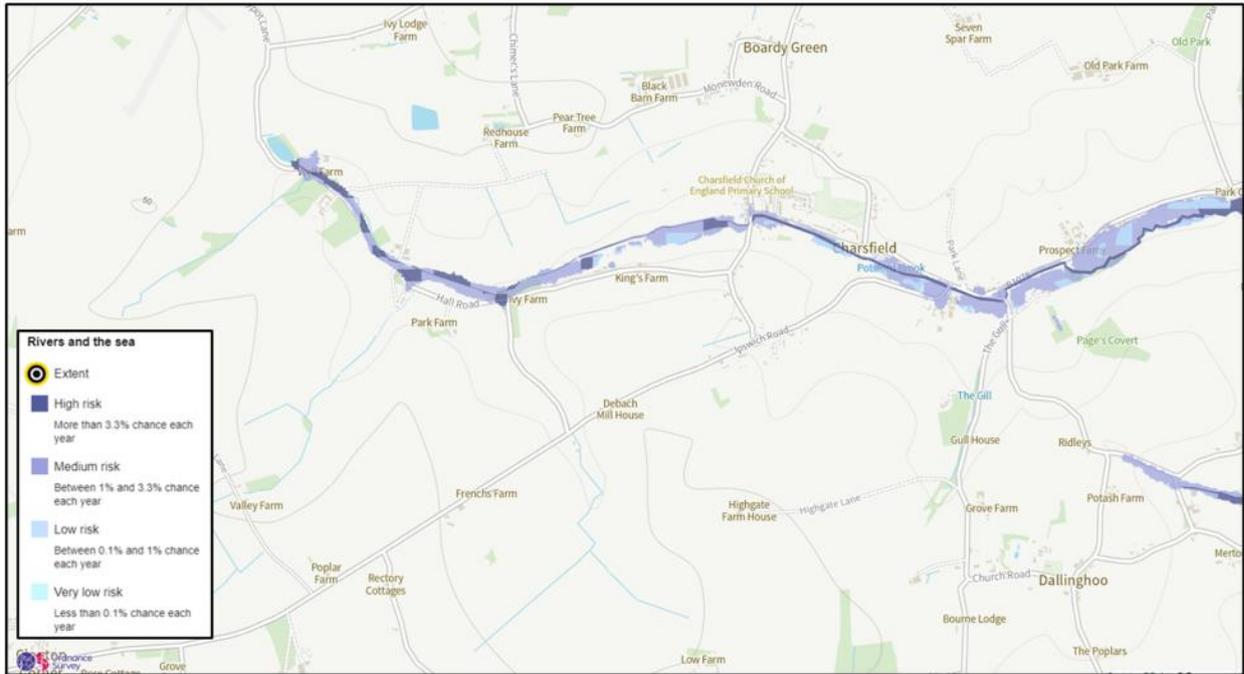
Figure 6 - Predicted flood risk from rivers and sea

Figure 6 highlights the predicted fluvial (from ordinary watercourse and main river) flood risk within Charsfield. The main fluvial influence is the Potsford Brook, a tributary of the River Deben. Church Road, The Street and Wickham Market Road are shown as being at risk from fluvial flooding. These areas were affected by flooding during Storm Babet.

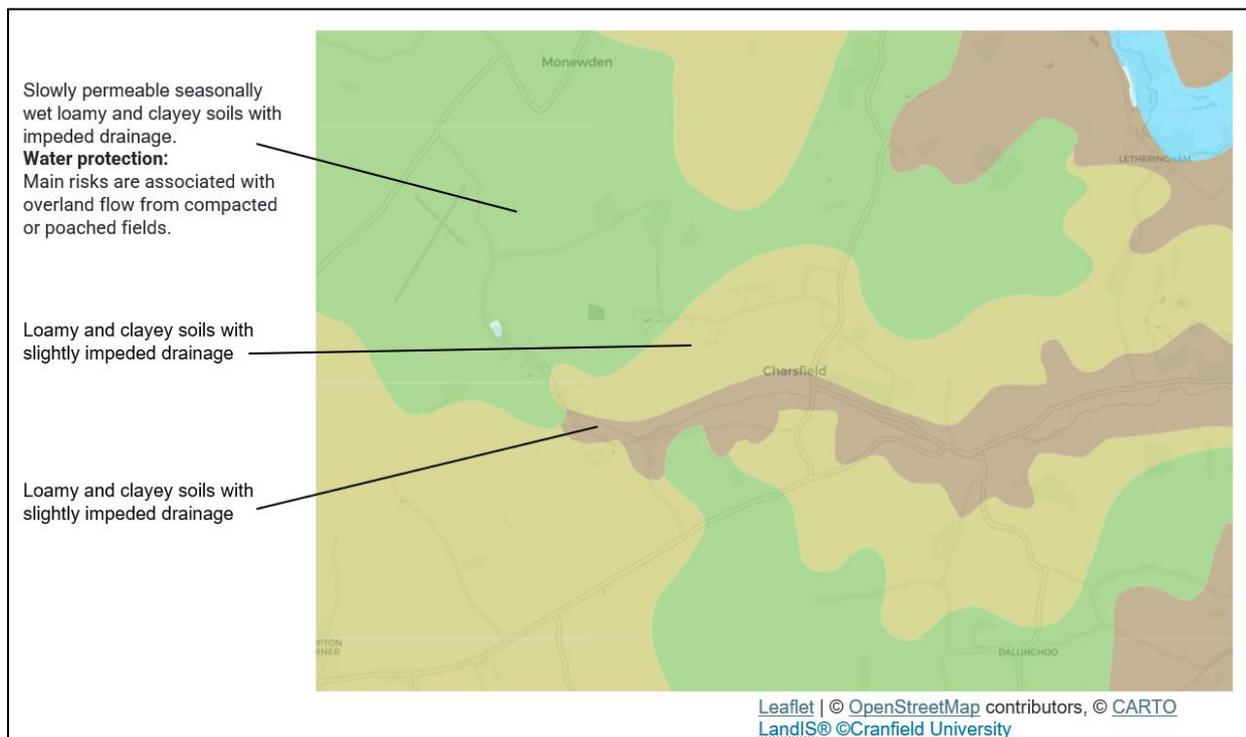
Figure 10 - Charsfield and surrounding soils

With reference to soils in the wider catchment, immediately around Charsfield, they are described as loamy and clayey soils with slightly impeded drainage (see Figure 10). At the higher levels surrounding the town, the soil is described as slowly permeable, seasonally wet, loamy and clayey soils with impeded drainage / reduced infiltration (LandIS, Cranfield University, 2024). Lower rates of infiltration to ground means that more surface water will stay on the surface and not be absorbed, potentially contributing to flood water.

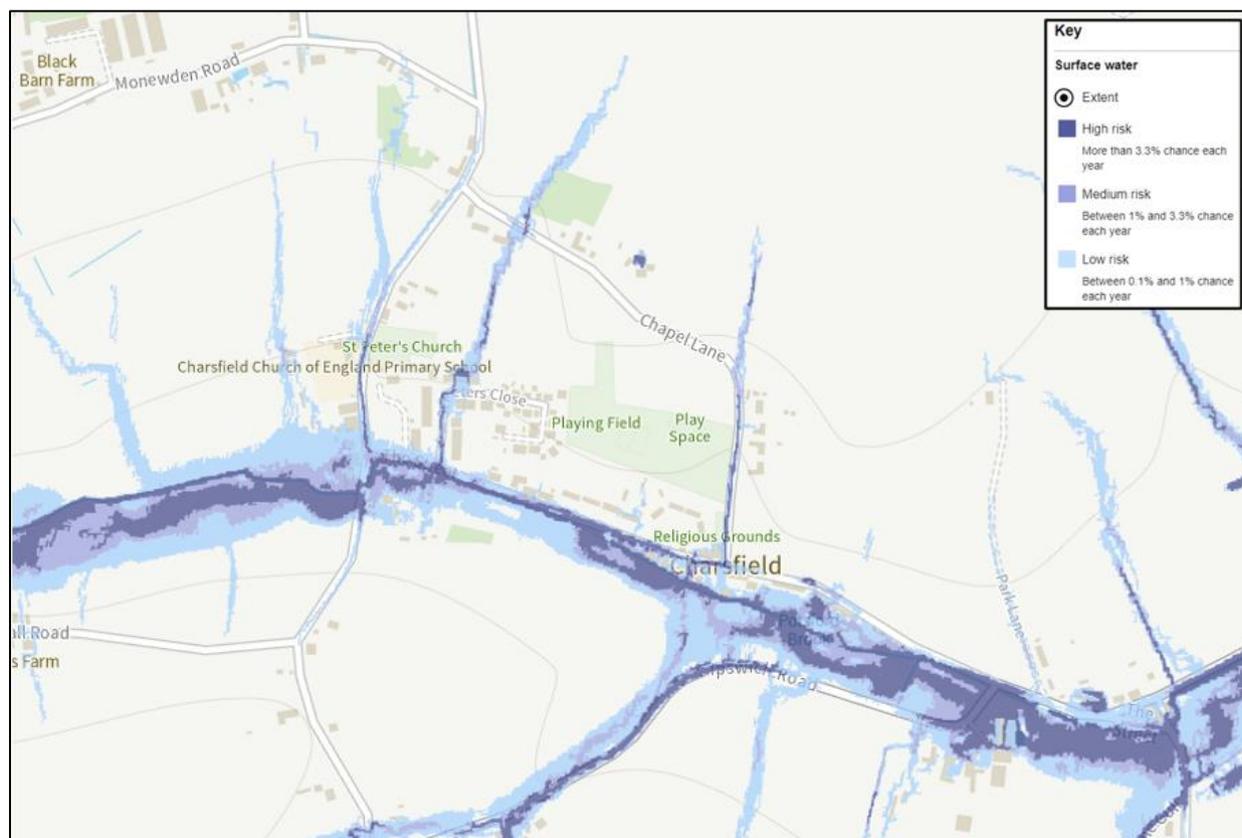
Figure 13 - Predicted surface water flood risk for Charsfield

Floodwater was accumulating at the bottom of St Peters Close from 7:00am onwards, making it one of the earliest sites of flooding in the village (Image 5). Internal flooding on St Peters Close was reported from 8:00am onwards with no sign of lessening until late afternoon. The observed floodwater flow path seen on Chapel Lane and St Peters Close is consistent with the predicted surface water flood risk which is defined as Medium to High in this location (see Figure 13).

As mentioned above, pluvial flooding was a significant factor in the flooding experienced on The Street. Surface water flowed down onto The Street from Church Road, St Peters Close and Chapel Lane, all of which brought additional flood water. This sequence of events closely matches the flow paths and extents shown in the predicted surface water flood mapping (Figure 13).

There is a significant flow path identified along Chapel Lane, as outlined in Figure 13, with flood flows merging at the junction with The Street. There are a series of 'grips' to allow water to flow off the road and into the adjacent watercourse. These have become silted up and are last recorded to have been formally inspected in 2019. Whilst there is a minor watercourse running parallel to Chapel Lane, floodwater mainly flowed down the highway, which is relatively steep, collecting in large volumes at the southern end of Chapel Lane where it meets The Street (Image 3). At this point the watercourse is piped for a short section before out falling into Potsford Brook. However, as the pipe is relatively small (approx. 300mm in diameter) and most of the floodwater was within the highway rather than the upstream watercourse, this indicates the pipe could not accommodate the flow. The piped section has less capacity than the original open channel and has likely reduced the volume of water that could be safely conveyed from the bottom of Chapel Lane into Potsford Brook during a storm event.
