Section 19 Flood and Water Management Act 2010

Cretingham Flood Investigation

Storm Babet 2023

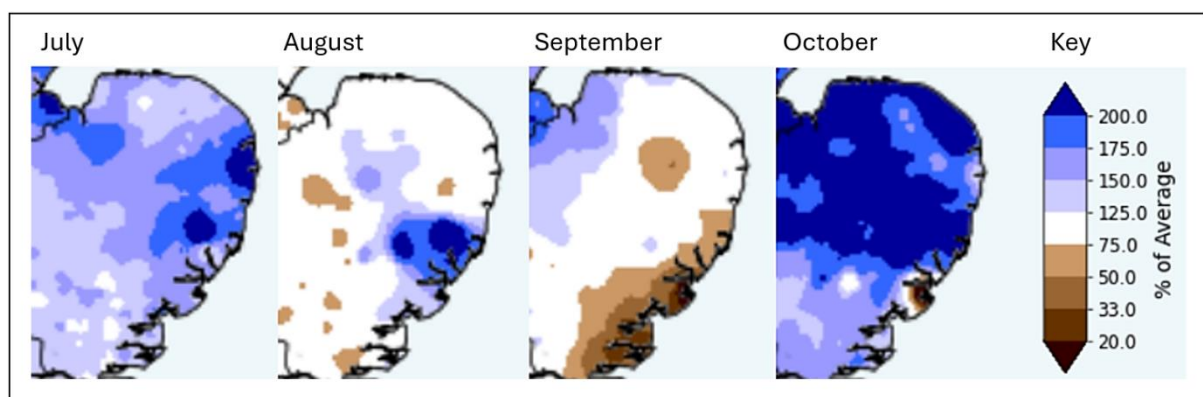
Fig. 1. Average monthly rainfall (July – October 2023) as a percentage of the historic average monthly rainfall

The Environment Agency River level gauging stations indicated many flows close to or exceeding their highest on record, and the weather remained wetter than average for the rest of the month. October 2023 was the joint wettest on record in the east of England since 1871. During Storm Babet, Suffolk saw the heaviest rainfall across East Anglia causing significant flooding of roads and properties. The river systems rose rapidly across whole catchments due to the existing conditions, which was unusual as storms will often impact a small area and result in a steady progression of flood water downstream. A major incident was declared by Suffolk Resilience Forum (SRF) in the afternoon of the 20th of October due to significant impacts on communities and disruption to the road and rail networks.

The following maps illustrate the extent to which the rainfall in the months preceding Storm Babet exceeded the average monthly rainfall for July to October in recent years in Suffolk.

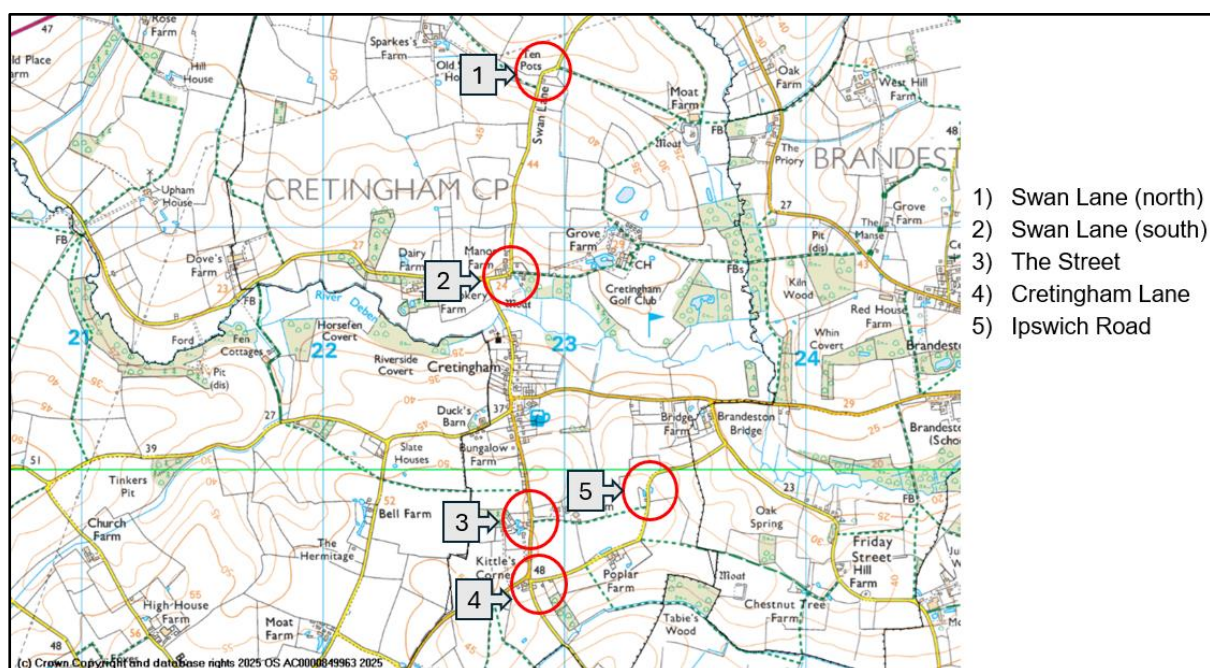
Fig. 5. Distinct flood zones

For the purposes of this investigation the various areas affected by flooding have been separated into three distinct zones:

1. Swan Lane (north)
2. Swan Lane (south)
3. The Street
4. Cretingham Lane
5. Ipswich Road.

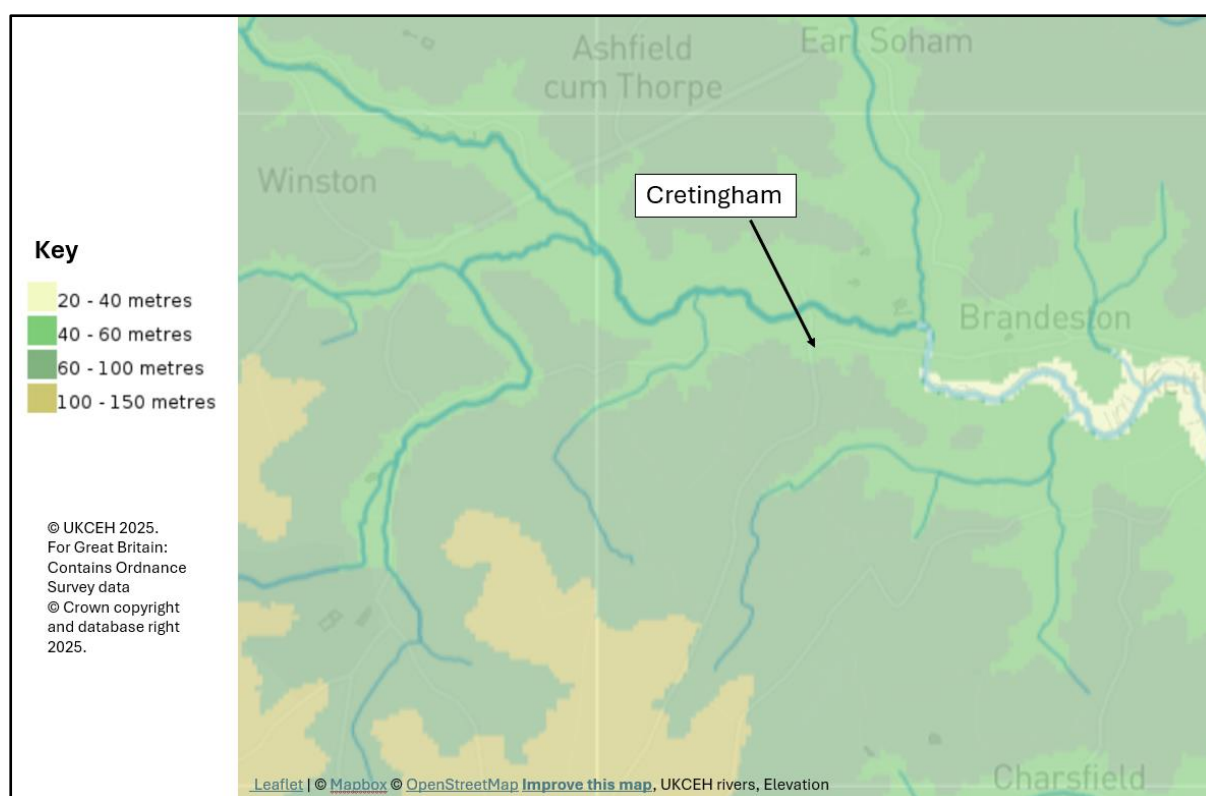
Fig. 8. Elevation (National River Flow Archive)

During high rainfall events considerable flows of water converge towards low-lying areas of the village (Fig. 8). Overwhelmed infrastructure and watercourses may be observed during these intense rainfall events.

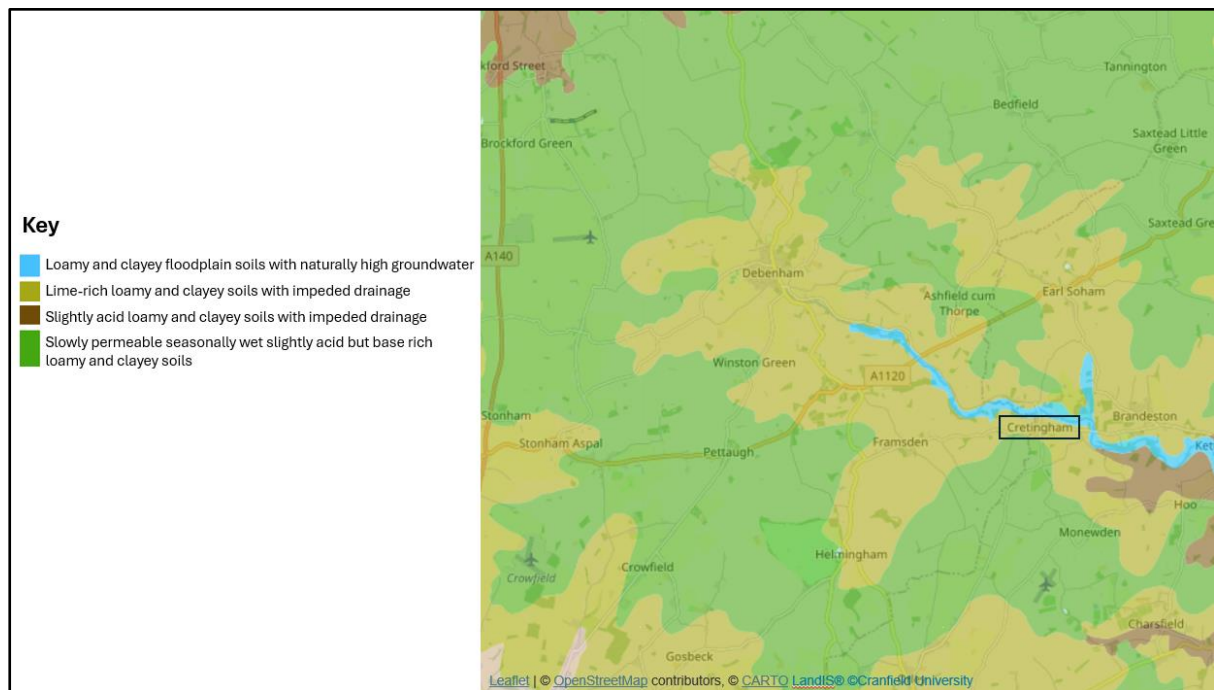
Fig. 9. Soil map of catchment area (LandIS Soils)

The soils in the catchment surrounding Cretingham are loamy and clayey with impeded drainage, meaning that water penetrates more slowly, and surface water runoff is greater, particularly during intense rainfall (Fig. 9). However, the saturated nature of the soils leading up to the event would also have prevented some infiltration.

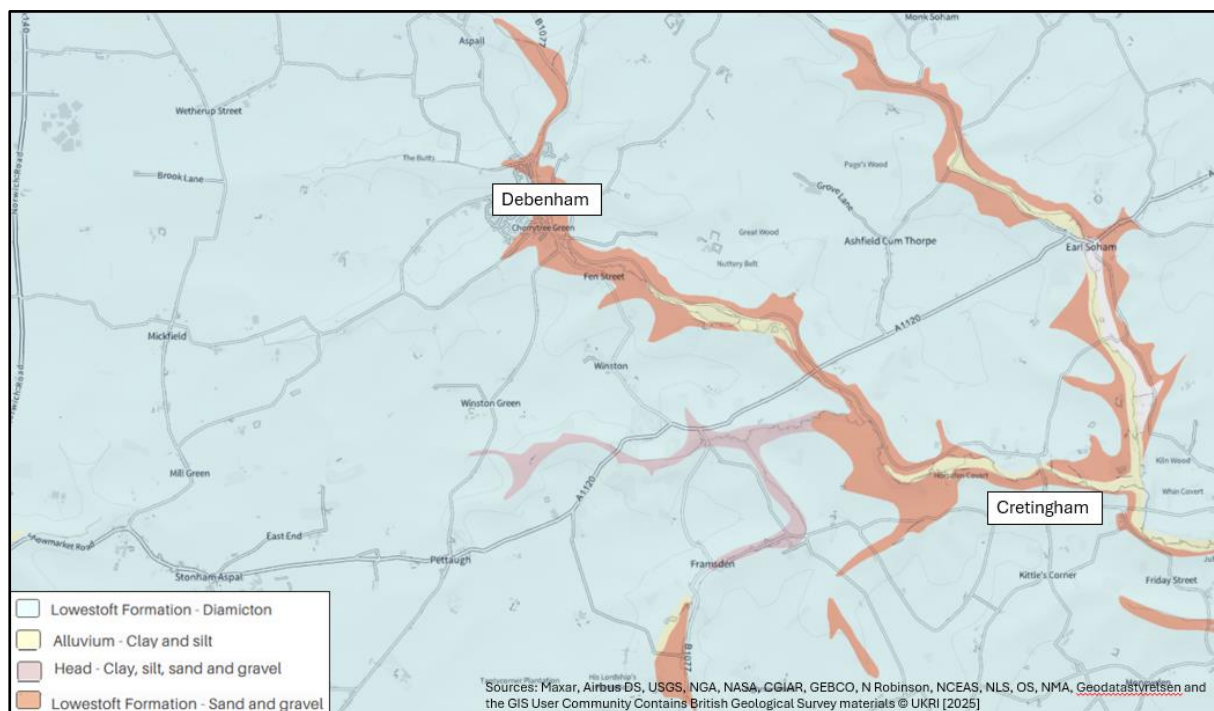
Fig. 10. Superficial geology (British Geological Society)

Fig. 10 shows that much of the superficial geology in the catchment surrounding Cretingham is made up of 'Lowestoft Formation – Diamicton' which is described by the British Geological Survey as a diverse mixture of clay, sand, gravel, and boulders varying widely in size and shape. This is sometimes known as boulder clay. This generally has a low permeability meaning water will tend to flow off it before it can infiltrate, which also reflects the reports collected during Storm Babet.
