Section 19 Flood and Water Management Act 2010

Easton Flood Investigation –

Storm Babet 2023

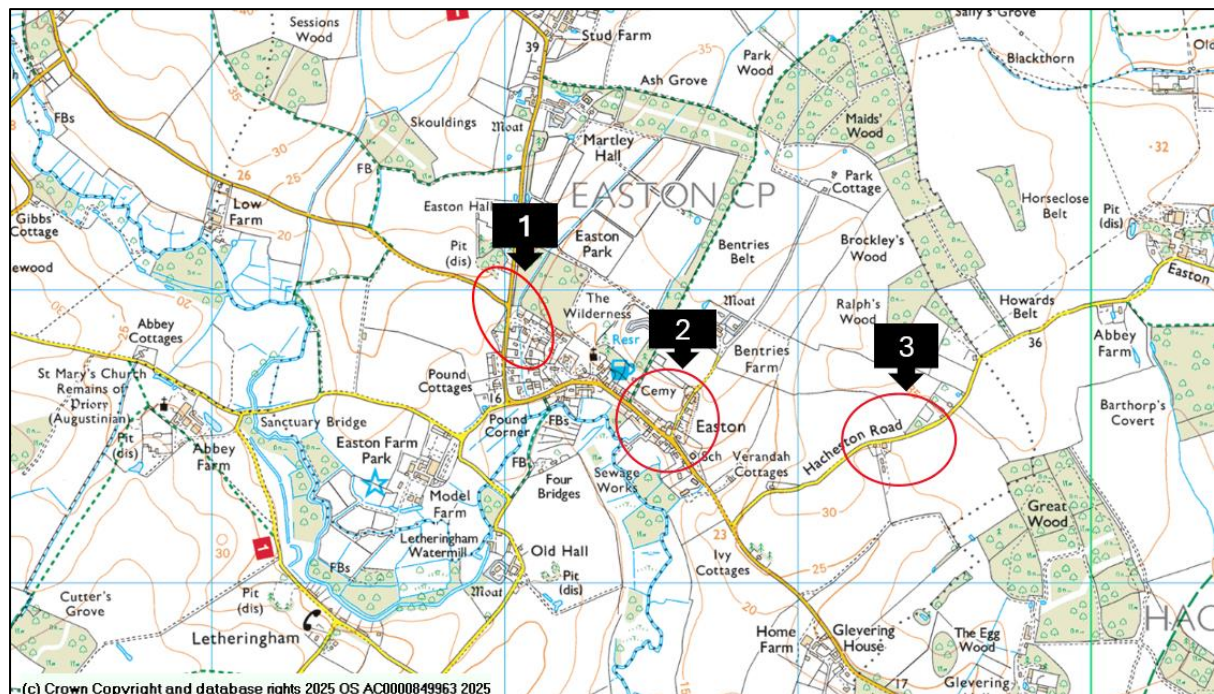
Figure 5. Easton investigation area map with locations

For the purposes of this investigation the areas affected by flooding have been separated into three distinct locations (see Figure 5). The locations are as follows:

1. Harriers Walk
2. The Street
3. Hacheston Road

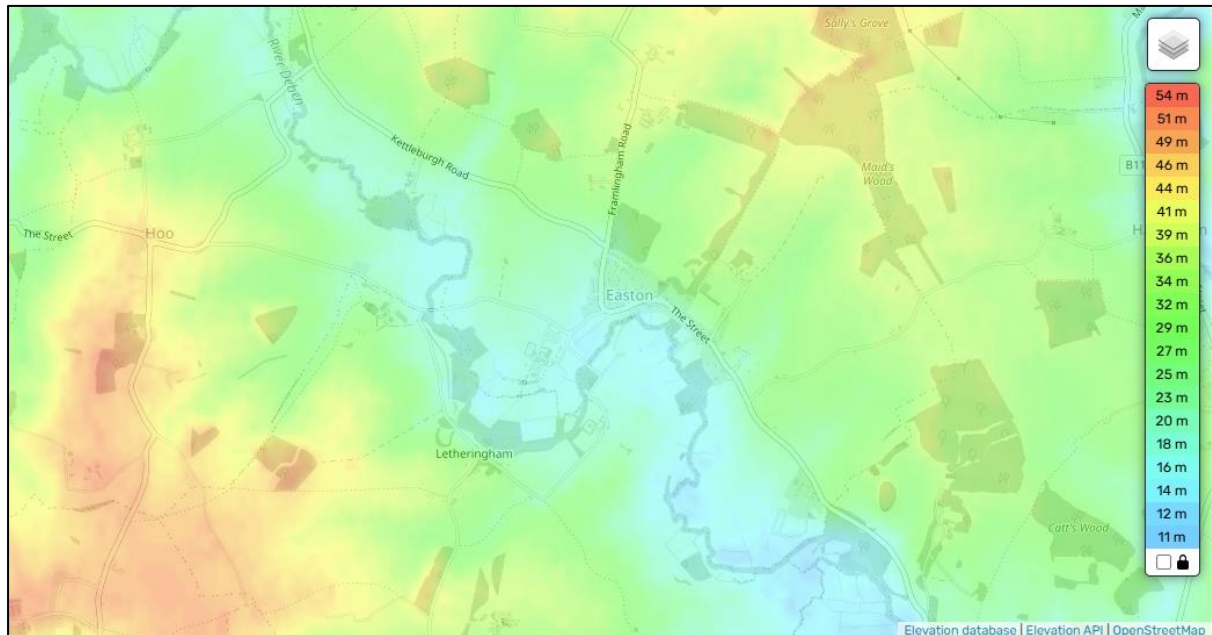
Figure 8. Easton and surrounding topography (TessaDEM as cited in topographic-map.com)

Figure 8 shows the topography surrounding Easton with gradient changes across the wider region. Easton village is situated low in the landscape, surrounded by higher ground to the northeast and southwest.

The low-lying nature of Easton in the valley of the river Deben, means that during high rainfall events, considerable overland flowpaths converge and flow through Easton towards the Deben, bringing floodwater in close proximity to properties in the village. Overwhelmed highway drainage infrastructure may be observed during these intense rainfall events. Sections of The Street are among the lowest points in the village and these areas were badly affected by flooding during Storm Babet.

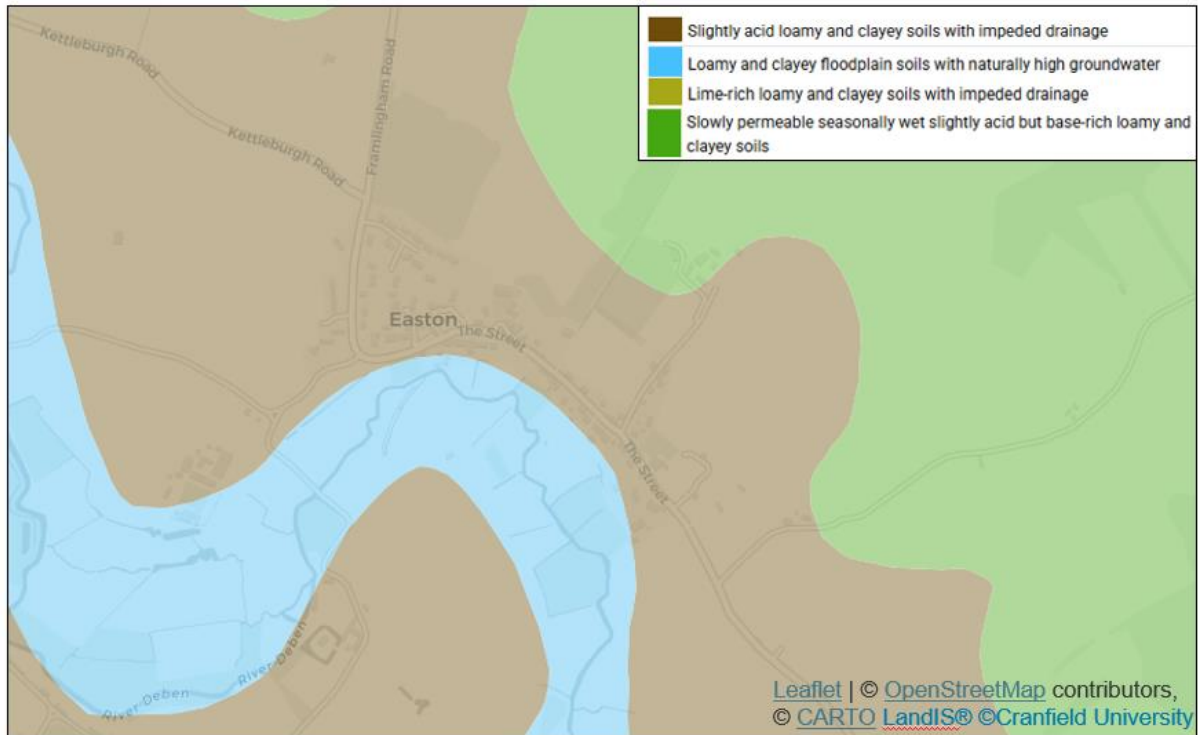
Figure 9. Soil map (LandIS Soils)

The soils of the higher ground surrounding Easton are loamy and clayey with impeded drainage, meaning that water permeates more slowly and surface water runoff is greater. The floodplain soils surrounding the River Deben are more freely draining with naturally high groundwater and tend to be wetter.

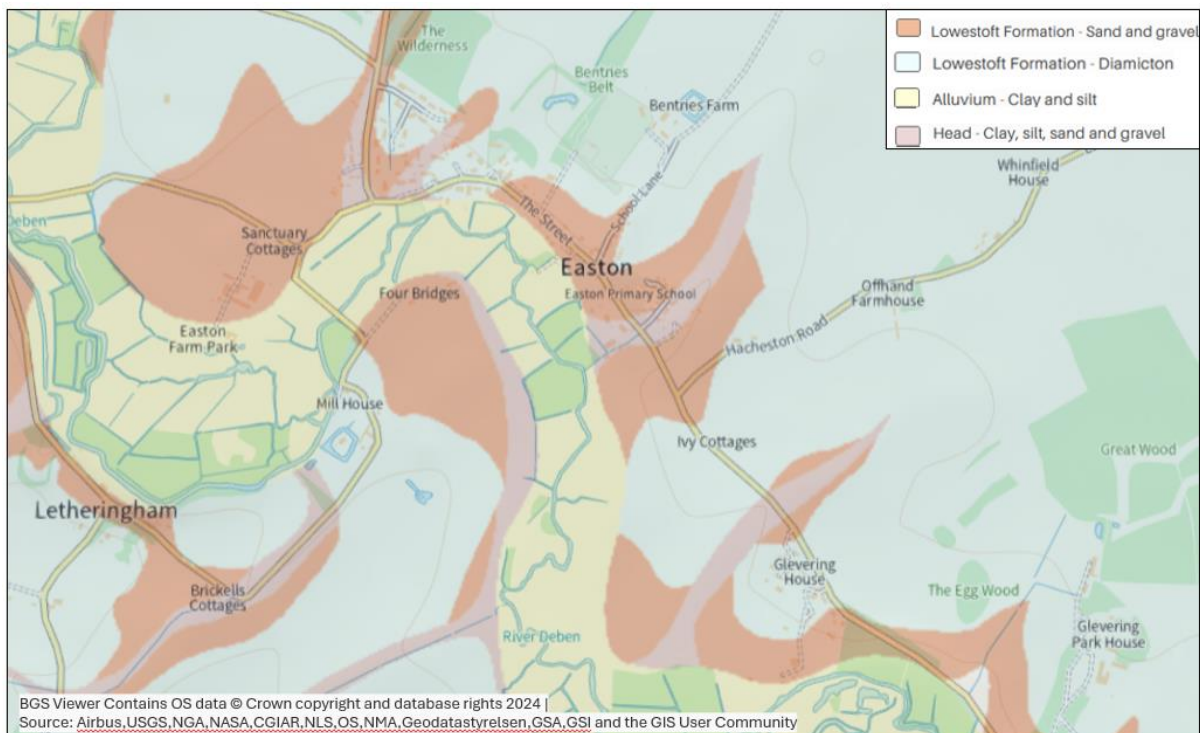
Figure 10. Superficial Geology (BGS Viewer)

Lowestoft Formation ‘Diamicton’ surrounds Easton which is described by the British Geological Survey as a diverse mixture of clay, sand, gravel, and boulders varying widely in size and shape. This generally has a low permeability, meaning water will tend to flow off it before it can be infiltrated.

The low-lying nature of Easton, with surface water flow paths merging before flowing into the River Deben and the low permeability of the wider surrounding soils, make it susceptible to flooding in extreme rainfall events.
