Section 19 Flood and Water Management Act 2010

Framlingham Flood Investigation – Storm Babet 2023

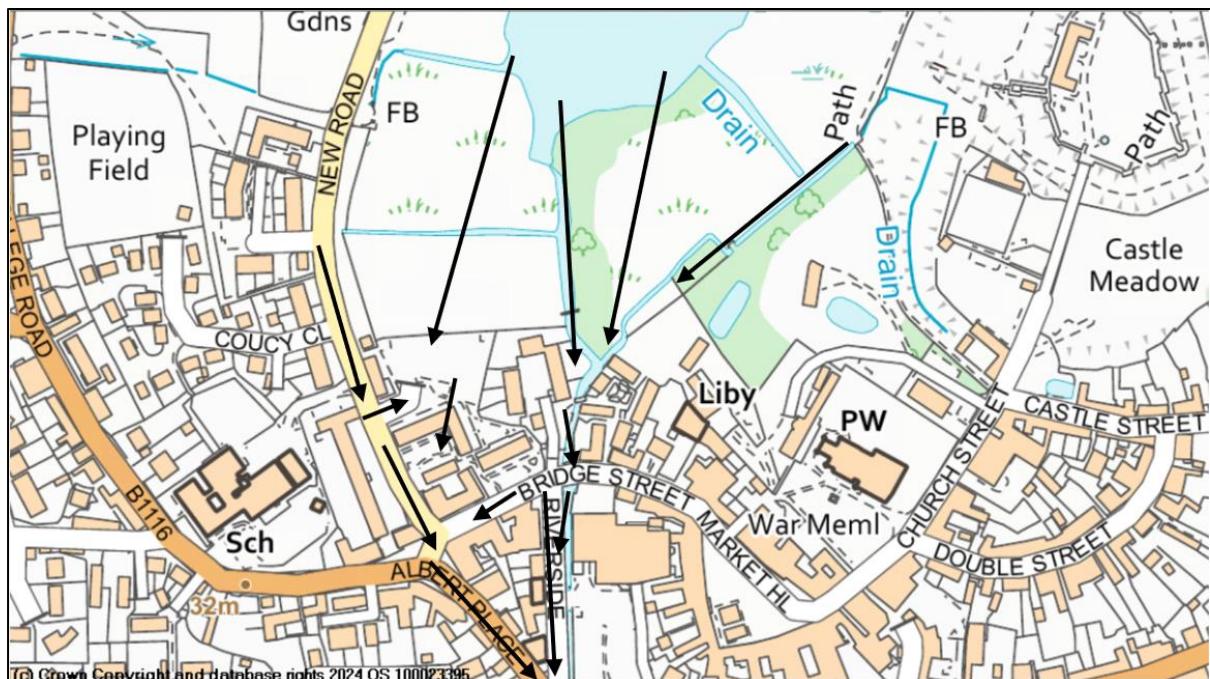
Figure 9 - Approximate flood water flow routes in North Framlingham

The primary source of flooding in the north of Framlingham was fluvial flooding, from the overtopping of the River Ore and the Mere through which the Ore flows. There are five overland flow paths that feed into the Mere from the Upper Catchment above Framlingham. Residents reported that the water flows in both the River Ore and Mere rapidly expanded on the morning of Friday 20th. After overtopping the banks, overland fluvial flows quickly moved towards The Elms car park where depths reached approximately 150cm (Image 1). The depths in the car park increased and the area of flooding was enhanced by pluvial flows coming from New Road.

Flood water continued through the car park to flood the Elms residential area from the rear, inundating the entire area. This was increased by the surface water run-off flowing eastwards off New Road towards the residential area and the car park from the west and northwards from Bridge Street. Residential housing was flooded internally to a depth of approximately 80cm. All ground floor premises are thought to have been flooded (approx. 10). Residential, commercial properties and the road on Bridge Street were also flooded as the river overtopped between the road bridge and the Mere. Reports from residents suggest that there were blockages, most likely woody debris from the Mere, under the bridges over the Ore in this area which may have contributed to overtopping of the river channel. The combined fluvial and pluvial flood water flowed South and West towards Riverside and Well Close Square respectively but was limited in the direction of Market Hill by the natural raising incline to the East (Image 2).

- Investigate potential NFM projects and funding opportunities which aim to attenuate water and 'slow the flow' in upper catchment north of Framlingham.
- Framlingham College and Suffolk Wildlife Trust to review their maintenance/management of the Mere.
- Investigate potential new/additional highway drainage assets on New Road.
- Improve drainage system on The Elms carpark
- Remove any observed blockages within main river and ordinary watercourses where flood risk is increased.
- Ensure the completion of highway drainage asset maintenance and investigate if capacity and condition are sufficient.
- Investigate any capital interventions that can improve the flood resilience of the town.

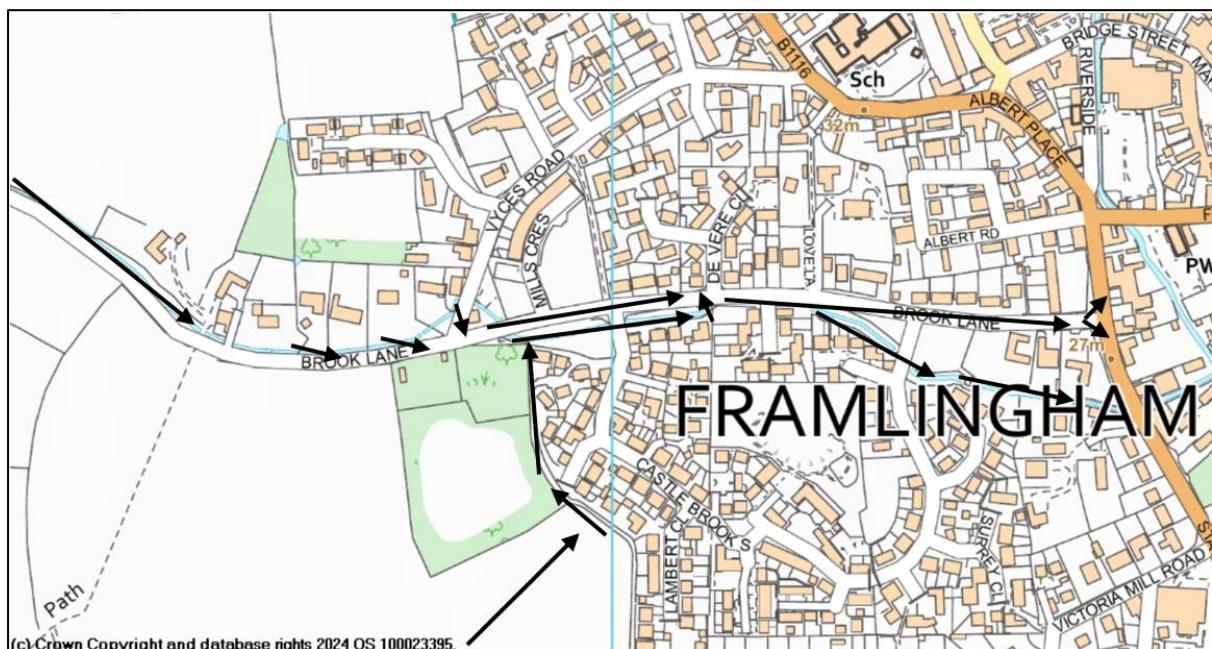
Figure 10 - Approximate flood water flow routes in West Framlingham

The primary source of flooding in the west of Framlingham was fluvial, with flood water overtopping the banks of the Cherry Brook watercourse. This was contributed to by surface water run-off from higher ground and the additional backing up of flood water from the culvert under The Mills. Brook Lane is aligned along the major flow path from the west coming into central Framlingham (Figure 5).

The Cherry Brook watercourse breached its banks early on 20th October and caused flooding of the adjacent Brook Lane (Image 3). The overtopping of the watercourse effectively creating a second flow path along the road, following the natural gradient towards Station Road (Image 9). This substantial amount of flood water is likely to have been greater than the design capacity of the highway gullies. This correlates closely with the predicted flood risk maps, with fluvial risk being categorised as Medium to High and the pluvial flood risk categorised as high along the length of Brook Lane.

Simultaneously, surface water run-off was rapidly flowing towards Brook Lane from the fields to the south, adding to the floodwater. This was described as 'a waterfall' by residents. The full extent to which this added to the flooding is less well understood as this overland flow path is not well represented on the national mapping. However, it can be acknowledged that it added to the already full main river and the flooding of Brook Lane. This caused internal flooding of several residential properties, in addition to the flooding of several gardens along Brook Lane.

The main river runs into a culvert under The Mills, opposite the entrance to De Vere Close. This restricts the capacity of the main river channel, and several reports indicated the fluvial flood water was backing up at this location. As the channel overflowed, this was another contributor to the flood water on the road, in the gardens and inside properties close by. This is consistent with the predicted fluvial flood risk which is defined as High in this location.

- Investigate potential NFM projects and funding opportunities which aim to attenuate water and 'slow the flow' in the catchments West of Framlingham.
- Remove any observed blockages within main river and ordinary watercourses where flood risk is increased.
- Ensure the completion of highway drainage asset maintenance and investigate if capacity and condition are sufficient.
- Investigate options to connect surface water flowing on Brook Lane back into the river.
- Investigate options to improve the capacity of the culvert below The Mills on Brook Lane.

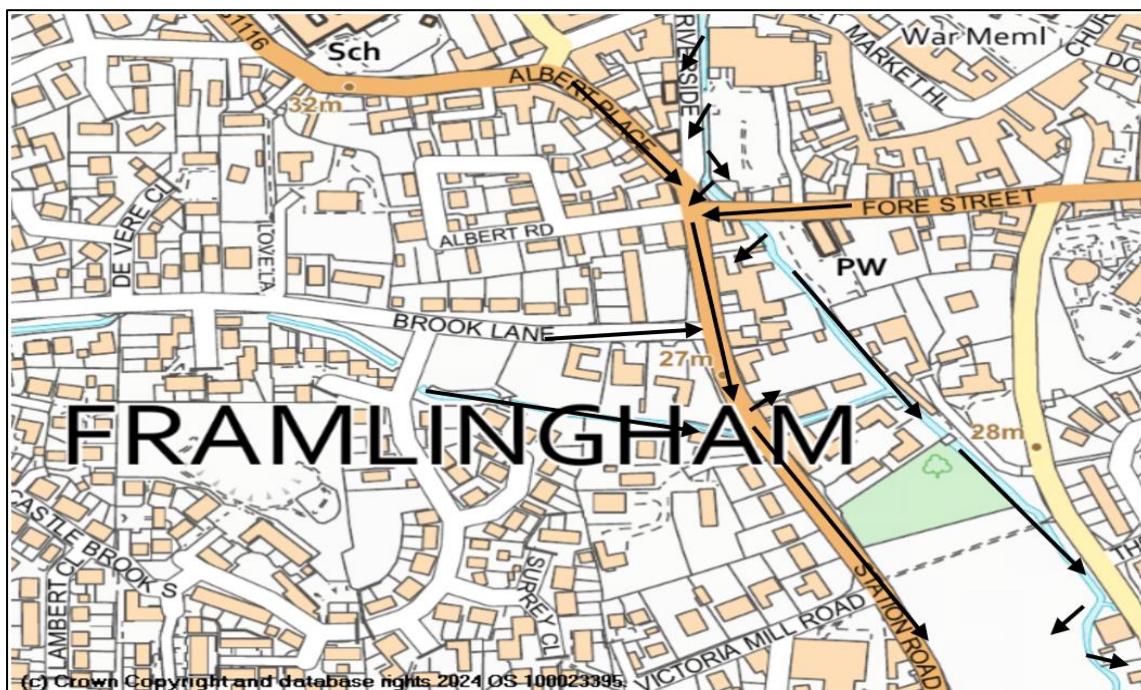
Figure 11 - Approximate flood water flow routes in Central Framlingham

The River Ore burst its western bank initially at the junction of Albert Place and Fore Street and then south of the Bridge Street and Riverside junction (Image 4). This flood water flowed along Riverside, with the road acting as a secondary river channel, carrying floodwater downstream, inundating Albert place (Image 5). Residential and commercial properties on Riverside were flooded internally to approximately 33cm. The flood waters were added to by surface water from Bridge Street and New Road, flowing into Well Close Square and toward Albert Place. Central Framlingham and Albert Place in particular, being amongst the lowest points in Framlingham, acted as the central basin into which a combination of pluvial and fluvial floodwater accumulated. The roadside drainage assets were completely overwhelmed. Outfalls for highway drainage were quickly submerged as they fell below the peak river level, were unable to discharge fully into the river and caused water to back up.

The flood water continued to flow south from Albert Place where the road and river diverge. At this point, the road became the primary channel for flood water flows, further building up through lateral pluvial inflows from Fore Street (coming downhill), Albert Road and multiple gardens. This merged with flood water flowing from the west along Brook Lane, flooding properties adjacent to Station Road between Albert Place and the junction with Brook Lane. Evidence suggests that the primary direction of flooding was from the front, i.e., from the road.

- Investigate potential NFM projects and funding opportunities which aim to attenuate water and 'slow the flow' in the catchments surrounding Framlingham.
- Remove any observed blockages within main river and ordinary watercourses where flood risk is increased.

- Ensure the completion of highway drainage asset maintenance and investigate if capacity and condition are sufficient.
- Investigate any capital interventions that can improve the flood resilience of the town.

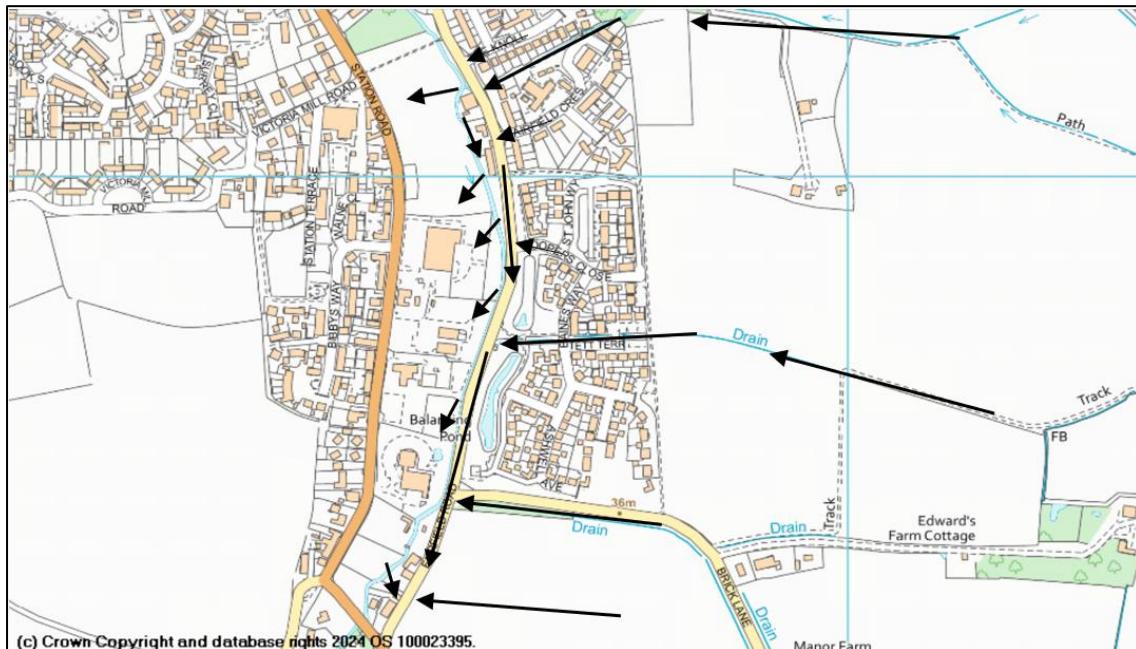
Figure 12 - Approximate flood water flow routes in East Framlingham

The flooding in the Fairfield Road area was caused by a combination of fluvial flooding from the River Ore overtopping its banks and pluvial flooding, with water flowing off fields from the east. Flood water originating from the fields to the east rapidly flowed down the watercourse between 'The Knoll' and 'Fairfield Crescent' where it would ordinarily pass under Fairfield Road via a culvert and discharge into the Ore. The capacity of this culvert was exceeded due to the sheer abundance of rainfall and surface run off flowing through the watercourse. As the flow backed up and overtopped the channel bank, flood water flowed along Fairfield Road in a southerly direction. The road was described by residents as becoming 'a river' within minutes (Image 6). Surface water also flowed down a combination of roads to the east of Fairfield Road, including The Knoll, Fairfield Crescent, Coopers Close and Brick Lane, all of which brought additional flood water. The extensive flood water accumulating on Fairfield Road flooded commercial and residential buildings along from the front. This sequence of events closely matches the flow paths and extents shown in the predicted surface water flood mapping.

Additionally, the Ore exceeded its Eastern bank and fluvial water flowed towards properties along Fairfield Road from the rear. Consequently, as the drainage assets on the highway were overwhelmed, the flood water on the road could not discharge into the river, creating a large expanse of water around the properties. The Ore also overtopped its Western bank, flooding the public open space and commercial buildings to the west of the river.

The open watercourse adjacent to Tett Terrace filled to the top of bank but did not exceed its capacity. The drainage system in place at this location is designed to flow into the Ore via a culvert under Fairfield Road, but the capacity of the culvert was rapidly exceeded. The water from the channel spilled out onto Fairfield Road mirroring what was happening at the culvert in the channel between The Knoll and Fairfield Crescent to the north. This may have been compounded by a tree growing at the inflow / inlet. Fairfield Road experienced flooding again on 8th February 2024. On that occasion the floodwater was restricted to the road surface before making its way back into the main river channel.

- Investigate potential NFM projects and funding opportunities which aim to attenuate water and 'slow the flow' in the catchment East of Framlingham.
- Remove observed blockages within the man river channel along Fairfield Road.
- Create a ditch/improved drainage assets at the bottom of the field east of Fairfield Road
- Ensure the completion of highway drainage asset maintenance and investigate if capacity and condition are sufficient.
- Investigate options to improve the capacity of the culverts below Fairfield Road connecting the watercourses with the main river
- Investigate any capital interventions that can improve the flood resilience of the town.

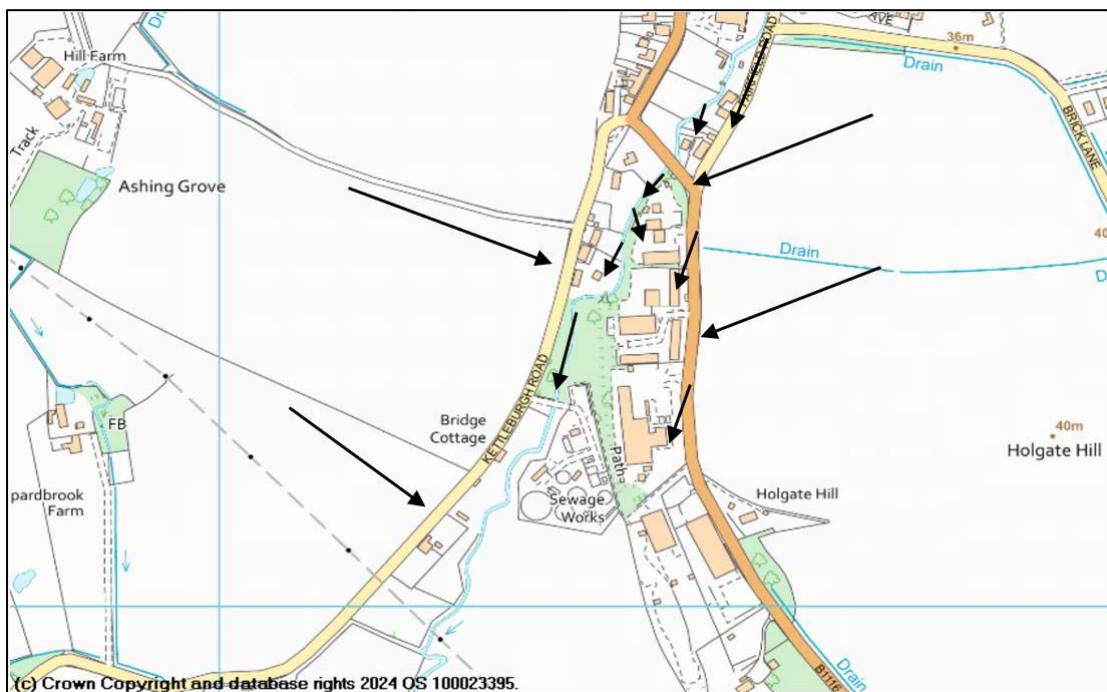
Figure 13 - Approximate flood water flow routes in Central Framlingham

Multiple commercial properties on the north end of Woodbridge Road suffered pluvial flooding from the front, as flood water flowed south-west from Fairfield Road and merged with substantial surface water runoff from the fields to the east. The observed flow paths and flood extents closely match the national predicted surface water flood risk mapping. The River Ore was at full capacity and overtopped in places to the rear. Blockages and in channel debris may also have slowed the conveyance of the flood water in the river channel at this location.

Several residential properties also flooded on Kettleburgh Road. Pluvial flows coming across the fields from the west, overwhelmed the drainage ditches and spilled onto the road impacting properties from the front. There have also been reports of water backing up from assets associated with the sewage works on Kettleburgh Road. Water was emerging from manhole covers on the road and caused internal flooding from a backed-up toilet in one property.

- High rainfall resulted in large amounts of pluvial flows coming from fields to the East and West.
- Flood water flowed along Woodbridge Road and Kettleburgh Road impacting properties from the front.
- Drainage assets on the highway were overwhelmed.

- Investigate potential NFM projects and funding opportunities which aim to attenuate water and 'slow the flow' in the fields to the East and West.
- Remove observed blockages within ordinary watercourses and main river.
- Investigate options to improve drainage / water storage at the bottom of the field east of Woodbridge Road.
- Ensure the completion of highway drainage asset maintenance and investigate if capacity and condition are sufficient.
- Investigate any capital interventions that can improve the flood resilience of the town.
