Section 19 Flood and Water Management Act 2010

Framsden Flood Investigation – Storm Babet 2023

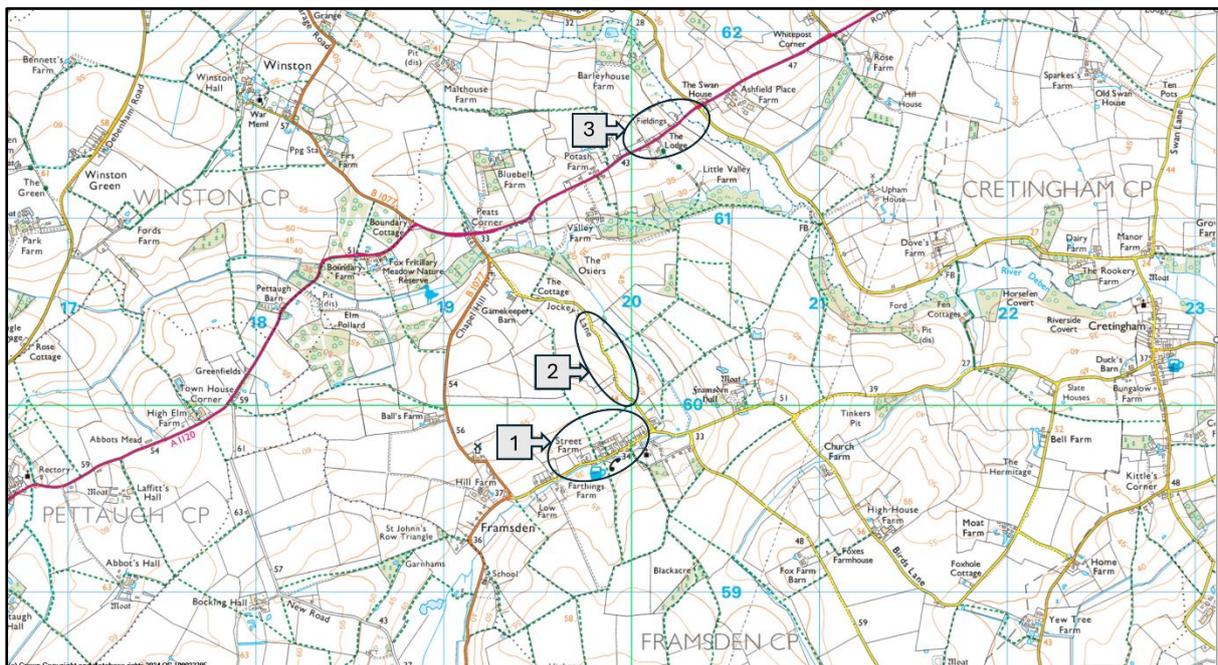
Figure 4. Distinct flood zones

For the purposes of this investigation the various areas affected by flooding have been separated into three distinct zones:

1. The Street
2. Jockey's Lane
3. Eastern section of A 1120 (Framsdén)

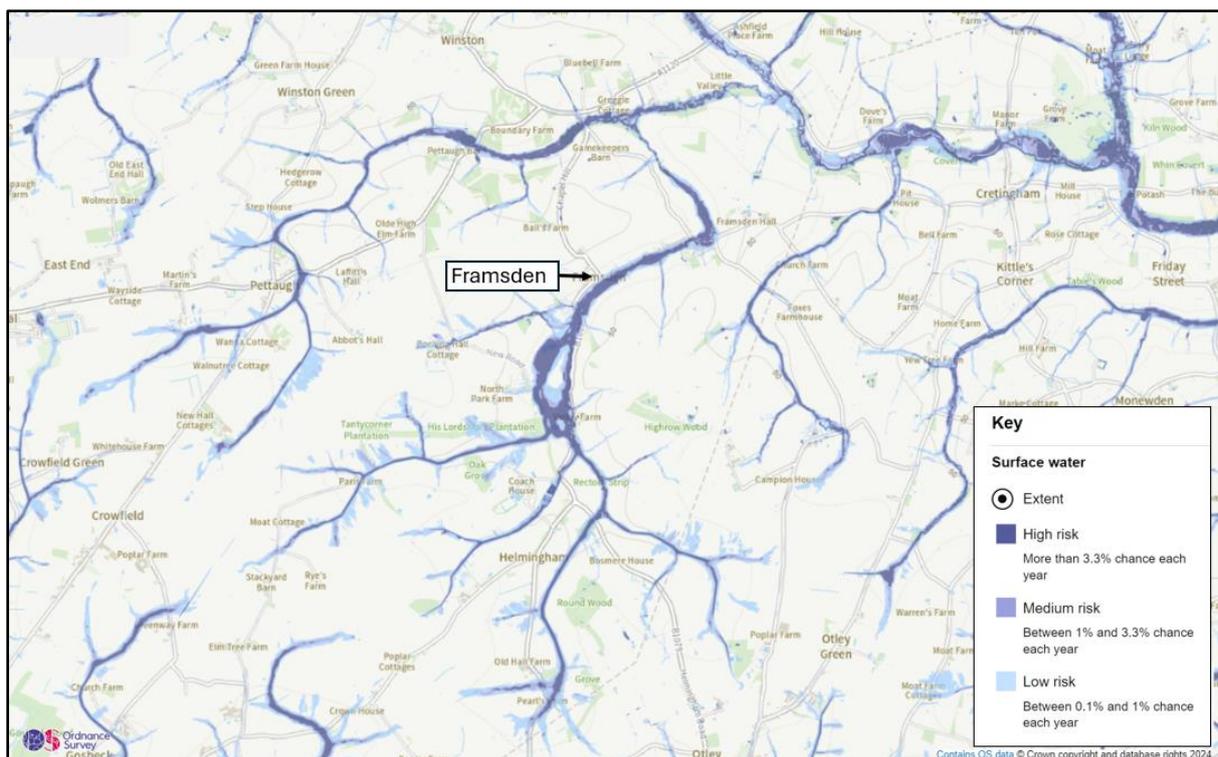
Figure 5. Projected flood risk from surface water

Framsdens parish has significant surface water flow paths, which channel water from the southwest, through the village (where properties were impacted) and then towards the River Deben (Fig.5). Framsdens village and an area immediately upstream, to the southwest of Framsdens, are projected to be at high risk of surface water flooding. Additionally, there is an area of high surface water flood risk beside the River Deben, on and adjacent to the eastern end of the A1120, where impacted property is also located. During Storm Babet, localised surface water flooding was also reported to property to the northeast of Framsdens on Jockey's Lane and surface water and groundwater flooding to property further up the east-facing slope from the River Deben on the A1120. These locations are not shown to be at significant surface water flood risk on national mapping.

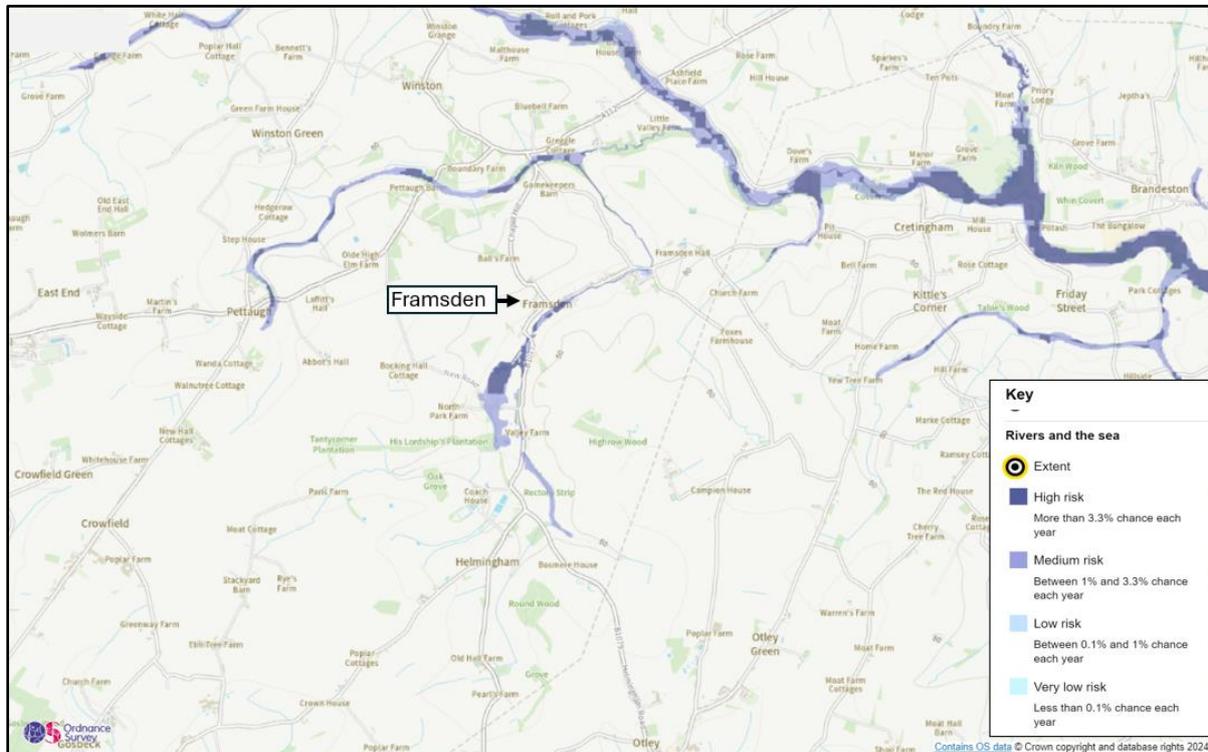
Figure 6. Projected flood risk from rivers

Fluvial flood risk in Framsdens village is associated with Framsdens watercourse (designated main river), which runs south of The Street (Fig.6). In the eastern part of the village, where most of the impacted properties are located, the river is projected to remain mostly in channel during high, medium and low risk scenarios. However, during

Storm Babet, flood water is reported to have overtopped the river in this section of the village and combined with surface water. East of the junction between The Street and Jockey Lane is an area which is at risk of surface water and fluvial flooding where considerable volumes of water also accumulated during Storm Babet. Fluvial flood risk from the River Deben also affects the eastern end of the A1120 in the parish, where properties were affected by flooding.

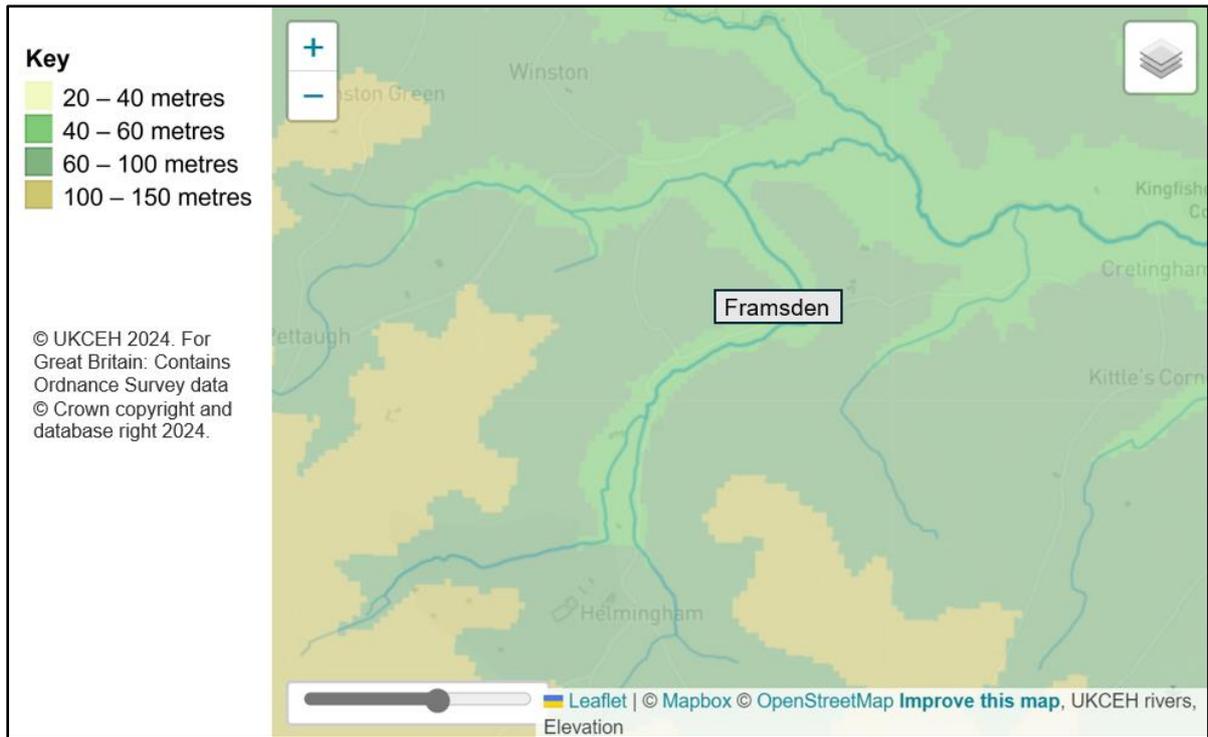
Figure 7. Elevation map of catchment area (National River Flow Archive)

The low-lying nature of the village means that during high rainfall events considerable flows of water converge towards Framsden and the River Deben (see Fig. 7). Overwhelmed infrastructure and watercourses may be observed during these intense rainfall events.

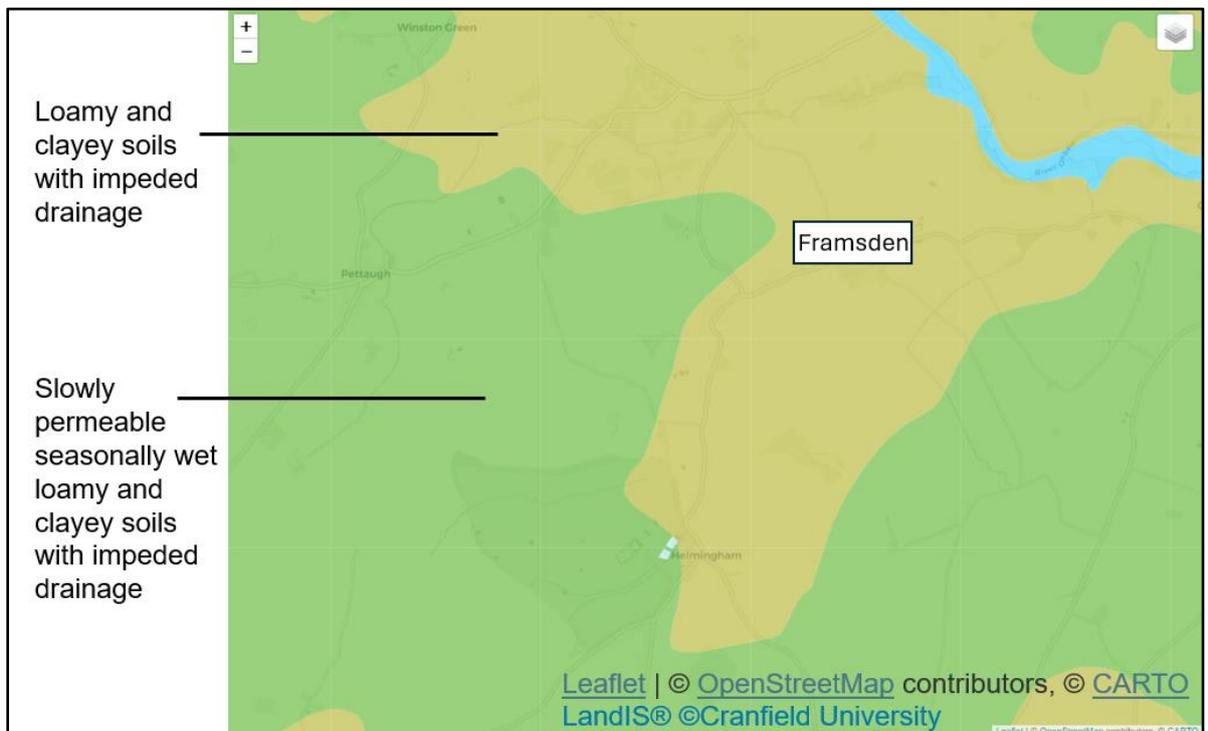
Figure 8. Soil map of catchment area (LandIS Soilscales)

The soils surrounding Framdsen are loamy and clayey with impeded drainage, meaning that water permeates more slowly and surface water runoff is greater, particularly during intense rainfall. However, the saturated nature of the soils leading up to the event would also have prevented some infiltration.

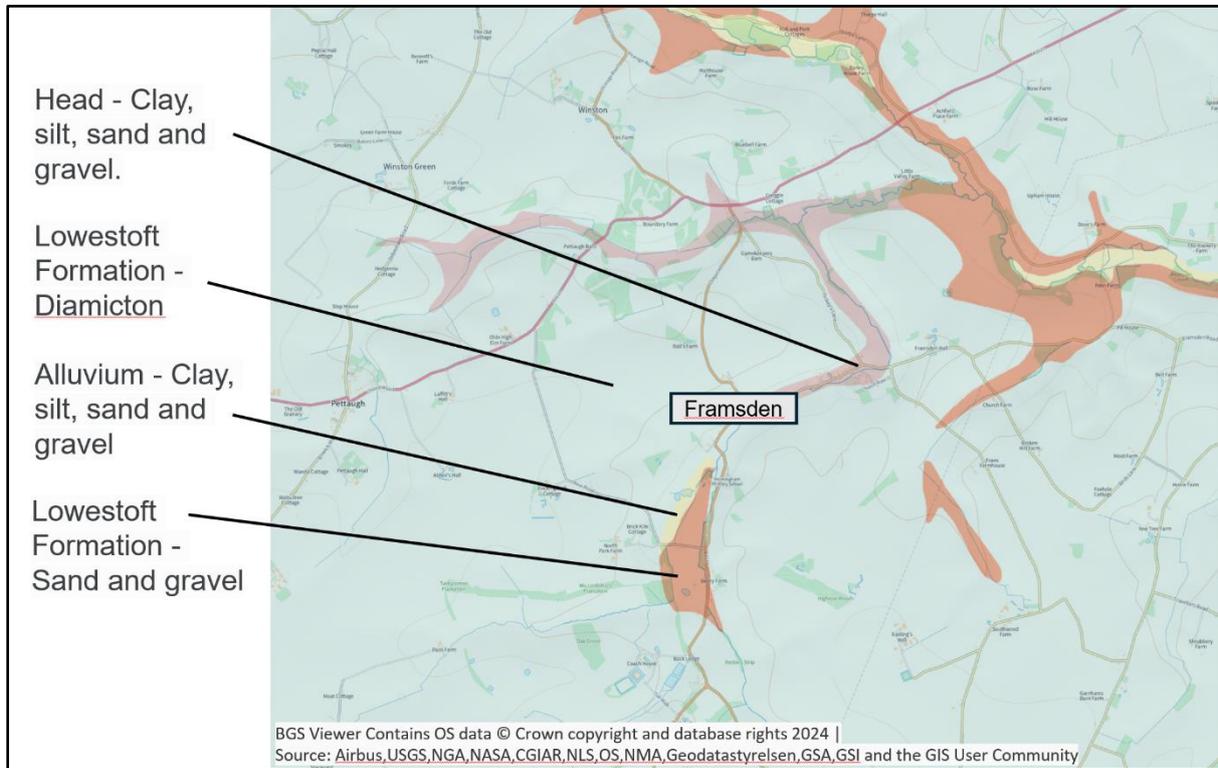
Figure 9. Superficial geology (BGS Viewer)

Fig. 9 shows that much of the superficial geology surrounding Framsdén is made up of 'Lowestoft Formation – Diamictón' which is described by the British Geological Survey as a diverse mixture of clay, sand, gravel, and boulders varying widely in size and shape. This is sometimes known as boulder clay. This generally has a low permeability meaning water will tend to flow off it before it can infiltrate, which also reflects the reports collected during Storm Babet.
