Section 19 Flood and Water Management Act 2010

Hundon Flood Investigation –

Storm Babet 2023

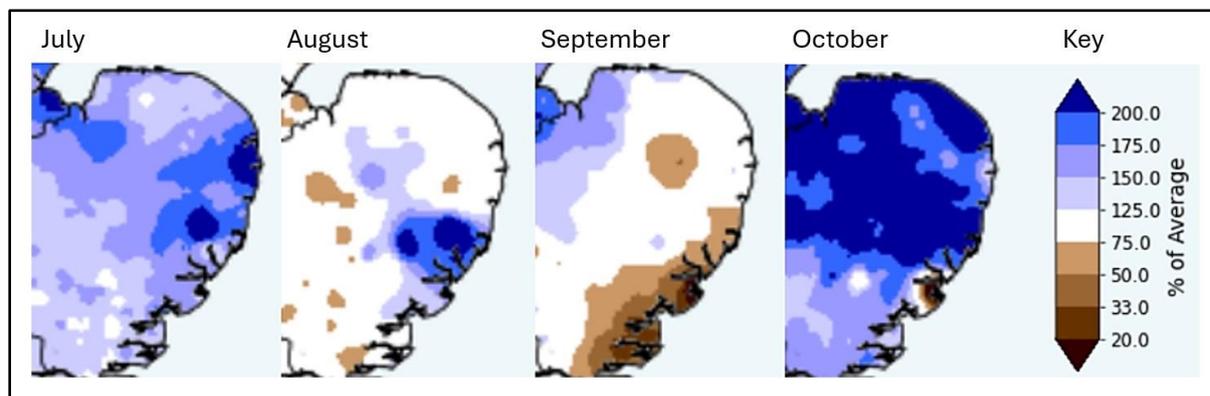
Figure 1. Average rainfall in East Anglia between July and October 2023 as a percentage of the historical average monthly rainfall

The following report acknowledges that October 2023, and in particular Storm Babet, was an extreme event and will assess the likely causes and impacts. The report will recommend measures to reduce the risk of flooding within the location, in line with best practice, ranging from large to small scale interventions and be targeted at a range of stakeholders. It should be noted that Storm Babet was a significant event, with a low probability of recurrence. The recommendations will provide advice about reducing flood risk; however, they should not be relied upon as a guaranteed failsafe to mitigate against all future flooding.

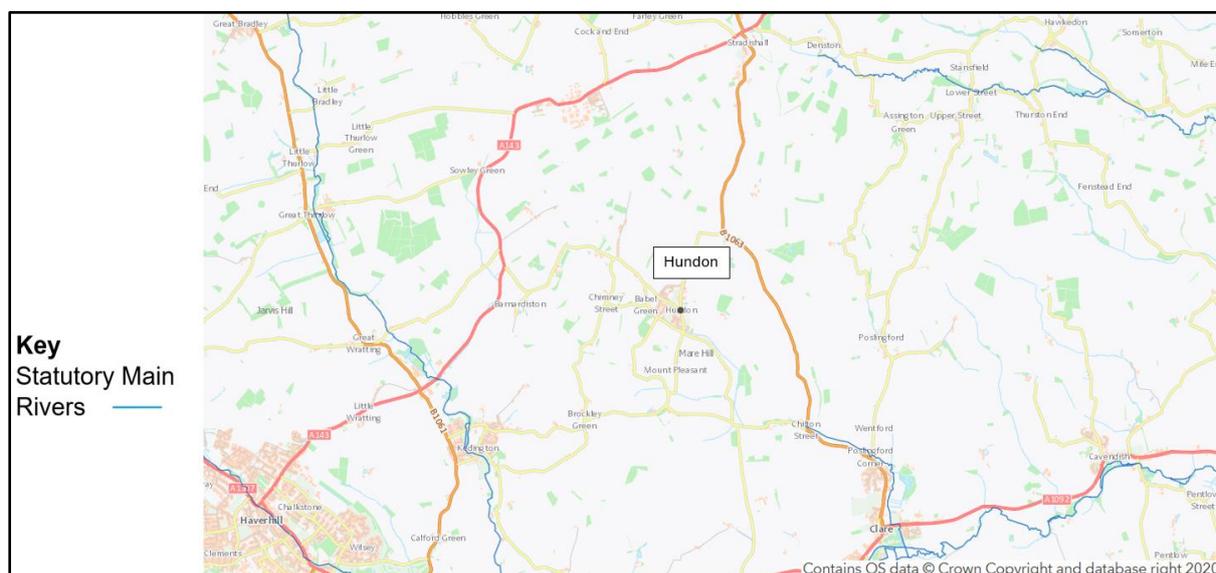
Figure 3. Location of statutory main river and ordinary watercourses

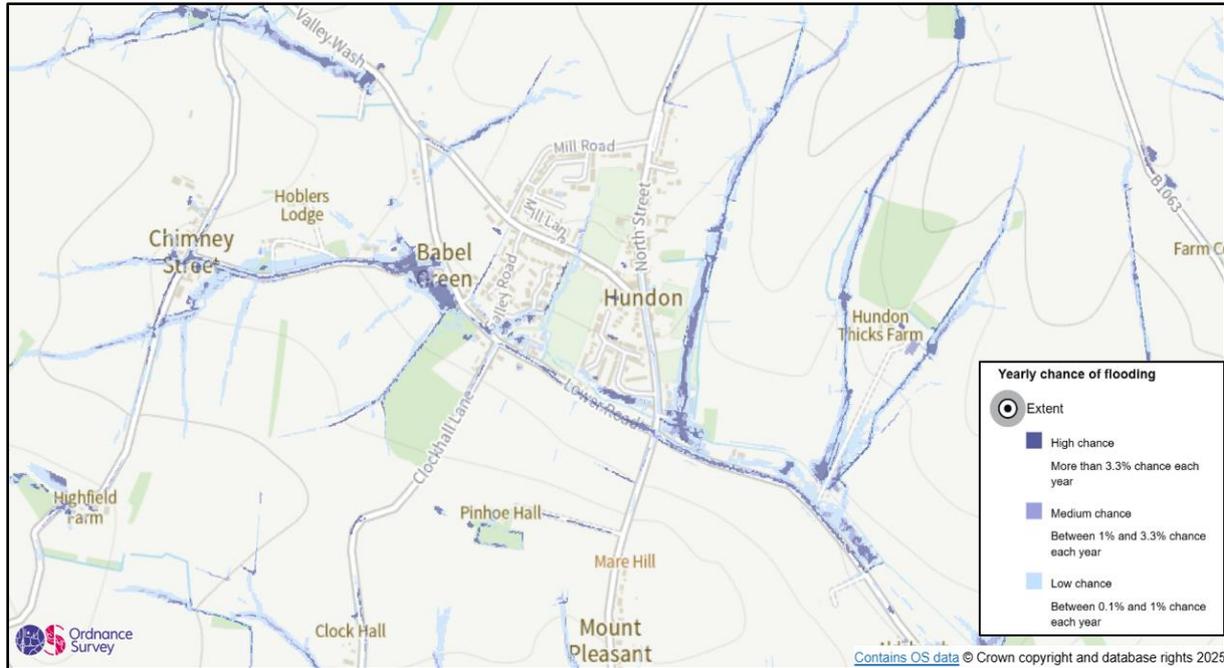
Figure 5. Surface water flood risk

Figure 5 highlights the predicted pluvial (surface water run-off from surrounding land and highways) flood risk in Hundon, with multiple flow paths from the north, west and southwest flowing through the village and into the Chilton Brook.

There is a high chance of surface water flooding on sections of Mary Lane, Valley Wash, Lower Road, Farmerie Road and Lower North Street. These areas were all affected by flooding during Storm Babet.

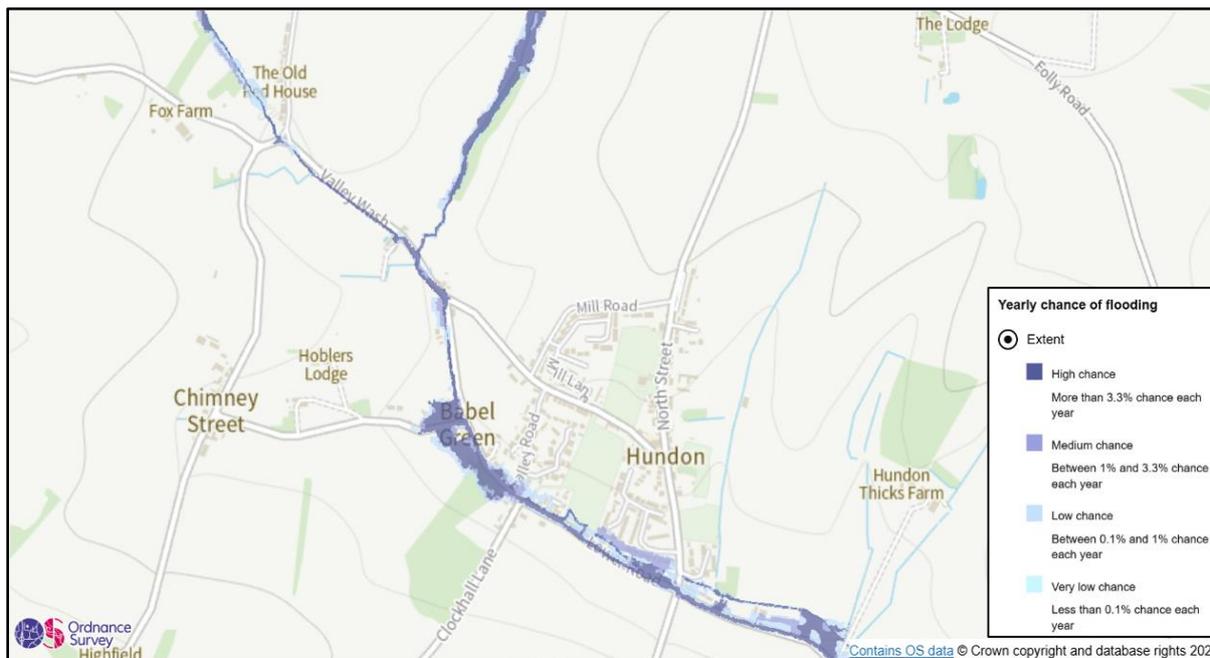
Figure 6. Flood risk from rivers and sea

Figure 6 shows the predicted fluvial (from designated main river and ordinary watercourses) flood risk in Hundon. The fluvial flood risk in Hundon is predominantly associated with the Chilton Brook which passes through the village.

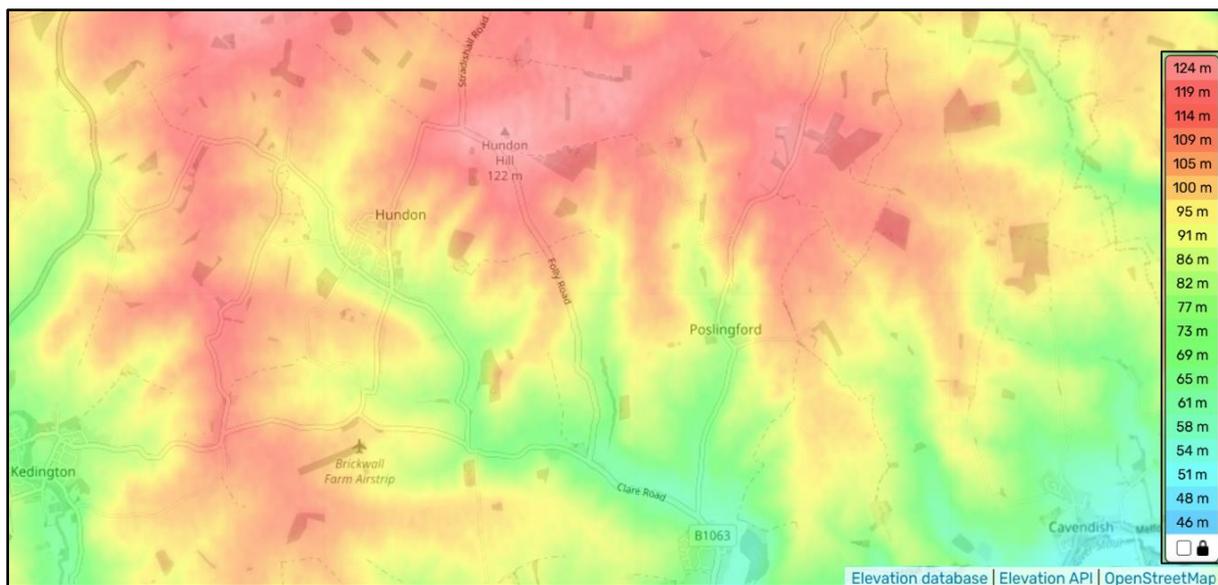
Figure 7. Hundon and surrounding topography (TessaDEM as cited in [topographic-map.com](#))

Figure 7 shows the topography surrounding Hundon with gradient changes across the wider village. Some of the lowest points in Hundon are along Lower Road adjacent to the Chilton Brook. The junction of Lower Road and Lower North Street is lower than the surrounding land to the north and south. These locations were identified as being some of the worst affected areas during Storm Babet.

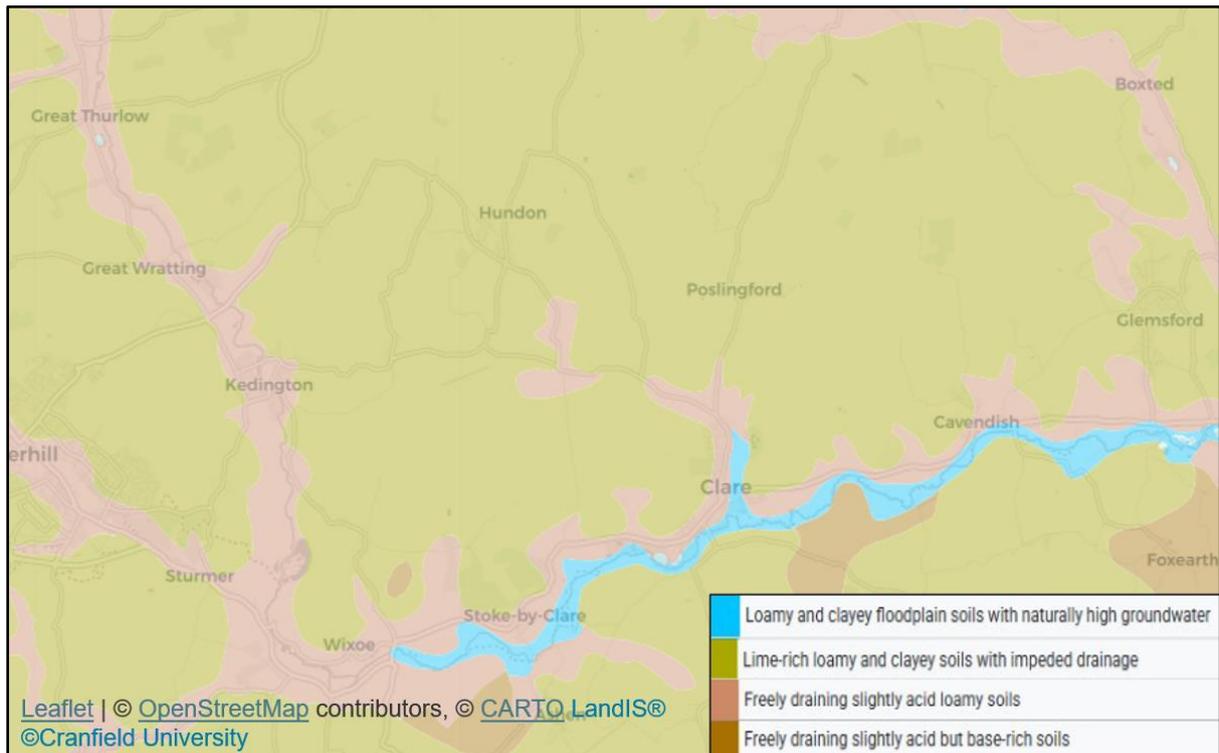
Figure 8. Soil map (LandIS Soilscales)

The soils more generally surrounding Hundon are loamy and clayey with impeded drainage, meaning that water permeates more slowly and surface water runoff is greater. The floodplain soils surrounding the Chilton Brook further downstream are more freely draining, usually having naturally high groundwater and tend to be wetter.

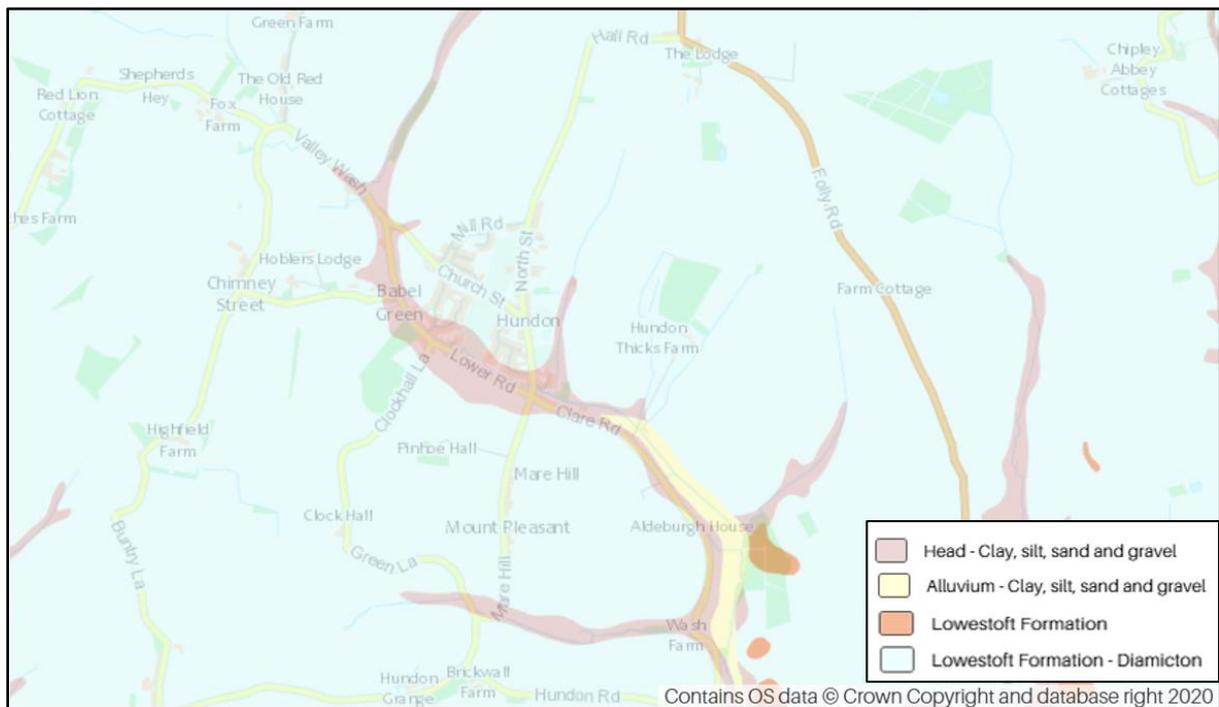
Figure 9. Superficial Geology (BGS Viewer)

Lowestoft Formation 'Diamicton' surrounds Hundon which is described by the British geological survey as a diverse mixture of clay, sand, gravel, and boulders varying widely in size and shape. This generally has a low permeability, meaning water will tend to flow off it before it can be infiltrated, which reflects some of the reports from the Storm Babet event.

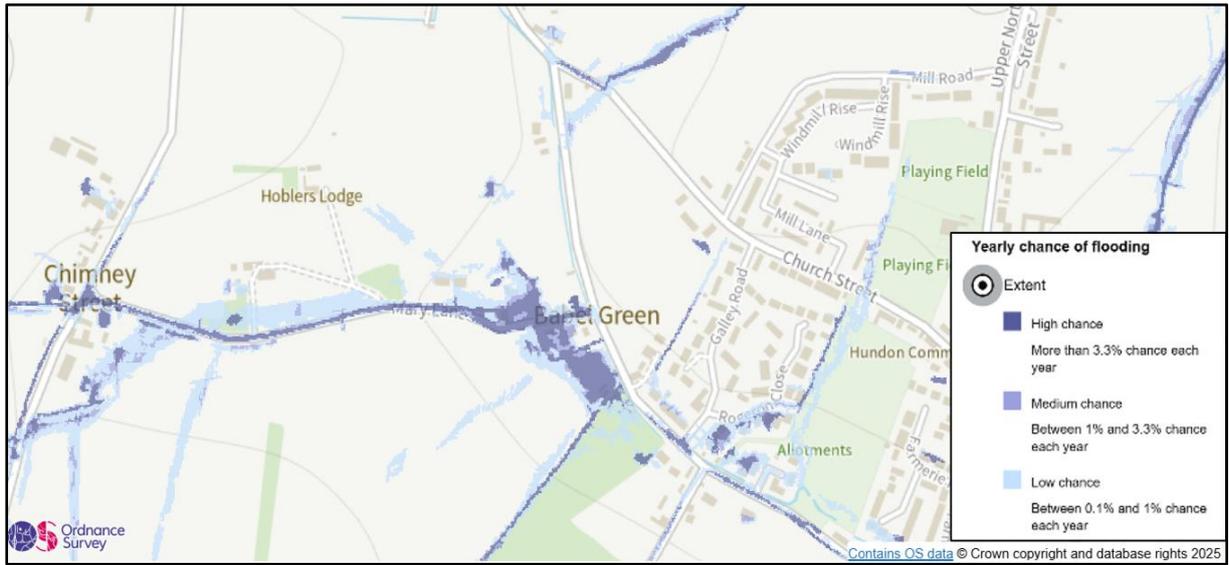
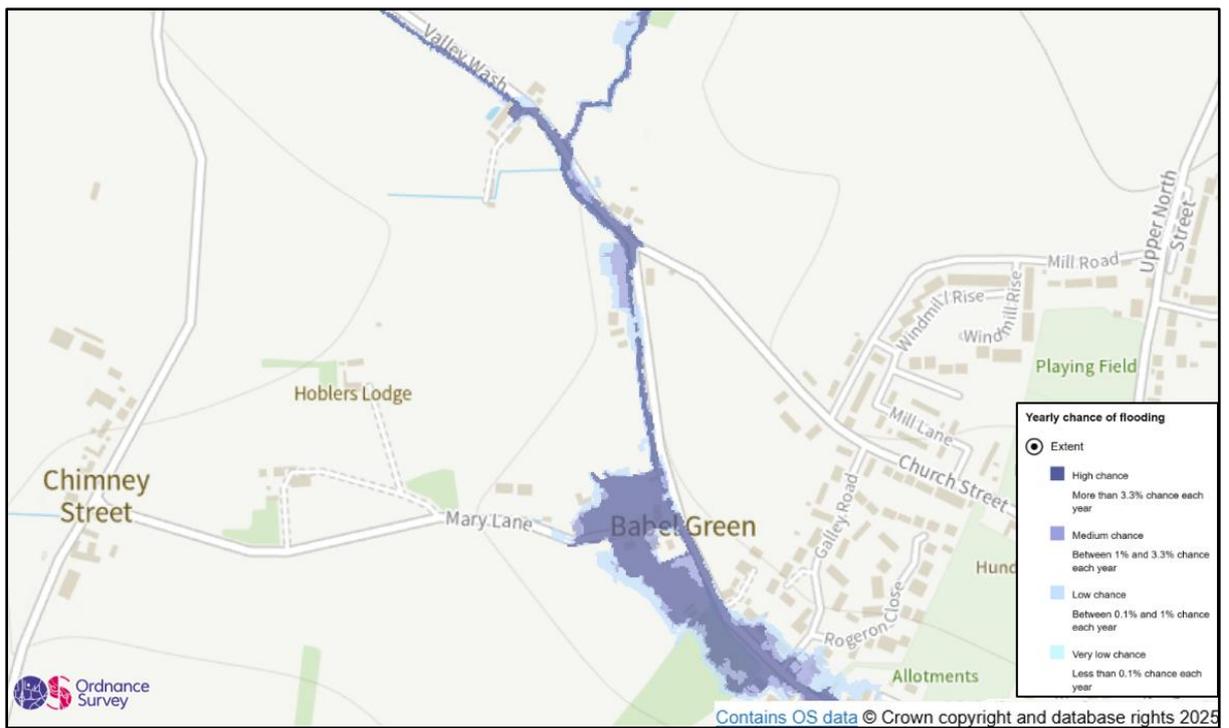
The floodwater flowpaths observed in this location during Storm Babet closely match the national surface water and fluvial flood risk mapping (see Figures 11 & 12). Mary Lane is characterised as having a high chance of surface water flooding, whilst sections of Valley Wash are shown to be highly susceptible to fluvial flooding from Chilton Brook (classified as an ordinary watercourse in this location before it becomes main river at Chilton Street).

Figure 11. Surface water flood risk on Mary Lane and Valley Wash

Figure 12. Fluvial flood risk on Mary Lane and Valley Wash

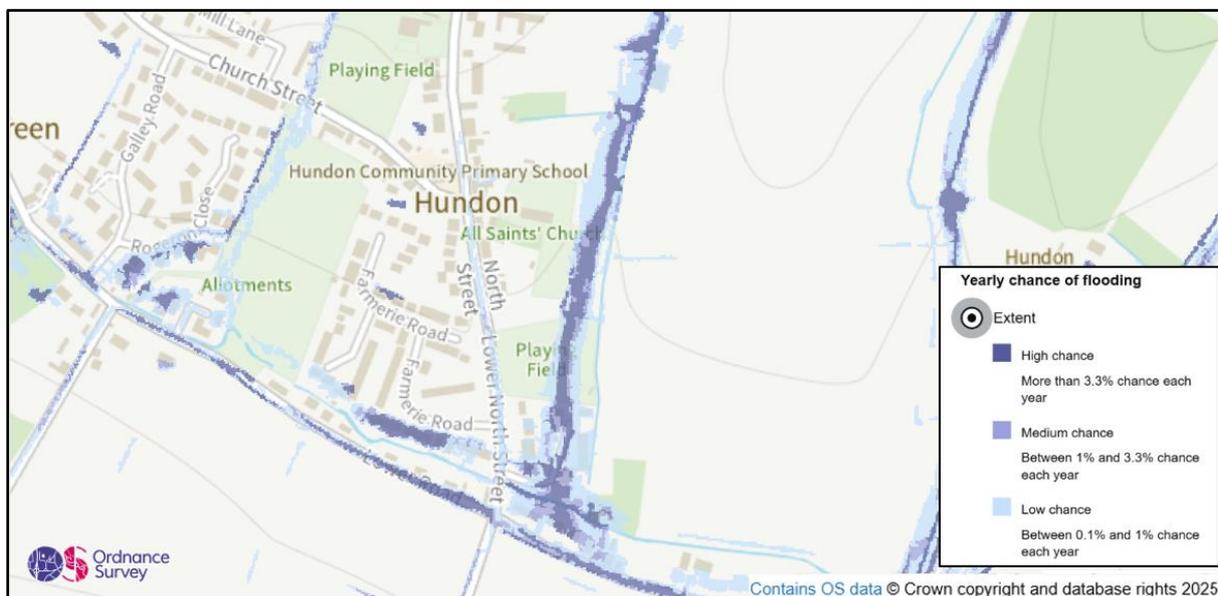
Residents have reported that the flow of the floodwater in the ditch was hindered by overgrown vegetation in the channel and a potentially blocked culverted section of the watercourse. Figure 14 shows the yearly chance of surface water flooding on Lower North Street.

Figure 14. Surface water flood risk on Lower North Street, Lower Road and Farmerie Road

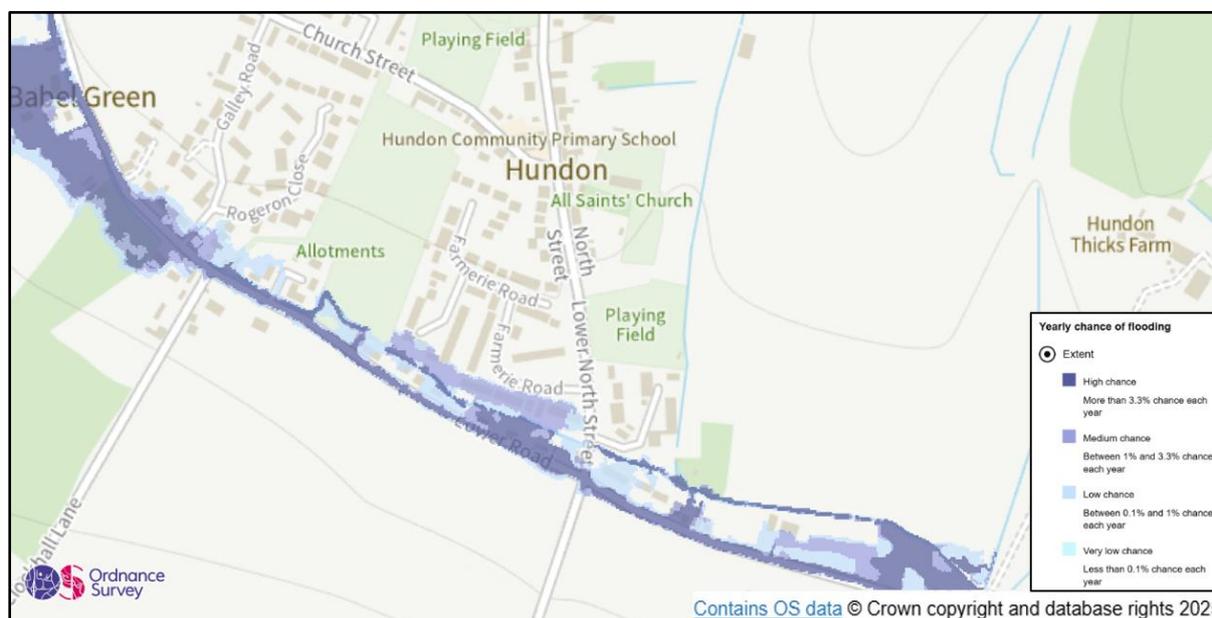
Figure 15. Fluvial flood risk on Lower North Street, Lower Road and Farmerie Road

Resident reports cited a general lack of maintenance within the Brook with the resultant overgrown vegetation causing blockages and holding up the flow of water.

There are also sections of the channel where historically, the capacity has been reduced over time, through straightening and narrowing. This has been contributed by various locations in which unconsented works have been undertaken along this stretch of the Brook. These alterations to the channel have likely contributed to the flooding as did a number of other nearby culverted sections. Taken together cumulatively, the floodwater flows were restricted in an area already greatly susceptible to both surface water and fluvial flooding (see Figures 14 & 15), and flooding is likely in this location irrespective of additional restrictions in the channel. The Lead Local Flood Authority has investigated and concluded no further action is to be taken regarding the unconsented works in this location.
