Section 19 Flood and Water Management Act 2010

Long Melford Flood Investigation – Storm Babet 2023

Name	Date
Report Author	Susie Clark	
Responsible Officer:	Susie Clark	
Checked by:	Ellie Becroft	06/03/2025
RMA Review:		21/03/2025
Approved by:	Matt Hullis	09/04/2025
Date Published		19/04/2025
Latest Update		27/10/2025
Date Report Closed

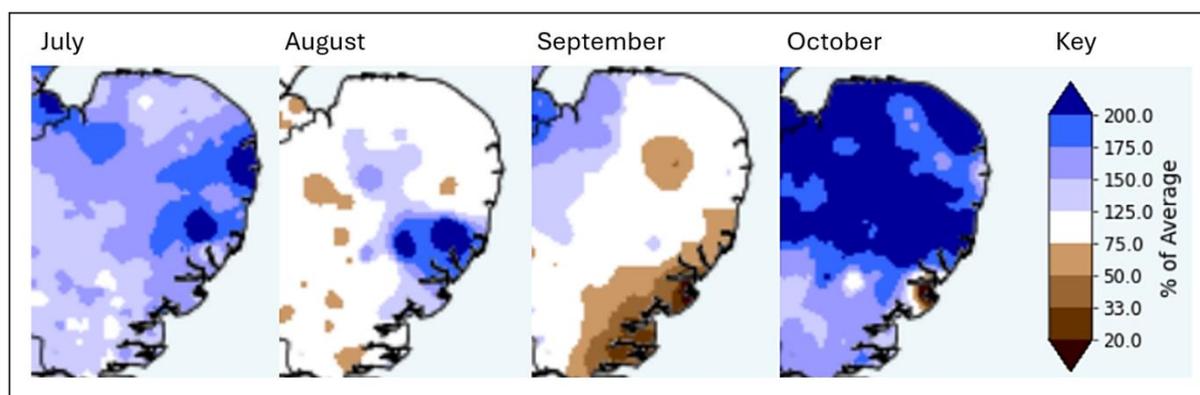
Figure 1. Average monthly rainfall (July – October 2023) as a percentage of the historic average monthly rainfall

The Environment Agency River level gauging stations indicated many flows close to or exceeding their highest on record, and the weather remained wetter than average for the rest of the month. October 2023 was the joint wettest on record in the east of England since 1871. During Storm Babet, Suffolk saw the heaviest rainfall across East Anglia causing significant flooding of roads and properties. The river systems rose rapidly across whole catchments due to the existing conditions, which was unusual as storms will often impact a small area and result in a steady progression of floodwater downstream. A major incident was declared by Suffolk Resilience Forum (SRF) in the afternoon of the 20th of October due to significant impacts on communities and disruption to the road and rail networks.

The following maps illustrate the extent to which the rainfall in the months preceding Storm Babet exceeded the average monthly rainfall for July to October in recent years in Suffolk.

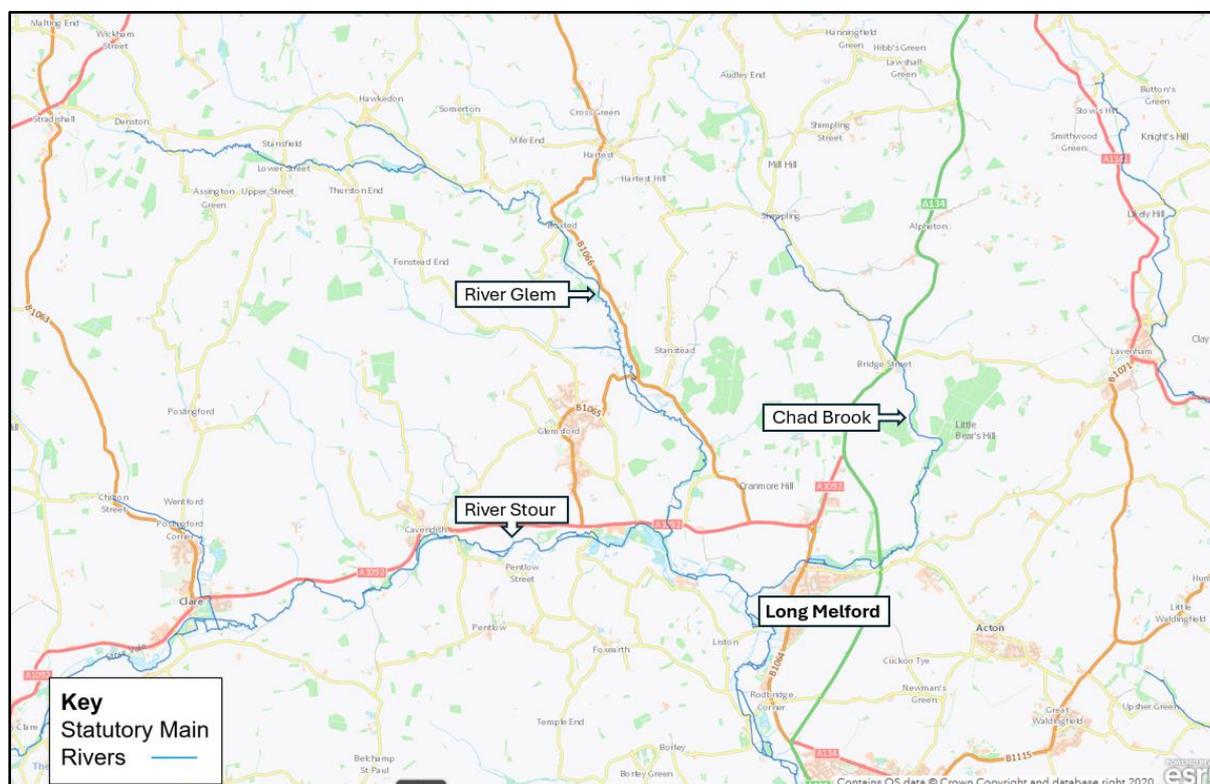
Figure 3. Location of statutory main rivers

Figure 3 shows the statutory main rivers in Long Melford parish. These include the River Glem (flowing from the northwest) which joins the River Stour (flowing from the west). Chad Brook flows from the north towards Long Melford, also joining the River Stour and flowing south towards Sudbury.

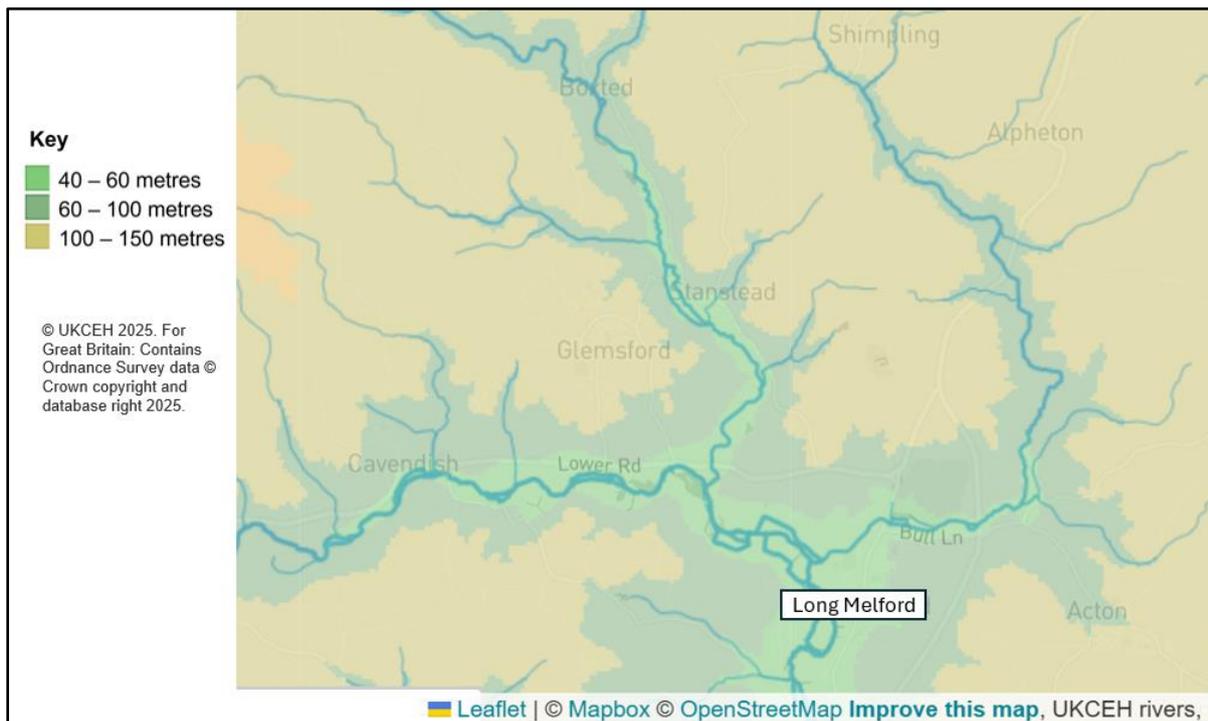
Figure 7. Elevation map of Chad Brook and River Glem catchment areas (National River Flow Archive)

The primary catchment affected by internal flooding of property in the parish of Long Melford is the Chad Brook catchment, where 8 properties were flooded. One property was flooded in the River Glem catchment. The rivers in both these catchments contribute to the River Stour, but this is downstream of affected properties. Both the Chad Brook and River Glem catchment and the parish of Long Melford which partly overlies them are located in a rural and predominantly arable area. The affected parts of the A1092, the village of Long Melford and Bridge Street are all in relatively low-lying areas (Figure 7).

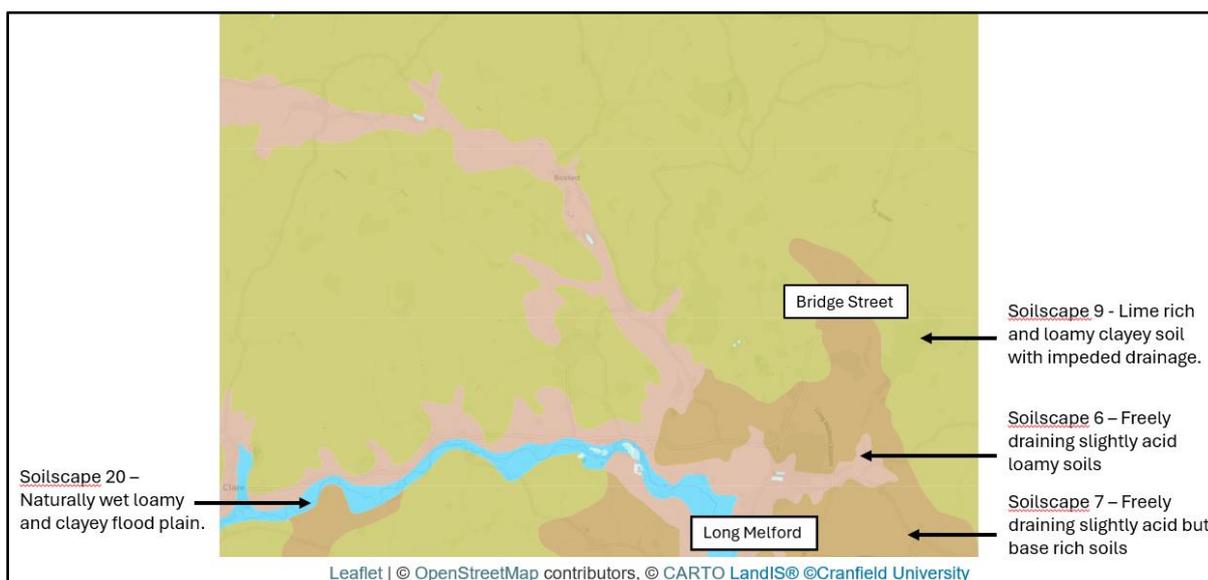
Figure 8. Soil map of upstream catchment areas for the River Glem and Chad Brook (LandIS Soilscales)

The soils in Long Melford village and Bridge Street are described as freely draining (Fig. 8). However, the soil type that covers much of the upstream catchment for the River Glem and Chad Brook is described as being loamy, clayey and having impeded drainage. In these areas, water permeates more slowly and surface water runoff is greater, particularly during intense rainfall. The saturated nature of the soils leading up to Storm Babet would also have prevented some infiltration, increasing runoff.

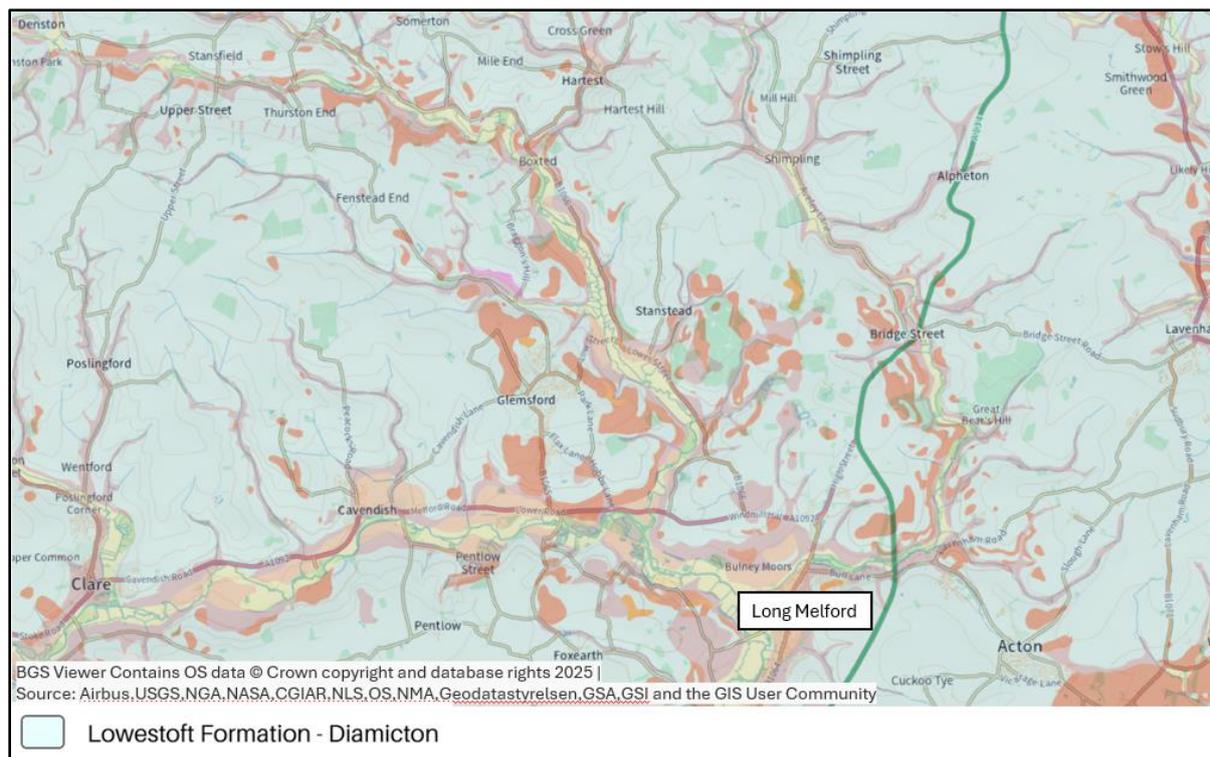
Figure 9. Superficial geology (BGS Viewer)

Superficial geology layers within the parish are diverse (Figure 9). However, much of the superficial geology in the wider area and upstream catchment is made up of 'Lowestoft Formation – Diamiction' which is described by the British Geological Survey as a diverse mixture of clay, sand, gravel, and boulders varying widely in size and shape. This is sometimes known as boulder clay. This generally has a low permeability meaning water will also tend to flow off it before it can infiltrate, which reflects the reports collected during Storm Babet. This also further increases fluvial flows as the surface water joins rivers.
