## Section 19 Flood and Water Management Act 2010

### Marlesford Flood Investigation –

#### Storm Babet 2023

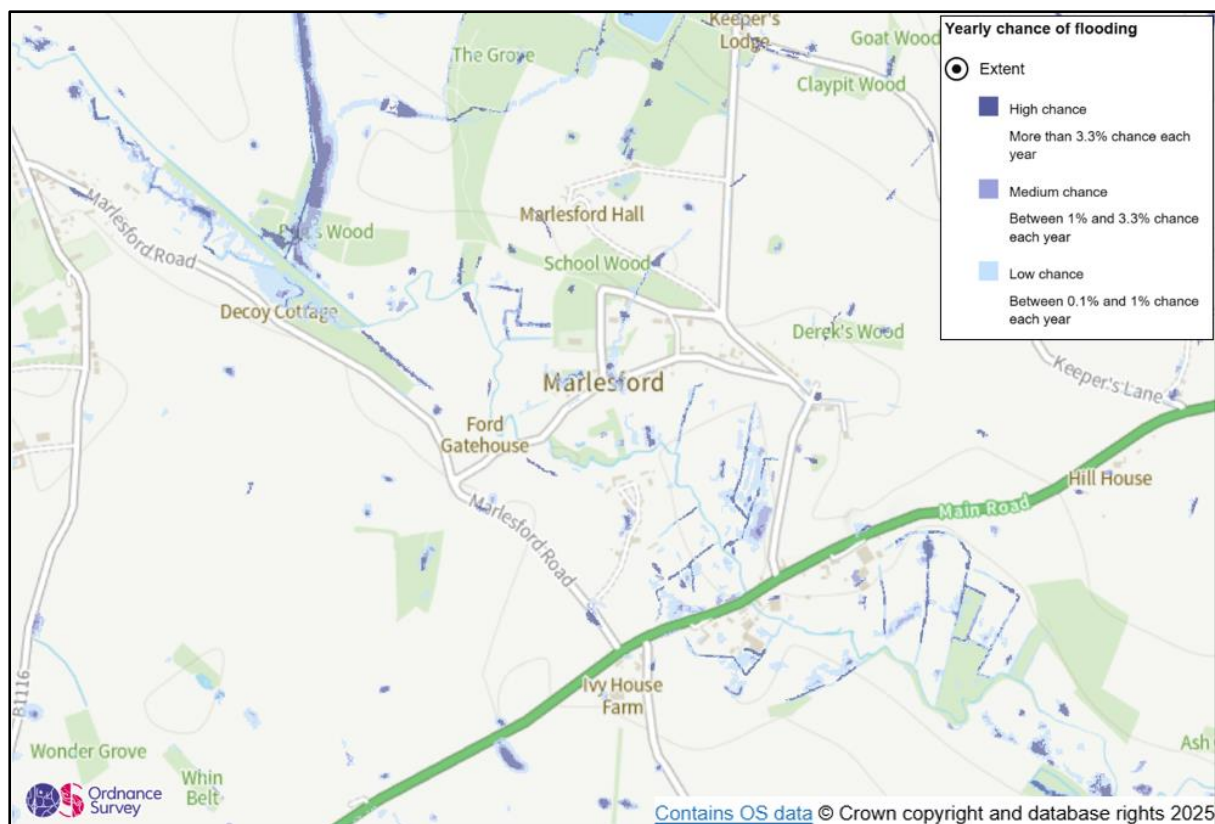
Figure 5. Surface water flood risk

Figure 5 highlights the predicted pluvial (surface water run-off from surrounding land and highways) flood risk in Marlesford, with multiple flow paths coming into Marlesford from the north into the floodplain of the river Ore.

There is a medium to high chance of surface water flooding on sections of Church Road. This area was affected by flooding during Storm Babet.

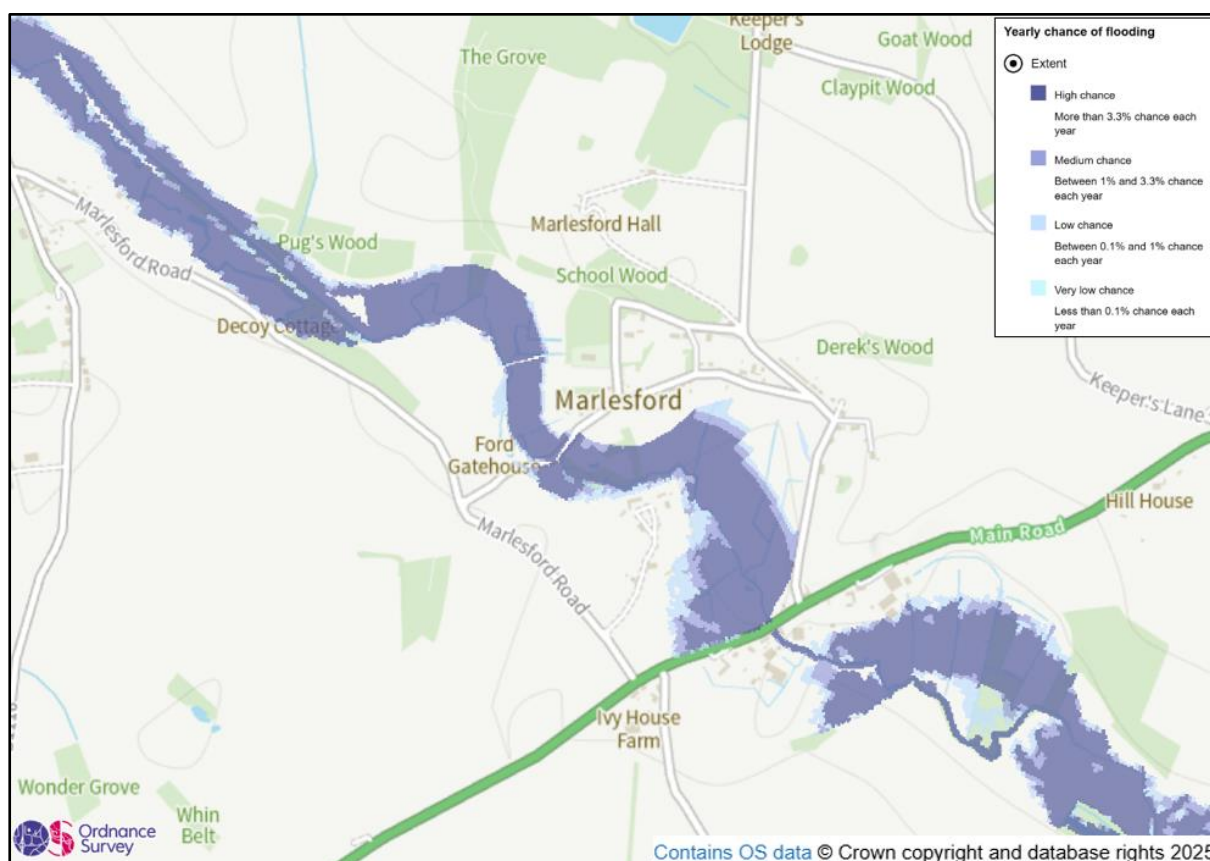
Figure 6. Flood risk from rivers and sea

Figure 6 shows the predicted fluvial (from designated main river and ordinary watercourses) flood risk in Marlesford. Fluvial flood risk in Marlesford is predominantly associated with the river Ore which passes through the village.

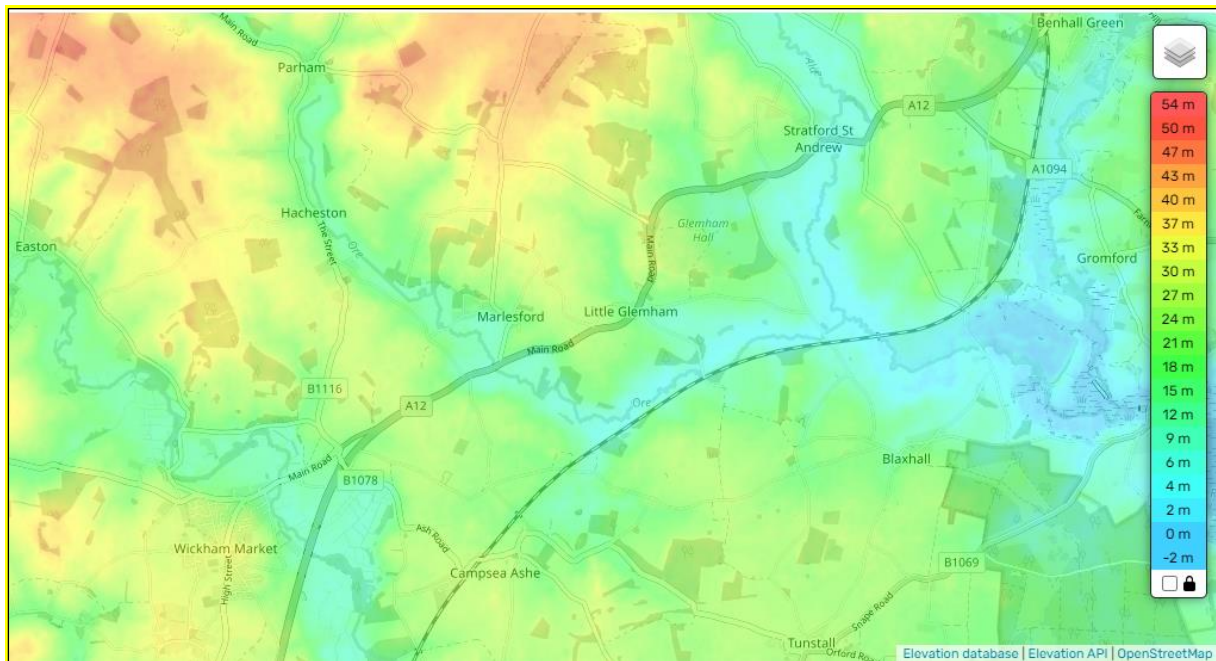
*Figure 7. Marlesford and surrounding topography (TessaDEM as cited in topographic-map.com)*

Figure 7 shows the topography surrounding Marlesford with gradient changes across the wider village. One of the lowest points in Marlesford is at the A12 road bridge over the river Ore. The junction of Church Road with Ford Road and Low Road is lower than the surrounding land to the north and west. These locations were identified as being some of the worst affected areas during Storm Babet.

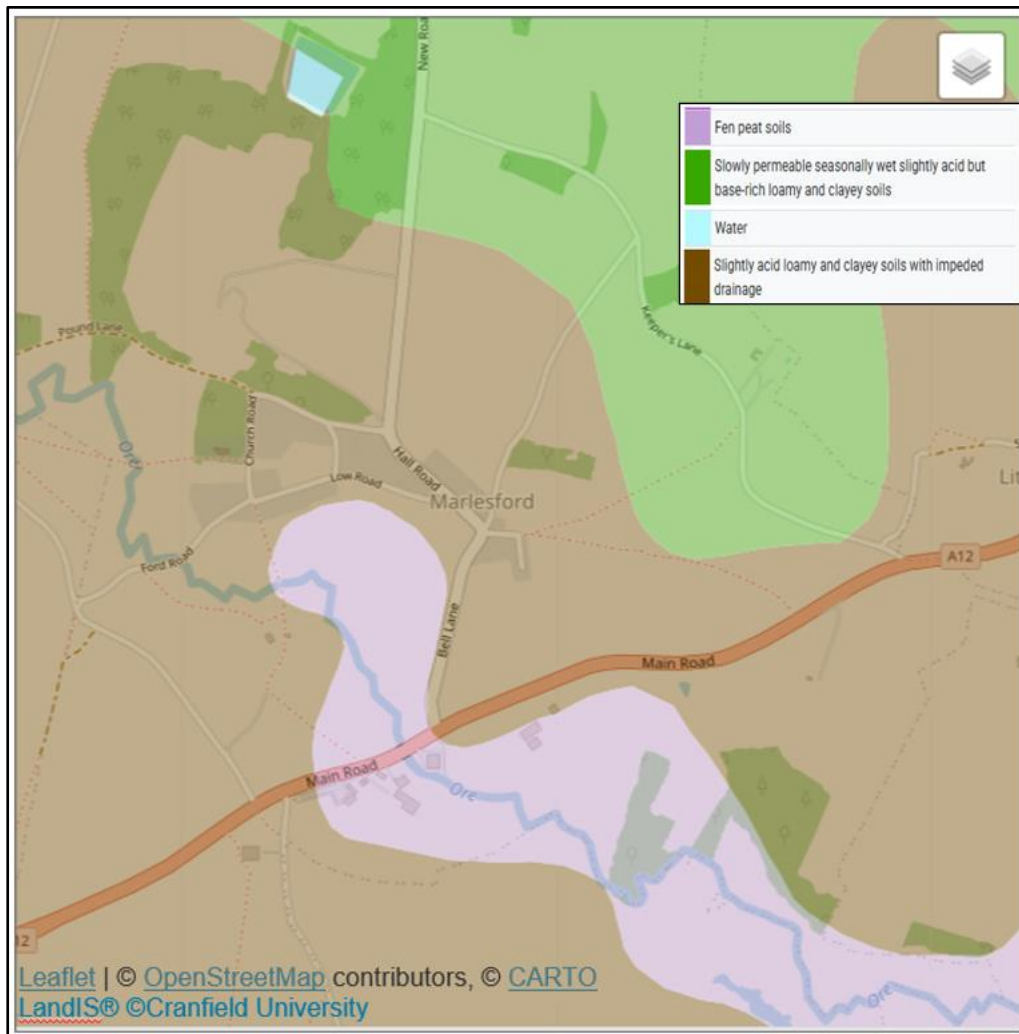
Figure 8. Soil map (LandIS Soilscales)

The soils more generally surrounding Marlesford are loamy and clayey with impeded drainage, meaning that water permeates more slowly and surface water runoff is greater. The floodplain soils surrounding the river Ore are more freely draining, usually have naturally high groundwater and tend to be wetter.

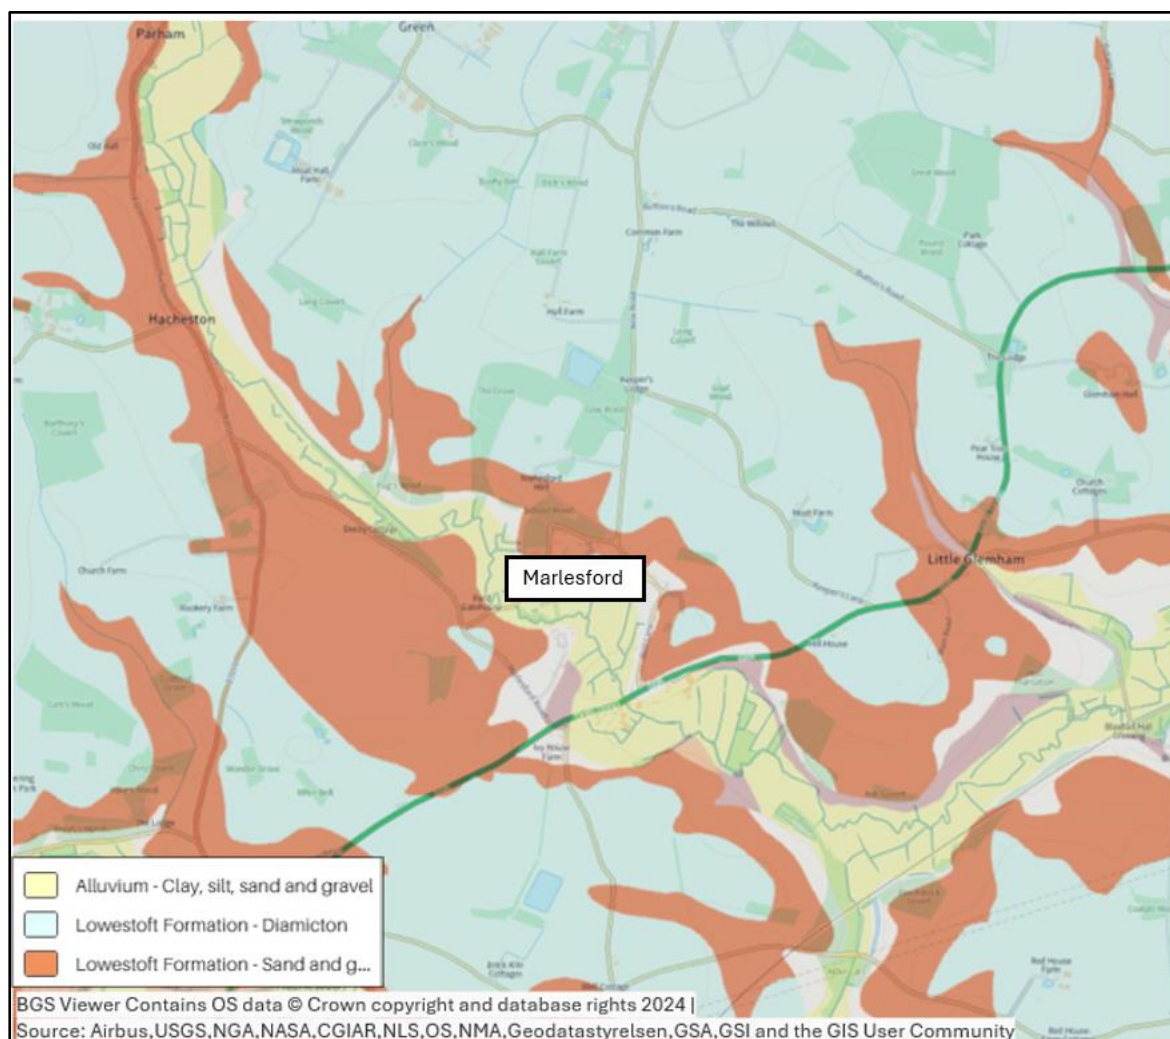
*Figure 9. Superficial Geology (BGS Viewer)*

Lowestoft Formation 'Diamicton' surrounds the village of Marlesford which is described by the British geological survey as a diverse mixture of clay, sand, gravel, and boulders varying widely in size and shape. This generally has a low permeability meaning water will tend to flow off it before it can be infiltrated, which reflects some of the reports from the Storm Babet event.
