Section 19 Flood and Water Management Act 2010

Needham Market Flood Investigation – Storm Babet 2023

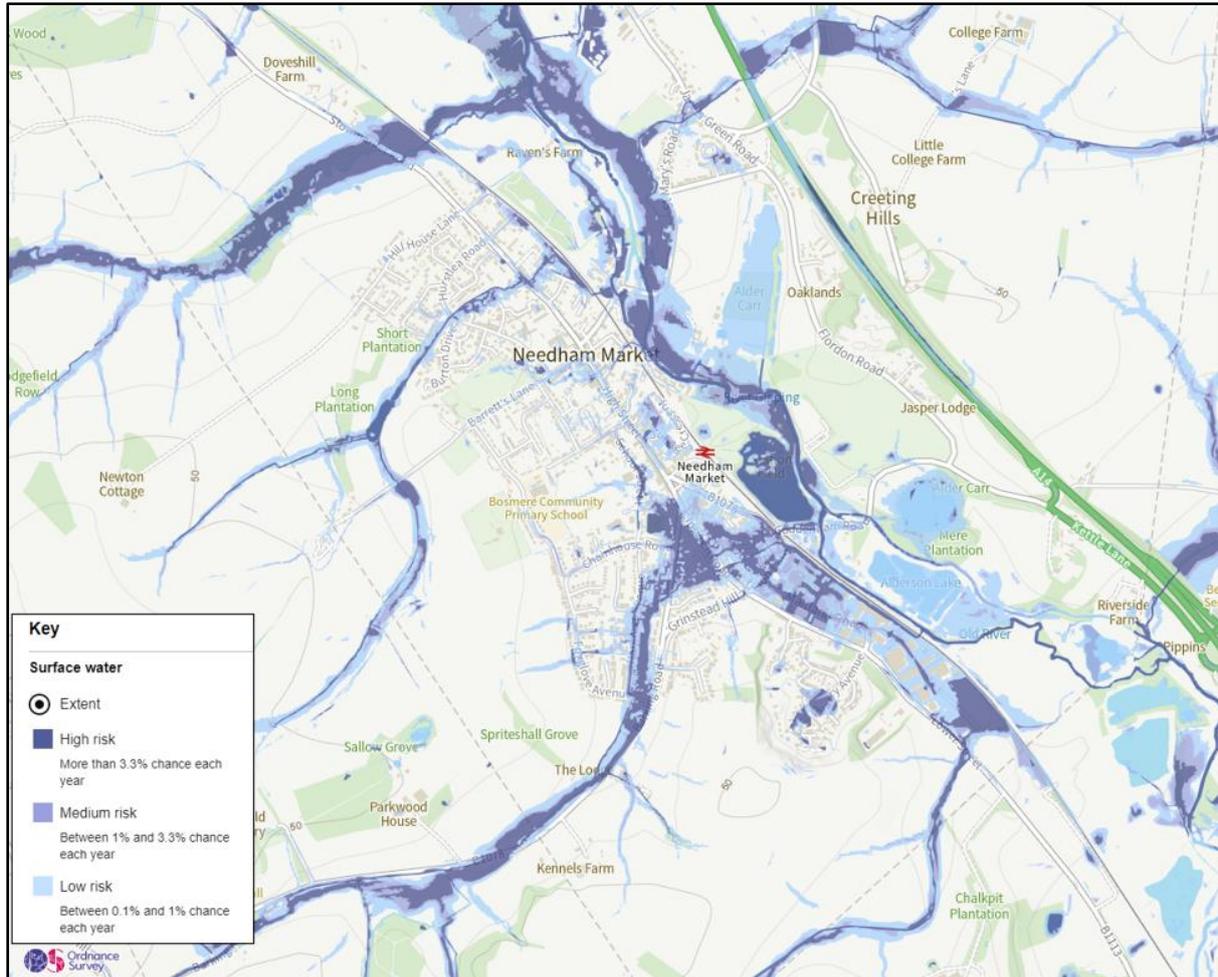
Figure 5 - Predicted Pluvial Flood Risk

Figure 5 highlights the predicted pluvial (surface water run-off from surrounding land and ditches) flood risk within Needham Market, with five main flow paths coming into the town. This indicates that there is significant risk of surface water flooding on Barking Road, Foxglove Avenue, Hargrave Avenue, Pinecroft Way, Limetree Close, Hawks Mill Street, Crown Street and Highland Close. These areas were all affected by flooding during Storm Babet.

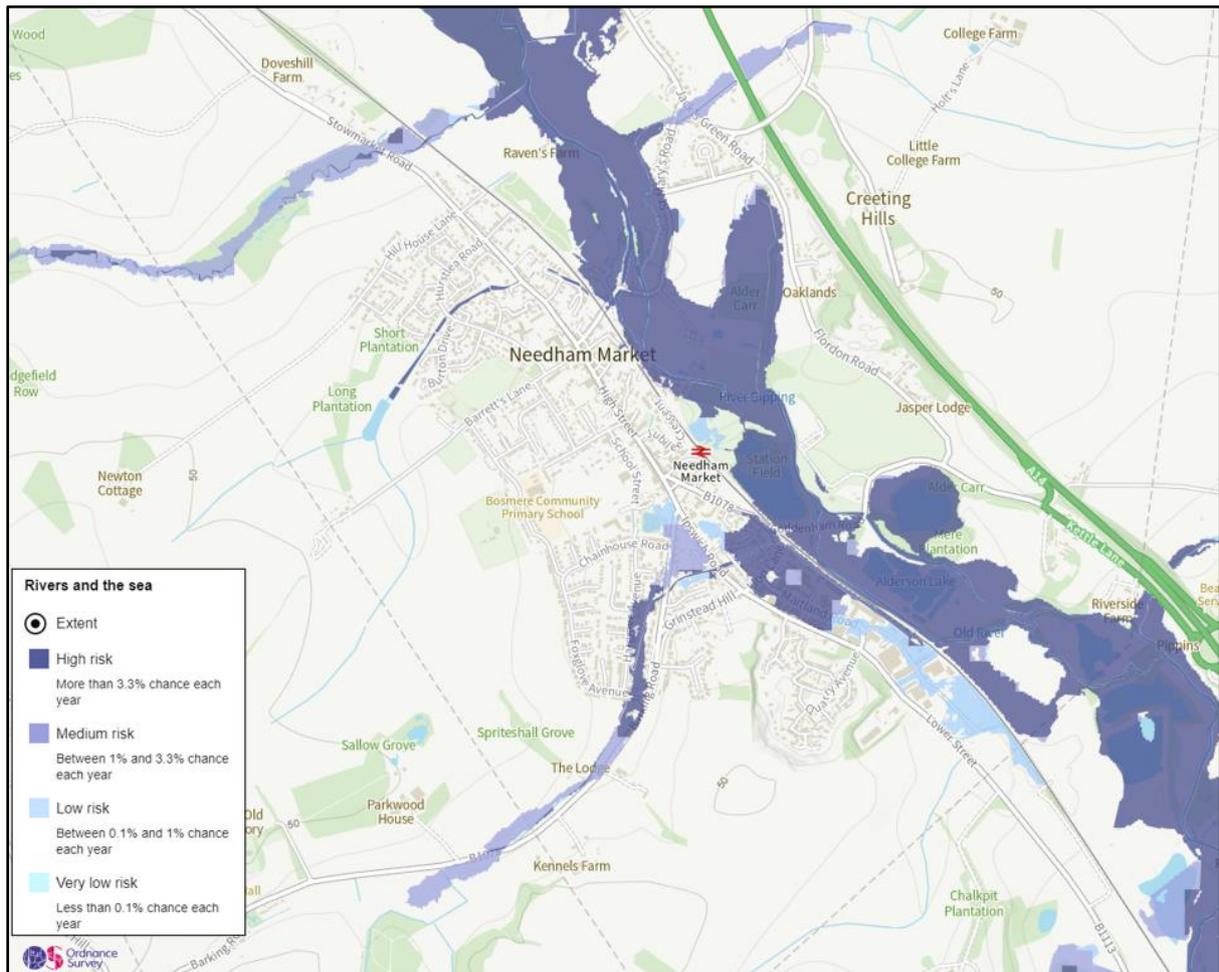
Figure 6 - Predicted Fluvial Flood Risk

Figure 6 highlights the predicted fluvial (from designated main river) flood risk within Needham Market. The main fluvial influences consist of the main river Gipping, the Lion Barn drain and the Orchard Gate watercourse. The Hawks Mill area, Crown Street, Pinecroft Way, Maitland Road, Barking Road and some areas of Foxglove Avenue are shown as being at risk for fluvial flooding. These areas were affected by flooding during Storm Babet.

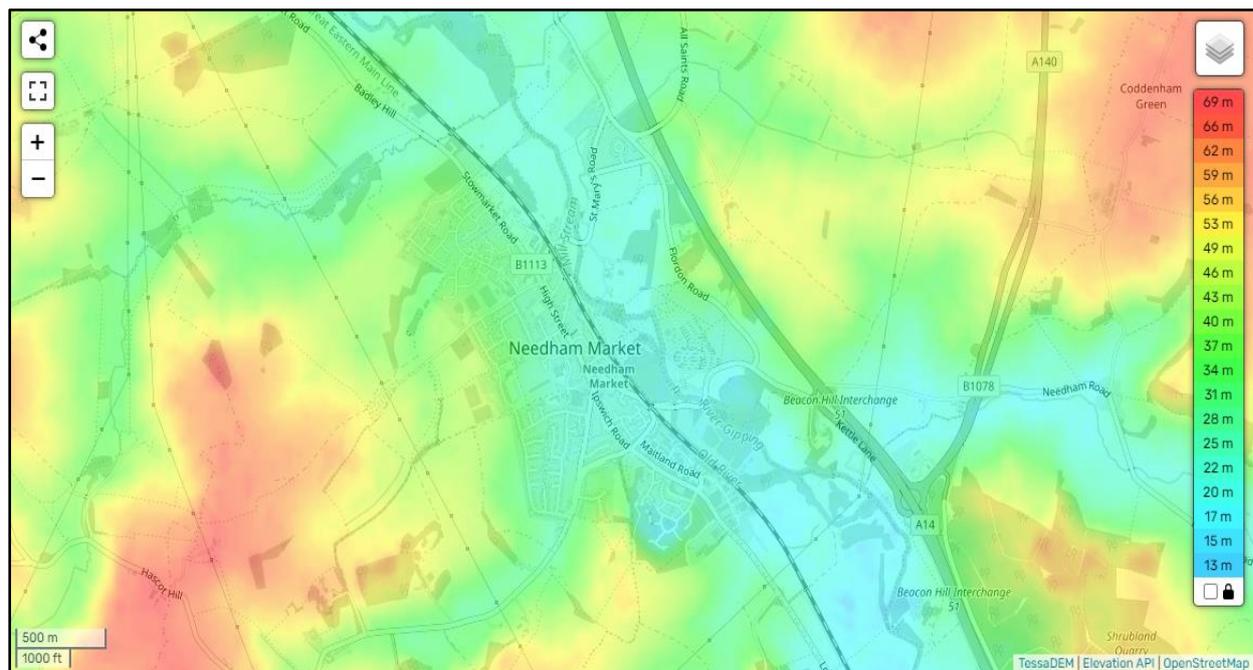
Figure 7 - Needham Market and surrounding topography

Figure 7 shows the topography surrounding Needham Market and the gradient changes across the town. Hawks Mill, Pinecroft Way, Limetree Close, Maitland Road and Lion Lane are among the lowest lying locations in Needham Market. These were identified as being some of the worst affected areas following Storm Babet.

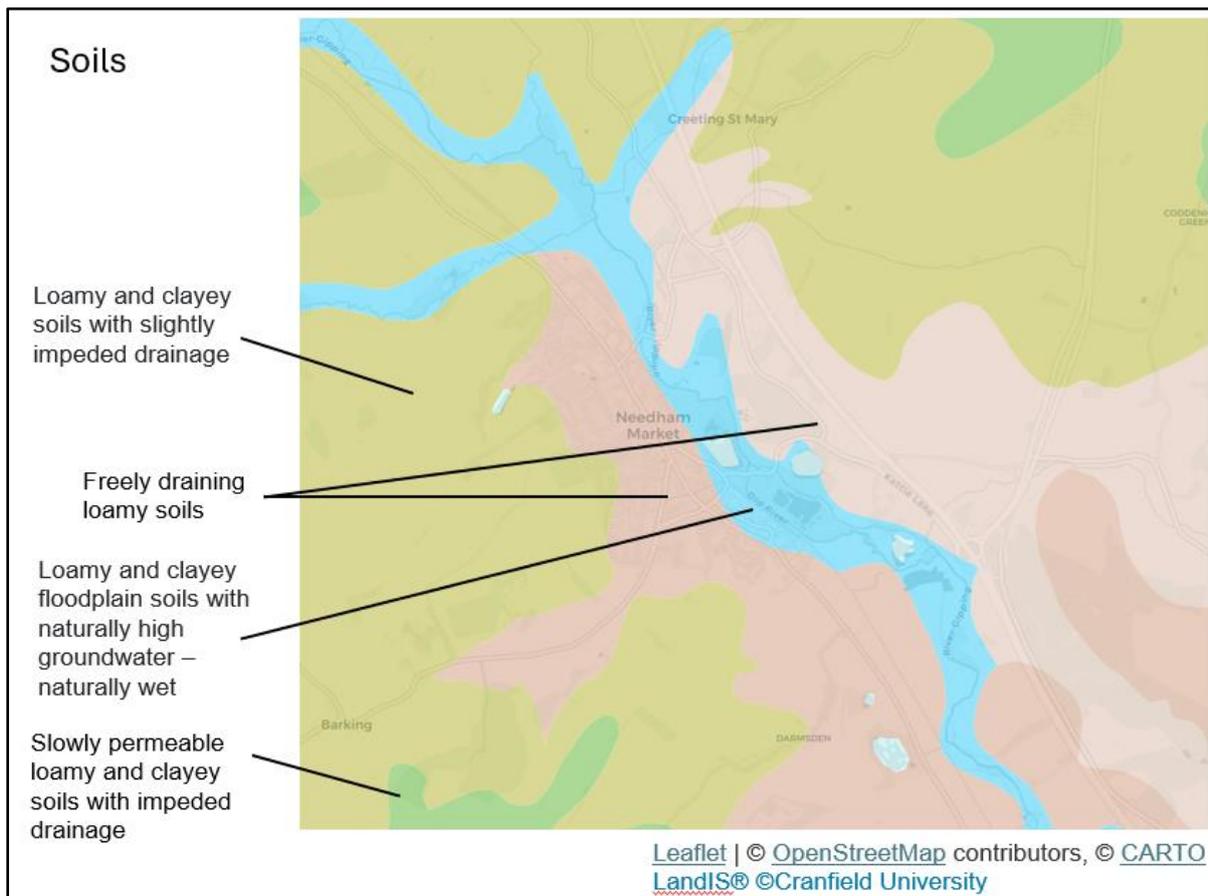
Figure 9 - Needham Market and surrounding soils

With reference to soils in the wider catchment, immediately around Needham Market, they are described as loamy and clayey soils with slightly reduced infiltration. This is sometimes known as boulder clay. At the higher levels surrounding the town, the soil is described as slowly permeable, seasonally wet, loamy and clayey soils with reduced infiltration (LandIS, Cranfield University, 2024). Lower rates of infiltration to ground means that more surface water will stay on the surface and not be absorbed, potentially contributing to flood water (see Figure 9).

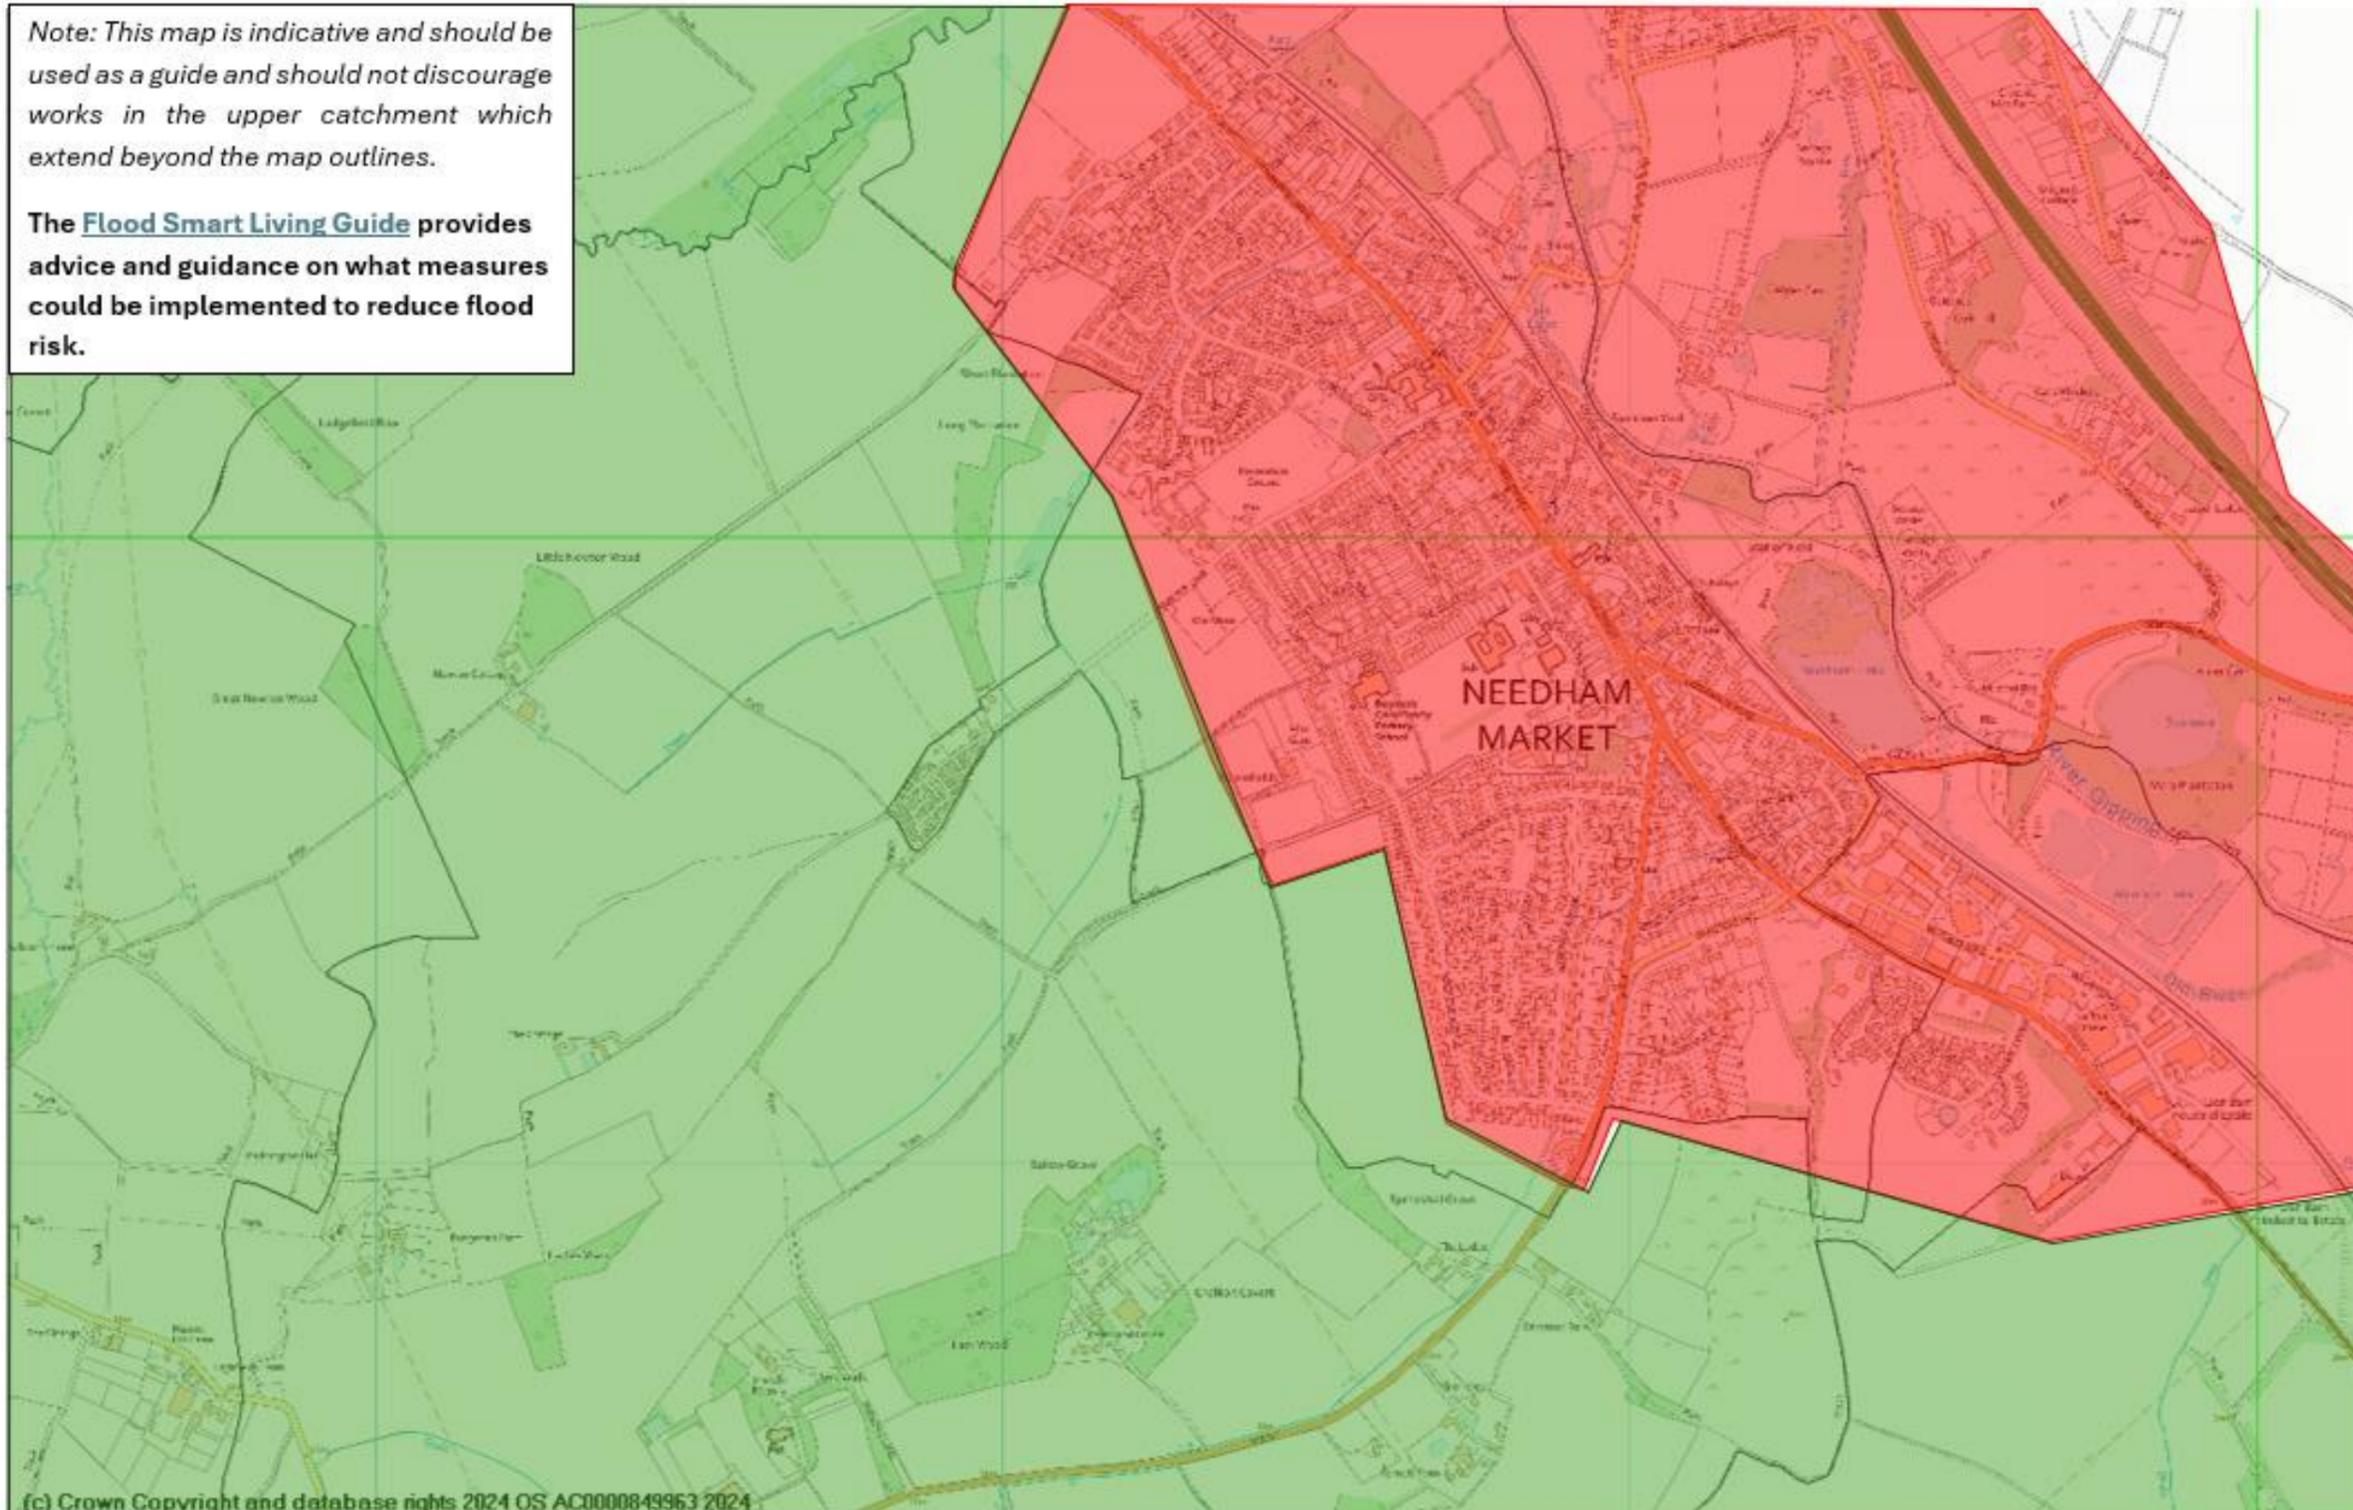
Red – Urban locations where watercourses should be kept clear and water free flowing.

These locations are vulnerable to flood risk and are where the most impact is experienced during an event. Drainage features are constrained with limited space for water and overwhelming of features may lead to flooding. Important to ensure water can flow through the systems with limited restrictions.
