Section 19 Flood and Water Management Act 2010

Report Title: Garrison Lane, Felixstowe

CRNos. 325731, 326167

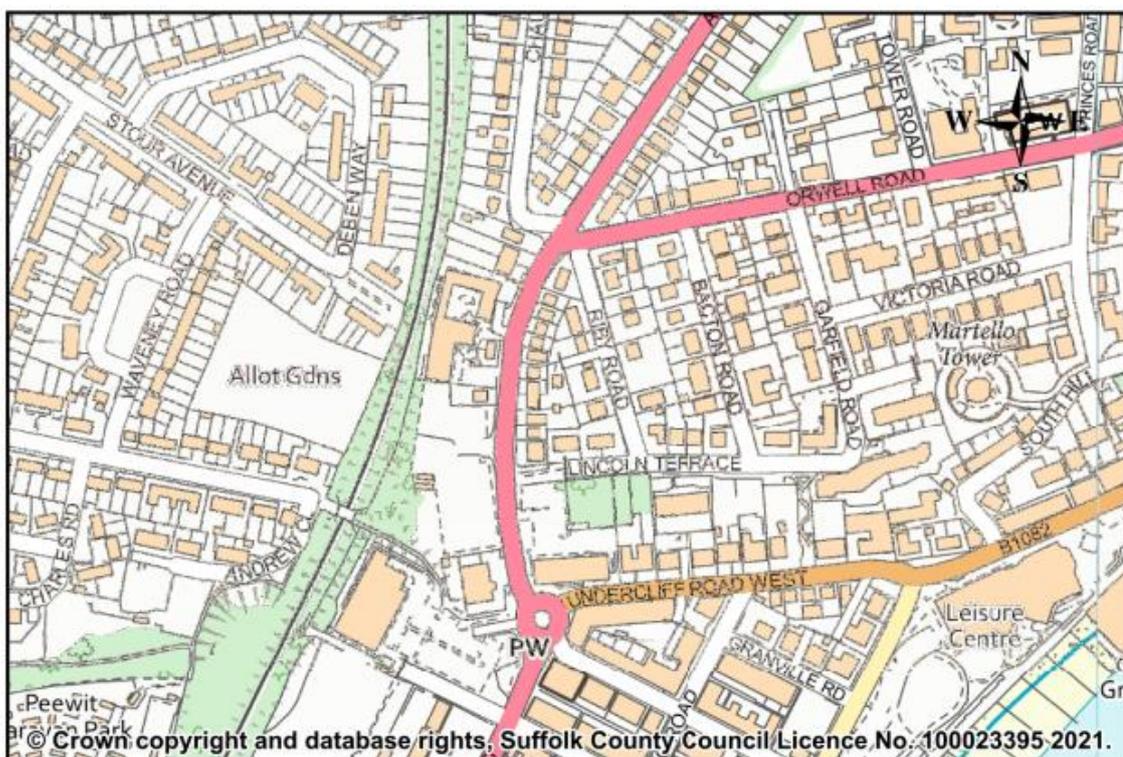
Figure 1 - Investigation Area Map

The properties which experienced flooding on Garrison Lane are located at a low point part way down the hill where the topography directs overland flows towards and past the site.

Stour Avenue marks a shallow “valley”, which also serves to funnel surface water (pluvial) runoff from surrounding areas towards the corner of Garrison Lane where the flooding occurred. These 2 flow paths can be seen in Figure 3.
