## Section 19 Flood and Water Management Act 2010

### Rickinghall Flood Investigation – Storm Babet 2023

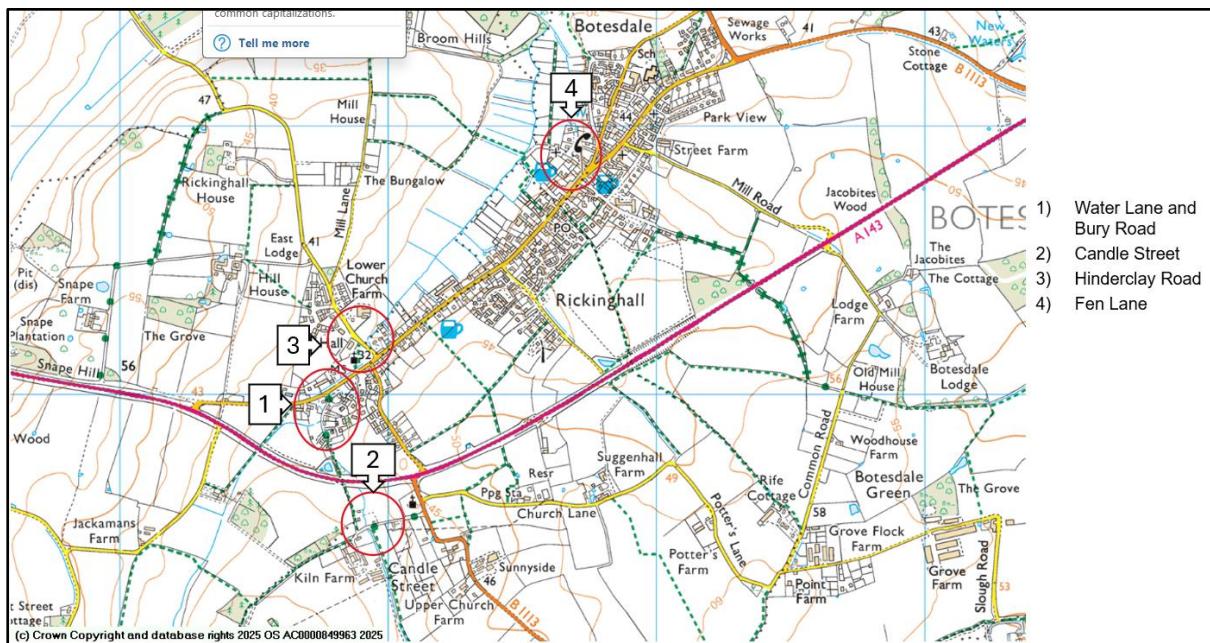
**Figure 4. Distinct flood zones**

For the purposes of this investigation the various areas affected by internal flooding have been separated into four distinct zones (Figure 4):

1. Water Lane and Bury Road
2. Candle Street
3. Hinderclay Road
4. Fen Lane

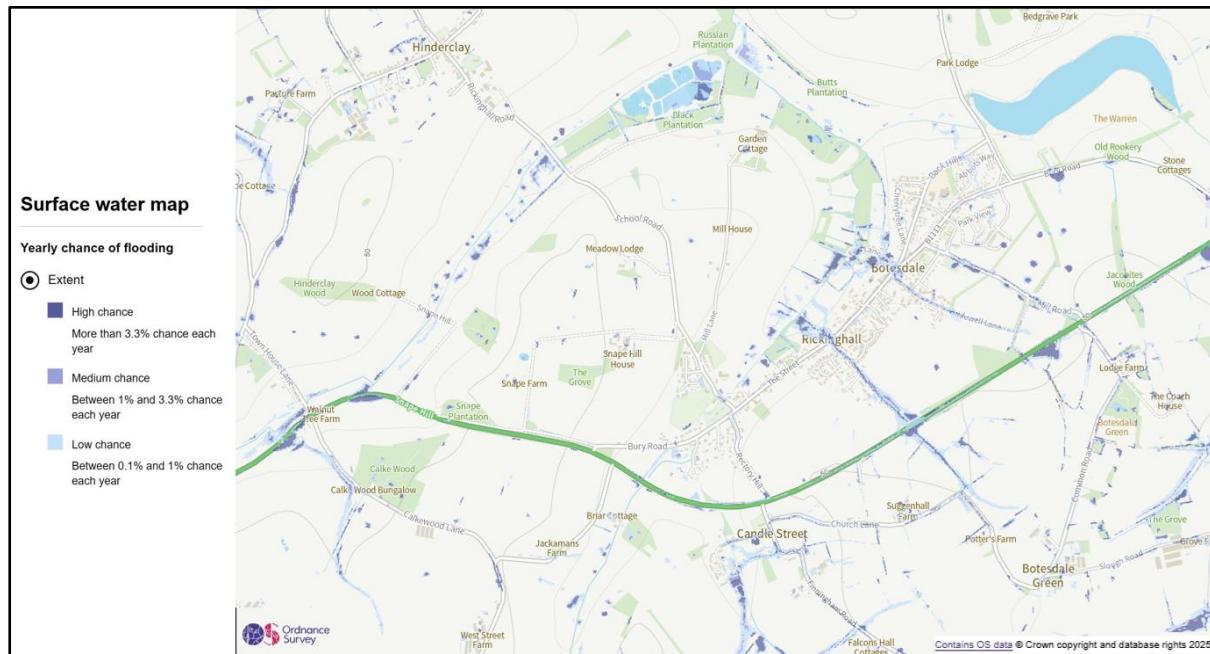
**Figure 5. Projected flood risk from surface water (Environment Agency)**

Areas of Rickinghall are at significant surface water (pluvial) flood risk See figure 5. Affected property in Fen Lane is projected to be at low or medium surface water flood risk and adjacent to a high risk area. Affected property in Kiln Farm Lane, Candle Street is at medium surface water flood risk and adjacent to a high risk area. However, affected property in Water Lane and Hinderclay Road is not projected to be at surface water flood risk. One of the affected properties on Bury Road is projected to be at low surface water flood risk and other affected property in Bury Road is projected to be at no risk.

It should be noted that low chance of flooding indicates a flood risk during extreme events, such as Storm Babet.

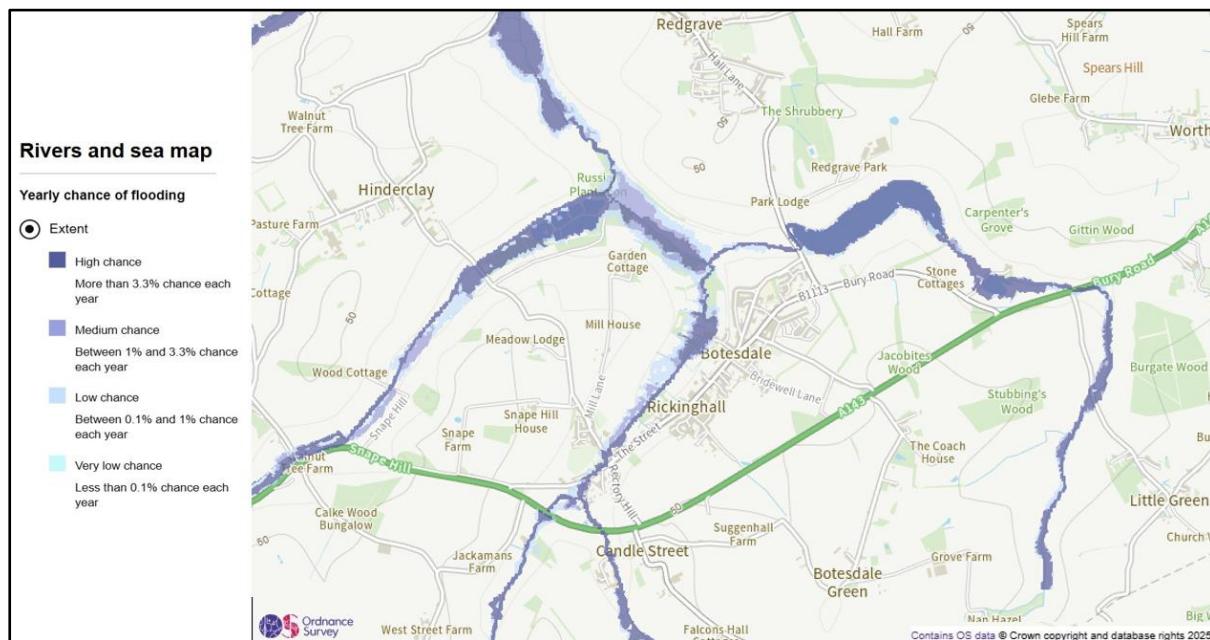
**Figure 6. Projected flood risk from rivers and seas (Environment Agency)**

Areas of Rickinghall are at significant projected fluvial flood risk. See figure 6. Affected property in Water Lane and Kiln Farm Lane, Candle Street is projected to be at high risk of fluvial flooding. Fluvial flood risk for affected property in Bury Road and Hinderclay Road is projected to range from low to high. Affected property in Fen Lane is not projected to be at fluvial flood risk.

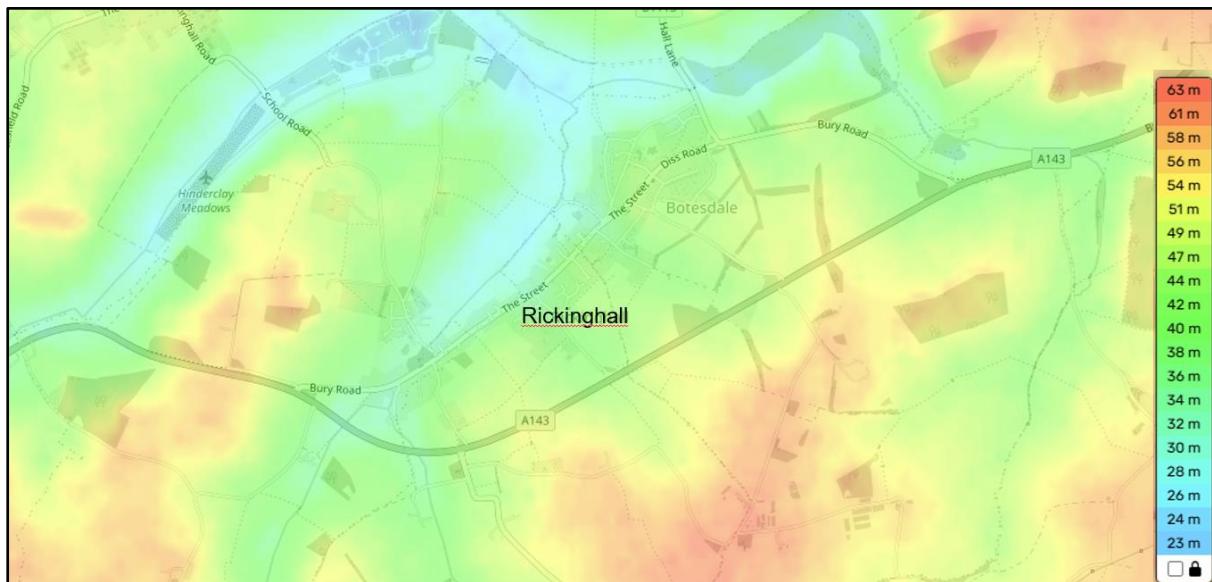
**Figure 7. Topography (TessaDEM as cited in [topographic-map.com](http://topographic-map.com))**

a valley which descends from the southwest to the northeast. Two major flowpaths converge southwest of Water Lane, contributing to a stream which flows north on the west side of Water Lane and under Bury Road. This stream continues to flow northeast to the rear of property on the west side of The Street. It then flows northwest to join the Little Ouse River.

During high rainfall events, considerable flows of water converge towards low-lying areas of the village, meaning that overwhelmed infrastructure and watercourses may be observed at these times.

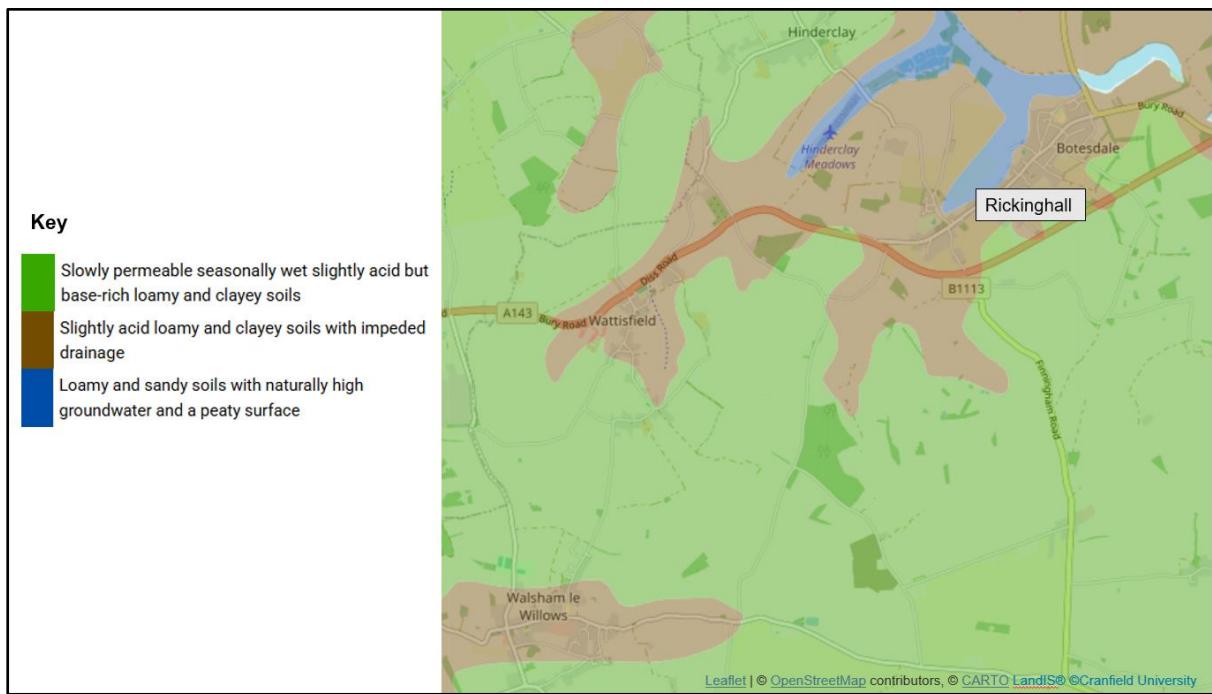
**Figure 8. Soil map of catchment area (LandIS® Soilscapes)**

The soils across which surface water flows towards the village of Rickinghall are loamy and clayey (Figure 8). This means that water infiltrates the soil more slowly and surface water runoff is greater, particularly during intense rainfall. However, the saturated nature of the soils leading up to the event would also have prevented some infiltration.

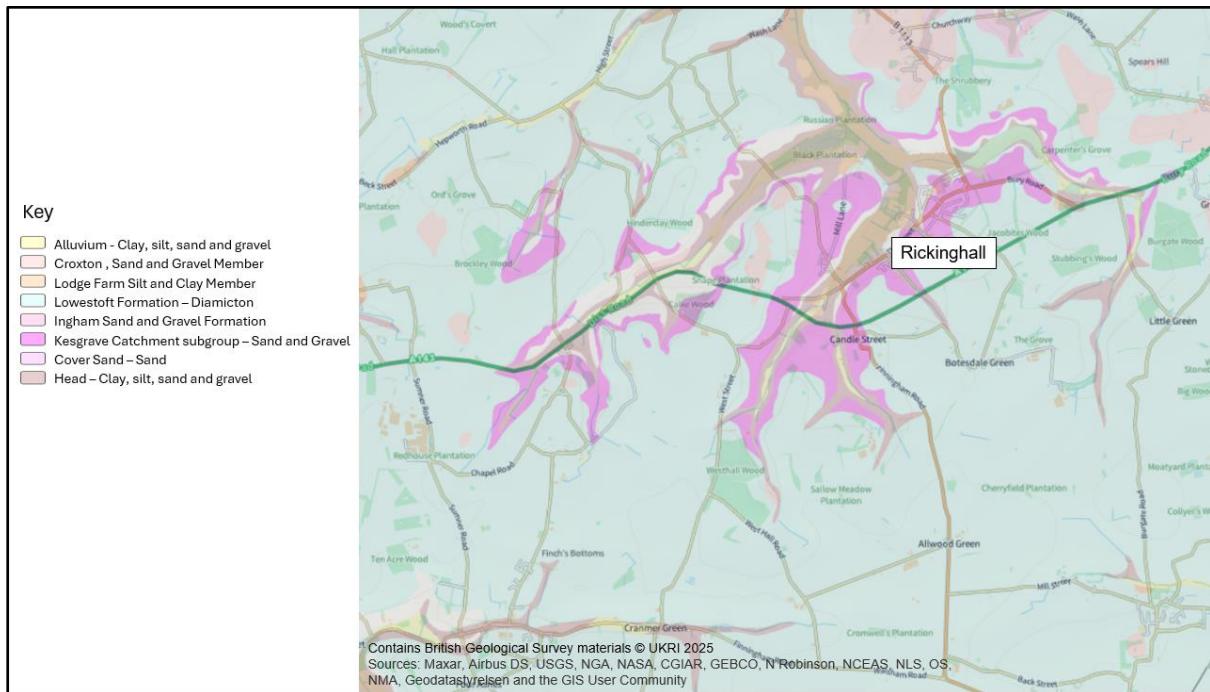
**Figure 9. Superficial geology (BGS Viewer)**

Figure 9 shows that the superficial geology in the catchment immediately upstream of Rickinghall is sand and gravel based and relatively permeable. However, further upstream the superficial geology is made up of 'Lowestoft Formation – Diamicton' which is described by the British Geological Survey as a diverse mixture of clay, sand, gravel, and boulders varying widely in size and shape. This is sometimes known as boulder clay. Generally, this has a low permeability, meaning water will tend to flow off it before it can infiltrate in short term events, which also reflects the reports collected during Storm Babet.
