# Section 19 Flood and Water Management Act 2010

## Tunstall Flood Investigation

### Storm Babet 2023

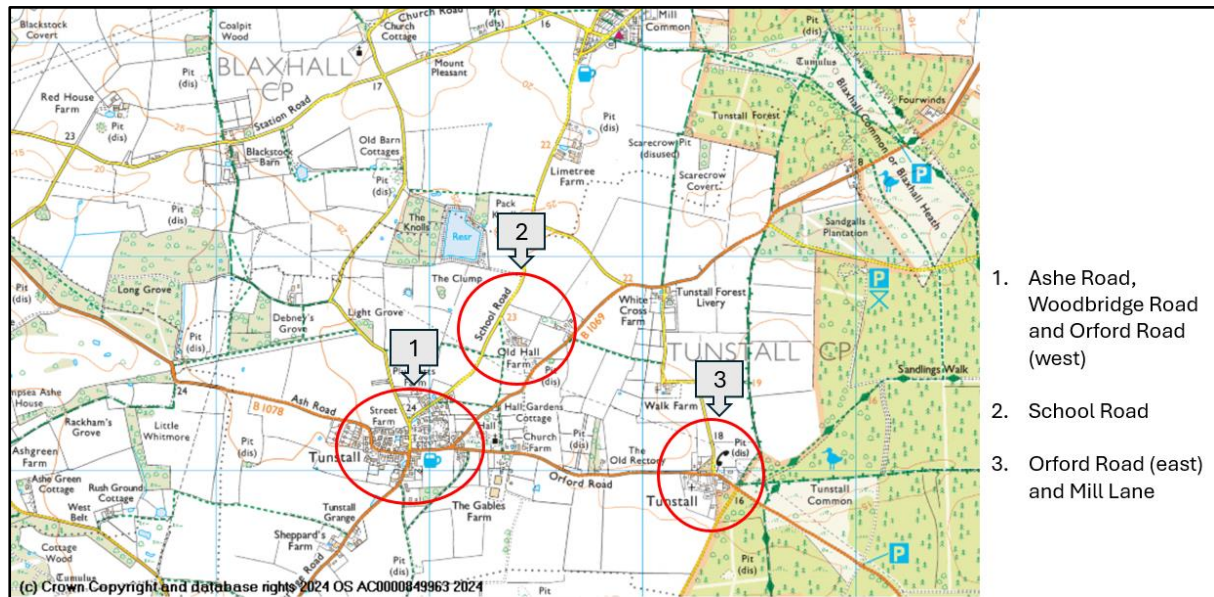
**Fig. 3. Distinct flood zones**

For the purposes of this investigation the various areas affected by internal flooding of property have been separated into three distinct zones:

1. Ashe Road, Woodbridge Road and Orford Road (west)
2. School Road
3. Orford Road (east) and Mill Lane

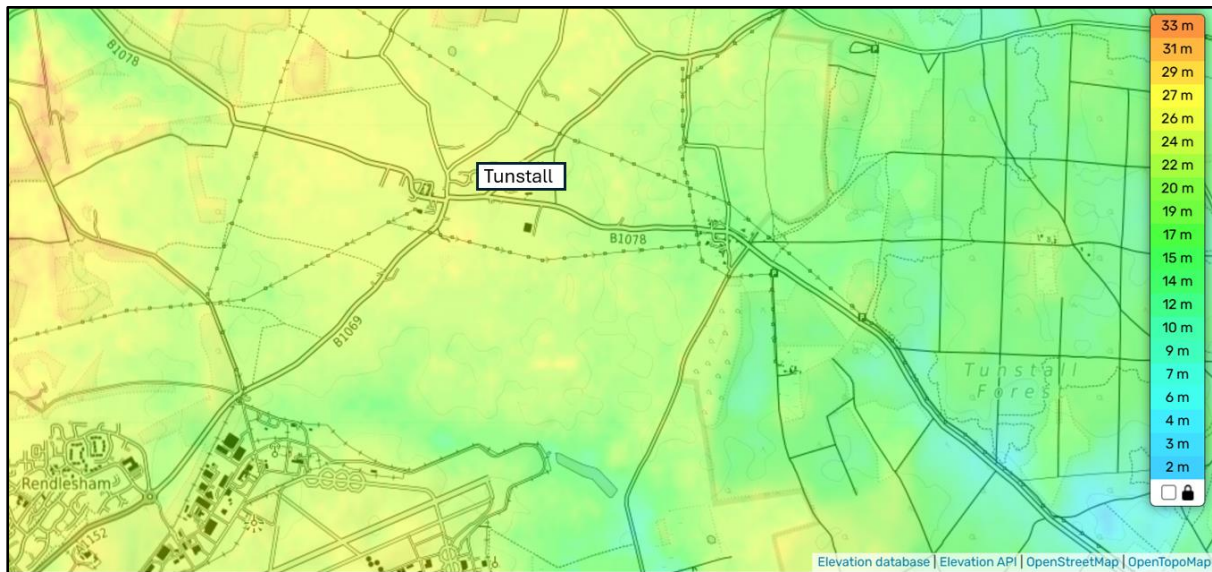
**Fig. 5. Elevation map of Tunstall**

The parish of Tunstall is situated in a relatively flat rural area with surrounding farmland used predominantly for arable agriculture (see Fig. 5). There are no main rivers in the affected zones. However, surface water still flows towards and collects in low-lying areas of Tunstall village (predominantly around Green Man Pond) and the eastern part of the village by Tunstall Common (predominantly around the Orford Road and Mill Lane road junction) during high rainfall events. Overwhelmed infrastructure and watercourses may be observed during these intense rainfall events.

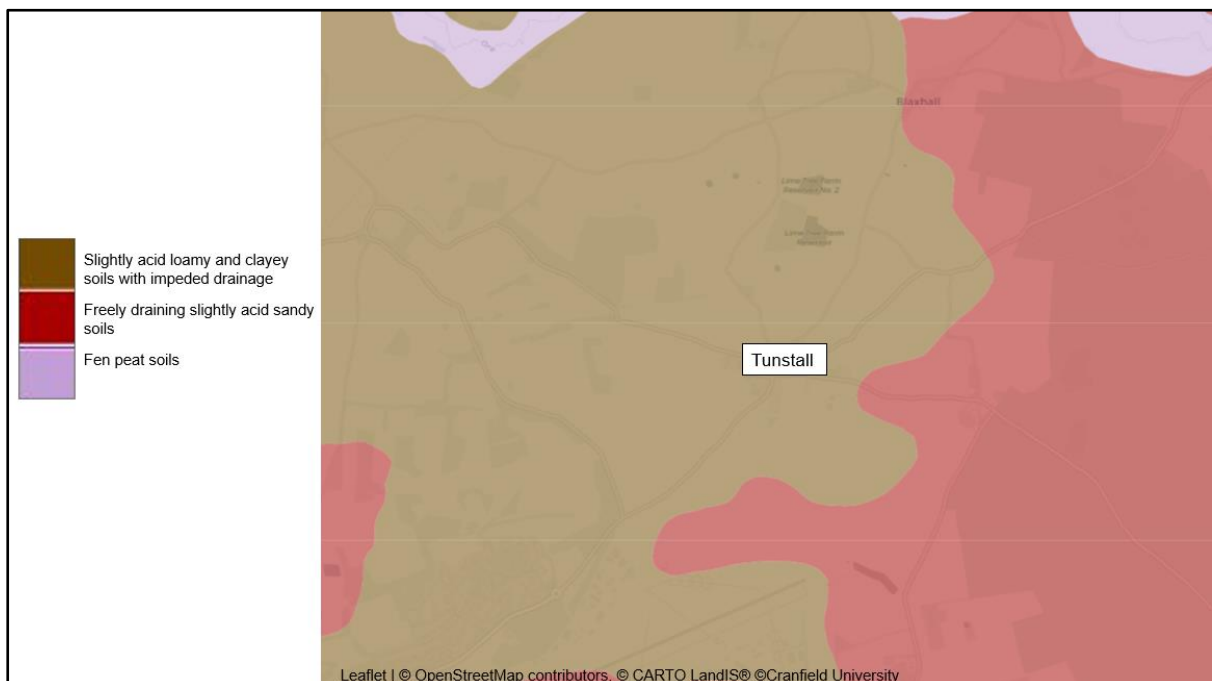
**Fig. 6. Soil map of catchment area (LandIS Soils)**

The soils surrounding Tunstall are predominantly loamy and clayey with impeded drainage, meaning that water permeates more slowly, and surface water runoff is greater, particularly during intense rainfall (Fig. 6). However, the saturated nature of the soils leading up to the event would also have prevented some infiltration.

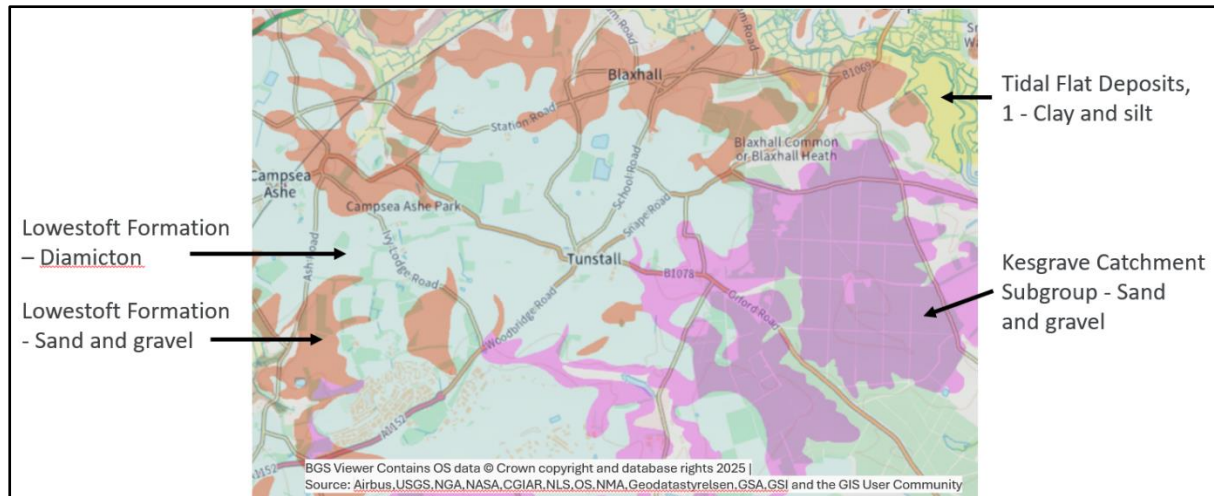
**Fig. 7. Superficial geology (British Geological Society)**

Fig. 7 shows that much of the superficial geology surrounding Tunstall is made up of 'Lowestoft Formation – Diamiction' which is described by the British Geological Survey as a diverse mixture of clay, sand, gravel, and boulders varying widely in size and shape. This is sometimes known as boulder clay. This generally has a low permeability

meaning water will tend to flow off it before it can infiltrate, which also reflects the reports collected during Storm Babet.
