**Section 19 Flood and Water Management Act 2010**  
**Wetheringsett-cum-Brockford Flood Investigation – Storm**  
**Babet 2023**

<b>Name</b>	<b>Date</b>
<b>Report Author</b>	John Jousiffe	
<b>Responsible Officer:</b>	John Jousiffe	
<b>Checked by:</b>	Ellie Beecroft	17/09/2024
<b>RMA Review:</b>		08/10/2024
<b>Approved by:</b>	Matt Hullis	08/11/2024
<b>Date Published</b>		11/11/2024
<b>Latest Update</b>		10/02/2026
<b>Date Report Closed</b>

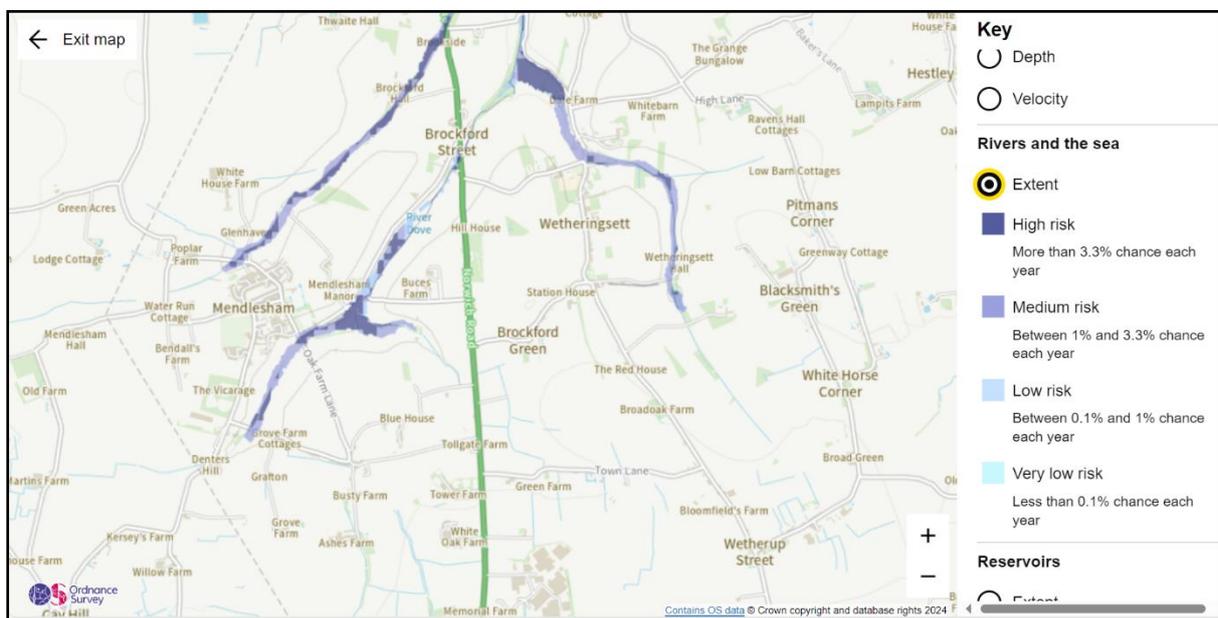
Figure 7 – Fluvial Flood risk map

Fluvial flood risk, described as water overflowing out of watercourses, is evident in the area. The River Dove (designated main river) runs through the Brockford Street area, flowing south to north. There is a significant watercourse that flows through Wetheringsett, before discharging into the River Dove, just north of the village. The map shows significant flood risk to central Wetheringsett and Brockford Street from the watercourses, in particular where the river crosses the A140, northwest Wetheringsett and the southern end of Brockford Road, see figure 7.

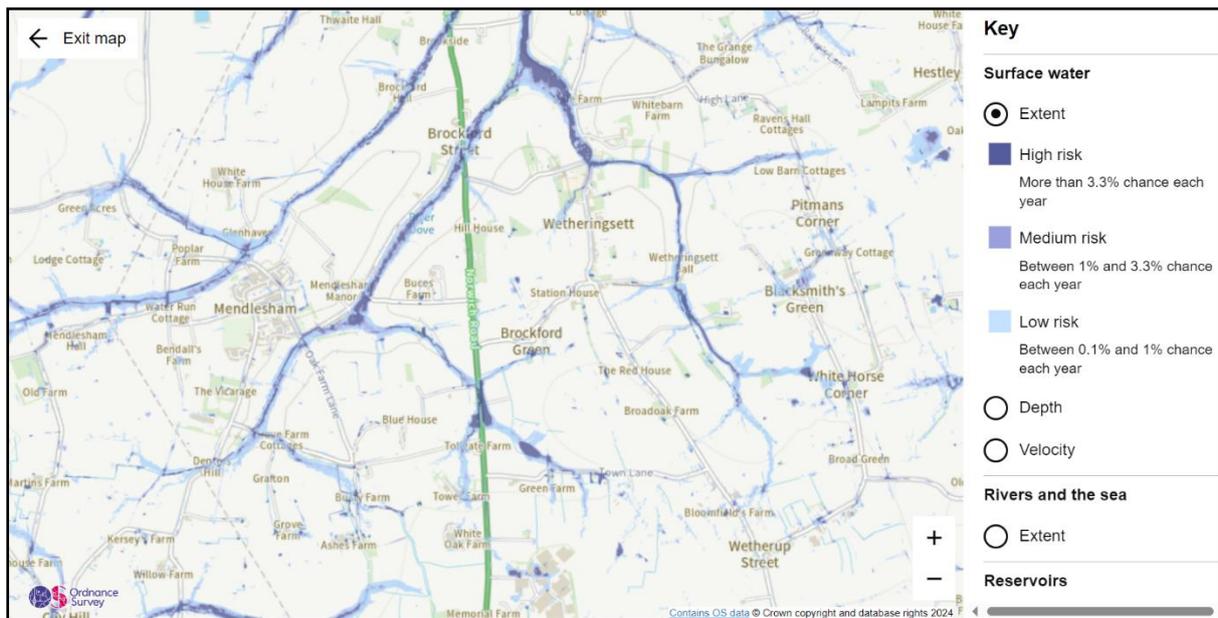
Figure 8 – Surface water flood risk map

The catchment is also at risk from pluvial flood risk (surface water run-off from surrounding land). As seen in figure 8, the flow paths roughly following the line of existing watercourses but also identifies changes in topography and localised low points of risk. Areas include Wetherup Street and Station Road.

As shown in figure 8, there are several flood flow paths which travel from south to north, flowing through Brockford Street and Wetheringsett. These areas are low-lying and noticeably shallower than the surrounding catchment and will be expected to be the primary locations to experience flooding during high rainfall events.

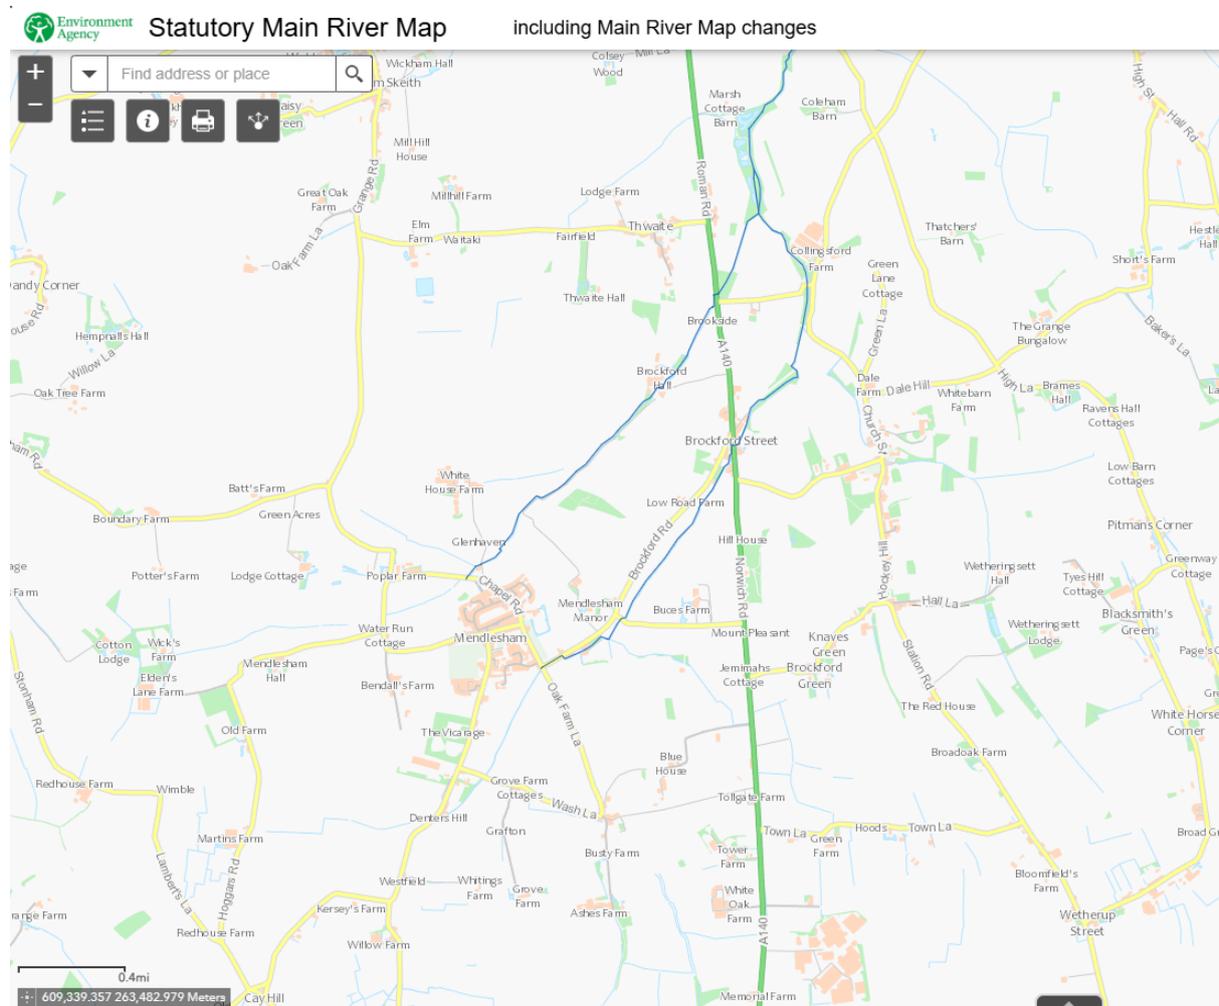
Figure 9 - Statutory main river map

Areas of Wetheringsett and Brockford Street are significantly lower lying than the surrounding topography to the east, south and west, causing all flow paths in the area to converge in these low spots before continuing their flow north towards the Waveney River (figure 9).

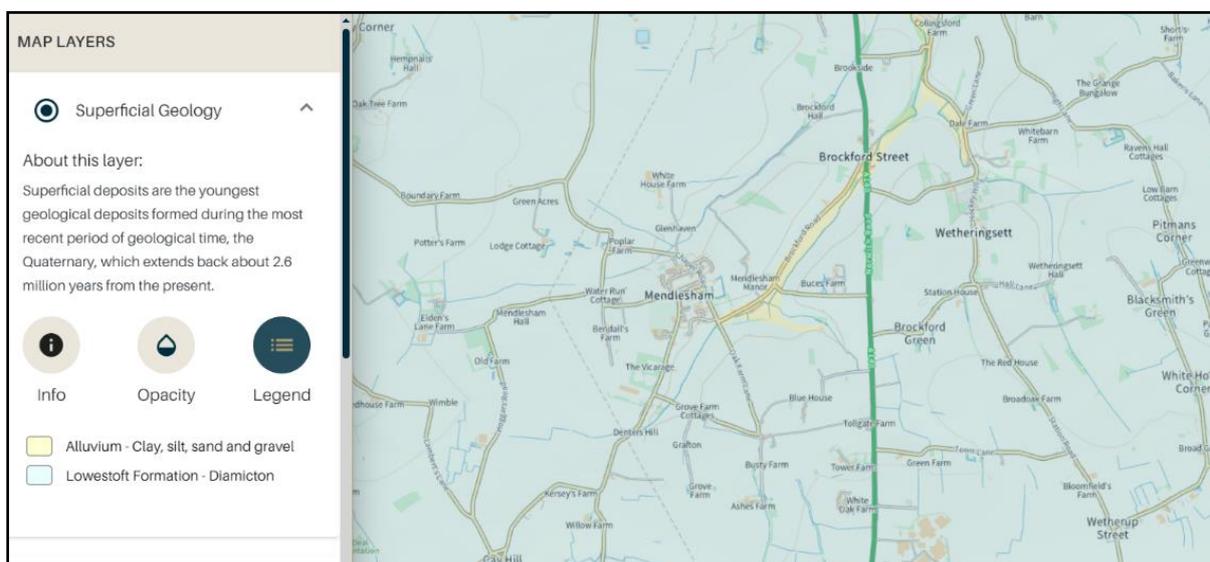
Figure 11 - Superficial Geology

The superficial geology in the area is primarily ‘Lowestoft Formation – Diamicton’ which is described by the British geological survey as a diverse mixture of clay, sand, gravel, and boulders varying widely in size and shape. This is sometimes known as boulder clay. This soil generally has a low permeability meaning water will tend to flow off it before it can infiltrate, which reflects the reports collected during Storm Babet.

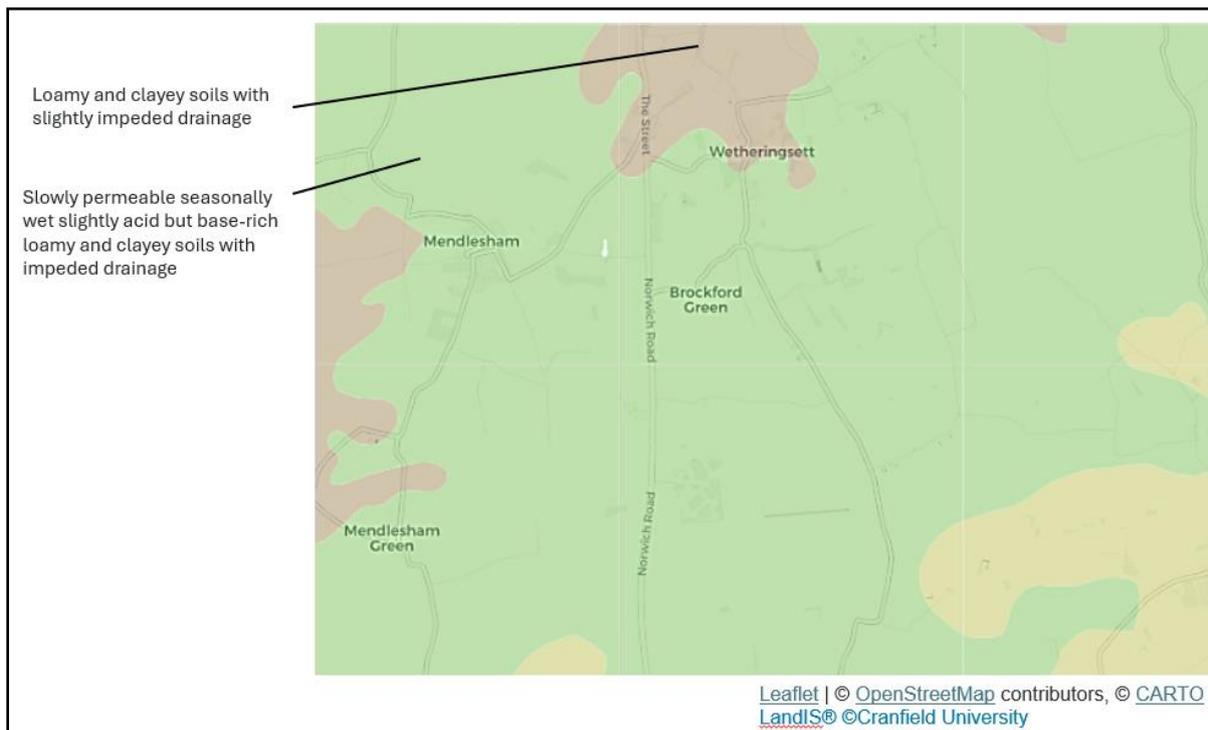
Figure 12 - Area map of soil composition

The soils in the area are primarily comprised of slowly permeable seasonally wet loamy and clayey soils with impeded drainage (see figure 12). This matches descriptions from the event of significant levels of surface water runoff and limited infiltration into the ground.
