Section 19 Flood and Water Management Act 2010

Witnesham & Swilland Flood Investigation –

Storm Babet 2023

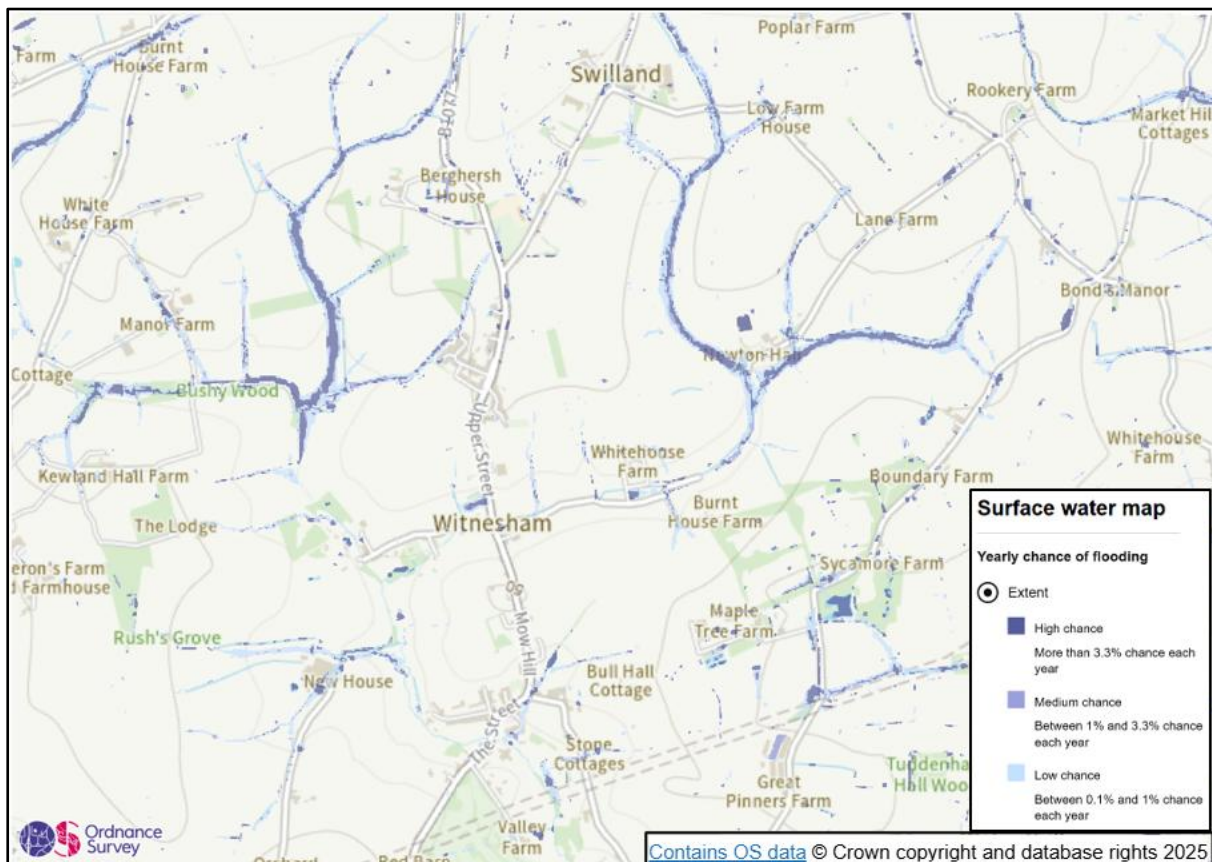
Figure 7. Surface water flood risk

Figure 7 highlights the pluvial (surface water run-off from surrounding land and highways) flood risk in Witnesham and Swilland, with multiple major flow paths coming into Witnesham from the northeast, northwest and west. Surface water flow paths come into Swilland predominately from fields to the west and north.

There is a high chance of surface water flooding on parts of The Street, Mow Hill and Tuddenham Lane. Upper Street, Weyland Road and Swilland are shown to be at a low chance of surface water flooding. All of these areas were affected by flooding during Storm Babet.

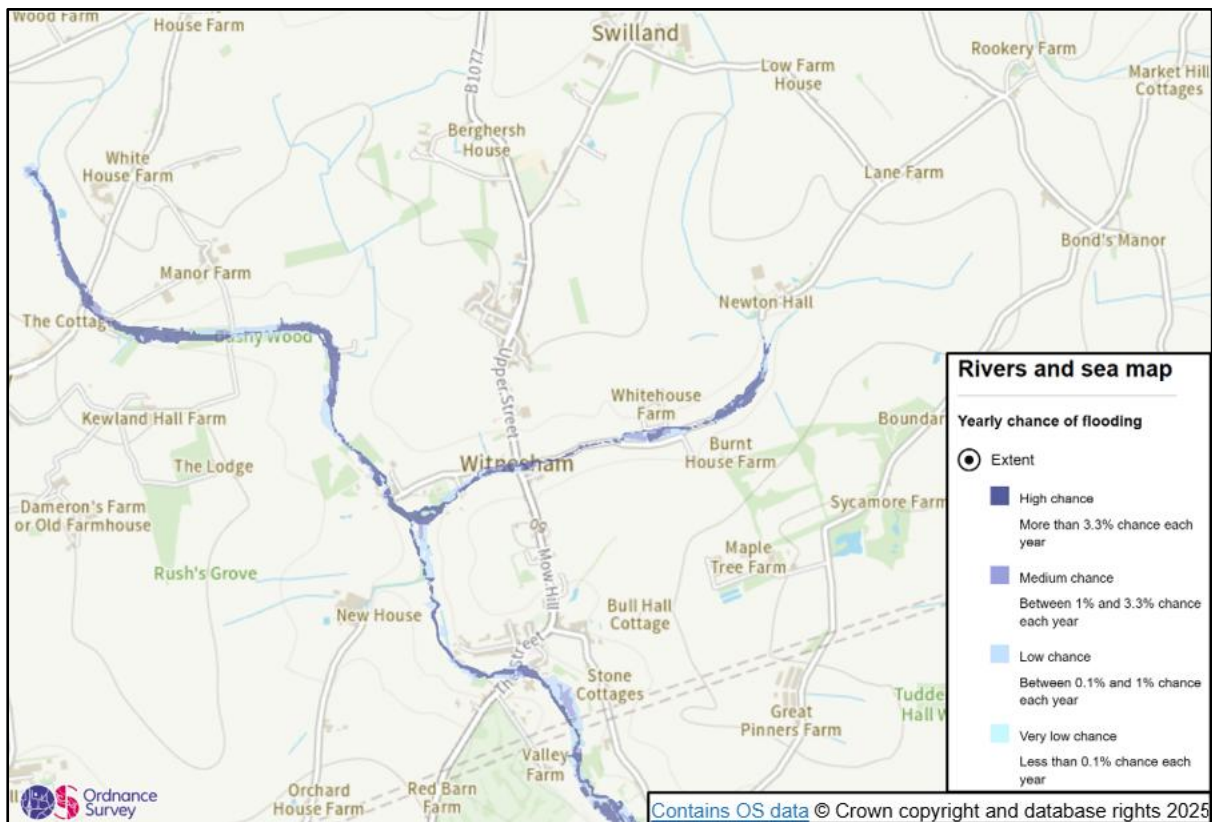
Figure 8. Flood risk from rivers and sea

Figure 8 shows the fluvial (from designated main river and ordinary watercourses) flood risk in Witnesham and Swilland. Fluvial flood risk in Witnesham is predominantly associated with the river Fynn which passes through the village. Swilland is shown not to have any fluvial flood risk.

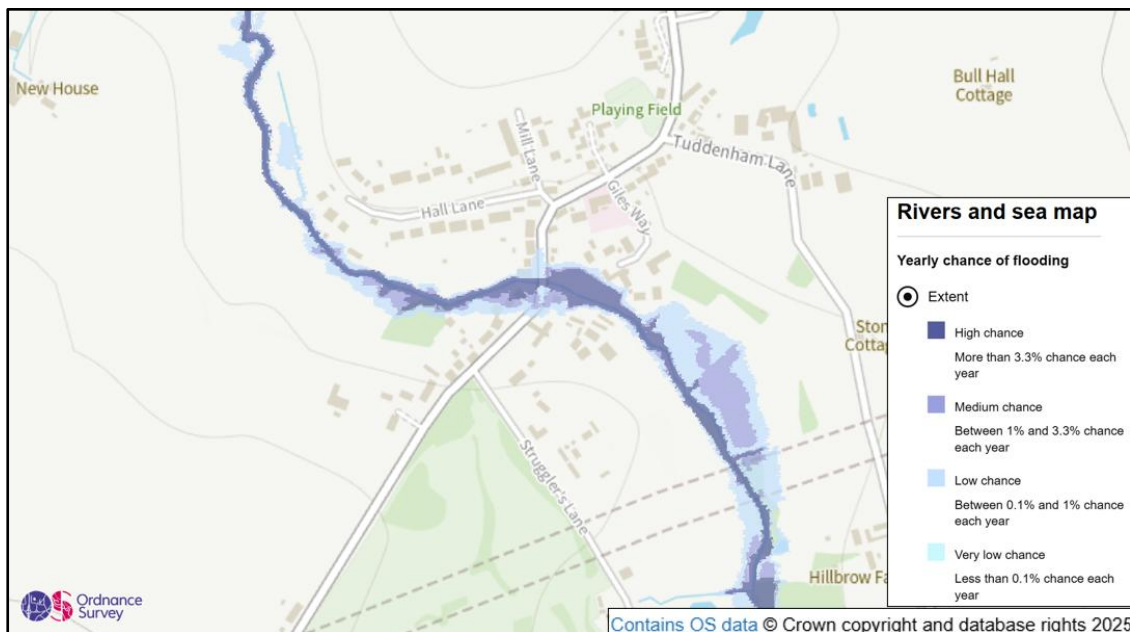
Figure 13. Witnesham flood risk from rivers and the sea

Residents reported that the road bridge inhibited the high flows, blocking the water from passing along the river. Floodwater also backed up onto the highway either side and over the road bridge (see Images 1 & 2). Surface water flows on the highway coming down the hill added to the extent of the floodwater. Local residents also stated a lack of river channel maintenance downstream of the road bridge, may have contributed to the heightened flood levels. The observed flood extents along The Street match closely with the national fluvial flood risk mapping (see Figure 13).

- Heavy rainfall on the morning of the 20 October caused the River Fynn to exceed capacity and the floodwater impacted properties along The Street directly from the rear.
- The flooding may have been exacerbated by the road bridge and a lack of in-channel maintenance downstream, slowing the flow and backing up floodwater toward properties and onto the highway.
- The area around the road bridge on The Street is shown to be at Medium to High risk of fluvial flooding on the national flood risk mapping.

- Residents to install Property Flood Resilience (PFR) via grant funded scheme.
- Landowners to carry out appropriate watercourse maintenance to reduce flood risk as necessary as per their riparian responsibilities.
- Explore potential NFM projects to ‘slow the flow’ and attenuate water on overland flow paths (leaky dams, restoration of watercourses, etc.) in the upper catchments and west of Witnesham.

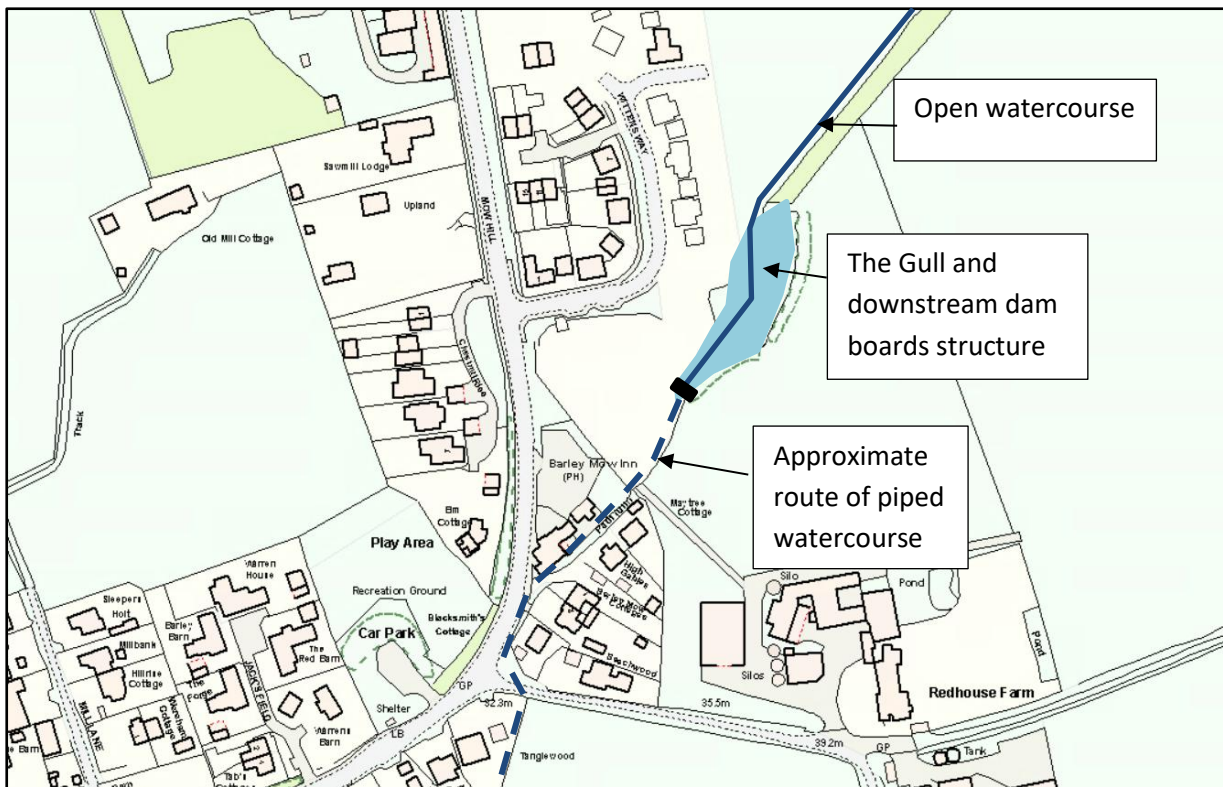
Figure 15. Watercourse and features north of Tuddenham Lane

There is a natural drainage feature known as 'the Gull', situated on this tributary, upstream of the impacted properties. The Gull can attenuate water due to a downstream damboard structure, designed as a flow control, which causes water to be held in the Gull. Downstream from the damboards, the watercourse is assumed to be piped. See Figure 15 for an overview of the drainage features in this location.

During Storm Babet, excess flows from adjacent farmland flowed overland to the south and west, bypassing the Gull and converged with flows from the development site before flowing overland towards Mow Hill. This flow is in addition to water in the piped watercourse that was flowing at full capacity. Surface water on the highway also added to the floodwater flows on Mow Hill and into the piped watercourse (see Figure 16).

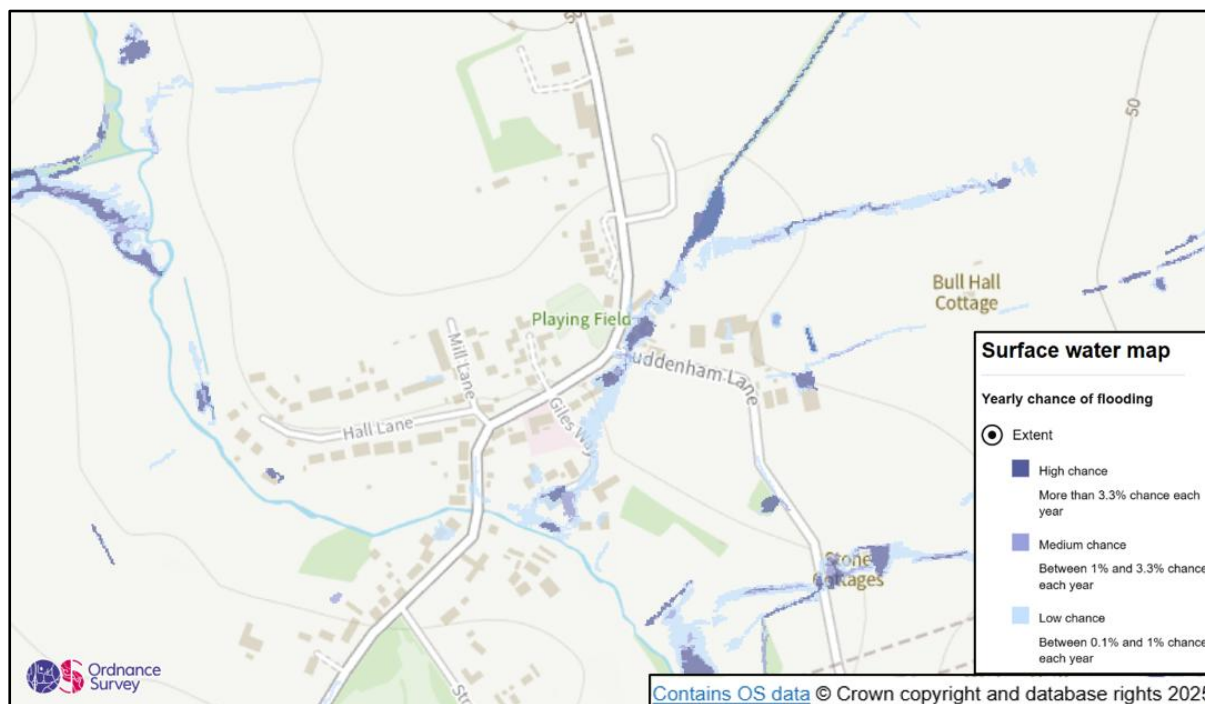
Figure 17. Surface water flood risk on Mow Hill, Tuddenham Lane and The Street

The observed extent and flowpaths of the floodwater in this area correlates closely with the national surface water flood risk map (Figure 16 above), with pluvial flood risk categorised as being medium to high on the affected areas of Mow Hill and Tuddenham Lane.

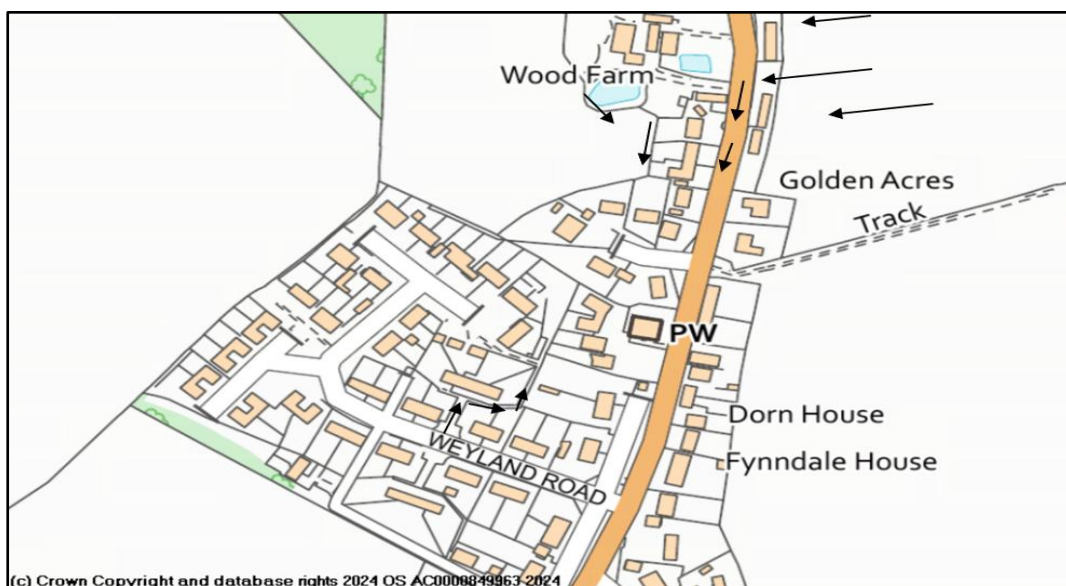
Figure 18. Approximate floodwater flow routes on Upper Street and Weyland Road

The primary source of flooding along Upper Street was pluvial runoff from the surrounding fields. One property cited the lack of maintenance of an overgrown ditch and an unploughed adjacent field as contributing to the drainage and flooding issue. There are also reports of some fields having no drainage feature(s) to intercept the surface water flows, and therefore flood water flowed directly off the field onto property and the highway. The sheer amount water was said to have overwhelmed drains outside the property.

On Weyland Road internal flooding occurred from surface water runoff directly from the public footpath. Floodwater impacted the property from the front and rear. There are no drainage assets to intercept floodwater along the footpath. This has been a recurrent issue on Weyland Road with regular flooding experienced after even moderate rainfall.

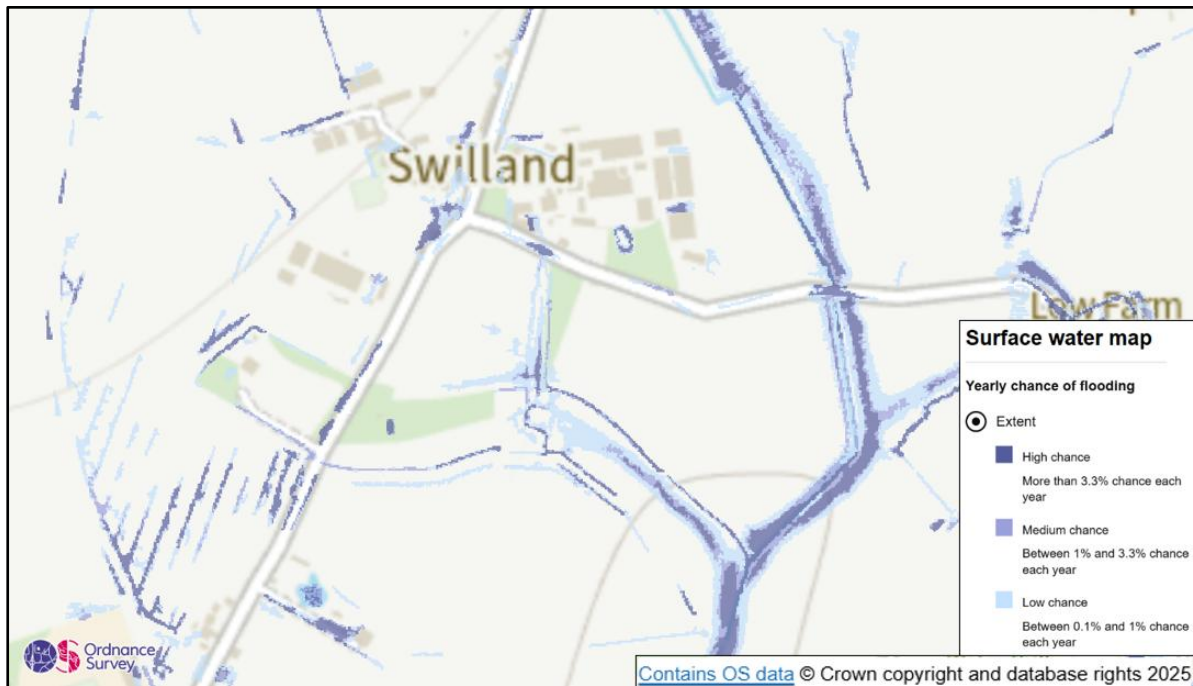
Figure 20. Surface Water flood risk in Swilland

Surface water flooding is characterised as low risk along Church Lane on the national flood risk mapping, and the observed pathway the floodwater followed is not shown (see Figure 19).
