Section 19 Flood and Water Management Act 2010

Tunstall Flood Investigation

Storm Babet 2023

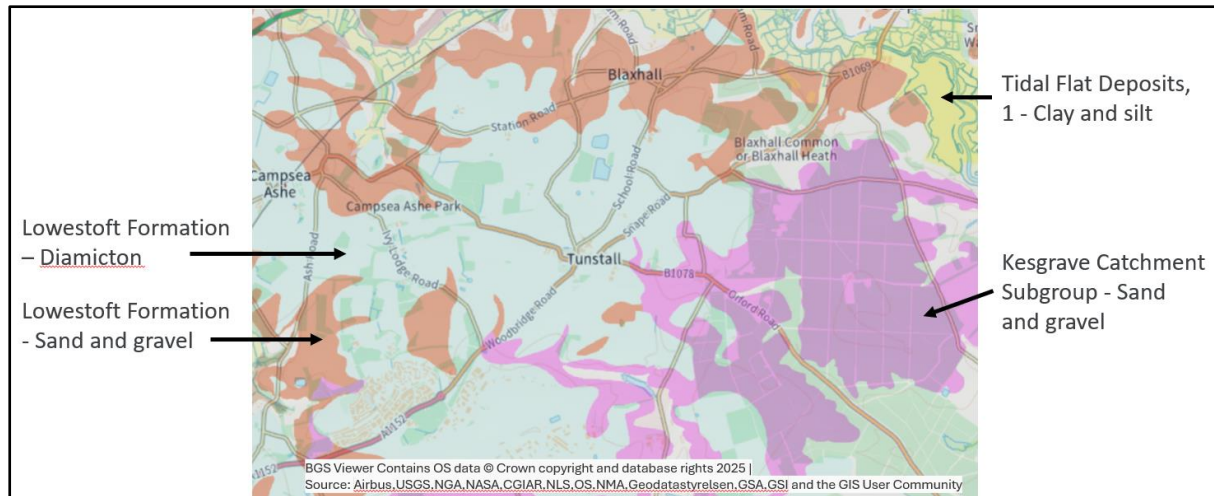
Fig. 7. Superficial geology (British Geological Society)

Fig. 7 shows that much of the superficial geology surrounding Tunstall is made up of 'Lowestoft Formation – Diamicton' which is described by the British Geological Survey as a diverse mixture of clay, sand, gravel, and boulders varying widely in size and shape. This is sometimes known as boulder clay. This generally has a low permeability

meaning water will tend to flow off it before it can infiltrate, which also reflects the reports collected during Storm Babet.
