Section 19 Flood and Water Management Act 2010

Wickham Market Flood Investigation - Storm Babet October 2023

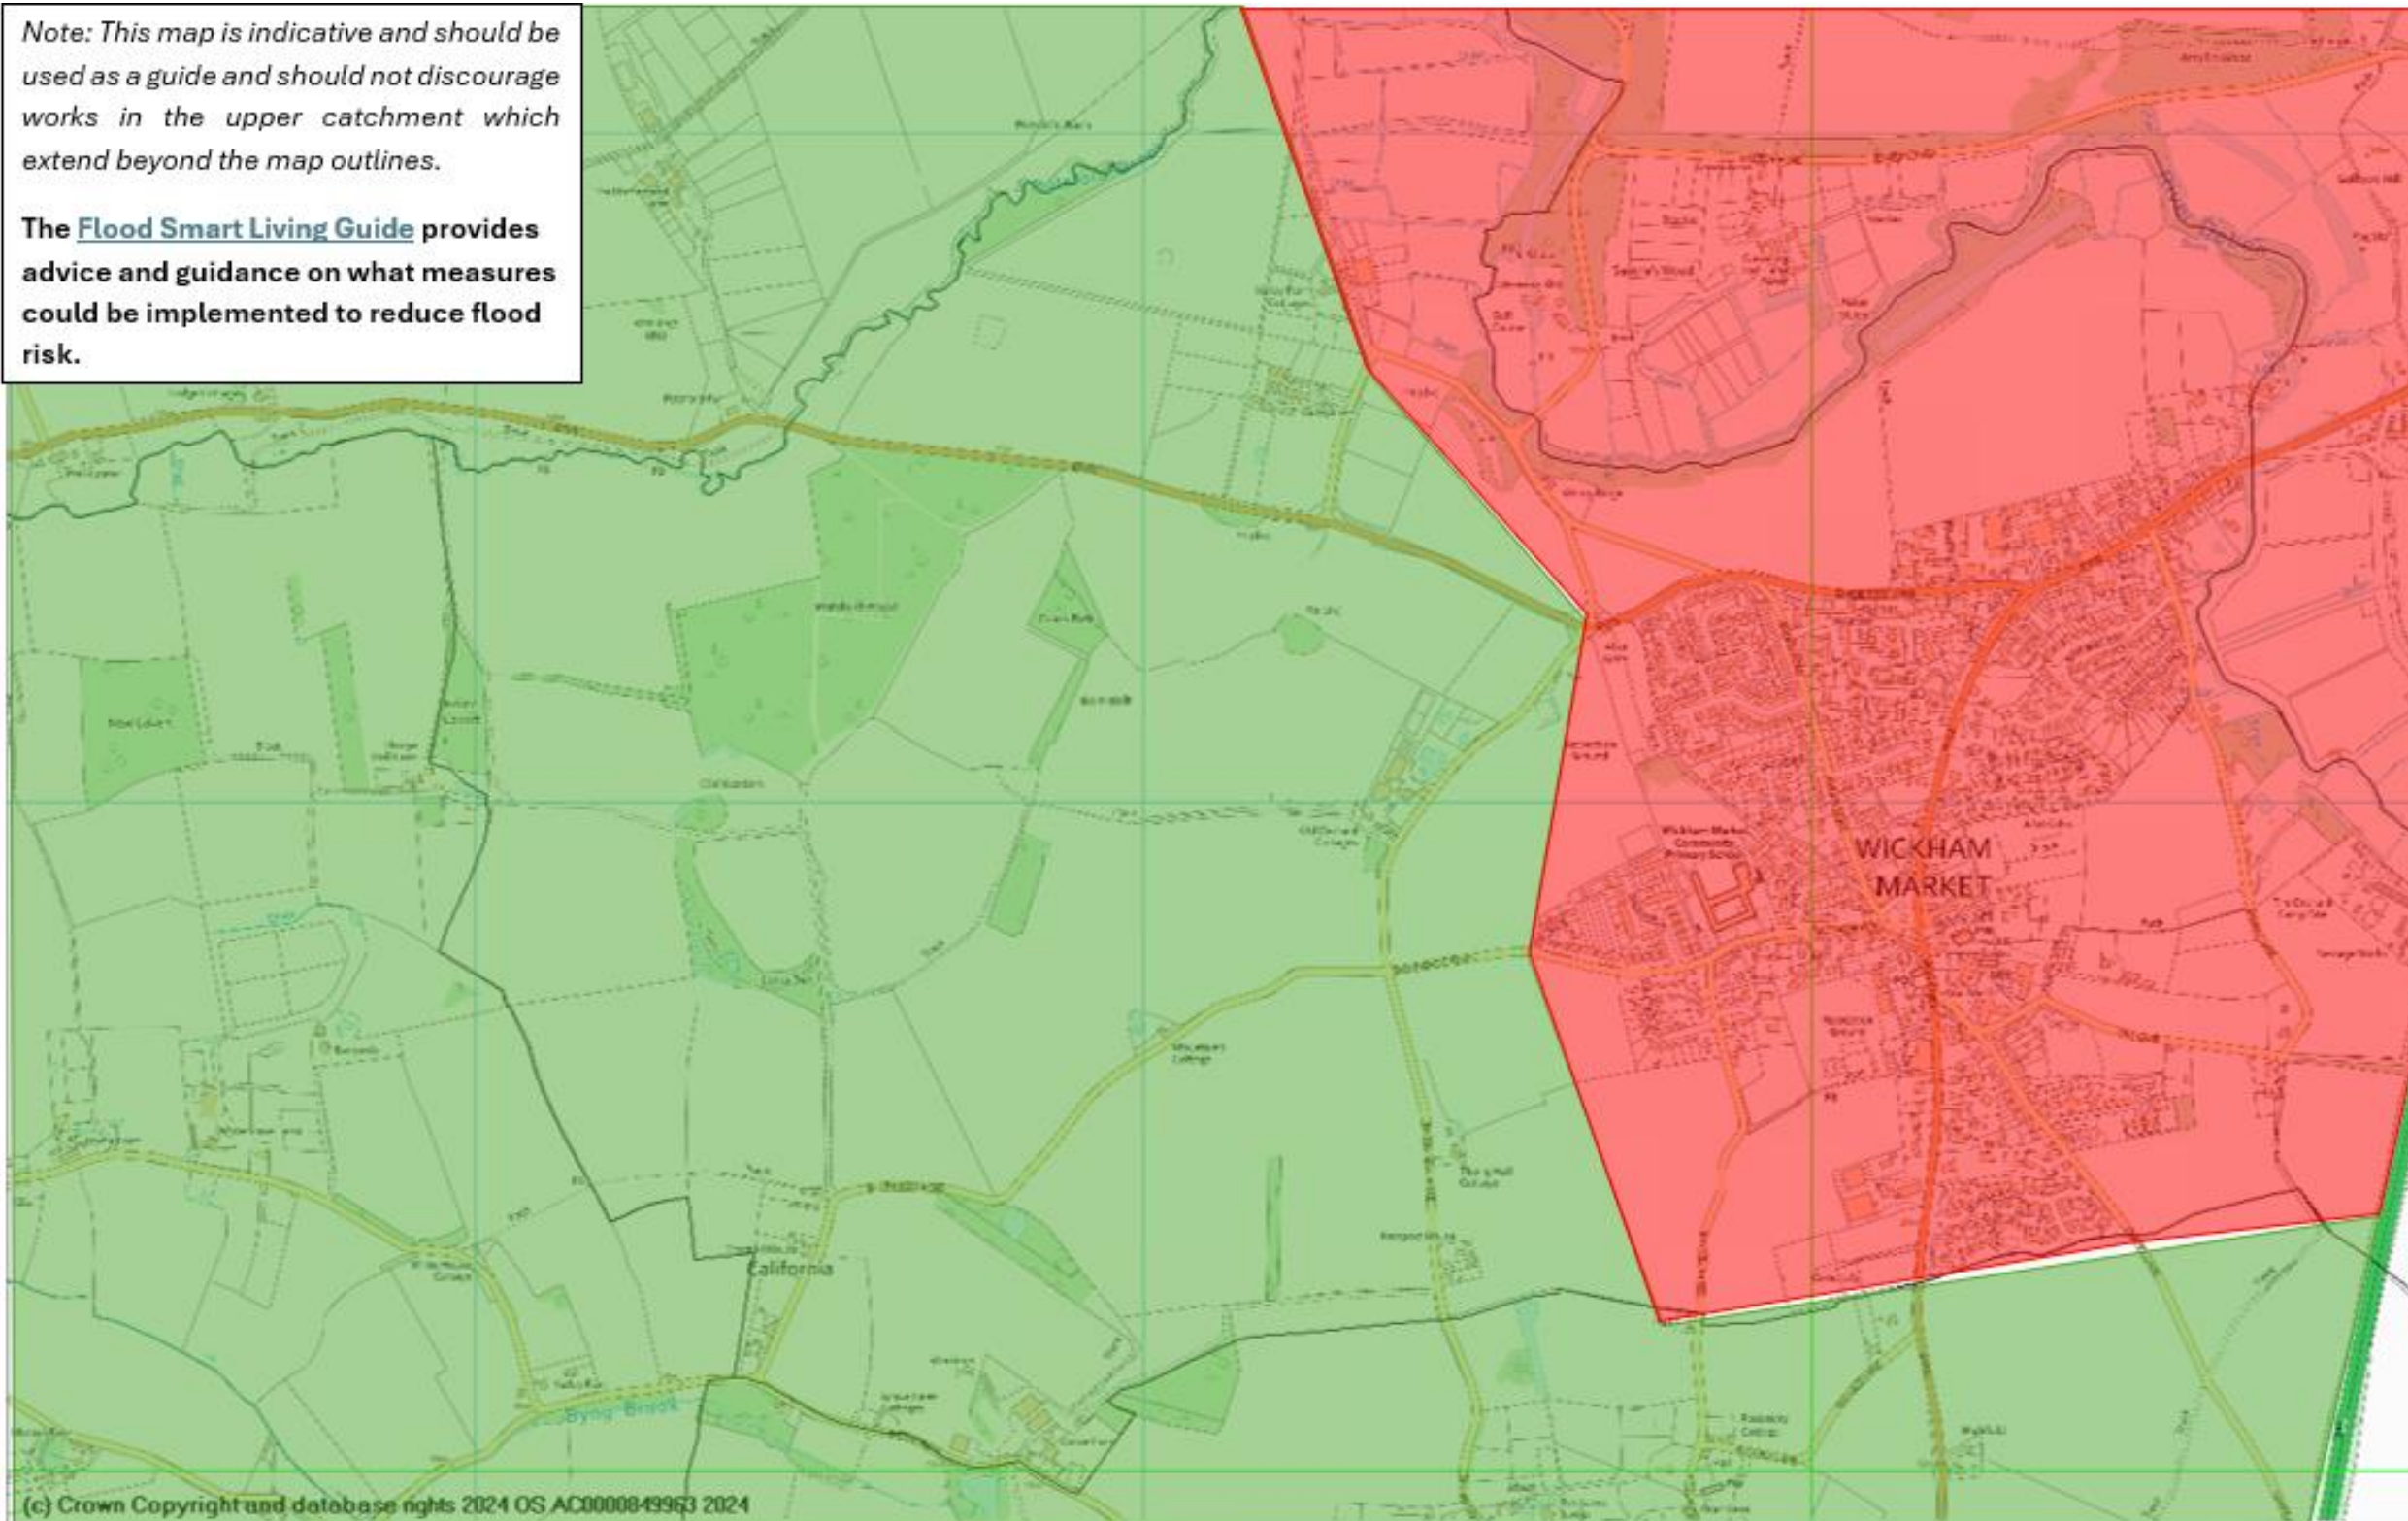
Red – Urban locations where watercourses should be kept clear and water free flowing.

These locations are vulnerable to flood risk and are where the most impact is experienced during an event. Drainage features are constrained with limited space for water and overwhelming of features may lead to flooding. Important to ensure water can flow through the systems with limited restrictions.
