Lead Local Flood Authority
Section 19 (Flood and Water Management Act
2010)
Flood Investigation Report

Birch Street, Stoke Road & Mill Street
Nayland with Wissington

FW2020-1063, FW2020-1311, FW2020-1315

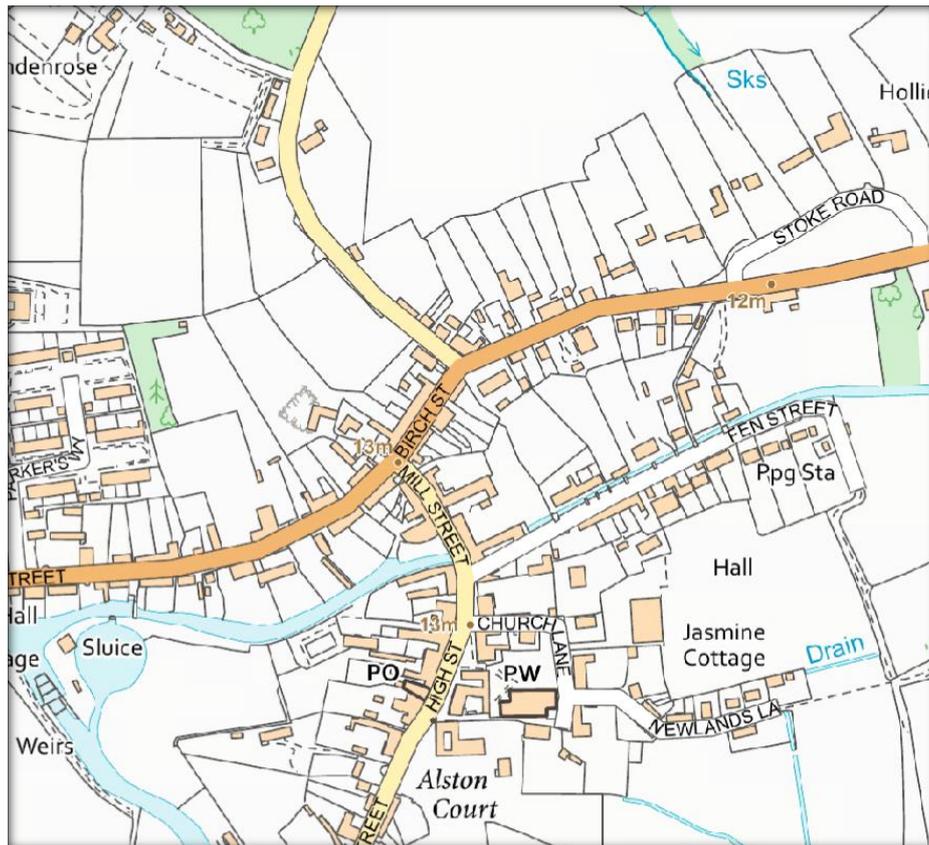
(Investigation area map)

2.6 OS Grid Reference: 597471 234392

2.7 Extent of flooding: Surface water flowed from Gravel Hill, on to Birch Street/Stoke Road before flowing on to Bear Street/Mill Street.
