Lead Local Flood Authority
Section 19 (Flood and Water Management Act
2010)
Flood Investigation Report

Birch Street, Stoke Road & Mill Street
Nayland with Wissington

FW2020-1063, FW2020-1311, FW2020-1315

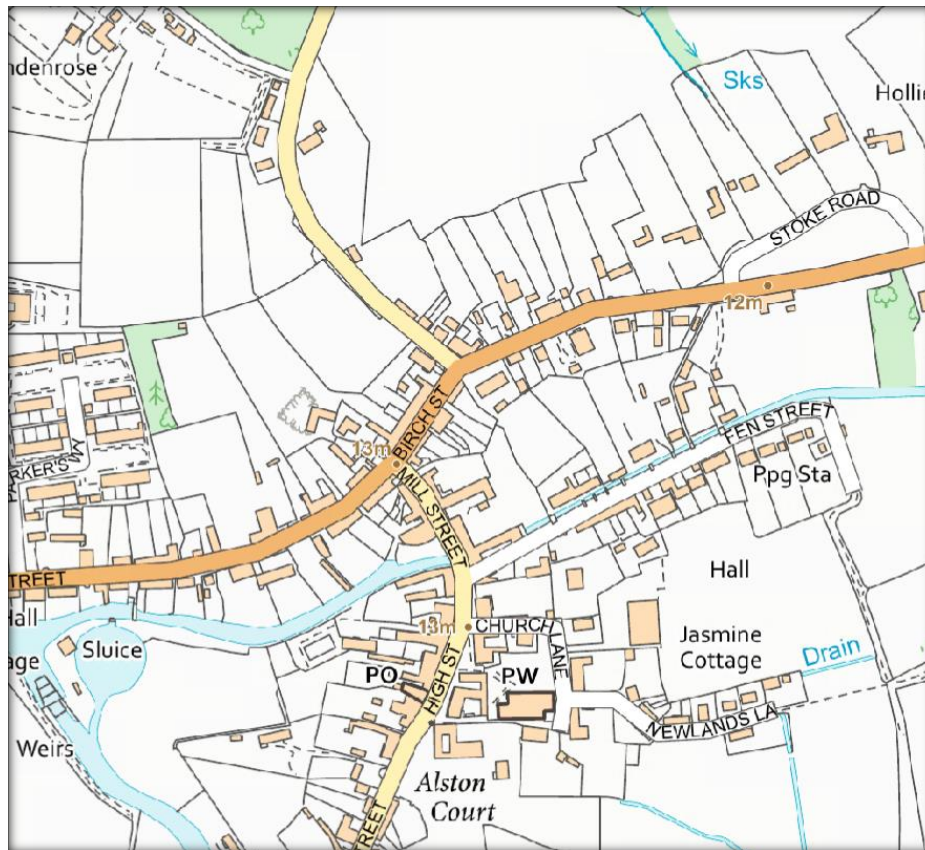
(Investigation area map)

2.7 Extent of flooding: Surface water flowed from Gravel Hill, on to Birch Street/Stoke Road before flowing on to Bear Street/Mill Street.

2.10 Flooding Source: Surface water runoff from the surrounding catchment draining to the low point at the junction of Birch Street & Bear Street & a second low point on Mill Street.
