**Flood Investigation Report**

Sheerwater Close and Mount Road

Bury St. Edmunds

FW2016-1215

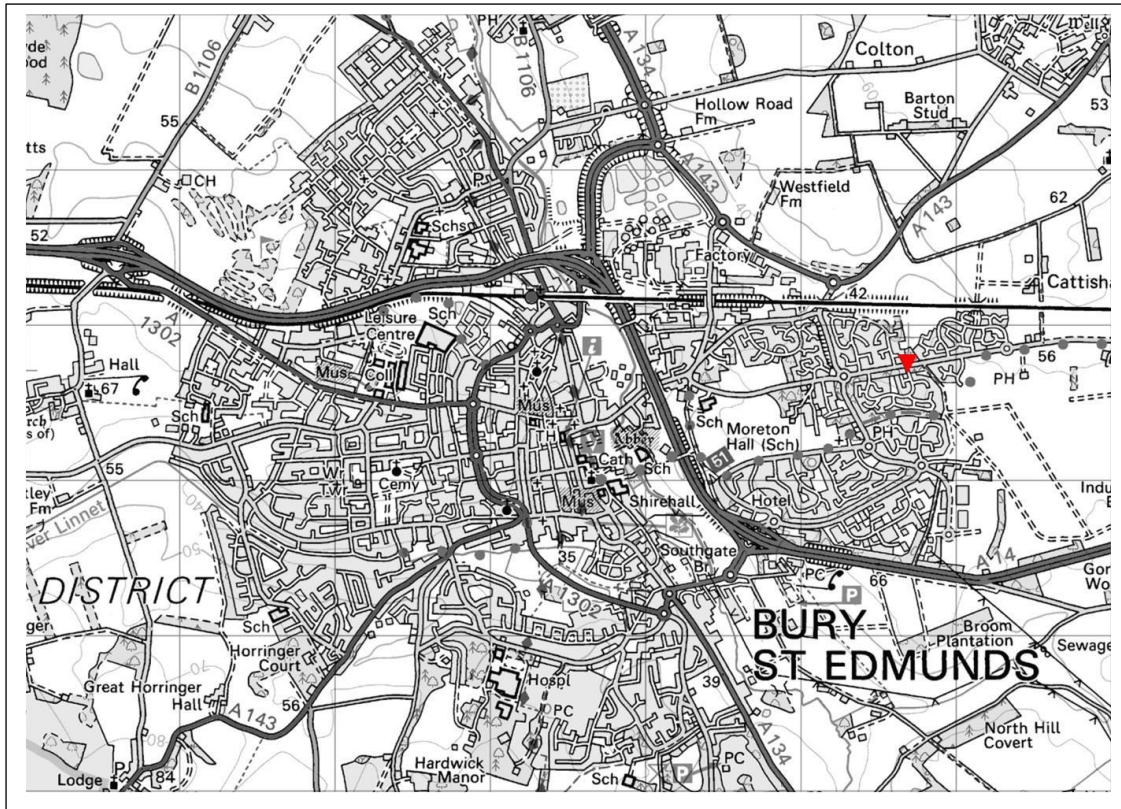
- 2.6 OS Grid Reference:** TL 8768 6473
- 2.7 Extent of flooding:** Deep surface water (>0.3m) within 1 property along the southern edge of Sheerwater Close. Mount Road carriageway, adjacent to these properties, also affected by deep surface water flooding.

- 2.10 Flooding Source:** An intense, localised storm event on the 20th June 2016 caused rapid runoff along Mount Road and Tassel Road. Both these roads are steeply inclined and converge towards a low point opposite Sheerwater Close. This low point is part of a natural flow path that runs in a north westerly direction through Sheerwater Close. Ultimately the development has been built in a valley where the properties have dammed the natural flow path resulting in pooling of deep surface water behind the properties. A number of measures in the highway have been installed to intercept runoff in the low point however these measures can be overwhelmed during high intensity summer storms.
