Lead Local Flood Authority
Section 19 (Flood and Water Management Act 2010)
Flood Investigation Report

Sudbury Rd (A134) Sicklesmere and
 Hambrook Close, Stanningfield Rd, Great Whelnetham

FW2020-0949	FW2020-0939
FW2020-0951

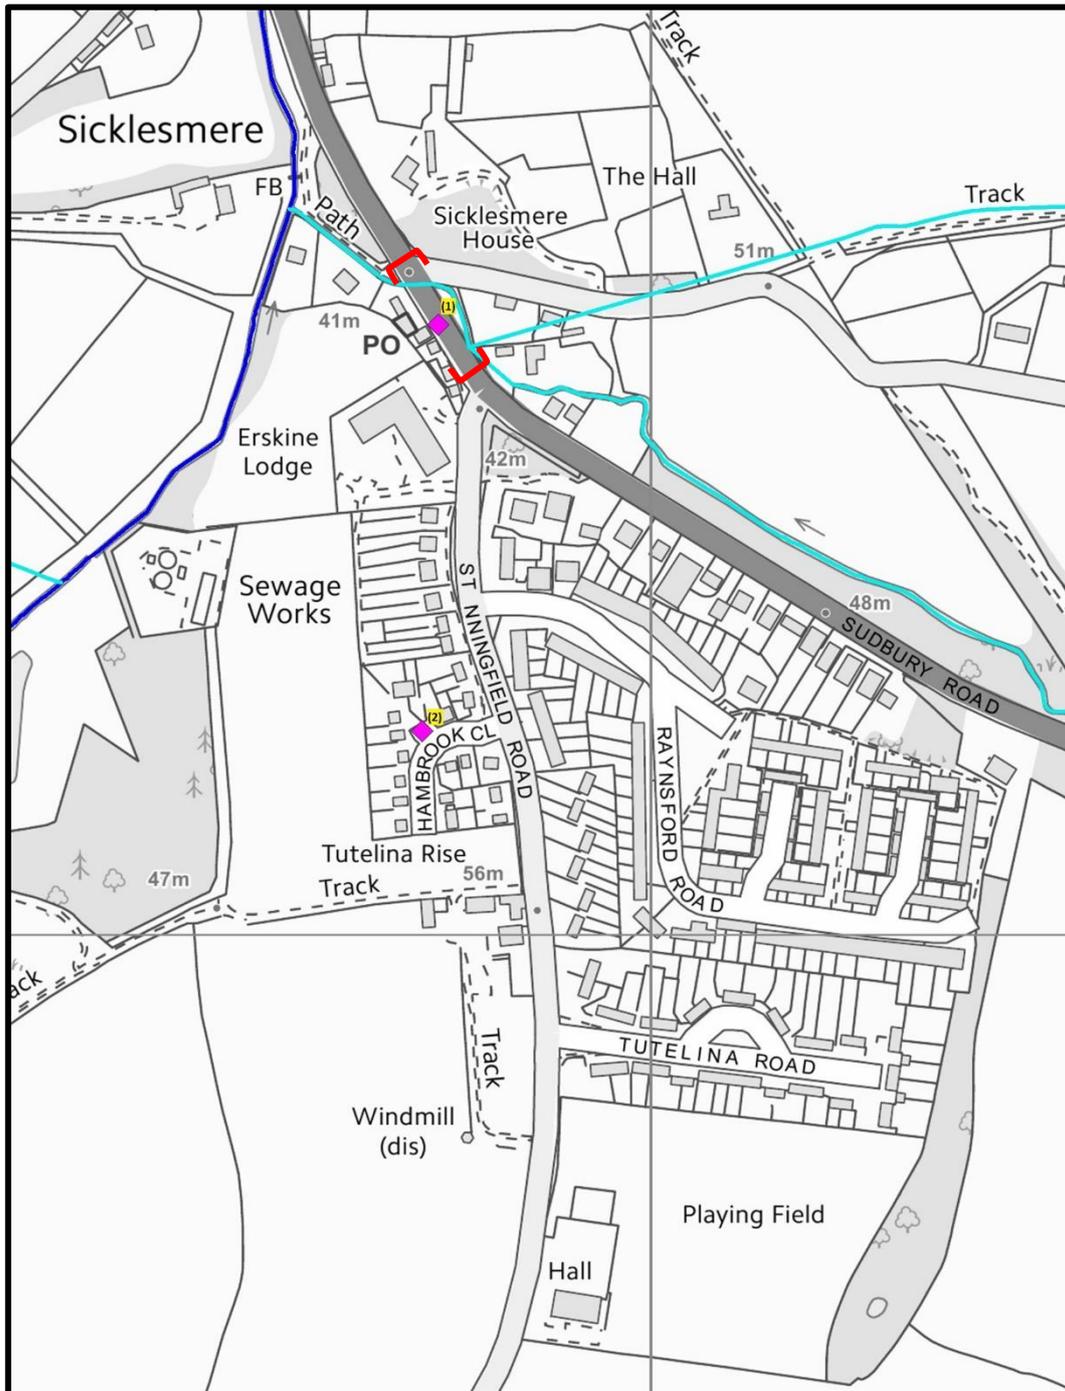
2.6 OS Grid Reference: TL 87850 60135 & TL 87860 60404

2.7 Extent of flooding: (1) Surface water (0.1<x>0.4m) within 3 properties and carriageway (A134) opposite to these properties, also affected by extensive deep surface water flooding. (2) Surface water (<0.3m) within 1 property – localised ponding in highway.

- Large Undrained Catchment - Stanningfield Rd and A134 have a combined catchment area of approx. 5,200m² from high point (Community Centre, shown as 'Hall' on the map) to low point (A134/Little Whelnetham Rd). 80% of this road catchment (4000m²) is effectively undrained and steeply inclined promoting fast runoff towards the natural low point. The only major highway drainage system starts at the bottom end of Stanningfield Rd. Overall 600m of Stanningfield Rd is largely undrained likely overloading what road drainage does exist or missing it altogether due to high flow velocities.
- Multiple new developments have been constructed and measures to prevent runoff onto the highways are provided in places but overall is limited.
- SCC Highways carried out initial surveys of existing drainage systems serving this catchment in June/July 2020. There was evidence of blockages within the
